**Subject: Transmittal of Technical Memoranda –  
Evaluation of Nickel Concentrations in Groundwater and  
Habitat Evaluation of Drainage Ditches  
Information Requested by Department of Environmental Health  
related to the Oakland Maintenance Center Site, 1100 Airport Drive  
Oakland, California  
(Site#: RO00000414 – MOIA, United Airlines)**

**Subject:** **Evaluation of Nickel Concentrations in Groundwater, Oakland Maintenance Center Site, 1100 Airport Drive, Oakland, California (Toxic Leaks Case RO0000414)**

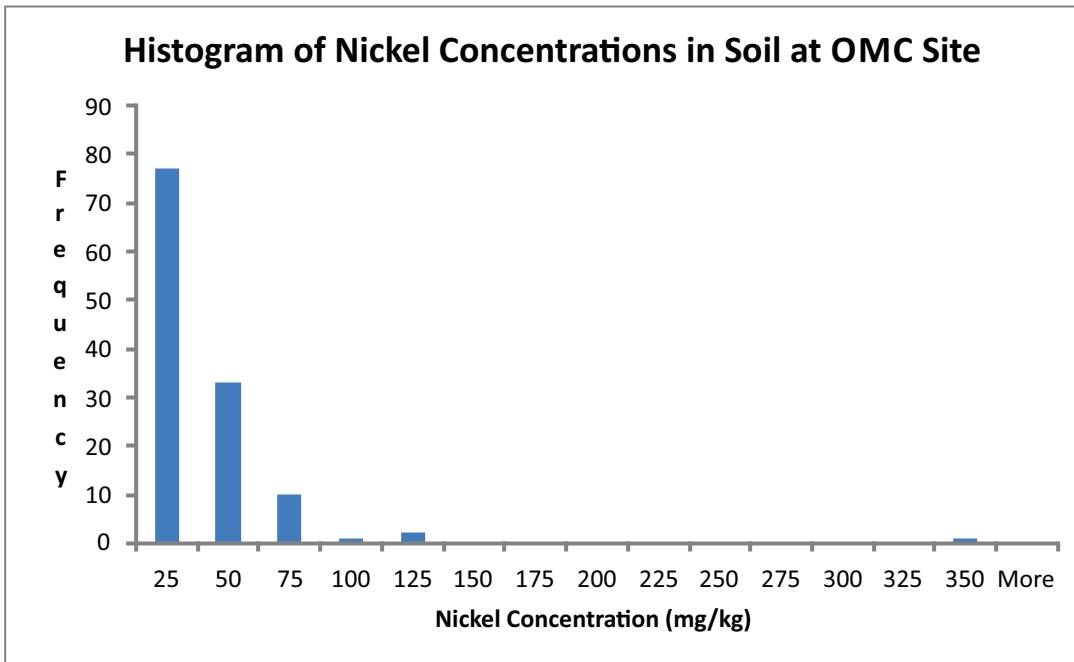
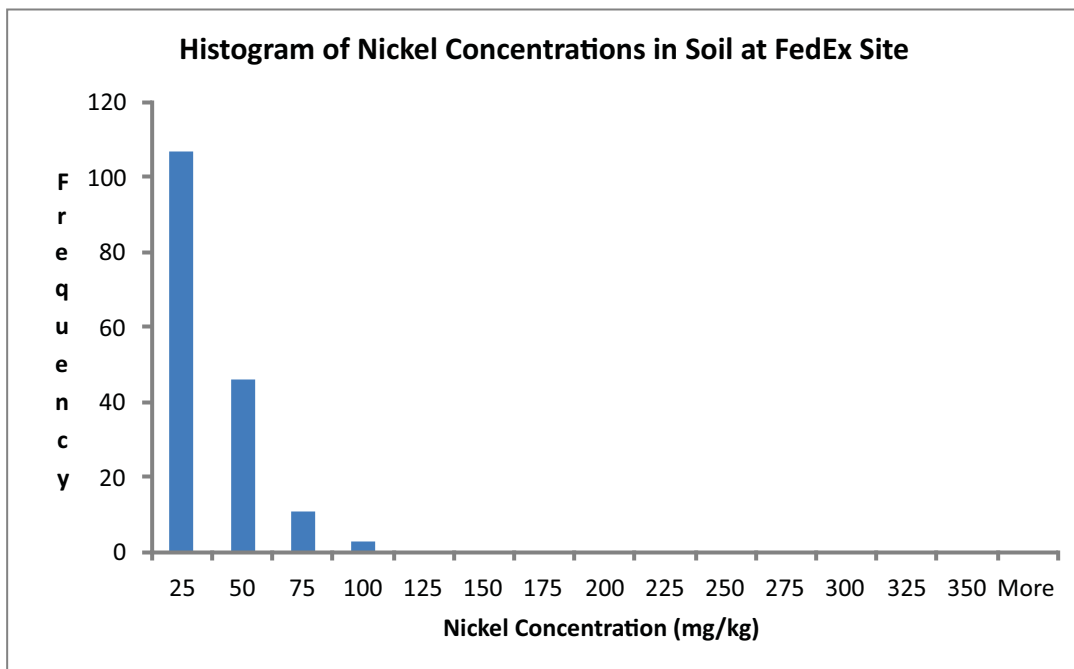
# NORMAL Q-Q AND BOX PLOT OF NICKEL CONCENTRATIONS IN SOIL

There are 124 and 166 data values for nickel concentrations in soil from the OMC and FedEx sites, respectively. These data are tabulated in Attachment B, the basic statistics on the data sets are provided in Table 2, and the histograms of the data sets are shown in Figure 5. The basic statistics indicate that the nickel concentrations on the OMC Site appear somewhat higher and more variable than the data from the FedEx site. The histograms show that both distributions are highly skewed to the right, with the OMC data set being more highly skewed. Figure 6 contains normal quantile-quantile plots and box plots of both sets of data. The plots illustrate that the OMC and FedEx data have somewhat different shapes, indicating that they are not likely from the same population.

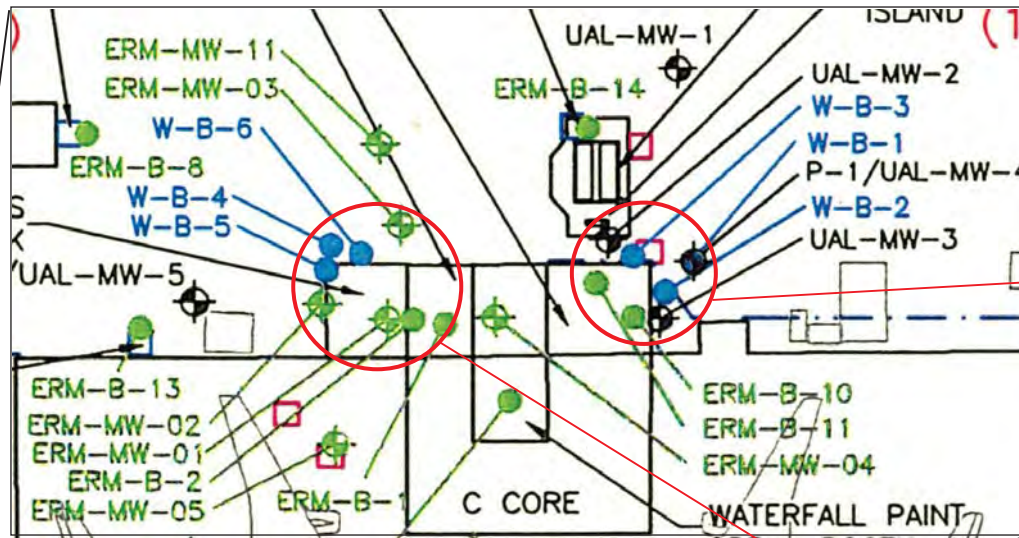
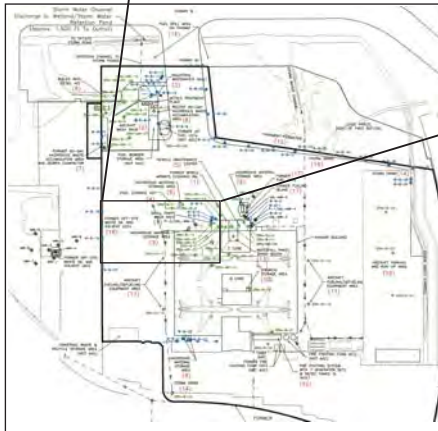
Sample Location	Date Sampled	Nickel in Groundwater ( $\mu\text{g/L}$ )
ERM-B-10	4/17/2003	<20
ERM-B-11	4/17/2003	<20
W-B-1	4/14/2003	<50
W-B-2	4/14/2003	<20
W-B-2 (c)	4/14/2003	<50
W-B-3	4/15/2003	<20
W-B-3 (c)	4/15/2003	60
UAL-MW-2	4/15/2003	<50
UAL-MW-3	4/15/2003	100
UAL-MW-4	4/22/2003	<50

Sample Location	Date Sampled	Nickel in Groundwater ( $\mu\text{g/L}$ )
ERM-B-1	4/15/2003	190
ERM-B-2	4/15/2003	130
W-B-4	4/15/2003	<20
W-B-5	4/15/2003	64
W-B-6	4/15/2003	31
ERM-MW-01	5/9/2003	90
ERM-MW-01	11/6/2003	190
ERM-MW-01	6/27/2006	71
ERM-MW-02	5/9/2003	36
ERM-MW-02	11/6/2003	15
ERM-MW-02	6/27/2006	24
ERM-MW-03	5/9/2003	<30
ERM-MW-03	11/6/2003	49
ERM-MW-03	6/27/2006	39

Source: Figure 4 from report titled *Former United Airlines Maintenance Center, Site Investigation and Risk Assessment Report, Oakland, California*, by ERM, dated June 2004.

Table 1 summarizes and Figure 7 illustrates nickel concentrations in groundwater samples collected from wells at the OMC Site in 2003 and 2006, when the major investigations were conducted. Twenty-one wells were sampled in as many as three separate groundwater monitoring events where nickel was analyzed. Nickel concentrations ranged from less than the laboratory reporting limits (note that laboratory reporting limits were as high as 50 µg/l) up to 590 µg/l. Higher concentrations were found under and near the northwestern edge of the hangar building (wells ERM-MW-1, ERM-MW-3, ERM-MW-4, ERM-MW-11, ERM-MW-13, and ERM-MW-14) and in area about 500 feet northwest of the hangar (wells ERM-MW-7, ERM-MW-8, ERM-MW-9, ERM-MW-10, and ERM-MW-15).

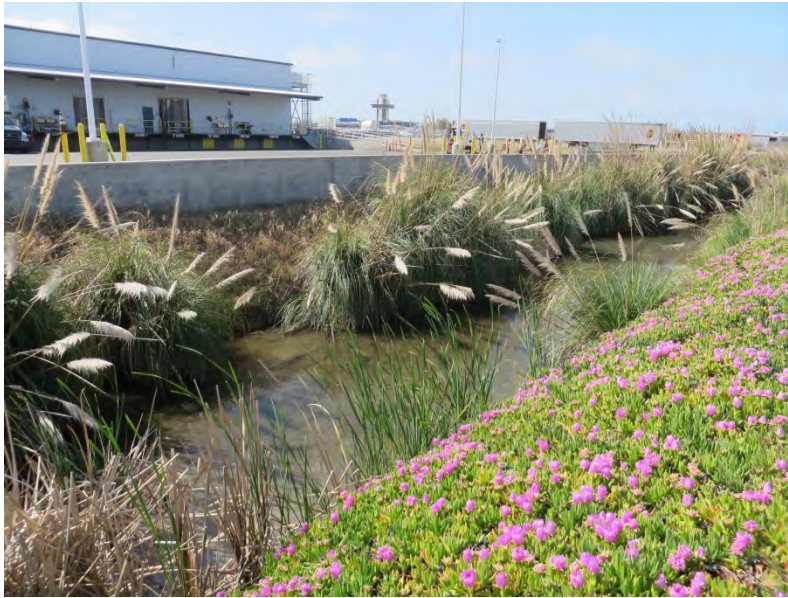
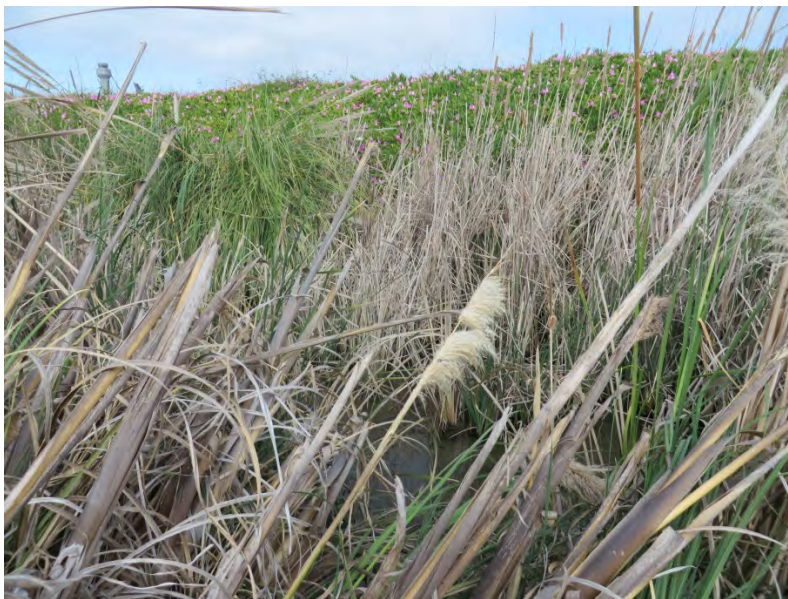
#### Photos #1 and #2

**Drainage Ditch 1 Vegetation:** Illustrates dominant vegetation (cattails, pampas grass, and Chilean iceplant) growing along the banks of Drainage Ditch 1 (top photo) and close-up of a transect (bottom photo), showing cattails and pampas grass.

**Drainage Ditch 1.** Within Drainage Ditch 1, the dominant vegetation is consistently cattail, a species tolerant of both freshwater and brackish water ecosystems. Pampas grass and ice plant are both species with general tolerances, and are typically found in upland habitats, but are not intolerant of freshwater or brackish water ecosystems. Indications of salinity within Drainage Ditch 1 included salt crust forming on dead vegetation, and loose soils.

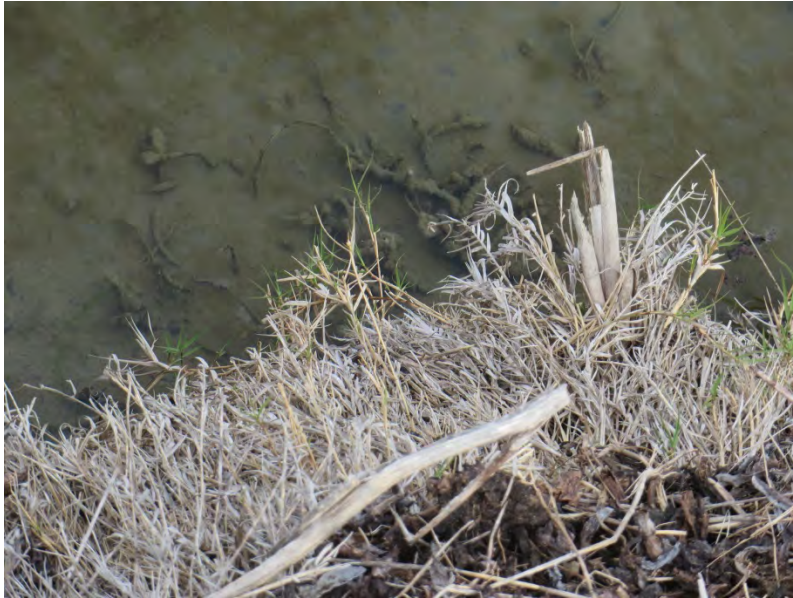
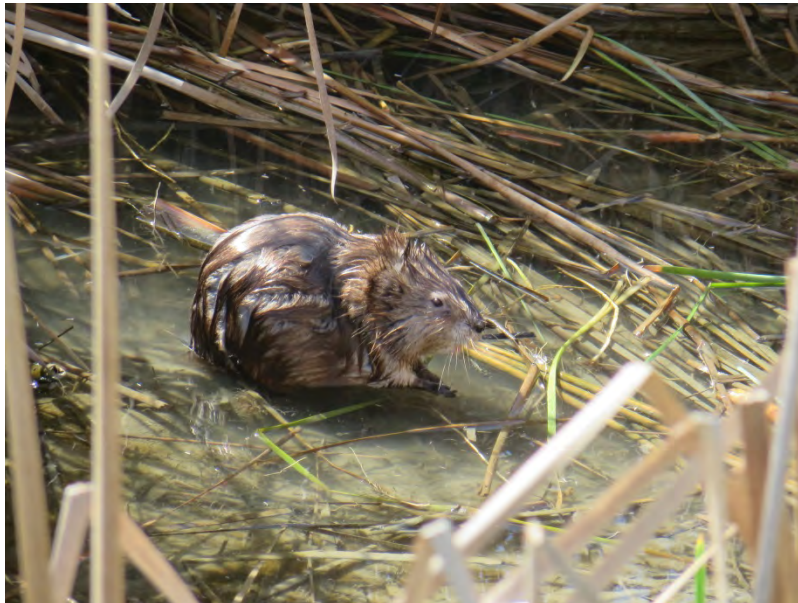
#### Photos #3 and #4

**Drainage Ditch 1: Illustrates salt encrusting the roots of salt grass (top photo) and a muskrat, a (typically) freshwater-dwelling rodent observed in Drainage Ditch 1 (bottom photo)**

Although wildlife was not the focus of the survey, the wildlife species observed during the surveys are summarized in Attachment D. Additional wildlife observations included breeding behavior of red-winged blackbirds within both of the drainage ditches and the sighting of a muskrat shown in Photo 4 (Attachment B).

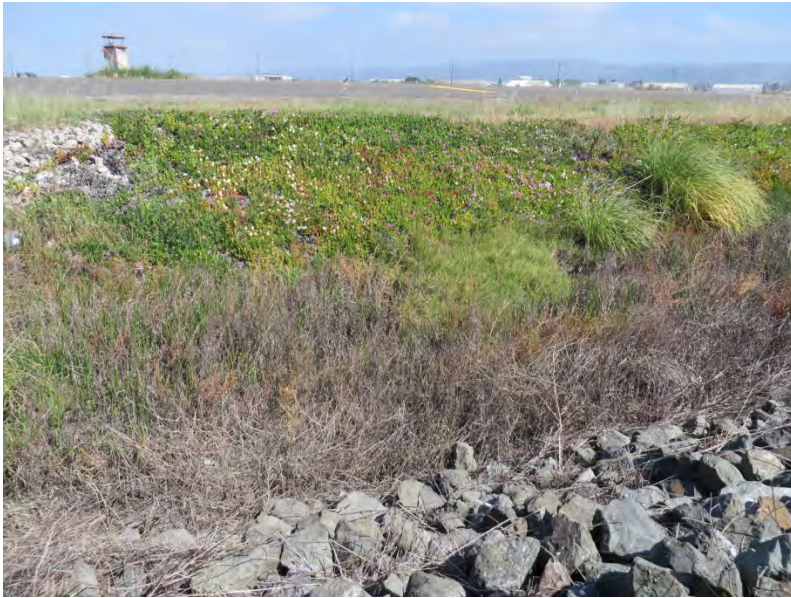
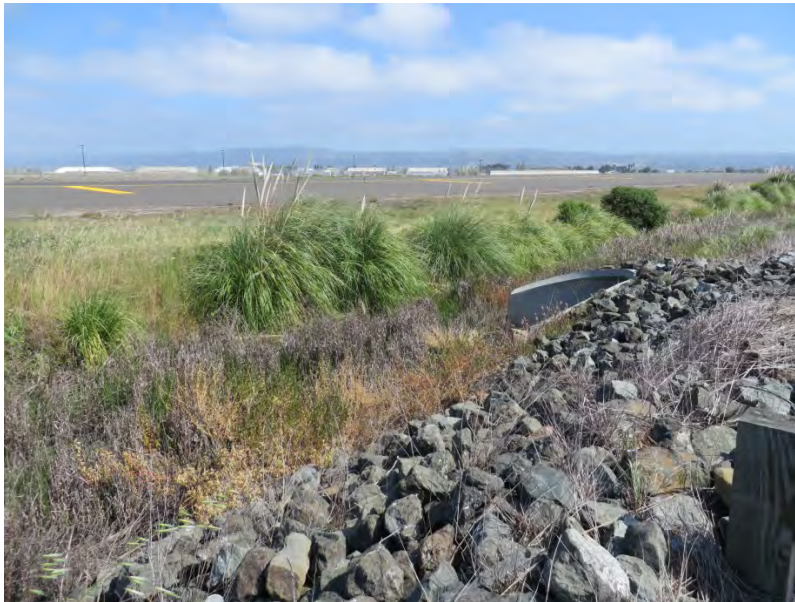
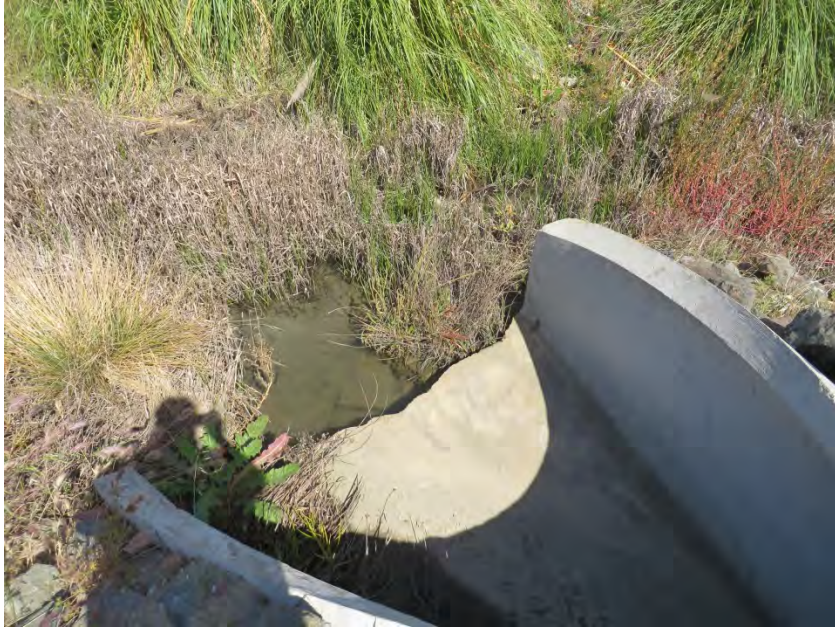
Photos #5, #6, and #7

**Drainage Ditch 2 Vegetation:** dominant vegetation growing along the banks of Drainage Ditch 2 (top photo) includes pickleweed, fathen, and saltgrass. The overview of the drainage ditch (center photo) shows alkali bulrush and fathen growing throughout the ditch. Photo #7 shows freshwater (rushes) and brackish water (alkali bulrush, fathen, and pickleweed) species adjacent to a culvert outlet.

Plant species typical of brackish habitats are dominant at Drainage Ditch 2. Based on the observed species, it is likely that the soil and water salinity is higher in Drainage Ditch 2 compared to Drainage Ditch 1, but the soil salinity is not likely to exceed 18 ppt for extended periods of time.
