Soil Vapor Intrusion Assessment

Chevron Service Station 90076
4265 Foothill Boulevard
Oakland, California
Fuel Leak Case No. RO0000427

GHD | 5900 Hollis Street, Suite A, Emeryville, CA
311977 | 2017.3 | 04.05 | Report No 33 | December 15, 2017

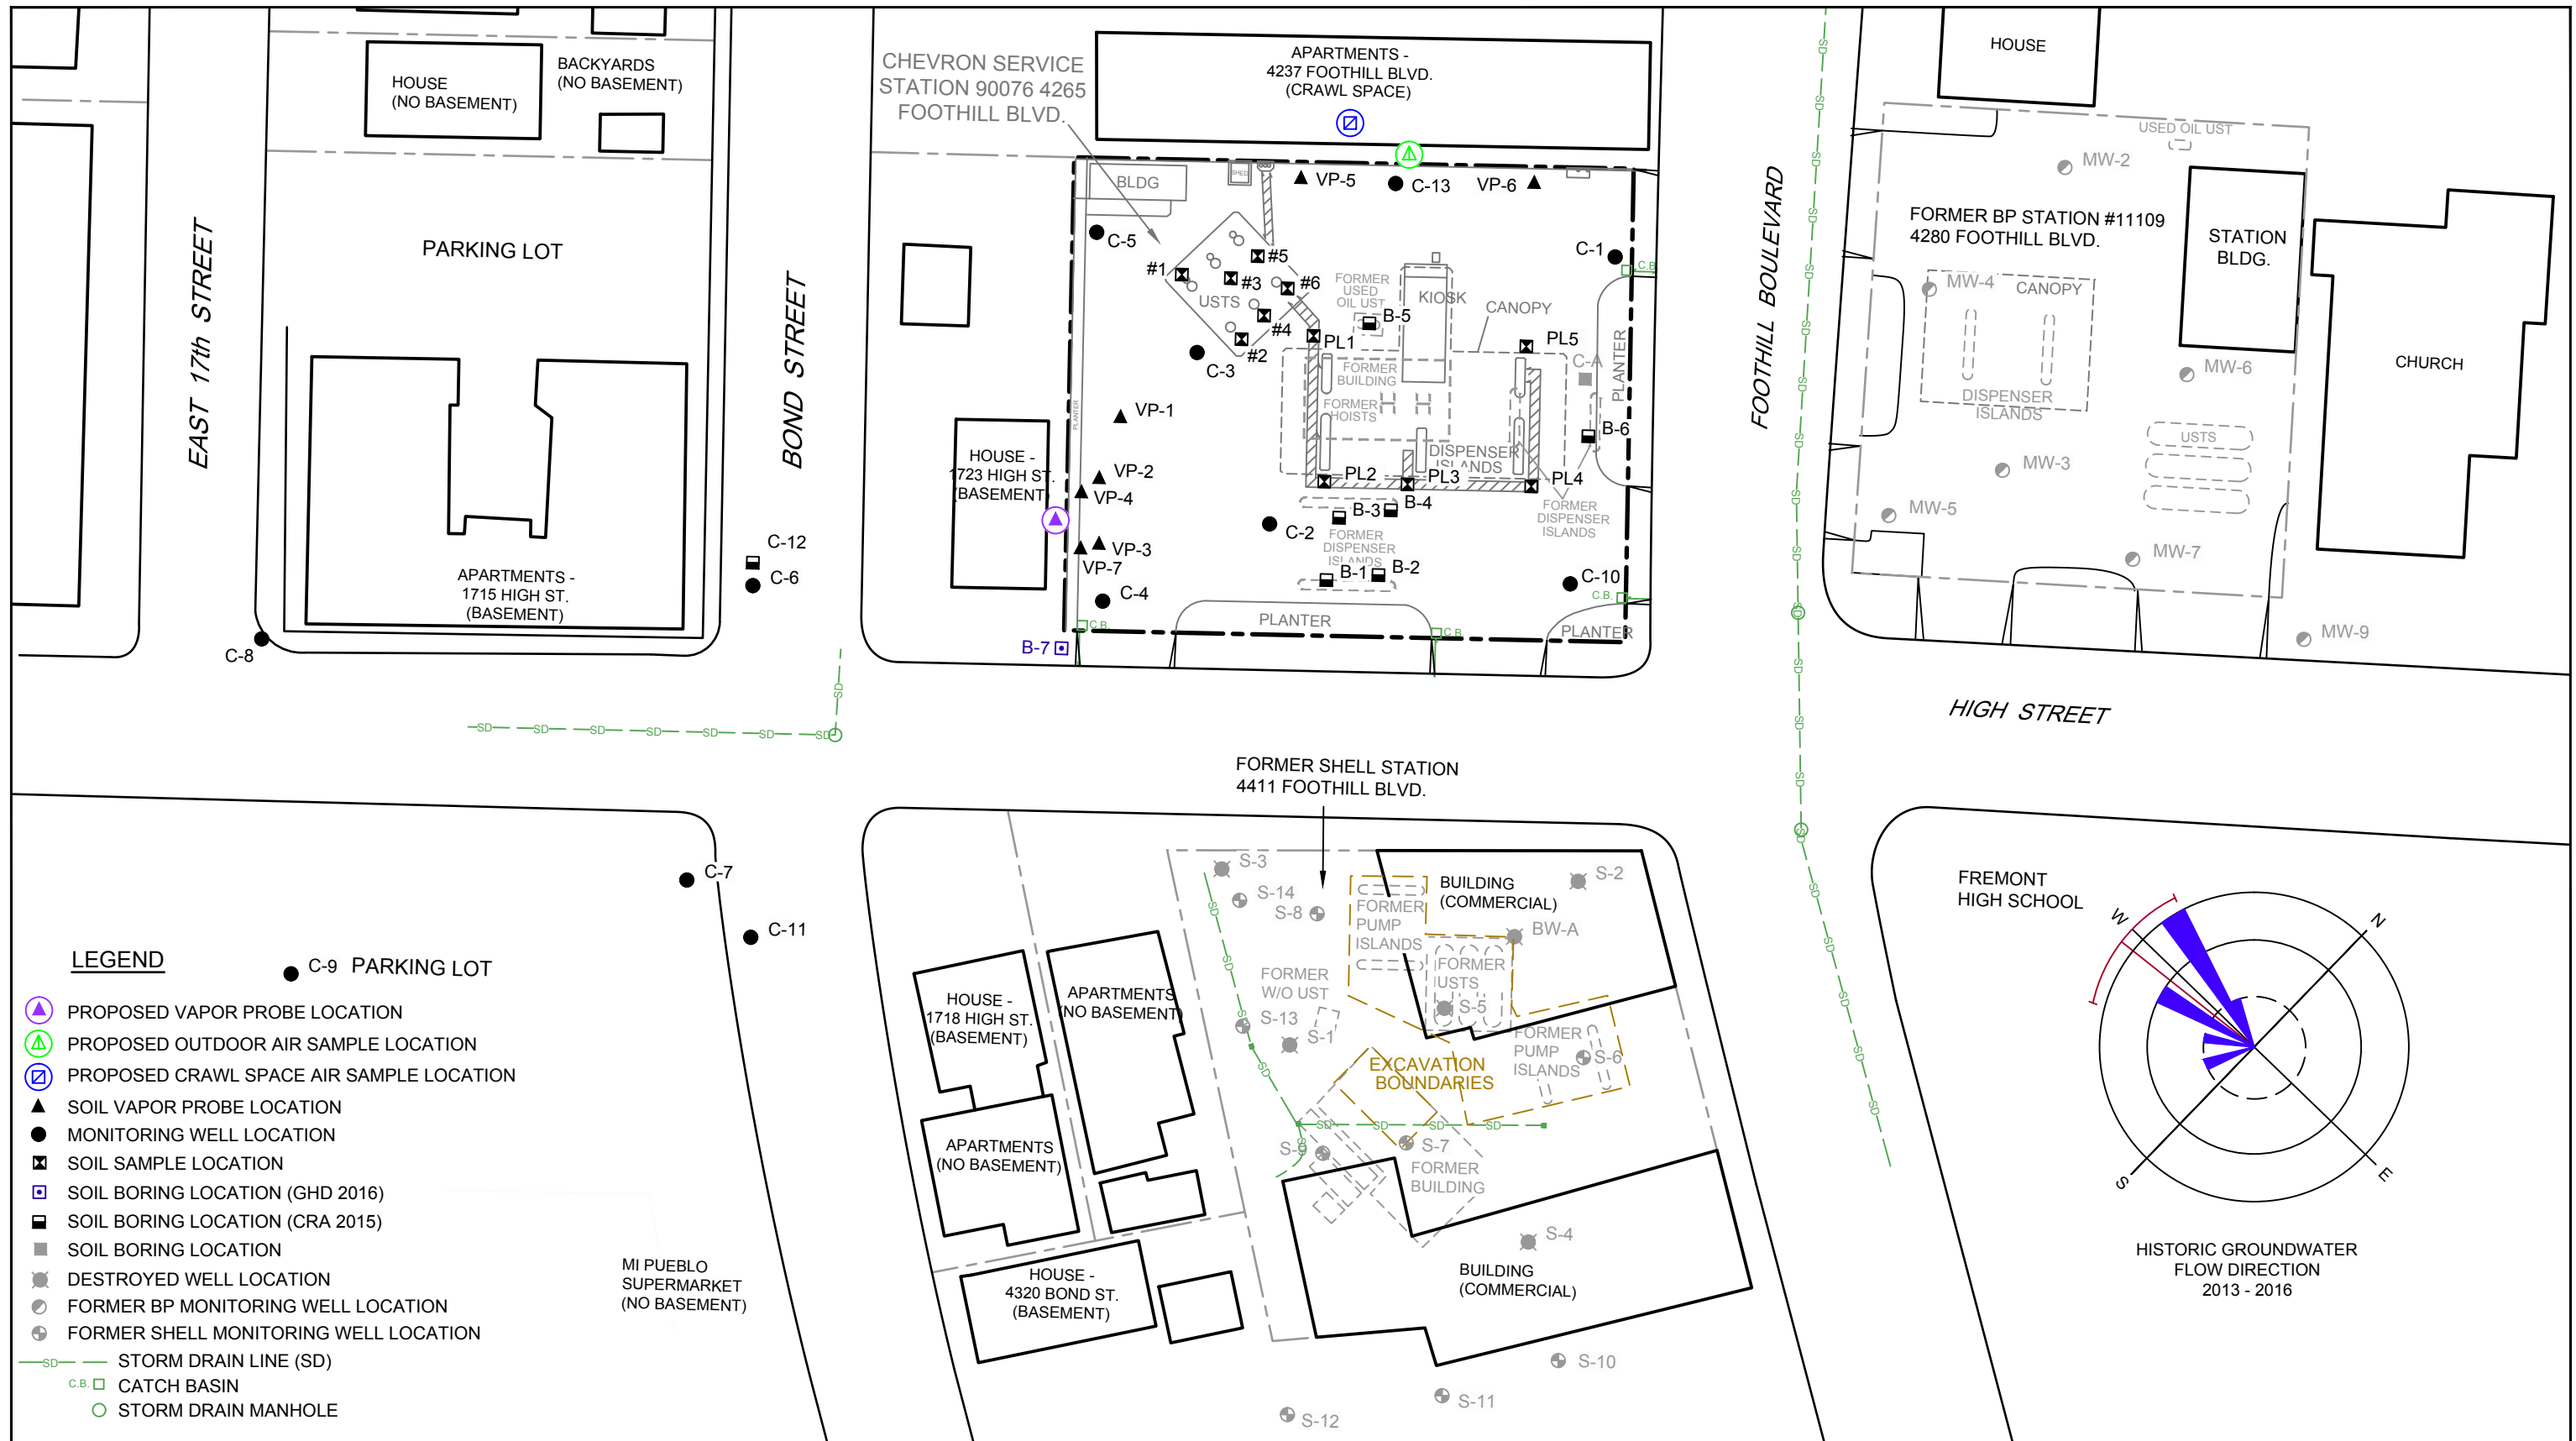
Figure 2

SITE PLAN

On November 2, 2017, GHD oversaw the advancement of soil vapor boring VP-7 near the southwestern border of the site (Figure 2). Prior to soil boring advancement, GHD tagged the depth to groundwater in nearby well C-4 to confirm groundwater was deeper than 7 fbg; depth to groundwater was measured at approximately 12 fbg. Therefore, the boring was advanced to a total depth of 7.5 fbg using a 2.75-inch outside diameter hand auger. A GHD geologist logged soil using the ASTM D2488-06 Unified Soil Classification System. Soil was field-screened using a photo-ionization detector (PID). A boring log showing lithology and PID data collected in the field is included in Appendix D.

Although depth to groundwater in nearby well C-4 was measured at approximately 12 fbg, a column of water entered the VP-7 probe/tubing and therefore no soil vapor sample was collected. Based on the fact water entered VP-7 at 7 fbg and previously entered VP-2 at 5 fbg, but not VP-3 and VP-4 at 5 fbg, it appears intermittent shallow perched water exists in the southwestern portion of the site (Figure 2). The station operates a hand car wash on weekends in the southwestern portion of the site. An onsite catch basin located in the southwestern corner of the site (Figure 2) catches water

from the hand car wash as well as rainwater, which may be contributing to shallow perched water entering VP-7 and VP-2 tubing. Therefore, GHD proposes the following order of approaches:

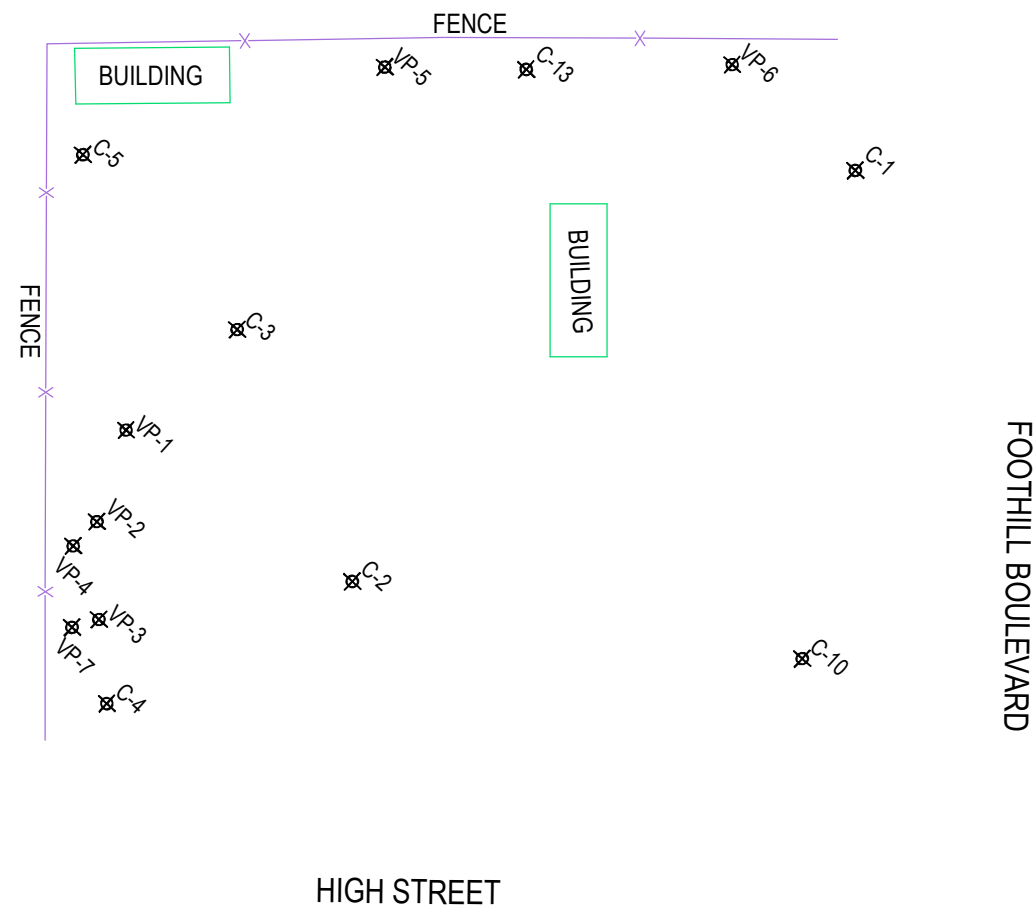
DESC.	NORTHING	EASTING	LATITUDE	LONGITUDE	EL. PVC	EL. RIM
C-1	2109146.1	6066818.3	37.7748960	-122.2122443	40.69	41.44
C-2	2109012.1	6066798.7	37.7745271	-122.2123036	40.05	41.22
C-3	2109034.7	6066745.6	37.7745947	-122.2124889	40.62	41.41
C-4	2108958.9	6066778.1	37.7743799	-122.2123715	38.69	39.56
C-5	2109039.9	6066697.3	37.7745983	-122.2126562	41.11	41.53
C-6	2108887.0	6066696.7	37.7741784	-122.2126486	37.94	38.52
C-7	2108807.1	6066745.4	37.7739615	-122.2124750	N/A	38.04
C-8	2108769.3	6066598.6	37.7738520	-122.2129805	37.22	37.72
C-9	2108700.9	6066677.3	37.7736664	-122.2127039	N/A	36.98
C-10	2109063.5	6066878.7	37.7746722	-122.2120301	40.96	41.26
C-11	2108808.1	6066772.0	37.7739656	-122.2123831	36.79	37.43
C-13	2109115.2	6066753.5	37.7748080	-122.2124666	42.02	42.47
VP-1	2109003.6	6066742.6				
VP-2	2108985.4	6066751.0				
VP-3	2108970.7	6066765.1				
VP-4	2108978.4	6066750.1				
VP-5	2109095.8	6066731.4

VP-6	2109145.1	6066748.5				
VP-7	2108965.8	6066762.0

Soil vapor probe VP-7 was constructed using a 1-inch long, stainless steel vapor screen with an approximately 50 micron pore diameter and a ¼-inch push-to-connect fitting connected to ¼-inch outside diameter Teflon® tubing. The probe was placed at approximately 7 fbg and surrounded by a 12-inch sand pack. Above the sand pack, 12-inches of dry granulated bentonite was topped with hydrated bentonite to 1 fbg. The probe was labeled and capped, and a sealed, traffic-rated well vault was installed slightly above grade to ensure surface water runoff away from the location. Soil vapor probe construction details are provided on the boring log presented in Appendix D. On November 8, 2017, Morrow Surveying Land Surveyors surveyed the northing and easting location of VP-7 (Appendix E).

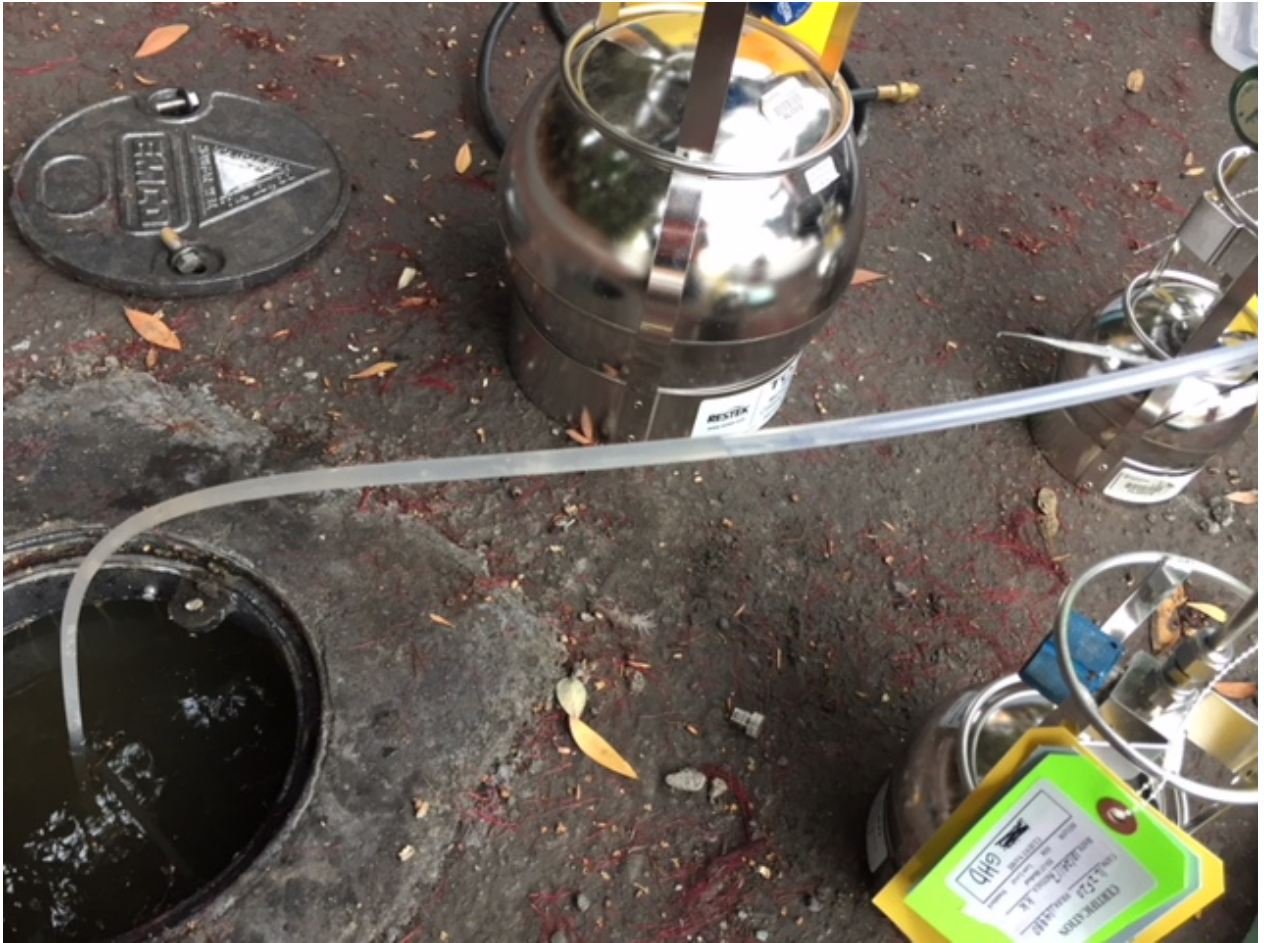
VP-7 Tubing

Although depth to groundwater in nearby well C-4 was measured at approximately 12 fbg, due to the presence of water in the vapor probe tubing, GHD field staff was unable to collect the necessary samples for TO-15 and TO-17 analysis. When the field staff began purging the required three purge volumes from the sampling tubing before sampling begins, a column of water entered the vapor probe tubing. Purging and sampling was terminated to prevent water from entering the sampling train manifolds or the summa canisters. A photo of the tubing with water is included as Appendix F.

- Purge VP-7 tubing using a vacuum pump. If the tubing can successfully be cleared of water, a soil vapor sample will be collected from VP-7 as described in GHD's July 25, 2017 *Soil Vapor Intrusion Assessment Work Plan*.

- If the tubing cannot successfully be cleared of water via vacuum pump purging, CEMC and GHD propose pushing the water back into the formation and waiting approximately 10 days for the subsurface to equilibrate. If water does not re-enter the probe, a soil vapor sample will be collected from VP-7 as described in GHD's July 25, 2017 *Soil Vapor Intrusion Assessment Work Plan*.

- If clearing the VP-7 tubing of water is not successful, then GHD proposes installing an offsite vapor probe on 1723 High Street, adjacent to the residential building, and collecting a soil vapor sample to evaluate the potential vapor intrusion risk to the indoor air of the residential building (Figure 2). Prior to installing the probe, the probe boring will be left open to see if water enters the boring. If no water enters the boring, a probe will be installed. If water does enter the boring, then an alternative location will be attempted. The proposed vapor probe will be installed and sampled as outlined in the work plan in GHD's July 25, 2017 *Soil Vapor Intrusion Assessment Work Plan*.
