**Re: Emeryville, CA - Preliminary Soil Quality Evaluation
Proposed Emeryville Postal Facility**

PRELIMINARY SOIL QUALITY EVALUATION
PROPOSED EMERYVILLE POSTAL FACILITY
6121 HOLLIS STREET
EMERYVILLE, CALIFORNIA

PRELIMINARY SOIL QUALITY EVALUATION

PROPOSED EMERYVILLE POSTAL FACILITY
Emeryville, California

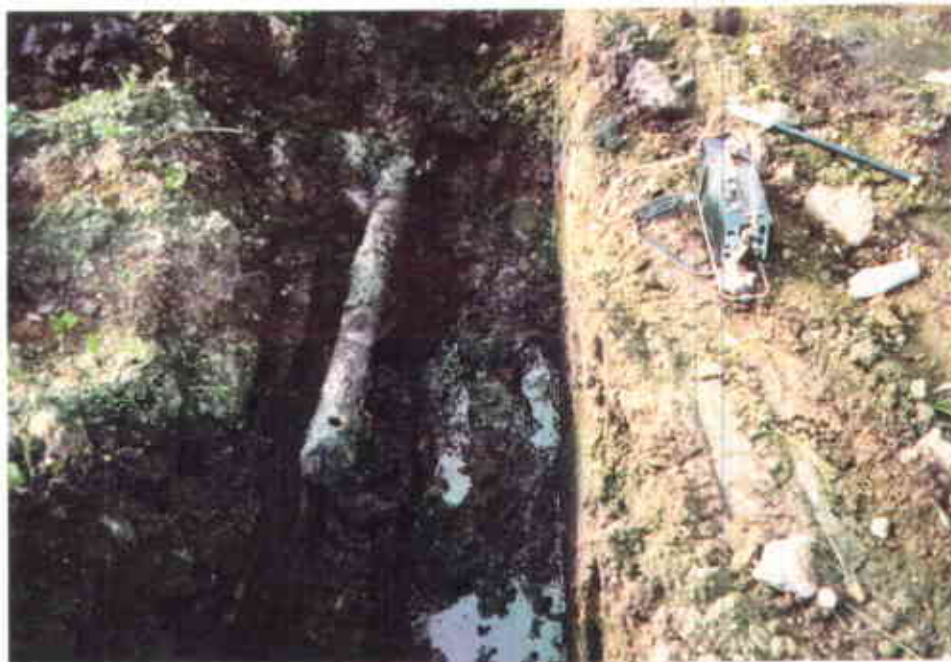
Photograph #1
Trench A

Trench A was excavated at the southeast corner of the property to further evaluate a north-south trending pipeline that was previously encountered in this area (Dames & Moore, March 1993). The end of a 4-inch diameter pipe was encountered at a depth of approximately 1 foot. This pipe extends off-site to the north. The southern pipe end was capped; however, an approximately 1-inch diameter screw plug was open at the top of the pipe. No fluids were observed in the pipe. Black silty clay was encountered at the ground surface to the top of the ground water table at a depth of approximately 3.5 feet. The silty clay visually appeared to be saturated with petroleum oil. Two soil samples (SS-8) collected at a depth of 1.5 and 3.0 feet revealed TPH as gasoline, TPH as diesel and petroleum oil at levels up to 320 ppm, 2,500 ppm and 13,000 ppm. An oil sheen was also observed floating on the ground water (Figure 4B).

The source of oil encountered and the purpose of the pipe were unclear. However, Because the pipe runs off-site, it is likely a former utility line.

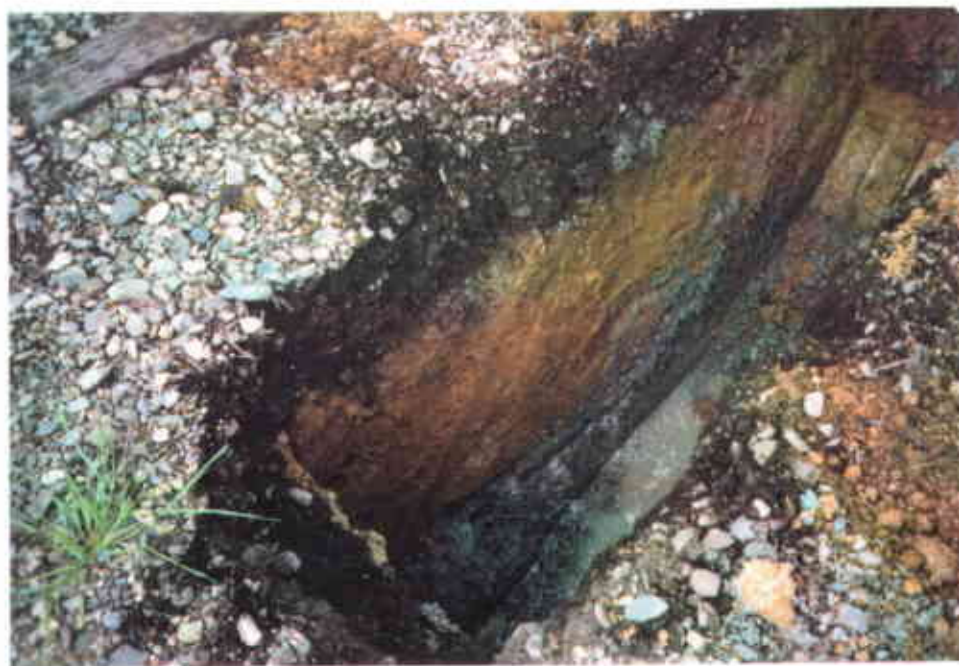
Photograph #2
Trench B

To evaluate soil quality along a former railroad spur, Trench B was excavated along the western site boundary. Approximately 1 foot of dark brown gravelly fill was encountered below the former track spur. Soil sample SS-7 was collected at a depth of 0.5 feet; TPH as diesel, petroleum oil, and PCB 1260 were detected at 37, 670, and 0.62 ppm, respectively. This gravel was underlain by brown silty clay to a depth of 3.5 feet. Between 3.5 to 4.5 feet, an increase in sand and gravel content as well as a strong petroleum odor were noted. A grayish green soil discoloration and OVM reading of over 1,000 ppm were noted. A diesel-like product was observed on the ground water which was encountered at a depth of 4.5 feet.

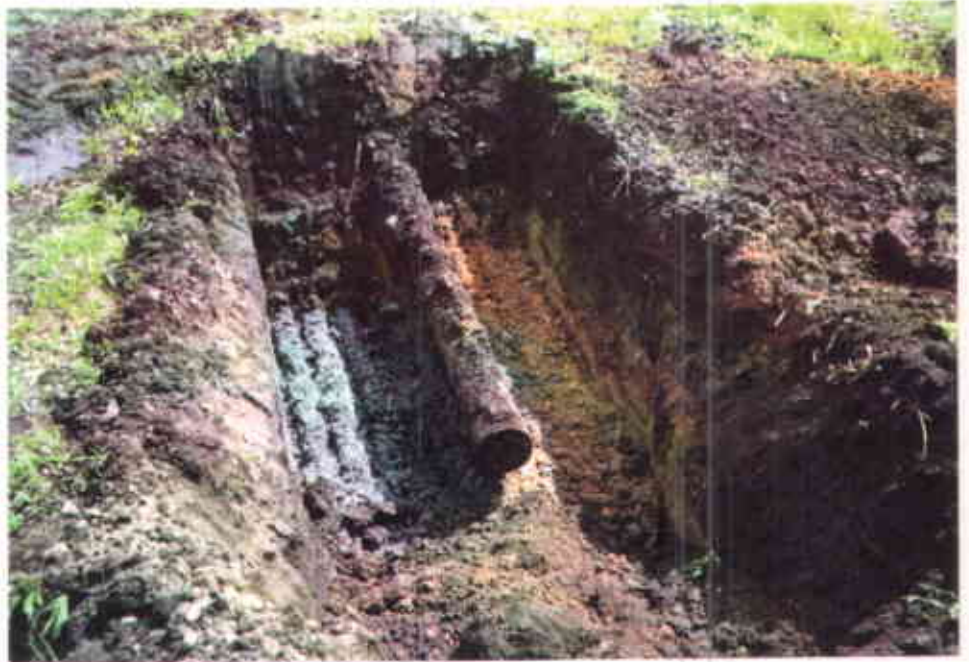
Photograph #3
Trench C

Trenches C, D, and E were excavated along an east west trending pipeline that was uncovered during previous on-site work (Dames & Moore, March 1993). This pipe was buried at a depth between 2.0 and 3.5 feet; it was 6 inches in diameter at the west end and 4 inches diameter pipe at its east end. The west end of the pipe was open and filled with soil. The eastern end was submerged in the existing water filled excavation.

Discolored grayish green soil (sandy/gravelly clay) was generally encountered between depths of 2.5 to 5-feet. OVM readings ranged to over 1,000 ppm with the highest levels recorded in Trenches C and E. Soil Sample SS-4 was collected at a depth of 4.5-feet in Trench E. TPH as diesel, TPH as gasoline and petroleum oil was detected at 880, 320 and 1,200 ppm,

respectively. Between the depths of 5 and 7 feet, a decrease sand and gravel content as well as discoloration was observed. A second soil sample was collected at 7 feet. TPH as diesel and TPH as gasoline was detected at 34 and 2.6 ppm, respectively. Near the surface of the ground water, an increase in the grayish green discoloration was observed.

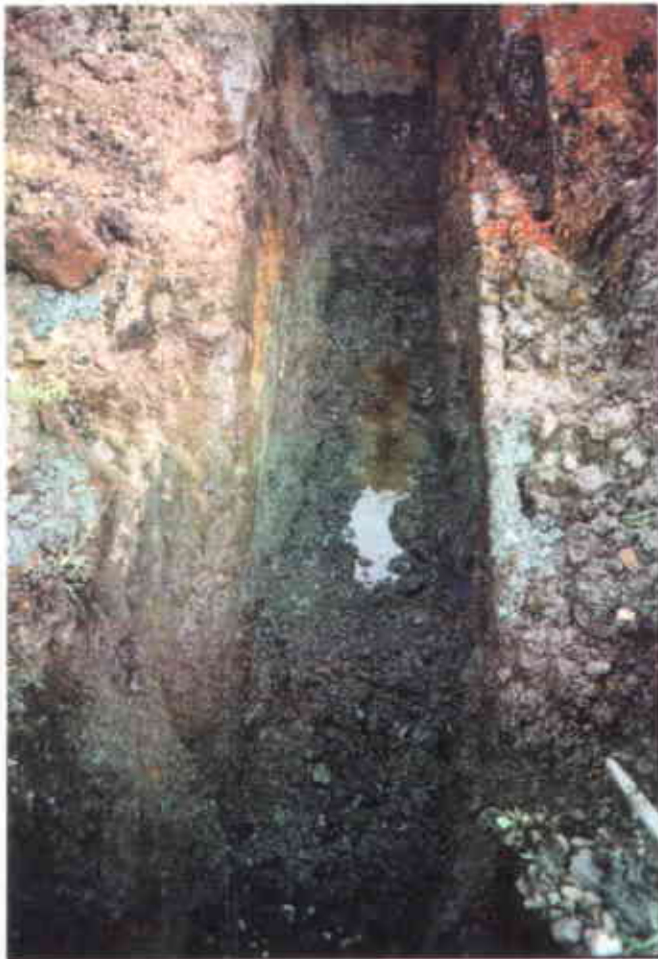
Photograph #4
Trench F

Trenches F and G were excavated along a 2-inch diameter pipe that was capped at its western end. This pipe was buried at a depth of approximately 2.5 feet and extended off-site to the east. Similar to the other trenches, discolored grayish-green silty and sandy clay was encountered extending downward from a depth of approximately 3 feet. An increase in sand and gravel was observed with depth. Ground water was encountered at a depth of approximately 6 feet. A diesel-like product was observed on the ground water. OVM readings ranged to over 1,000 ppm. Four soil samples were collected from Trenches F and G. TPH as diesel, TPH as gasoline and petroleum oil were detected at levels up to 2,900, 2,200 and 980 ppm, respectively.
