**REMEDIAL ACTION COMPLETION CERTIFICATION**

**StID 4081 - 2651 Grant Avenue, San Lorenzo, CA  
(diesel fuel release on February 12, 1999)**

**CASE CLOSURE SUMMARY**  
**Leaking Underground Fuel Storage Tank Program**

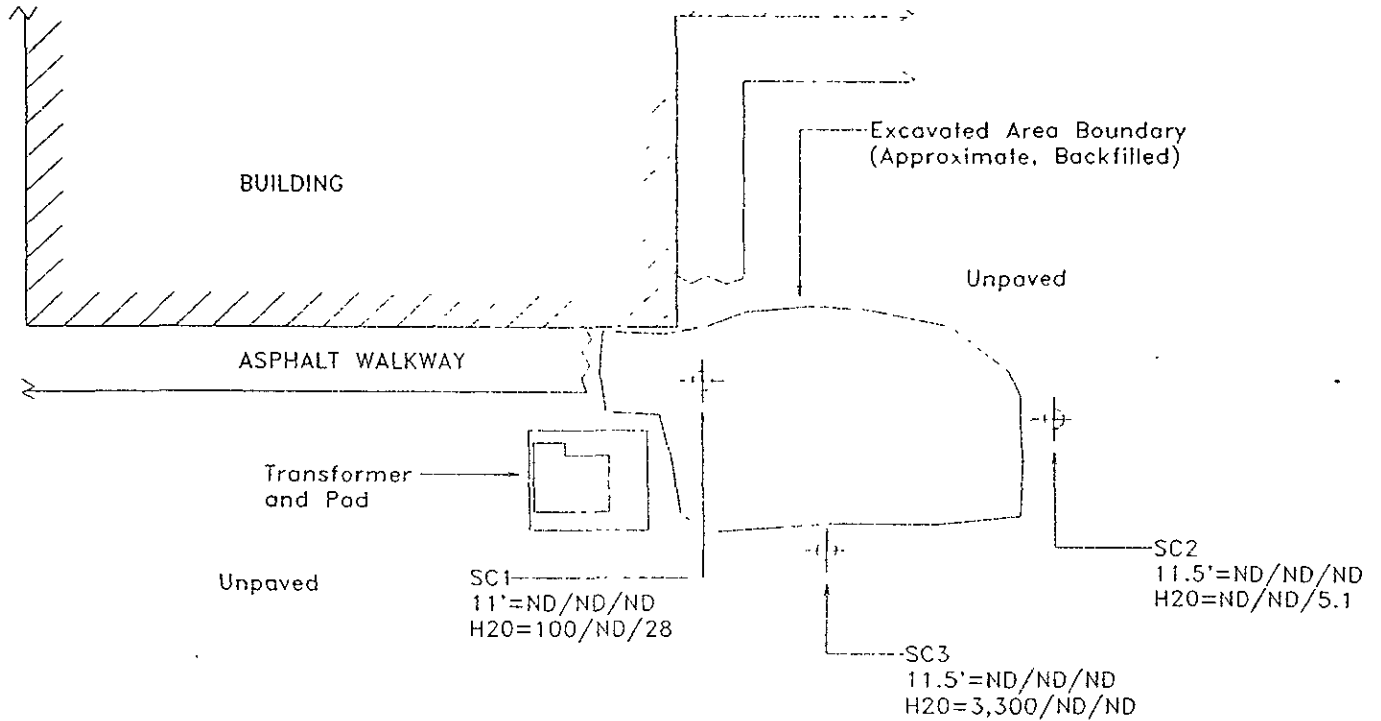
FIGURE 3.3 SITE MAP  
AND ANALYTICAL RESULTS

In September 1999 three direct push boreholes were advanced around the former excavation (see Fig 3). Groundwater was encountered at approximately 11.5' bgs. Soil samples were collected at 11' and 11.5' bgs. Grab groundwater samples were also collected from each borehole. All samples were analyzed for TPHd, BTEX, and MTBE. None of the soil samples contained analytes sought above the laboratory detection limits. Groundwater from the west borehole (assumed downgradient direction) contained 3,300ppb TPHd. (See Table 2 and 3)

| NOTES | |
|---|---|
| SC3 | BOREHOLE LOCATION AND DESIGNATION |
| 11.5'=ND/ND/ND | SOIL SAMPLE DEPTH TPHd/BENZENE/MTBE |
| H2O=3,300/ND/ND | WATER SAMPLE TPHd/BENZENE/MTBE |

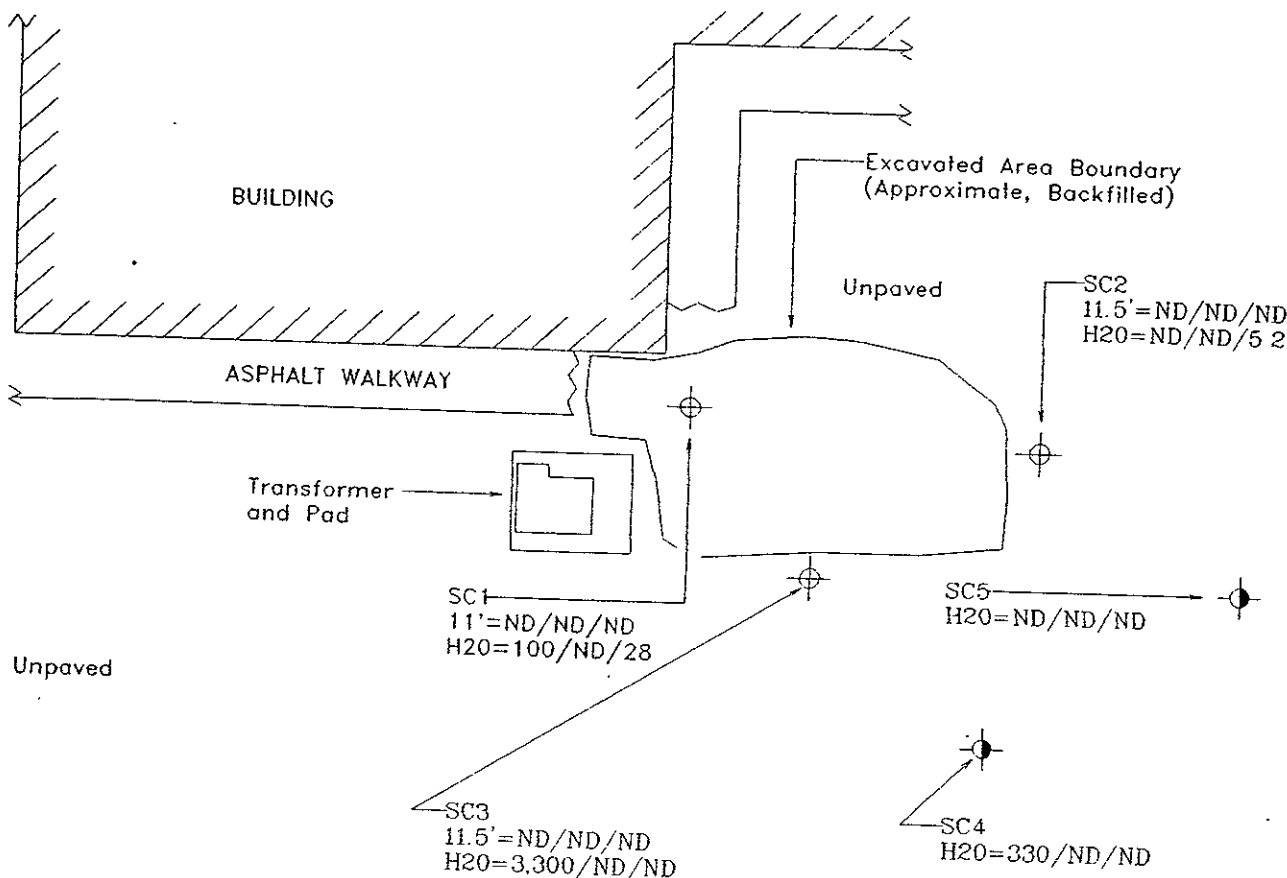
**FIGURE 40: CORE LOCATIONS  
AND ANALYTICAL RESULTS**

In February 2000, two additional direct-push boreholes were advanced approximately 20 feet further downgradient of the previous boreholes advanced in September 1999. These borings were advanced to delineate the extent of the TPHd plume. The grab groundwater samples from Boring SC4 contained 330 ppb TPHd (see Fig 4 and Table 4). However, the laboratory chromatogram suggests the compound detected was weathered diesel. It appears that the diesel fuel release in February 1999 did not significantly impact groundwater quality beneath the site. The source of the weathered diesel is not known. Residual TPHd in groundwater should continue to naturally bioattenuate. Although the San Francisco Bay is 500 feet west of the spill area, it is not likely that residual hydrocarbons in groundwater will migrate in the low permeable Bay Mud to impact aquatic life in the Bay.

⊕ SC3  
 11.5'=ND/ND/ND SOIL SAMPLE DEPTH TPHd/BENZENE/MTBE  
 H2O=3,300/ND/ND WATER SAMPLE TPHd/BENZENE/MTBE

⊙ CORE LOCATION AND DESIGNATION (2/00)

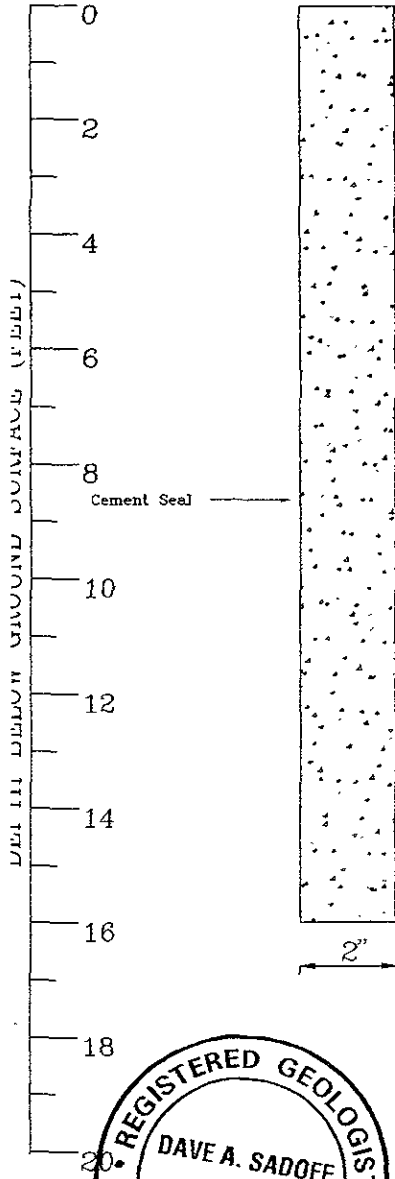
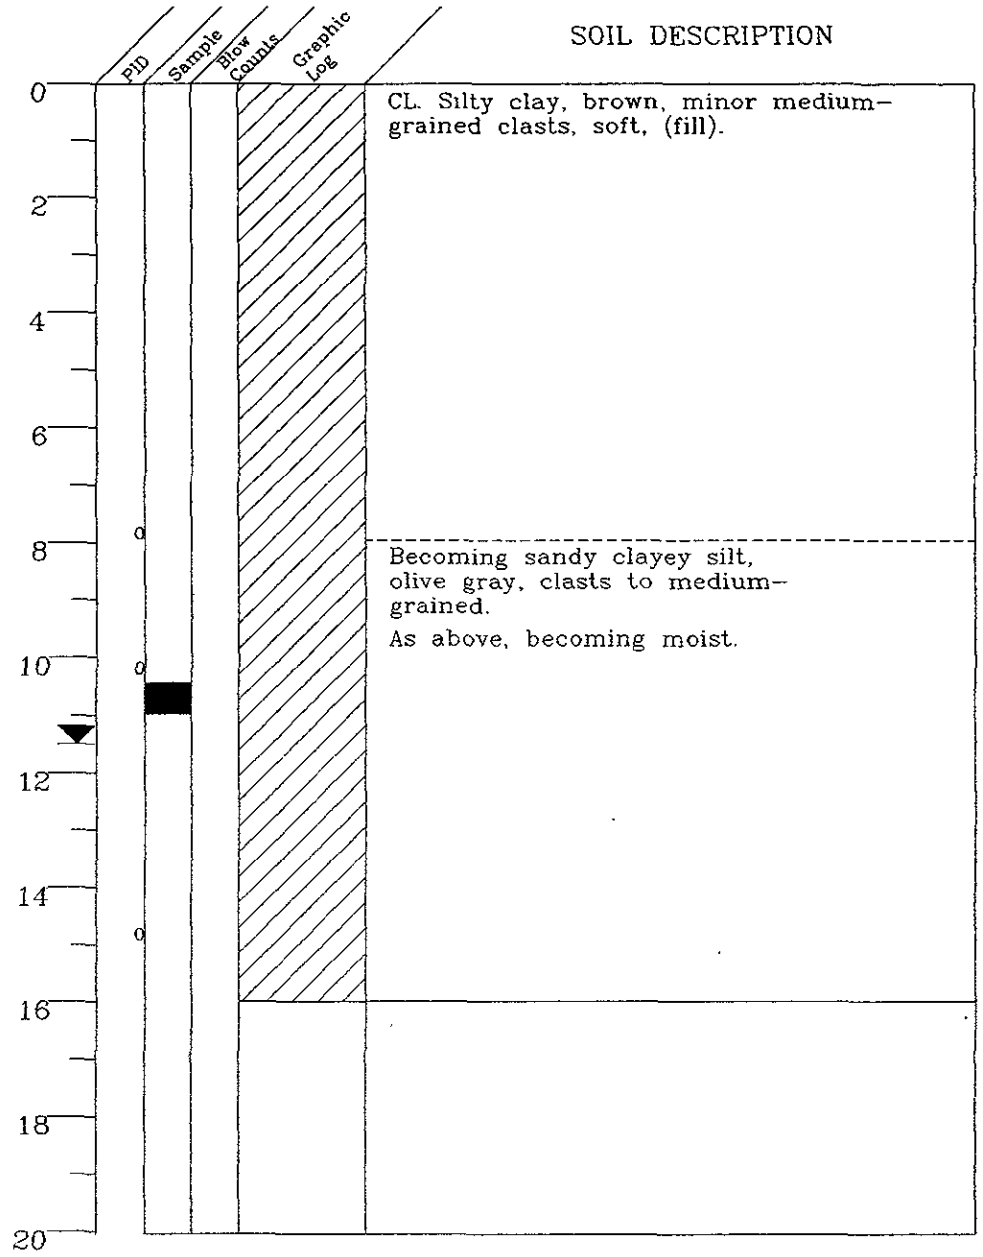
Logged by: DAS  
 Inspector: N  
 Date: 9/9/99  
 Drilling Contractor: Fast-Tek  
 Drilling Method: DPT  
 Driller: Tom  
 Sanitary Seal/Backfill: Cement  
 Sampler Type: Acetate Sleeve  
 Total Boring Depth: 16 feet

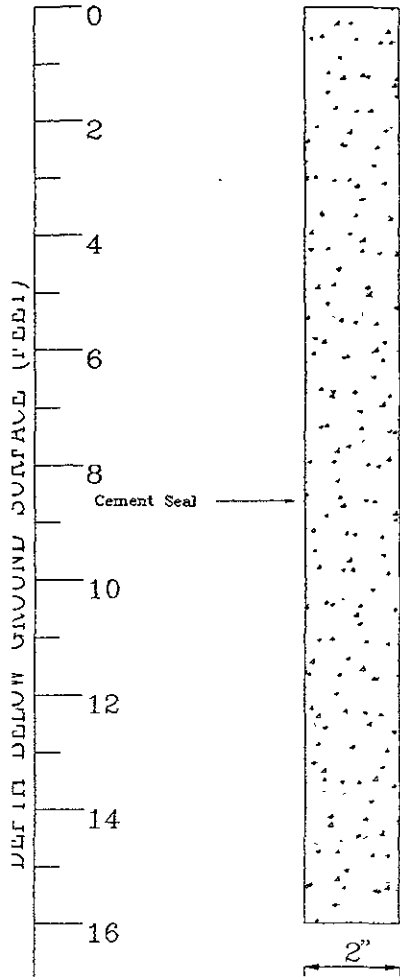
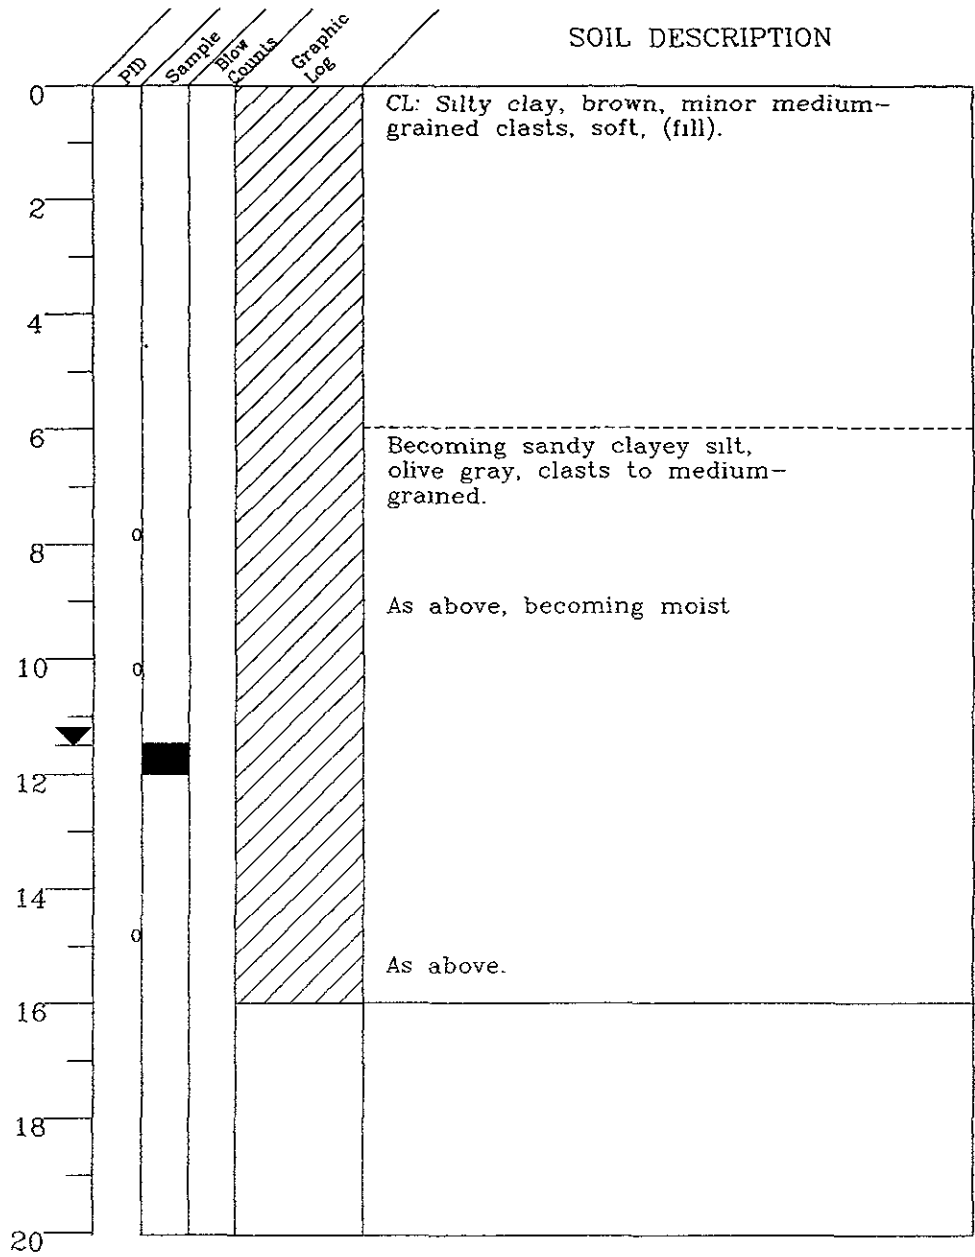
Logged by: DAS  
 Inspector: N/A  
 Date: 9/9/99

Drilling Contractor: Fast-Tek  
 Drilling Method: DPT  
 Driller: Tom

Sanitary Seal/Backfill: Cement  
 Sampler Type: Acetate Sleeve  
 Total Boring Depth: 16 feet

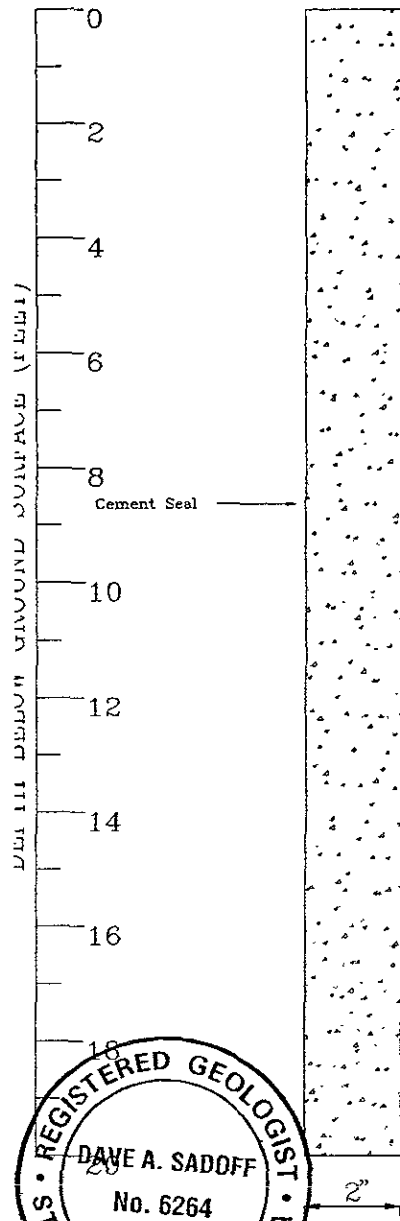
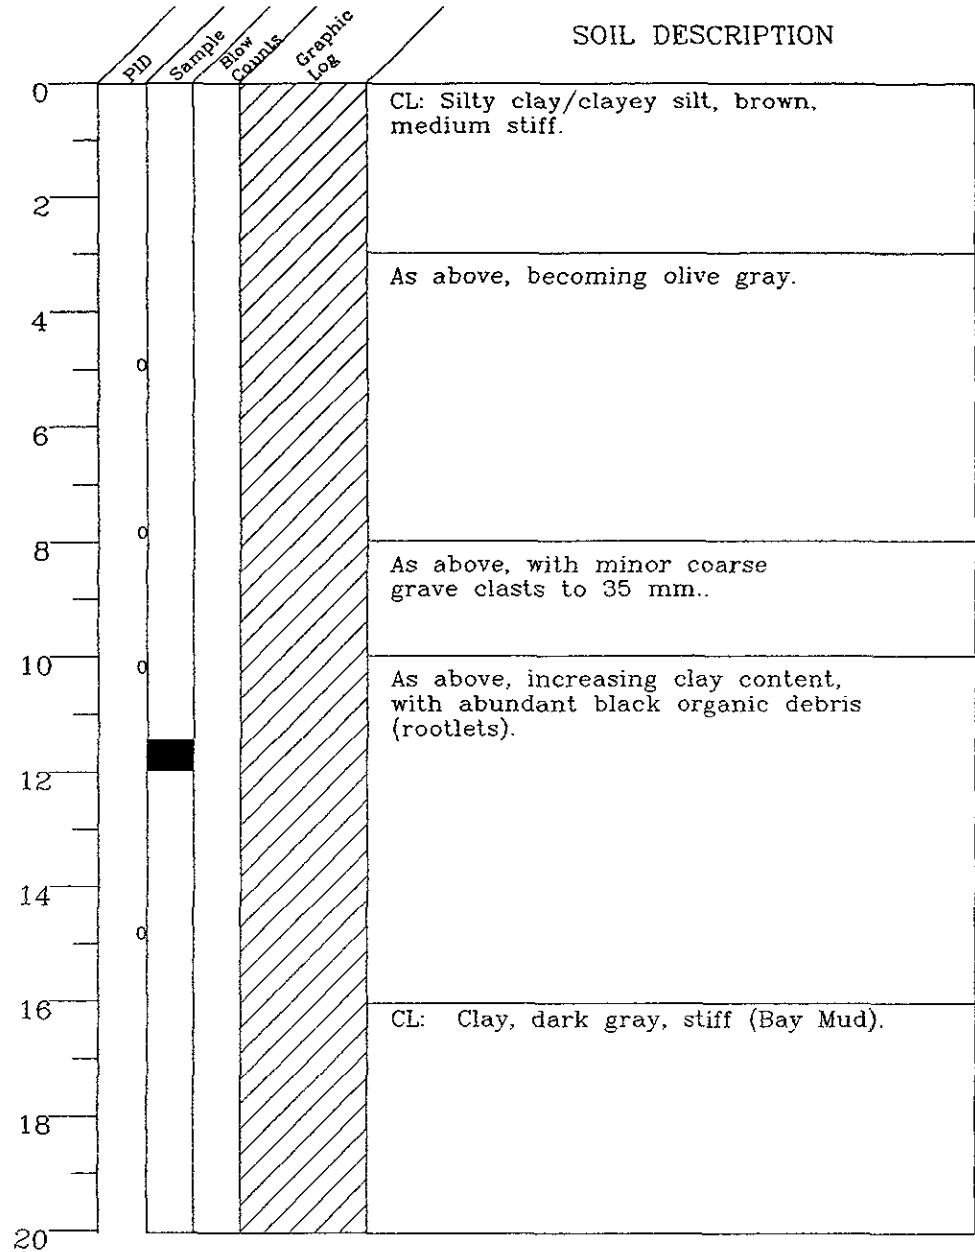
| Logged by: [Signature]<br>Inspected by: [Signature]<br>Date: 9/9/99 | Drilling Contractor: Fast-Tek<br>Drilling Method: DPT<br>Driller: Tom | Sanitary Seal/Backfill: Cement<br>Sampler Type: Acetate Sleeve<br>Total Boring Depth: 20 feet |

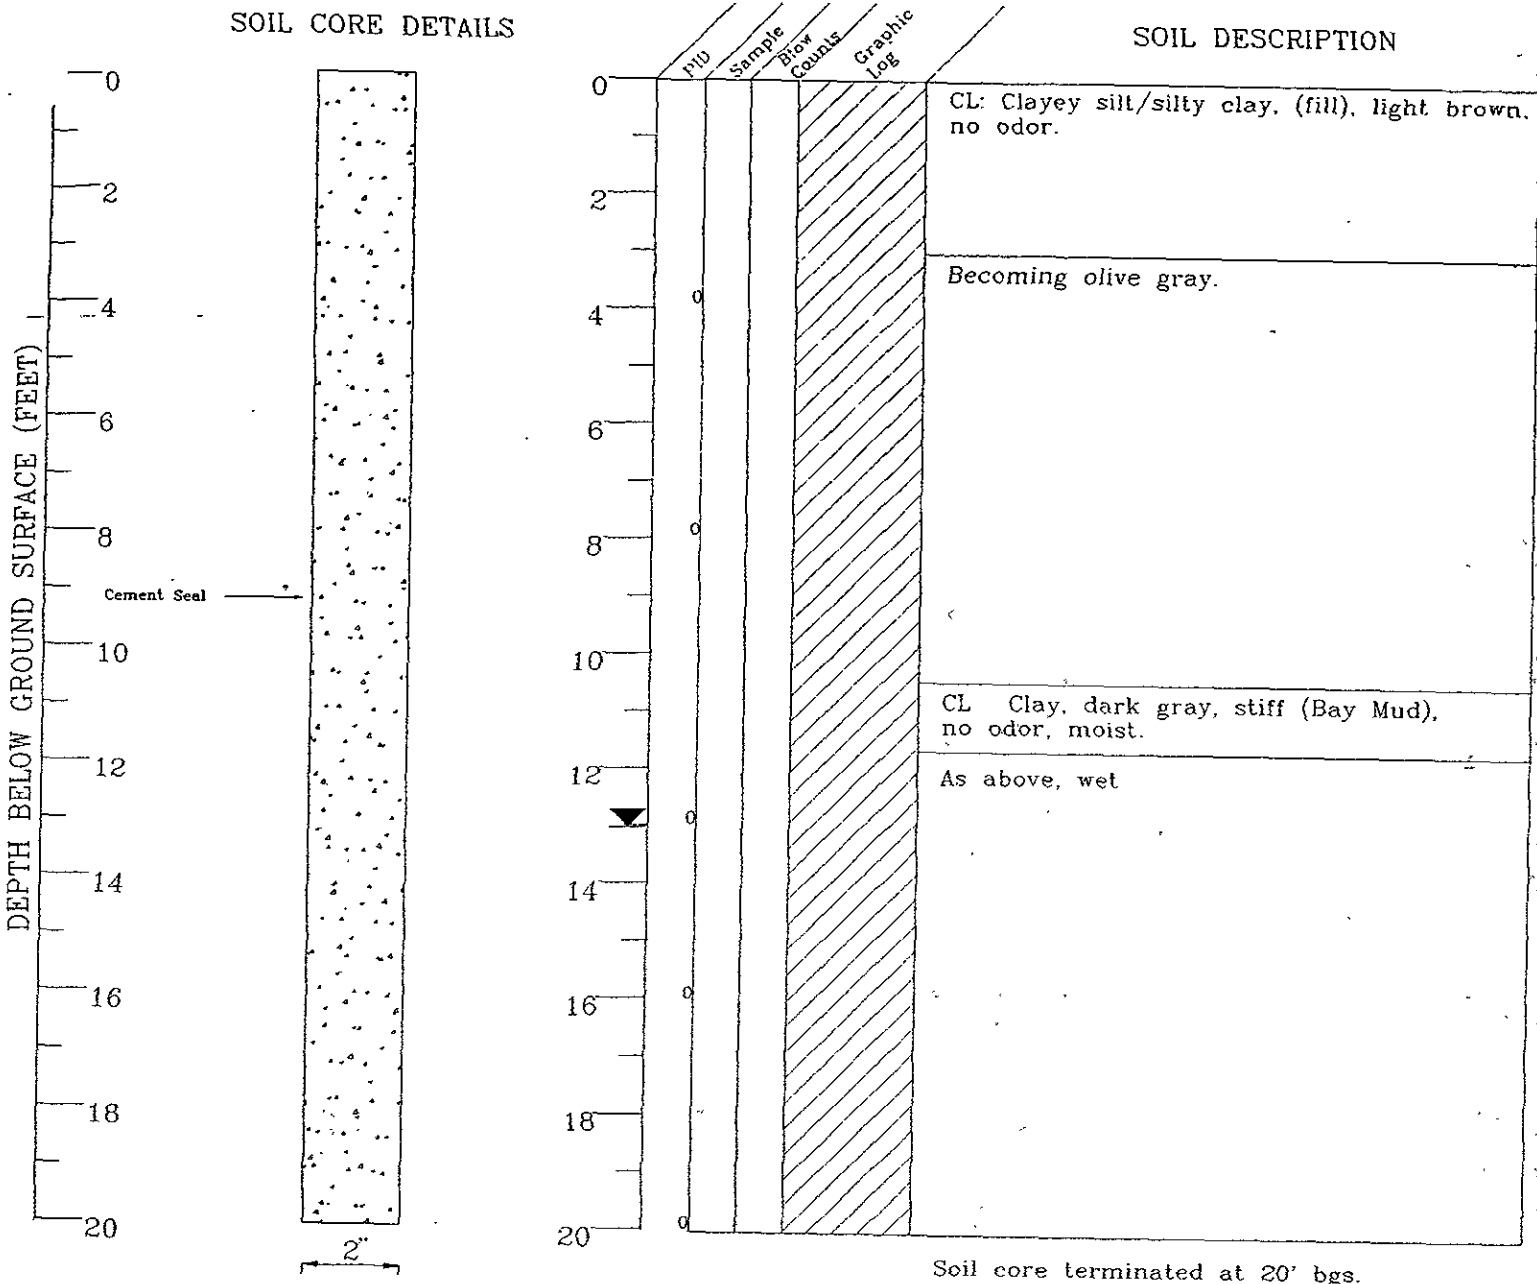
# LOG OF SOIL BORING SC4

Logged by: DAS  
 Inspector: N/A  
 Date: 2/15/00

Drilling Contractor: Fast-Tek  
 Drilling Method: DPT  
 Driller: Eric

Sanitary Seal/Backfill: Cement  
 Sampler Type: Acetate Sleeve  
 Total Boring Depth: 20 feet

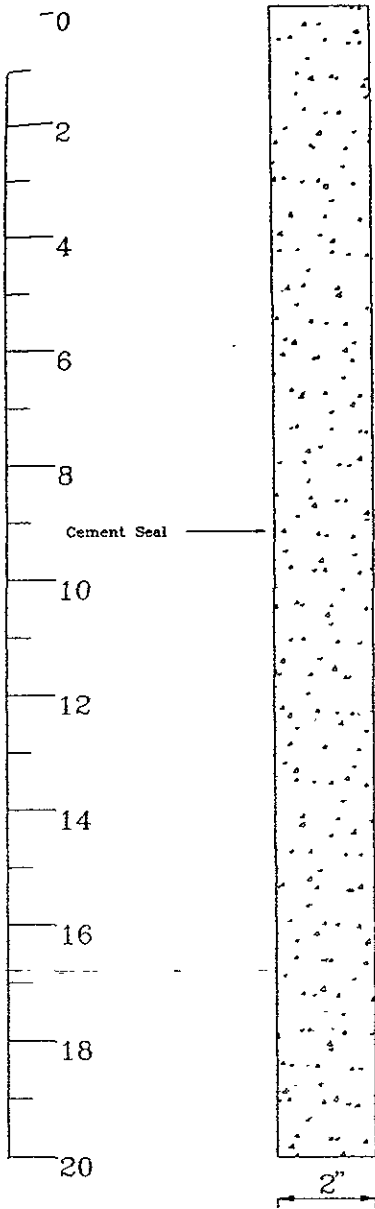
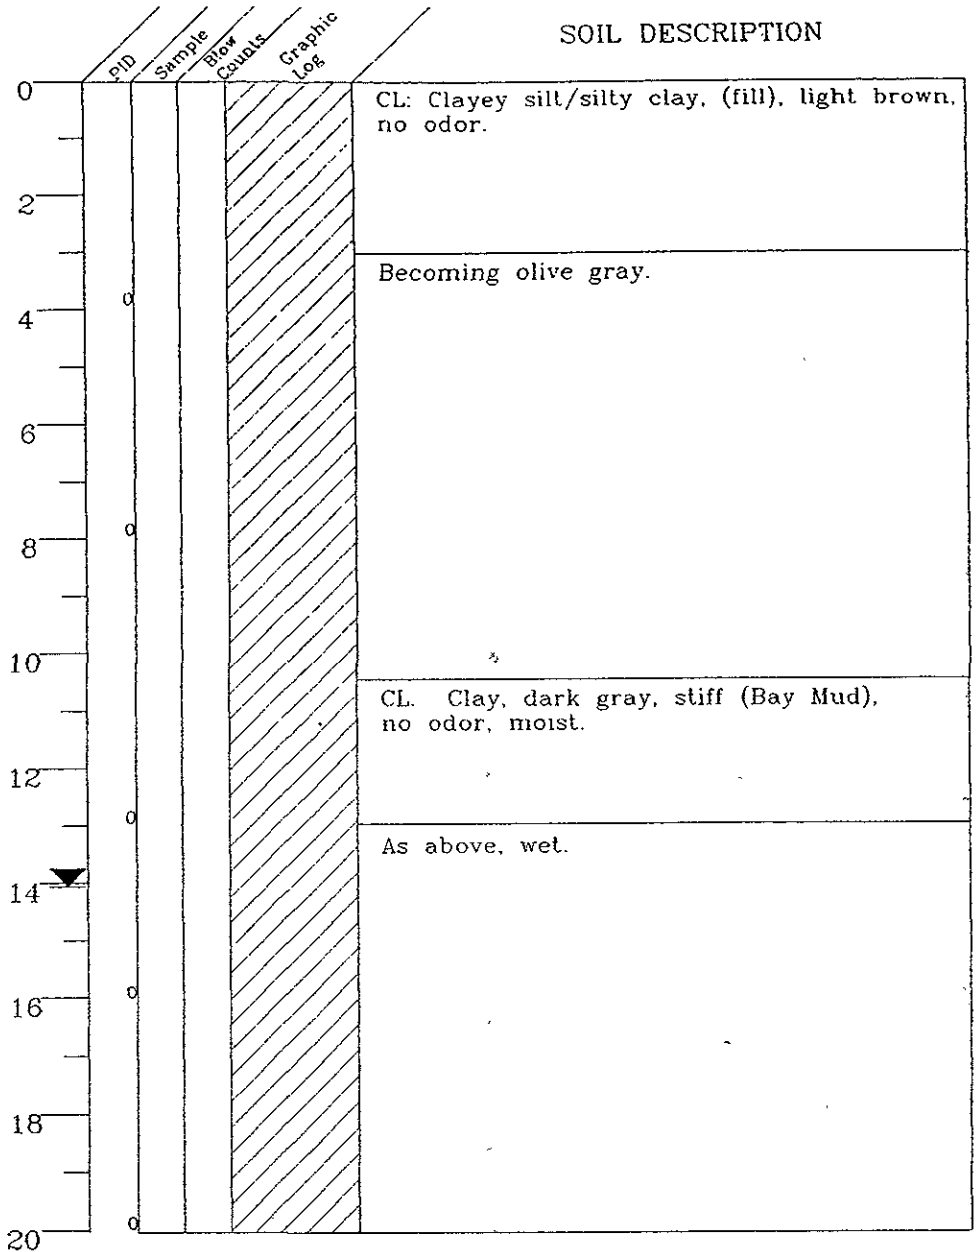
Soil core terminated at 20' bgs.

Logged by: DAS  
Inspector: N/A  
Date: 2/15/00

Drilling Contractor: Fast-Tek  
Drilling Method: DPT  
Driller: Eric

Sanitary Seal/Backfill: Cement  
Sampler Type: Acetate Sleeve  
Total Boring Depth: 20 feet
