REVIEW OF HISTORICAL AERIAL PHOTOS AND SANBORN® MAPS

FORMER SHELL SERVICE STATION 2350 (2368) HARRISON STREET OAKLAND, CALIFORNIA

SAP CODE 173318 INCIDENT NO. 97743969 AGENCY NO. RO0000505

FEBRUARY 18, 2011 Ref. no. 060119 (18)

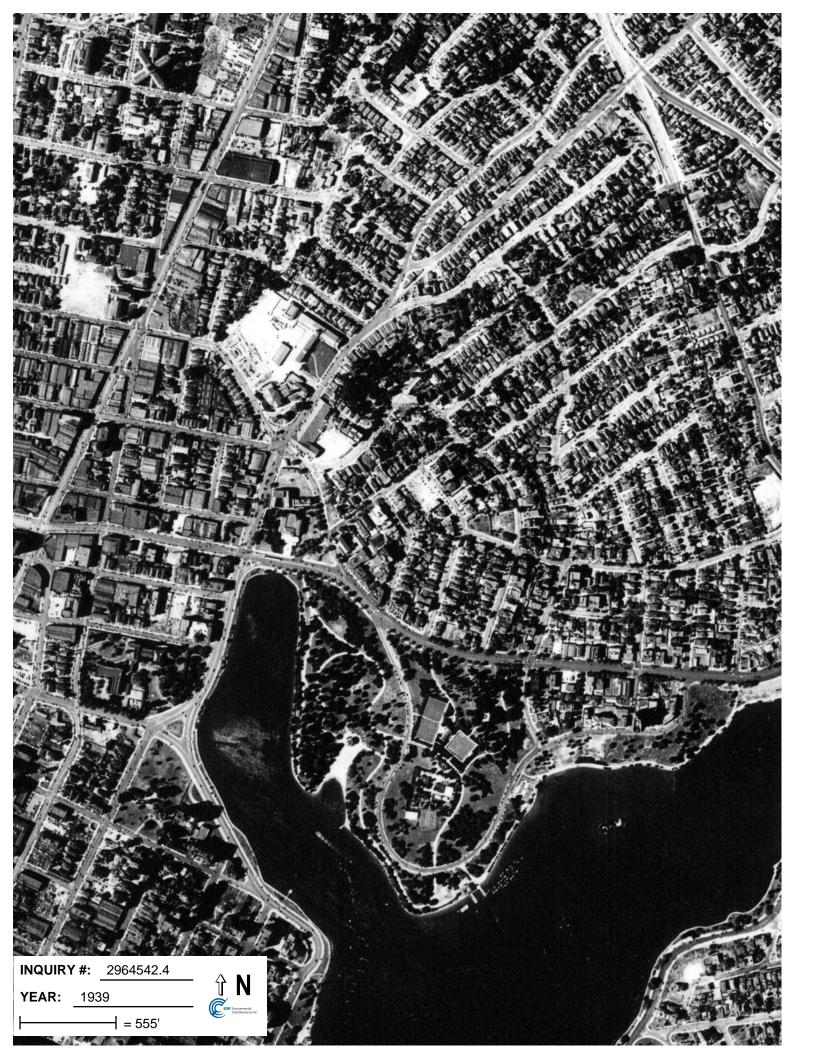
2.1 1939, 1"=555'

The subject site is a developed lot on the southern corner of the Harrison Street and Bay Place intersection. A service station building appears to be located across the southern third of the property with a dispenser canopy in the north corner. South of the site, a hotel (currently the Lake Merritt Hotel) and an apartment building east of the hotel are present. Properties south of the site, between the subject site and the hotel and apartment building, are undeveloped. The current Oakland Senior Center building is present south of the hotel and apartment building, a warehouse is located northeast of the site across Bay Place, a church is to the north on the corner of Harrison Street and 27th Street, and the corners northwest and west of the site are occupied by commercial buildings with residences occupying the remainder of each block.

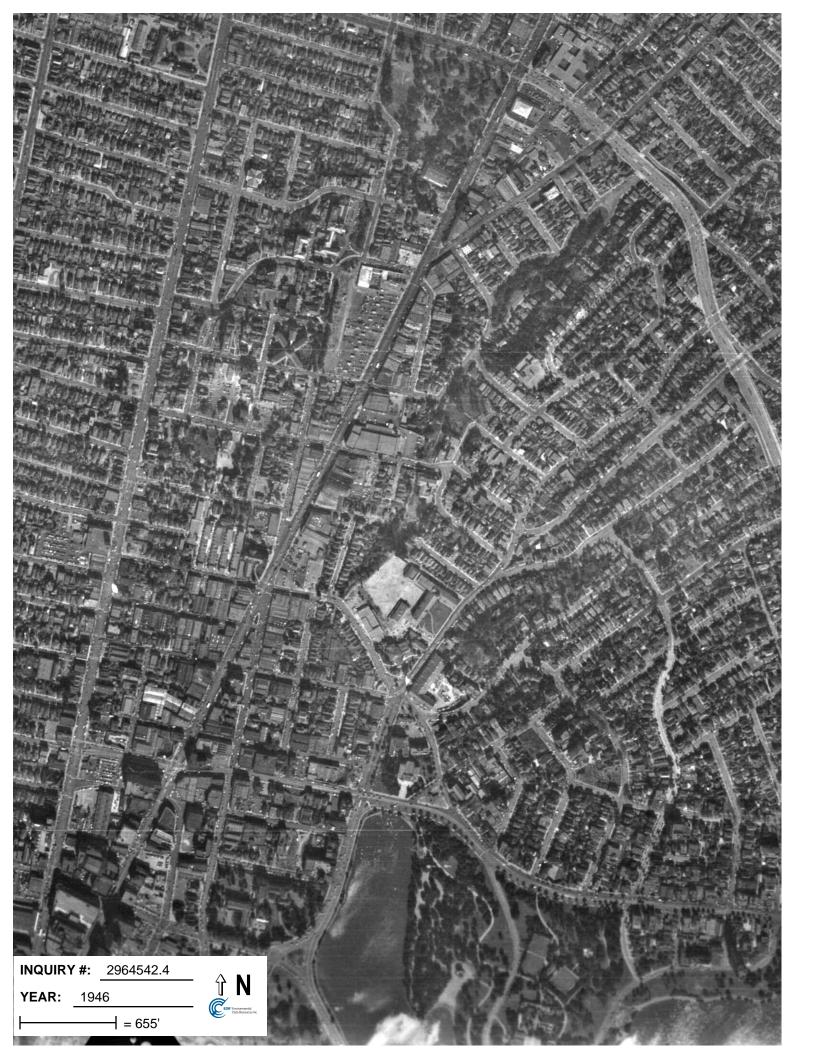
2.2 1946, 1'=655'

The subject site shows the same structures as the previous photo and appears to be a gasoline service station. The lots directly north, east, and west of the site show the same commercial buildings. The property between the site and the current Lake Merritt Hotel appears to have been partially developed.

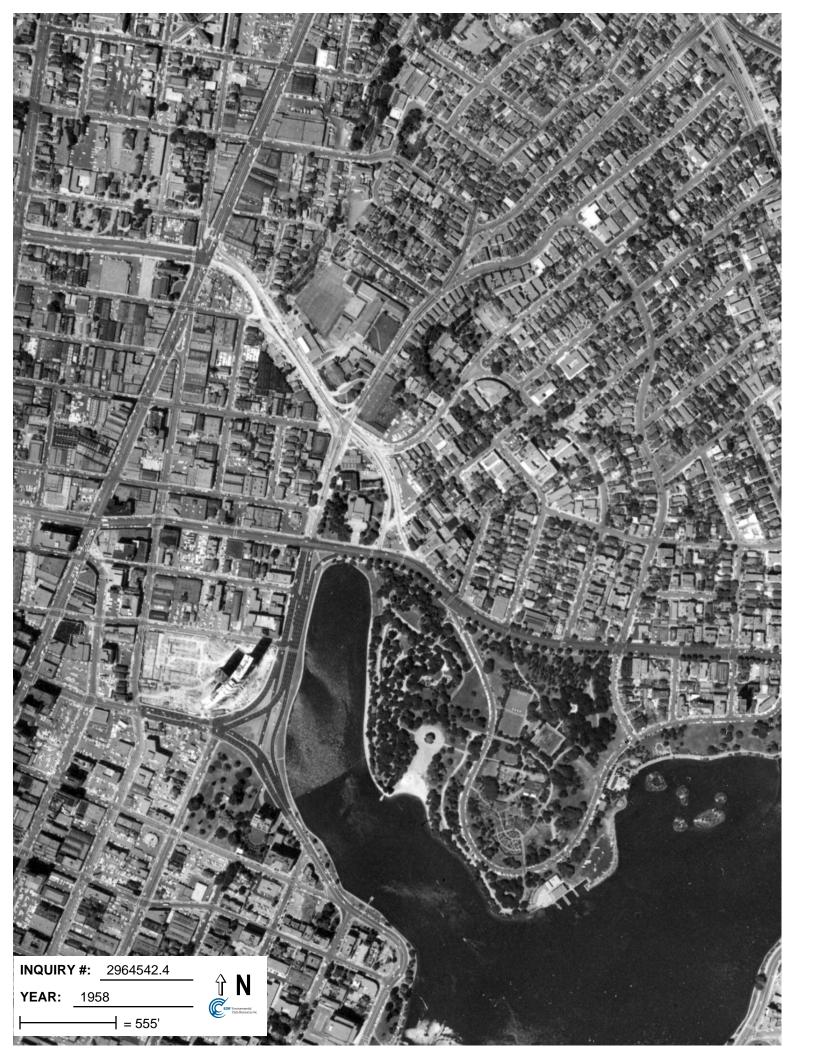
2.3 1958, 1"=555'

The configuration of the service station on the subject site is changed with the station building now occupying the central portion of the southern third of the site and the canopy is gone. The lots directly north and west of the site show the same commercial buildings. The properties east and northeast of the site across Bay Place now appear to be an automobile dealership. The properties between the site and the current Lake Merritt Hotel have been developed and appear to be occupied by two commercial buildings.

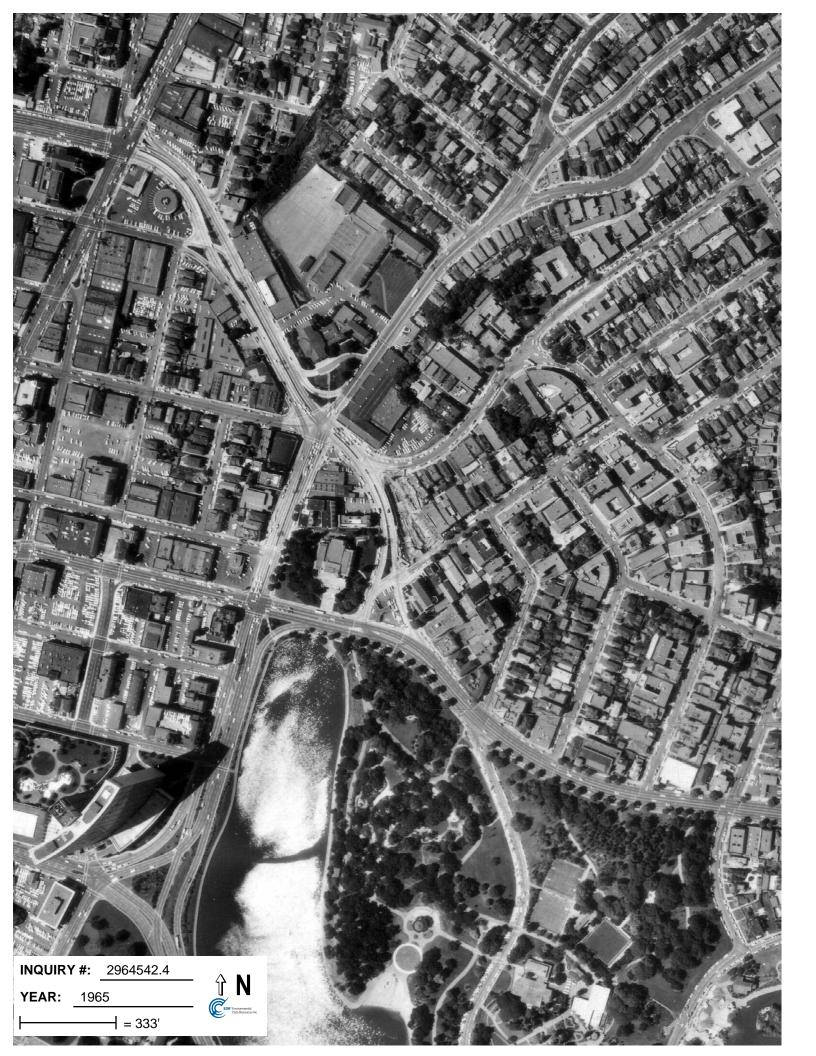
2.4 1965, 1"=333'

The subject site shows the same structures as the previous photo and appears to be a gasoline service station. The lots directly north, west, and south of the site show the same commercial buildings. The property east of Bay Place and south of Vernon Street appears to show grading activity.

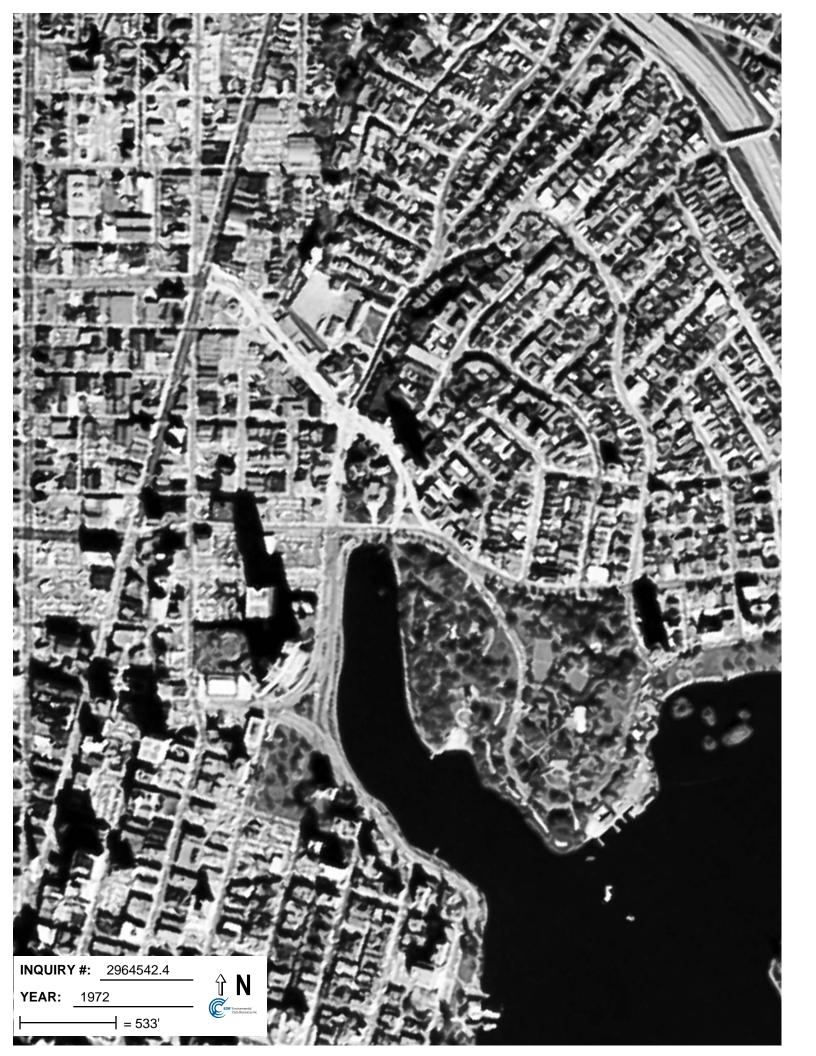
2.5 1972, 1"=533'

The resolution of this photo is insufficient to identify changes to the subject site or surrounding properties.

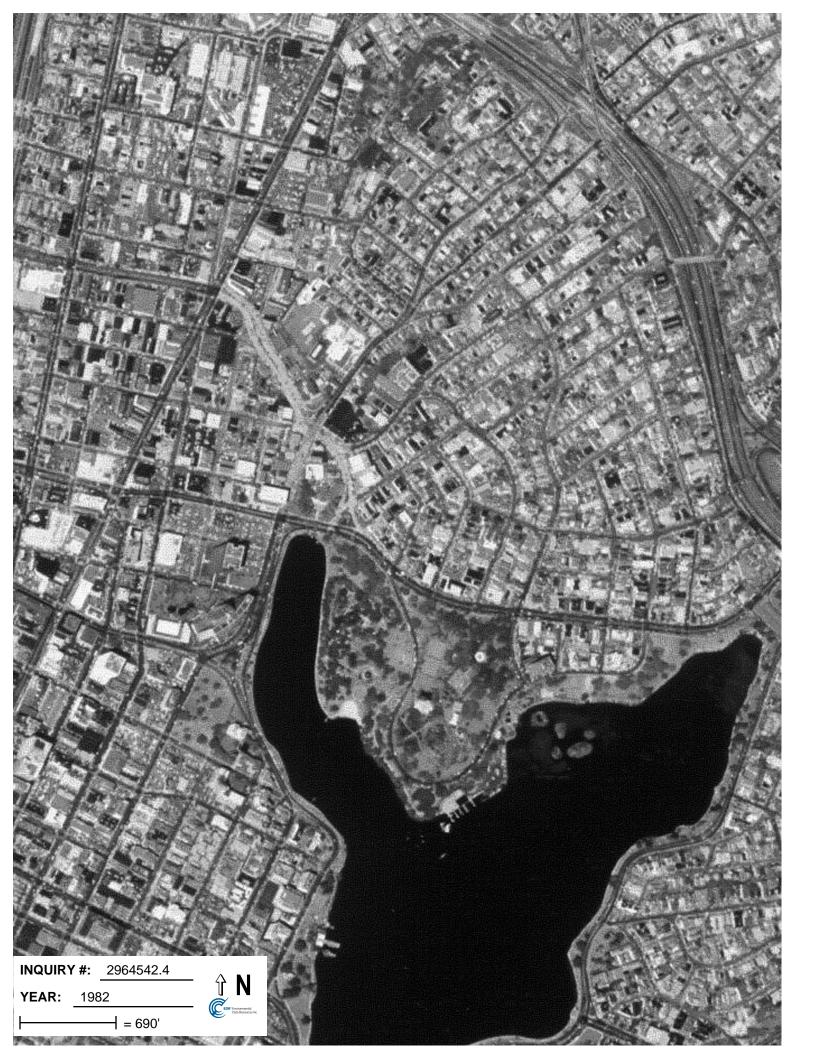
2.6 <u>1982, 1"=690'</u>

The resolution of this photo is insufficient to identify changes to the subject site. The surrounding properties appear to be unmodified with the exception of a change in the configuration of the warehouse located northeast of the site across Bay Place.

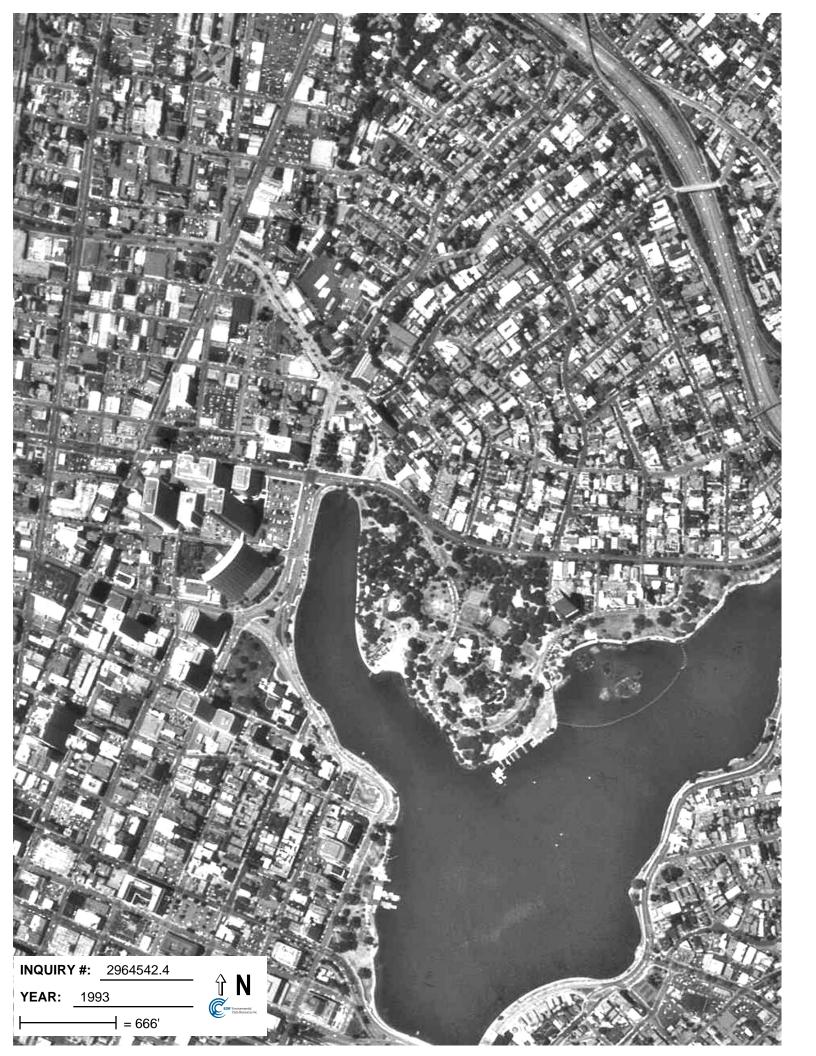
2.7 <u>1993, 1"=666'</u>

The resolution of this photo is insufficient to identify changes to the subject site. The surrounding properties appear to be unmodified with the exception of reconfiguration of buildings and the removal of residences in the block at the corner of 24th Street and 27th Street.

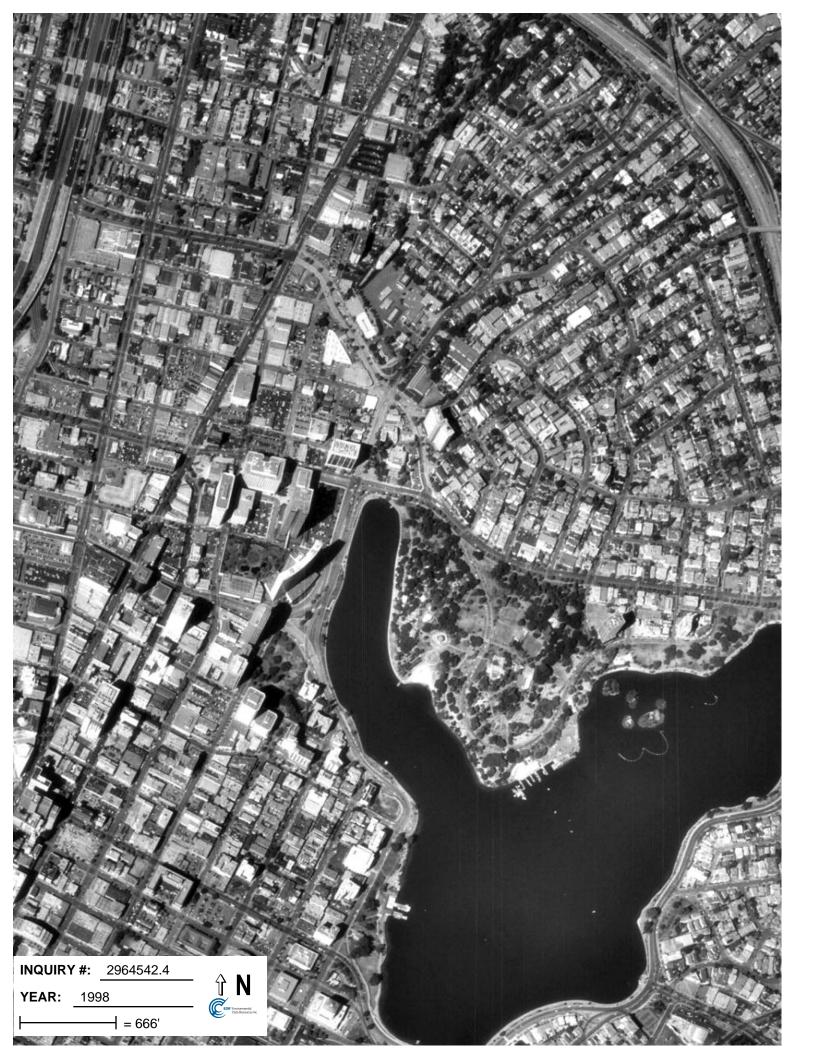
2.8 1998, 1"=666'

The subject site has been redeveloped with a building located across the southern third of the property. Surrounding properties appear to be unmodified with the exception of the Saint Paul Apartment Towers Apartments located east of Bay Place and south of Vernon Street.

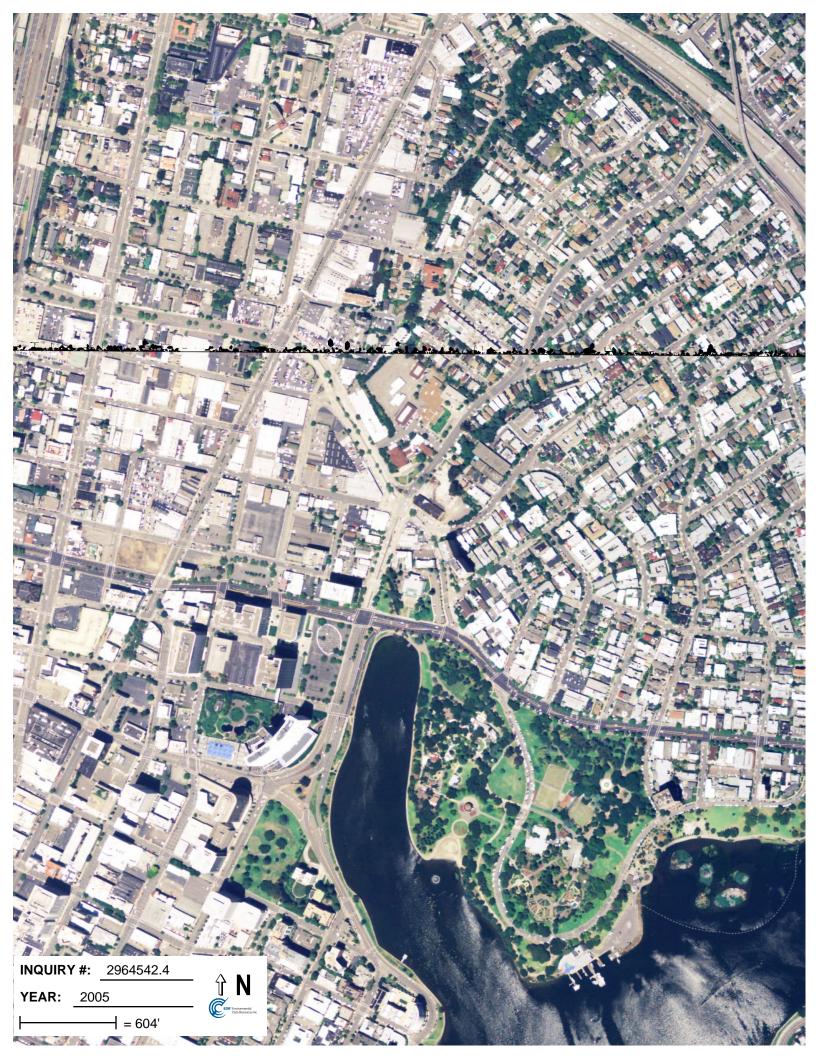
2.9 <u>2005, 1"=604'</u>

The subject site shows the same structures as the previous photo. Surrounding properties appear to be unmodified with the exception of a reconfiguration of the warehouse located directly northeast of the site across Bay Place.
