UNDERGROUND FUEL STORAGE TANK REMOVAL AND REPLACEMENT REPORT

SOUTH COUNTY CORPORATION YARD
17930 LAKE CHABOT ROAD
CASTRO VALLEY, CALIFORNIA

EAST BAY REGIONAL PARK DISTRICT
OAKLAND, CALIFORNIA

January 1999

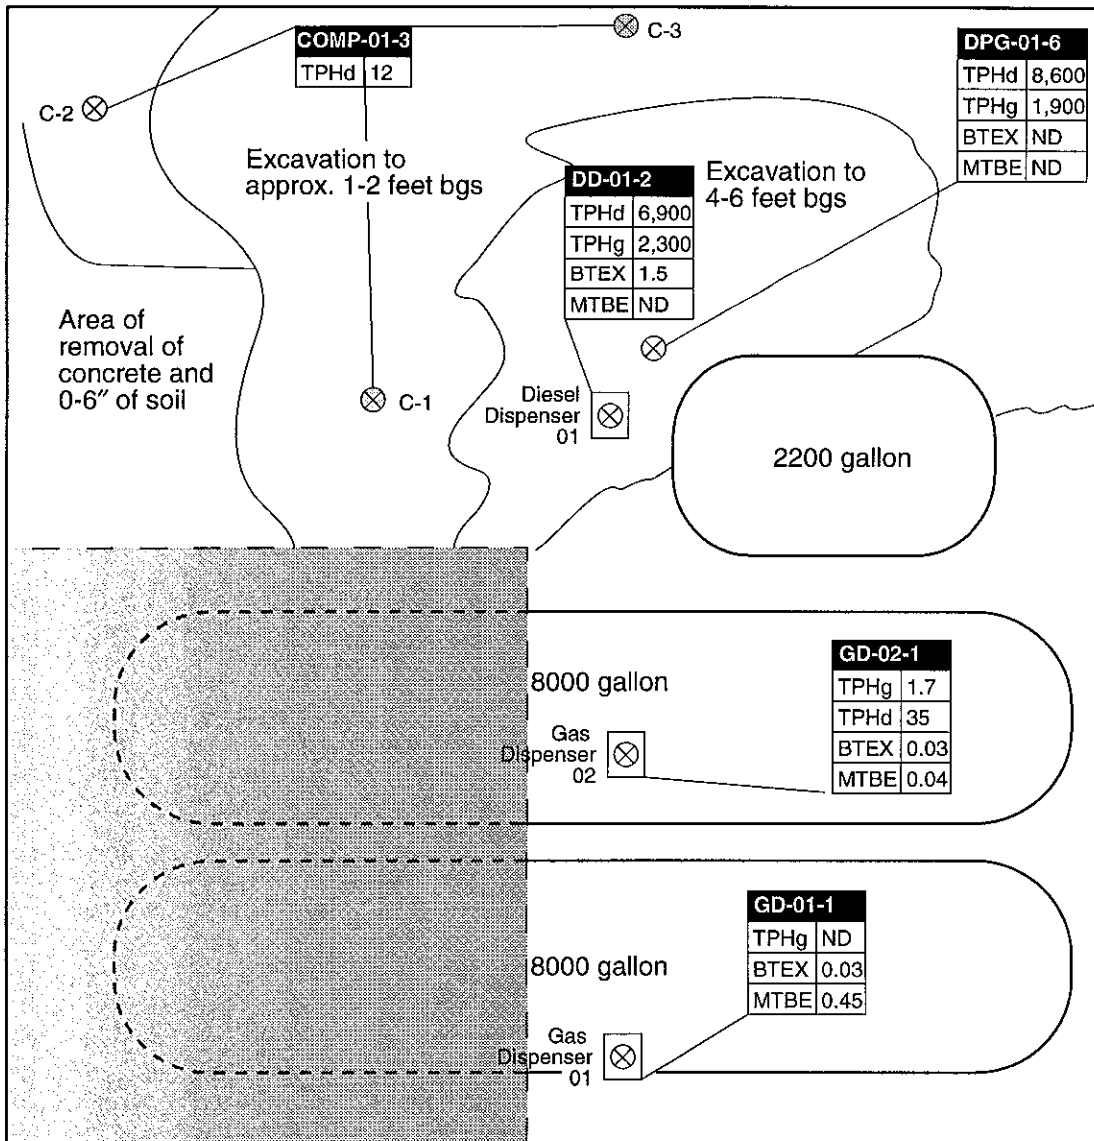
The removal of the concrete slab covering the two gasoline UFST fill pipes showed no obvious contamination and the FID showed no response. SES collected one soil sample at each of these locations ("Gas Dispenser 01-1" and "Gas Dispenser 02-1") at a depth of approximately 1 foot bgs. Following removal of the concrete slab overlying the diesel line, petroleum odor was noted, indicating leakage. SES collected a soil sample for placement in a plastic bag for 5 minutes in the sun, and the response showed 40 parts per million as vapor (ppmv). A soil sample was collected for laboratory analysis adjacent to the diesel UFST piping ("Diesel Dispenser 01-2").

Two additional soil samples were collected during the November 9, 1998 event to document the extent and character of the contamination. One 3-point composite sample ("Comp. Sample 01-(3)") was collected at approximately 1 to 2 feet bgs in the sidewalls of the excavation to document the inferred absence of contamination in the clean overburden and sidewalls. One sample ("Diesel Pea Gravel 01") was collected from the apparently contaminated backfill material around the top of the diesel UFST, at a depth of approximately 6.5 feet bgs. The migrational pattern of contamination could be seen to run down the fill pipe to the top of the UFST and down either side of the UFST at the pipe entry point. Visual, odor and FID evidence suggested soil contamination at this location. Given that the backfill and originally excavated area was common to all three UFSTs, it appeared obvious that the contaminated backfill could not be fully removed without removing the UFSTs. The excavation was discontinued at the end of the day, and because of the need to evaluate options and present the initial findings to the District and the ACHCSA.

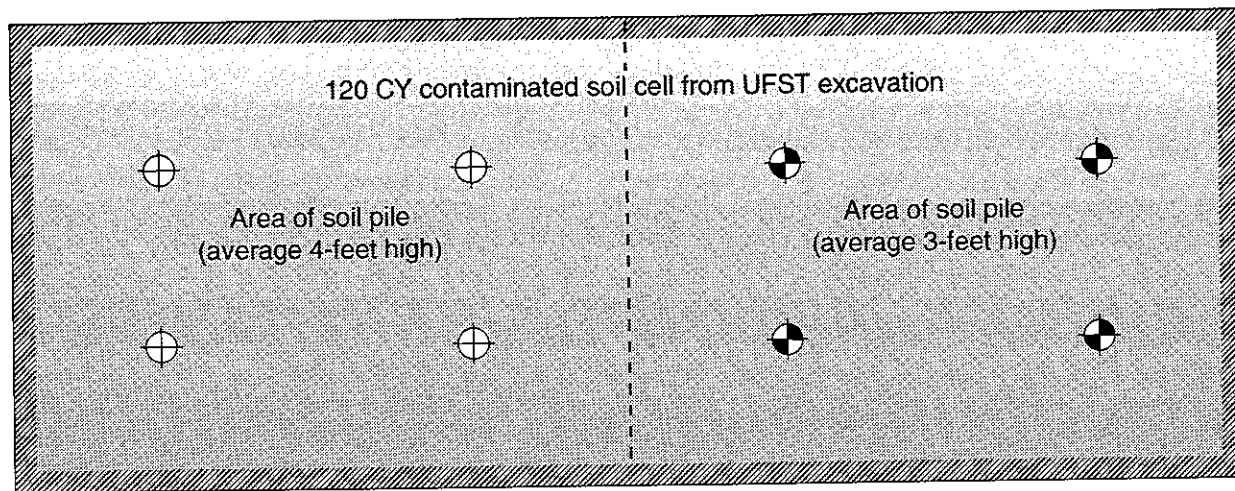
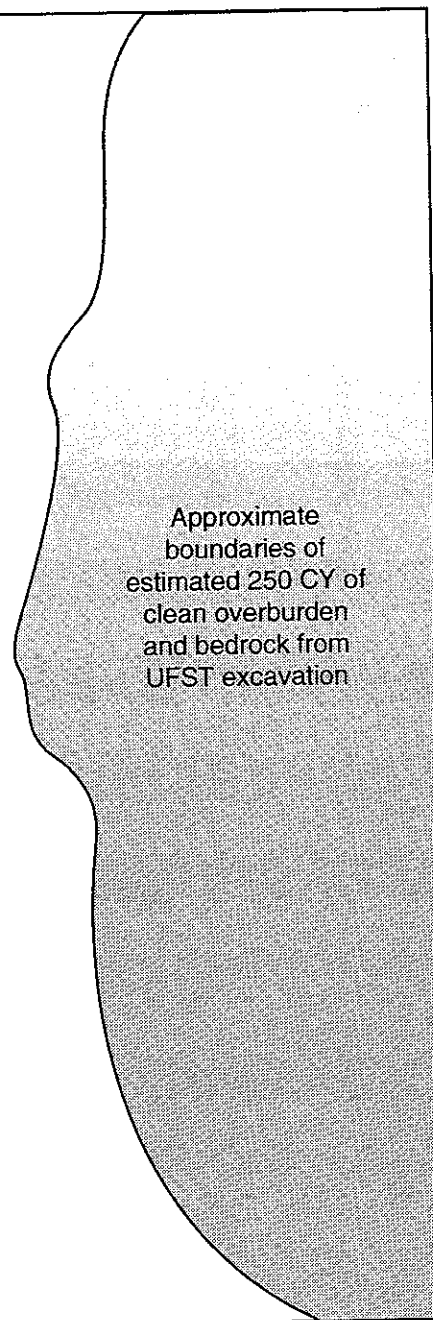
CS-Comp 01	
TPHd	2,000
TPHg	79
BTEX	ND
MTBE	ND

CS-Comp 02	
TPHd	590
TPHg	21
BTEX	ND
MTBE	ND

The majority of the contaminated soil (120 CY) is being treated by aeration in the onsite bermed soil stockpile. This aeration of the soil over time should result in decreases in the TPH concentration through the processes of volatilization and biodegradation. The TPH-contaminated soil in the soil aeration pile is very permeable because of the high percentage of inter-mixed pea gravel. Indigenous microbes common to the type of soils found, in combination with the low concentrations of residual contamination at the site, should result in reduction of the TPH to non-detectable levels over time, even with relatively low biodegradation rates (Howard et al., 1991).

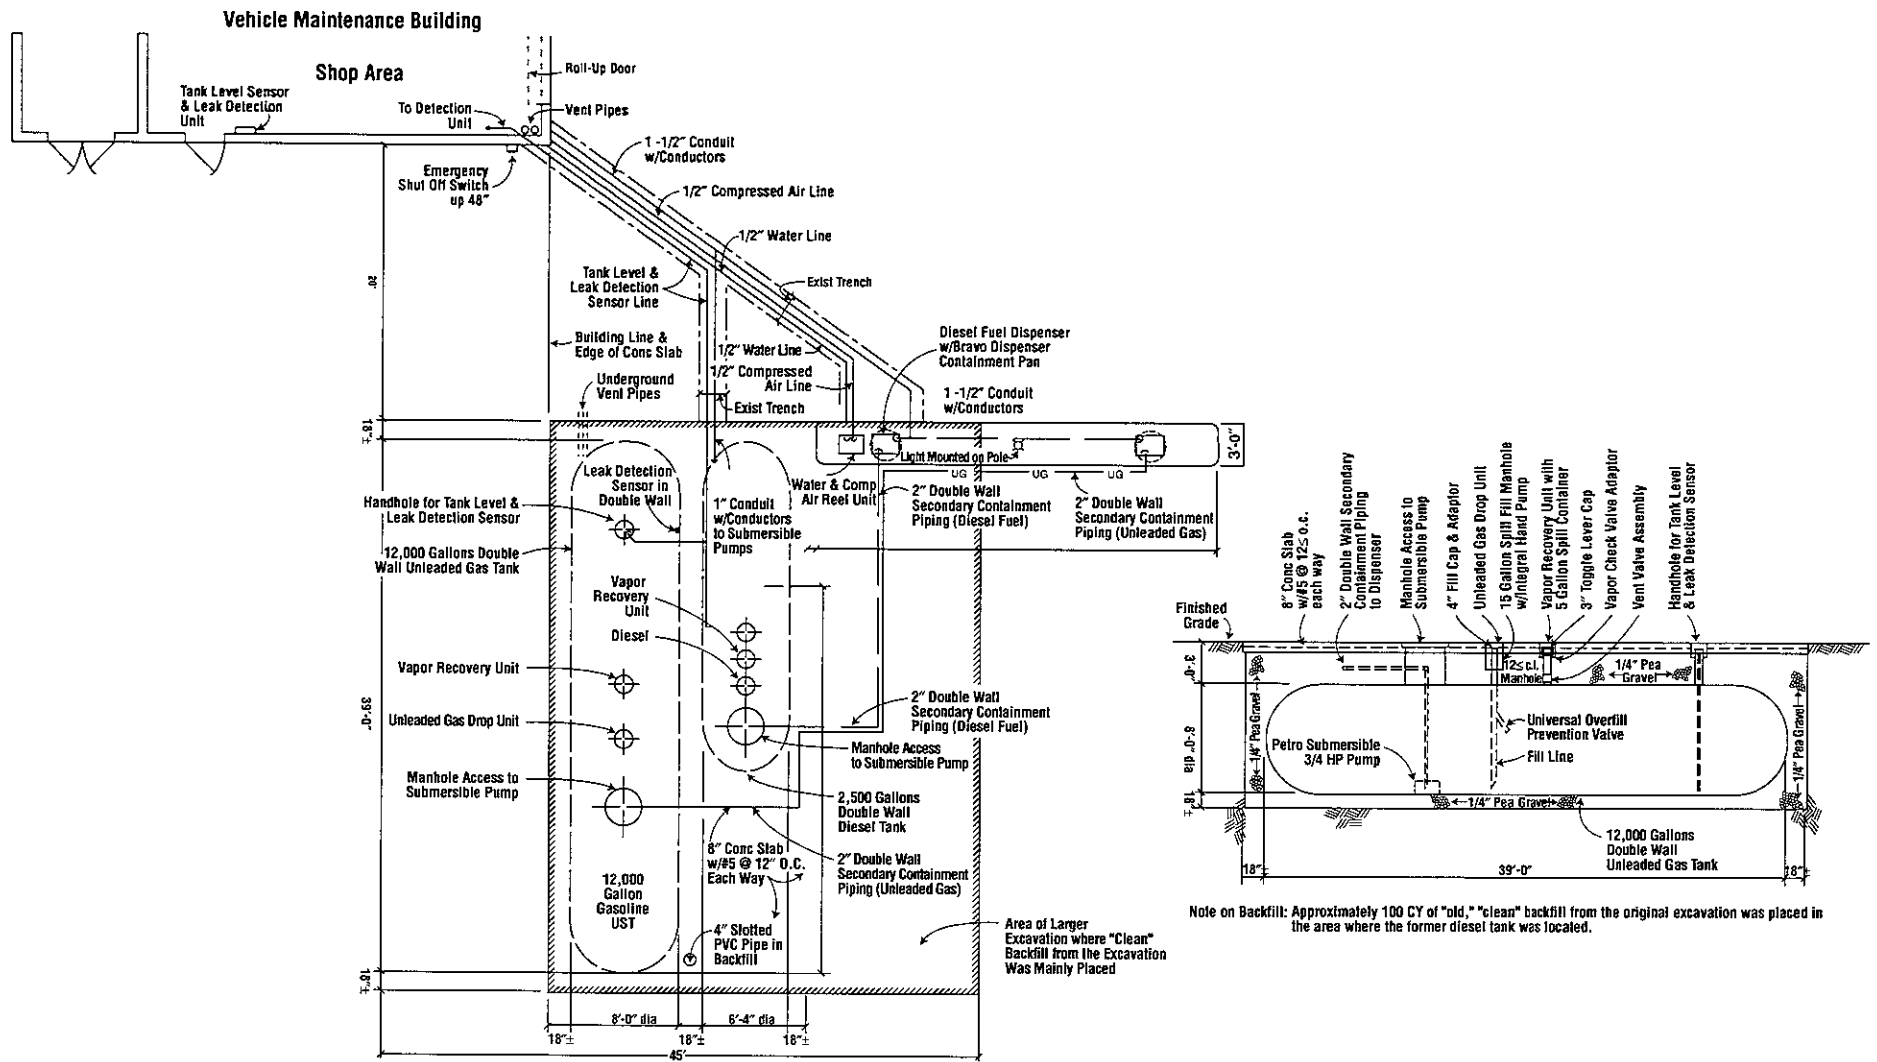
Figure 7 is an as-built plan for the replacement UFSTs. Appendix G contains installation specifications for the replacement UFST system. The as-built is substantially the same as the plan drawing for the two new tanks approved by ACHCSA on November 23, 1998. The main difference in the as-built drawing is the more extensive excavation area and the location of the one monitoring "well" in the backfill area near the new gasoline tank.

////// Boundaries of excavation to take out former UFSTs and place new UFSTs

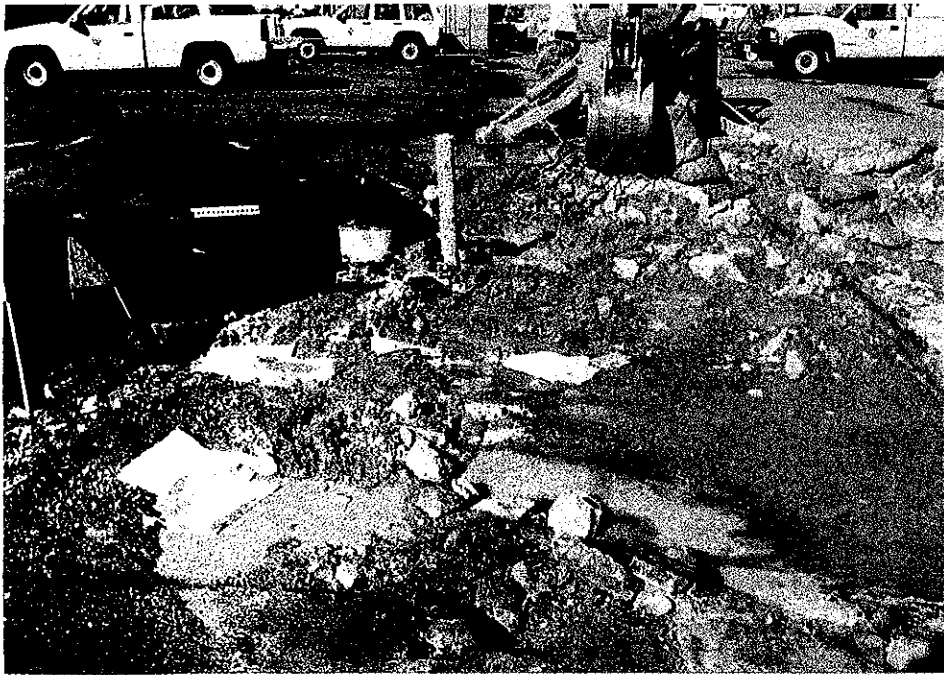
Photo No.: 01

Subject: View of backhoe breaking up and scraping away concrete cover before starting to excavate

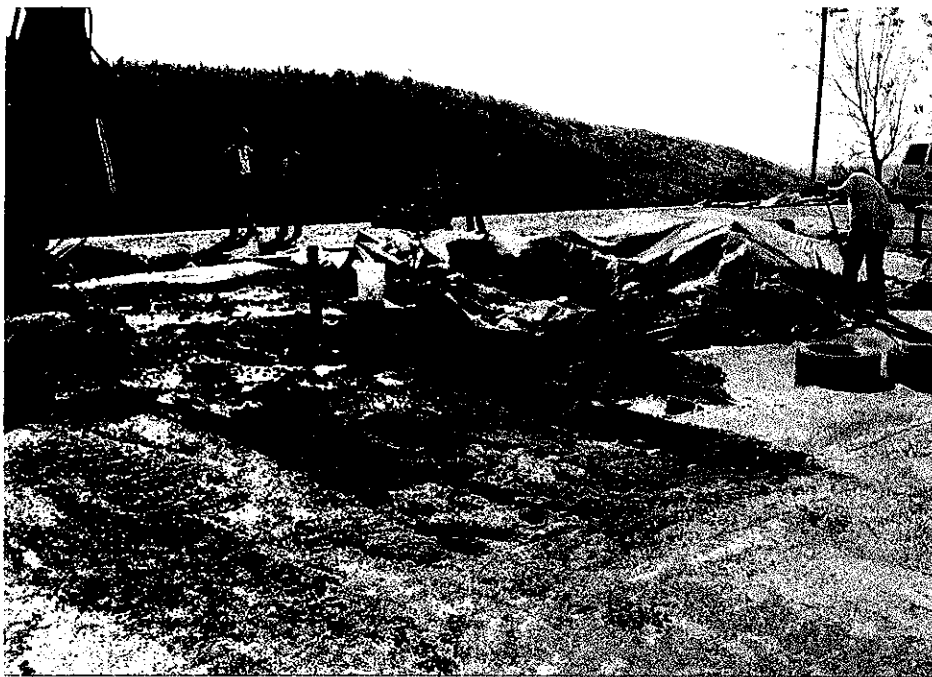
Photo No.: 02

Subject: View of "L" shaped area to be excavated looking southward with Iland area UFST piping covered with tarp against rain

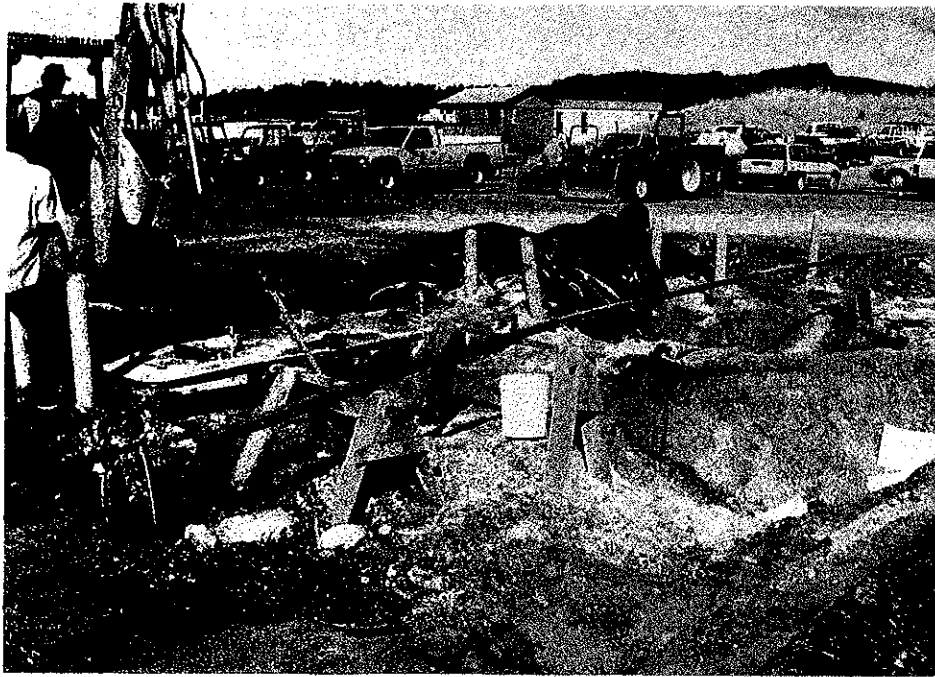
Photo No.: 03

Subject: View of backhoe preparing to remove the "Island" where the three pumps (2 gasoline and 1 diesel) were located

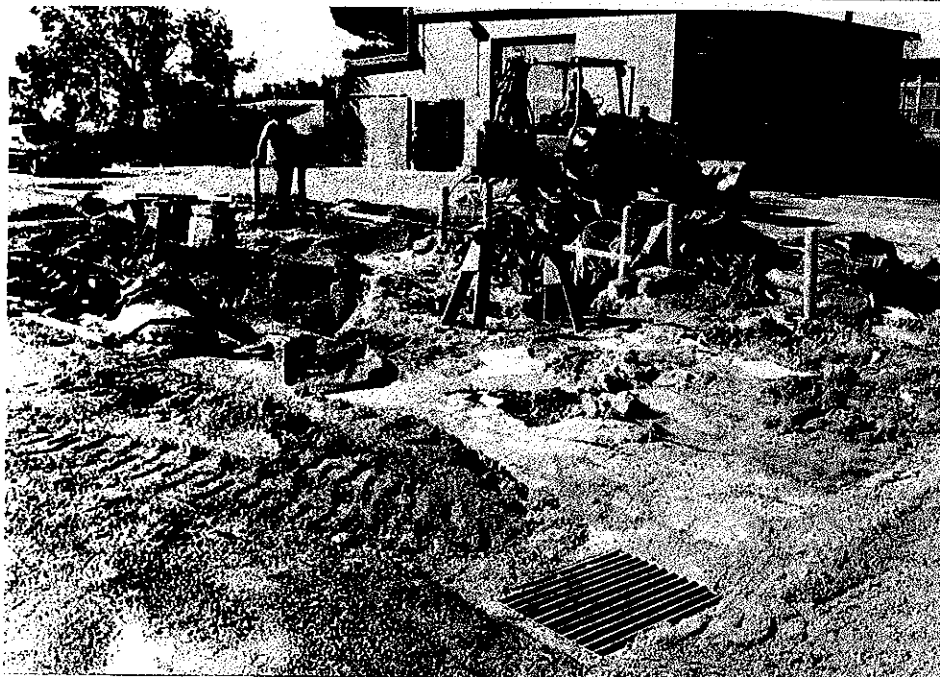
Photo No.: 04

Subject: View of initial excavation showing the location of the drain along its southern boundary

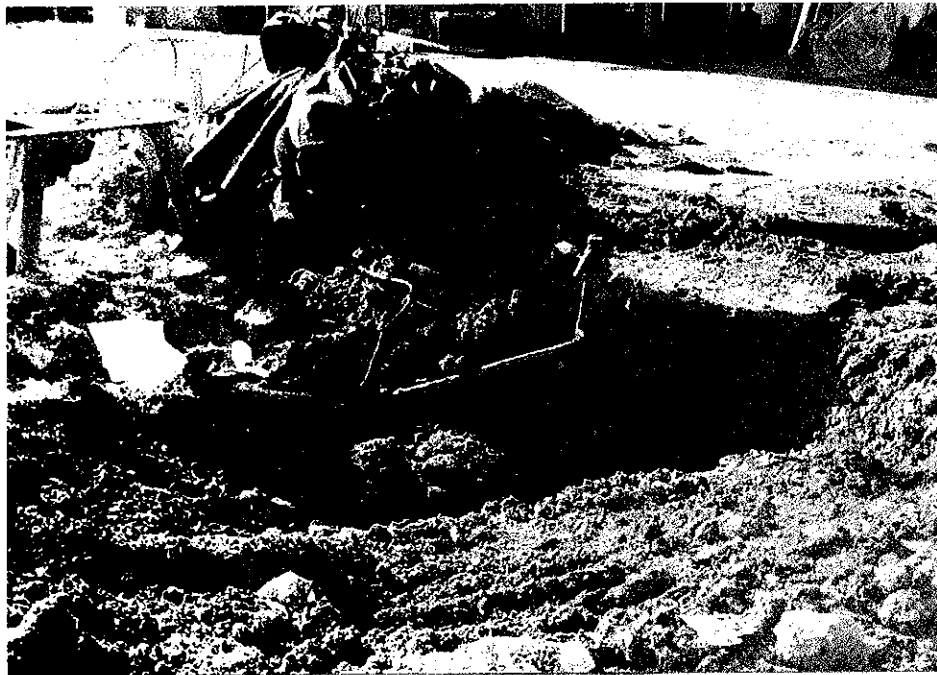
Photo No.: 05

On November 6, 1998 the asphalt and concrete surface cover over the tanks was removed (activities conducted prior to SES's arrival onsite). At that time, visual evidence of contamination was noted in the vicinity of the diesel tank suction piping union, which was noted to be leaking into the backfill material. Based on this observation, ACHCSA completed an Underground Storage Tank Unauthorized Release (Leak)/Contamination Site Report (copy included in Appendix D).

Subject: First evidence of contamination encountered while exposing the diesel piping to the UFST: product seen along piping

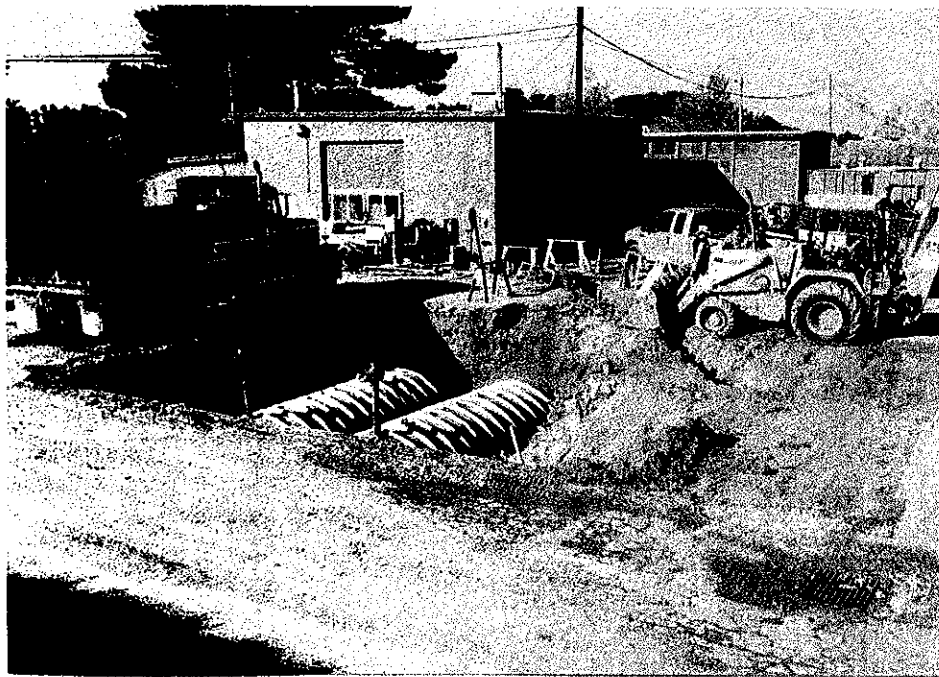
Photo No.: 07

Subject: The excavation and three exposed UFSTs (Two 8,000 gallon gasoline; one 2,200 gallon diesel) looking toward EBP building

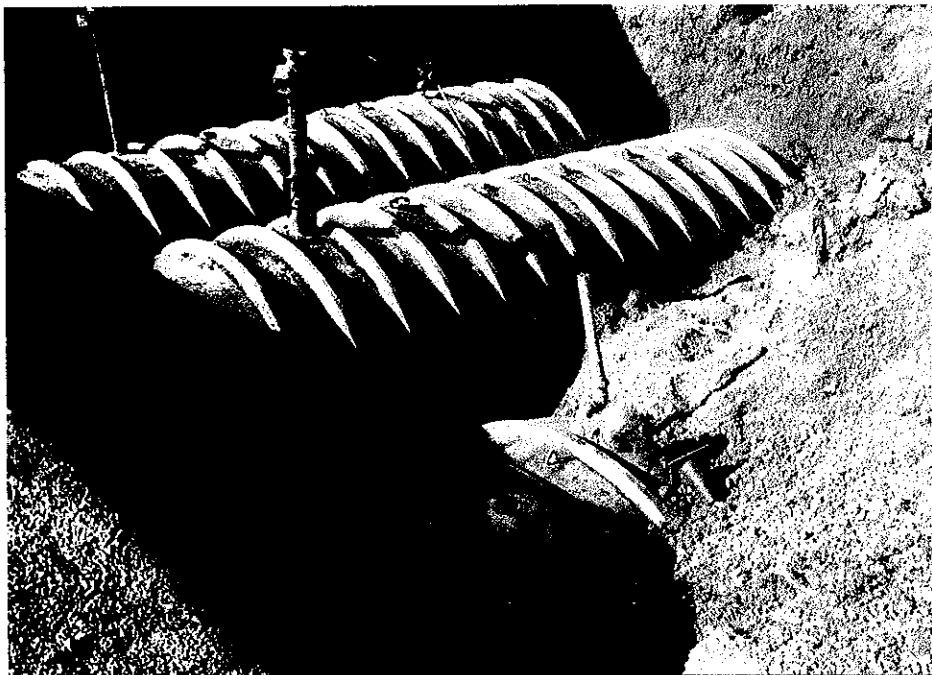
Photo No.: 08

On November 18, after the decision had been made to remove the UFSTs and replace them, the tanks were inerted (rendered non-flammable) prior to their removal. Dry ice (solid carbon dioxide) was emplaced in each tank at approximately 10:00 a.m.—including 350 pounds (7 bags) in Gasoline Tank 1 (GT-1); 250 pounds in Gasoline Tank 2 (GT-2); and 100 pounds in the Diesel Tank (DT). Appendix E includes the dry ice receipt. At approximately 1:00 p.m. Mr. Robert Weston of ACHCSA observed measurement of the lower explosive limit (LEL) and oxygen measured inside the UFST, and approved the removal of the UFSTs from the excavation.

Subject: Close up of three UFSTs in excavation after putting dry ice in them and waiting for tanks to become inert re. LEL/Oxygen

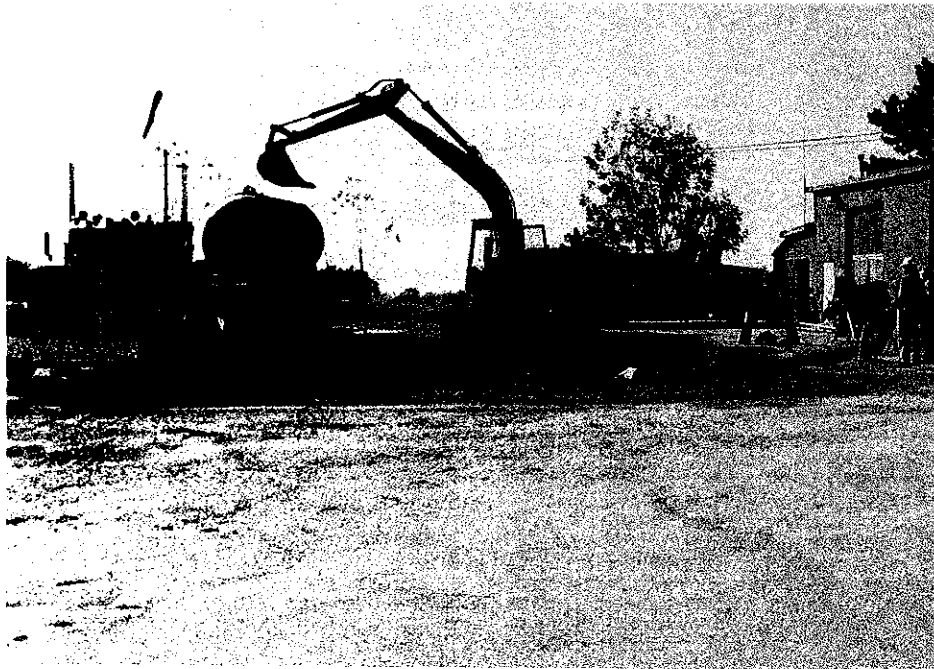
Photo No.: 09

The UFSTs were removed from the excavation and were visually inspected for signs of leakage. Following Mr. Weston's concurrence that there were no signs of leakage from the UFSTs themselves, the UFSTs were transported offsite (see following section for discussion of tank transport and disposal).

Subject: Removing tanks and loading onto truck to haul off for destruction.

The three removed UFSTs were transported offsite for scrapping. Prior to transport, a Uniform Hazardous Waste manifest was completed and then signed by Mr. Gil Lopez of the District. The UFSTs were transported on November 18, 1998 by Trident Trucklines (EPA transporter I.D. number CAD982484370) to Erickson, Inc. (a subsidiary of Ecology Control Industries) (EPA I.D. CAD009466392). The U.S. Department of Transportation proper shipping name and hazard class assigned to the UFSTs on the manifest were "Waste Empty Storage Tank" and "Non-RCRA hazardous waste solid," respectively. The State of California waste code assigned to the UFSTs was "512" (for containers larger than 30 gallons). Copies of the hazardous waste manifests are included in Appendix E. Following arrival at Erickson's facility, Erickson completed the hazardous waste manifests (signed to acknowledge receipt of the UFSTs and assigned a handling code – "01" for recyclable material) and sent copies of the manifests to the California Department of Toxic Substances Control (DTSC). The UFSTs were then cleaned and destroyed on November 20, 1998. The UFST certificates of destruction are included in Appendix E.

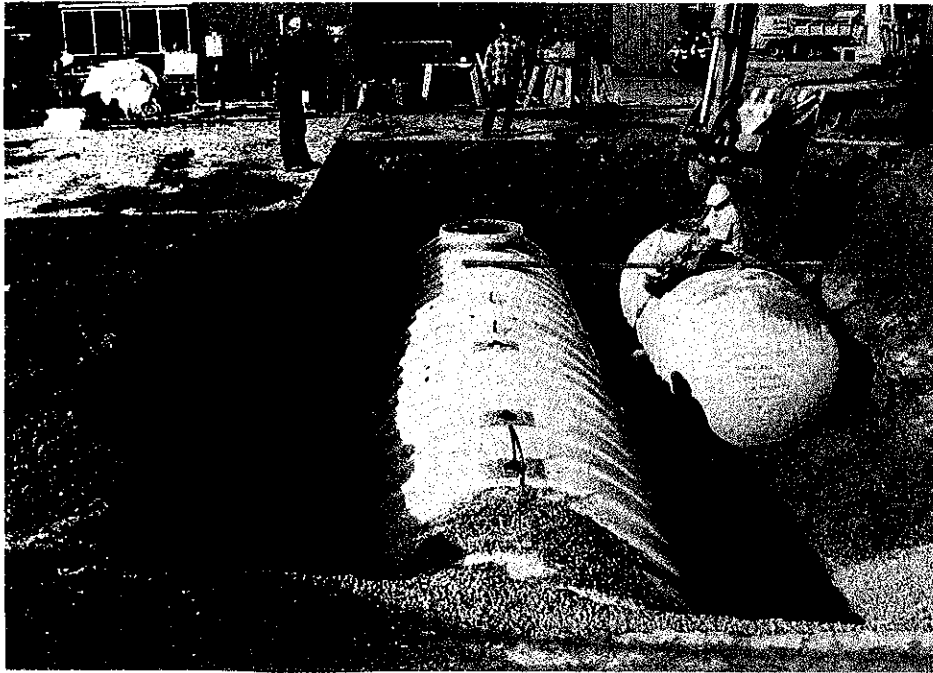
Photo No.: 11

Subject: View of new 12,000 gallon gasoline and 2,500 gallon diesel tanks being installed in excavation, looking north

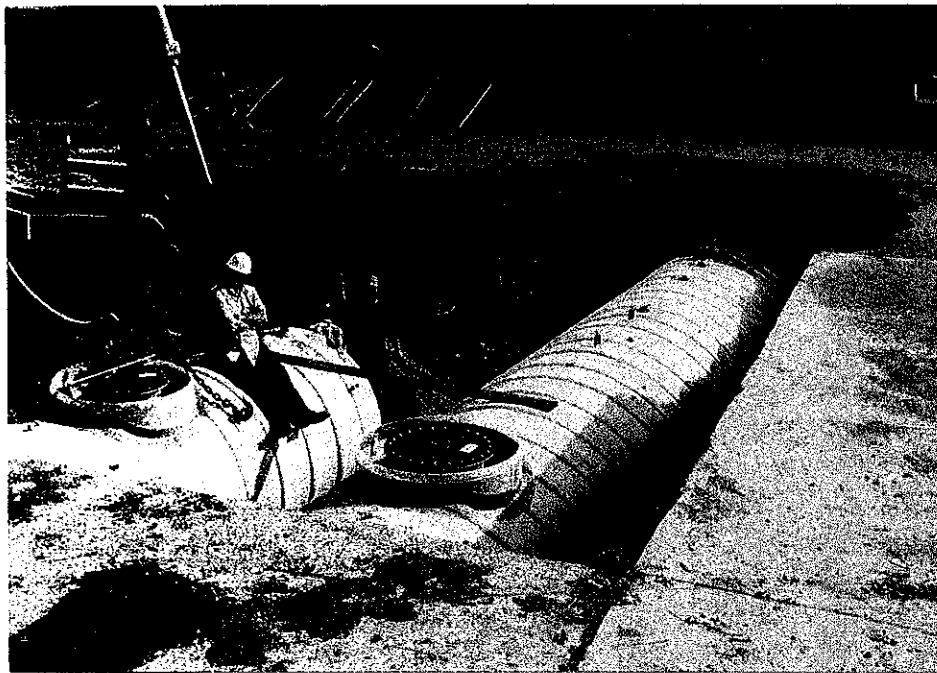
Photo No.: 12

Subject: View of new 12,000 gallon gasoline and 2,500 gallon diesel tanks being installed in excavation, looking south

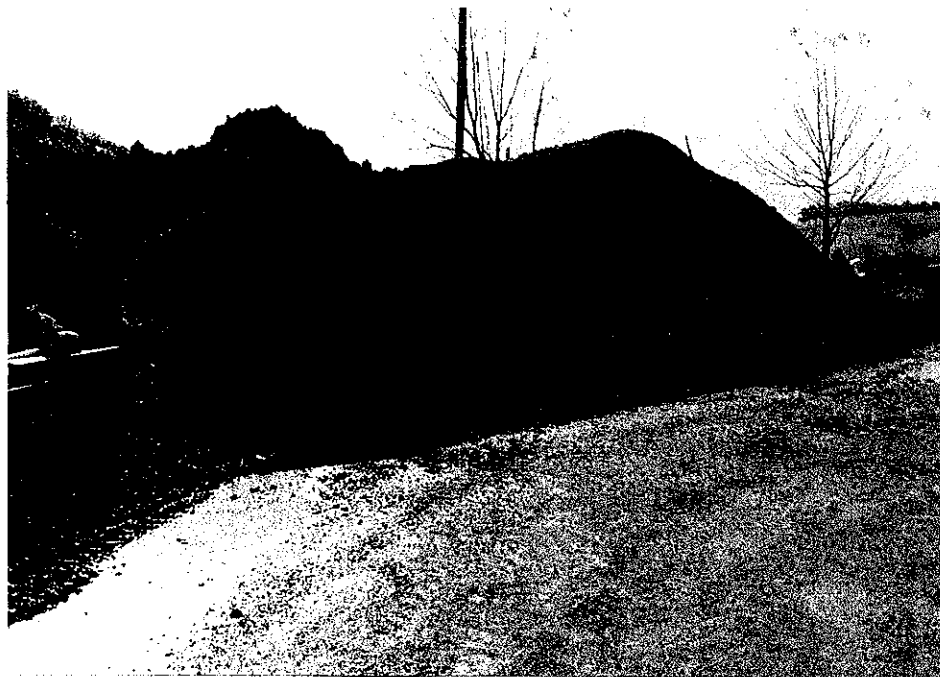
Photo No.: 13

Subject: "clean" soil/backfill stockpile (overburden and clean backfill) that went back into excavation around new tanks

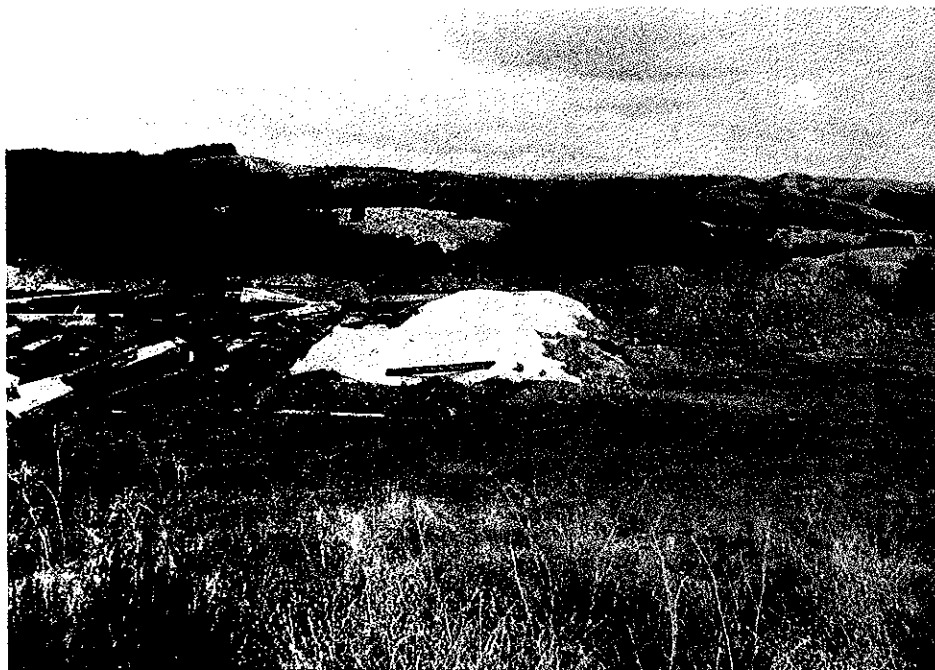
Photo No.: 14

Subject: Location near Parks police main building showing general construction debris and bermed contaminated soil from excavation

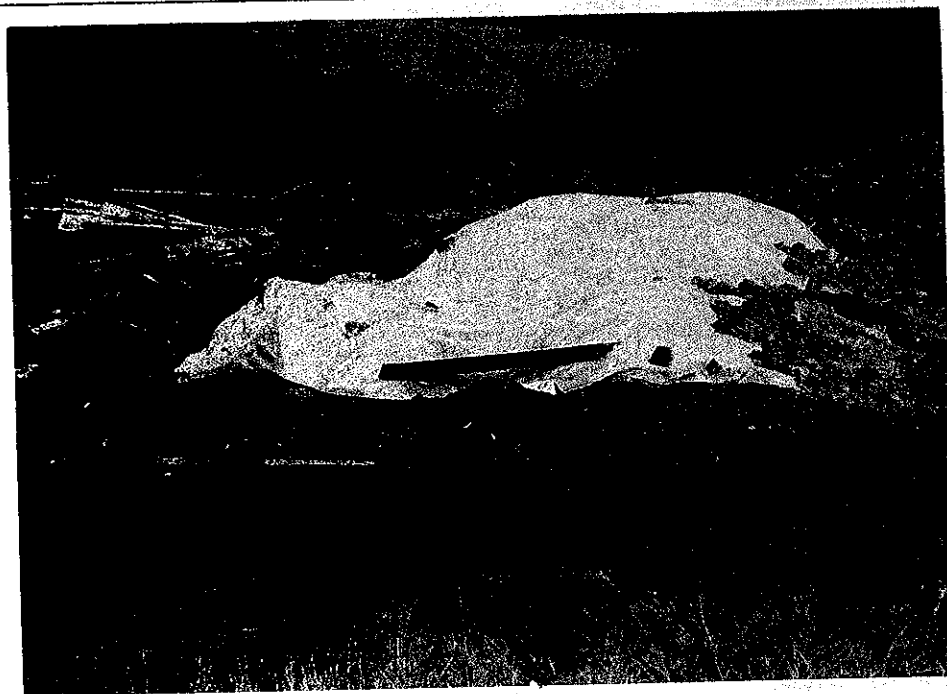
Photo No.: 15

On December 10, 1998, two 4-point composite soil samples were collected from the approximately 120 CY of contaminated, stockpiled soil (sample I.D.s "CS-Comp-01" and "CS-Comp-02"). Four discrete soil samples were collected in each of two approximately equal volumes of the pile, with each 4-point sample set to be composited by the laboratory prior to analysis. Each sample was collected by removing the upper 6 to 12 inches of soil and using a trowel to collect the soil sample, which was then placed in a glass sampling jar and labeled.

Subject: View of contaminated soil stockpile (estimated at 120 CY) where the two 4 to 1 composite samples were collected 12/10/98.

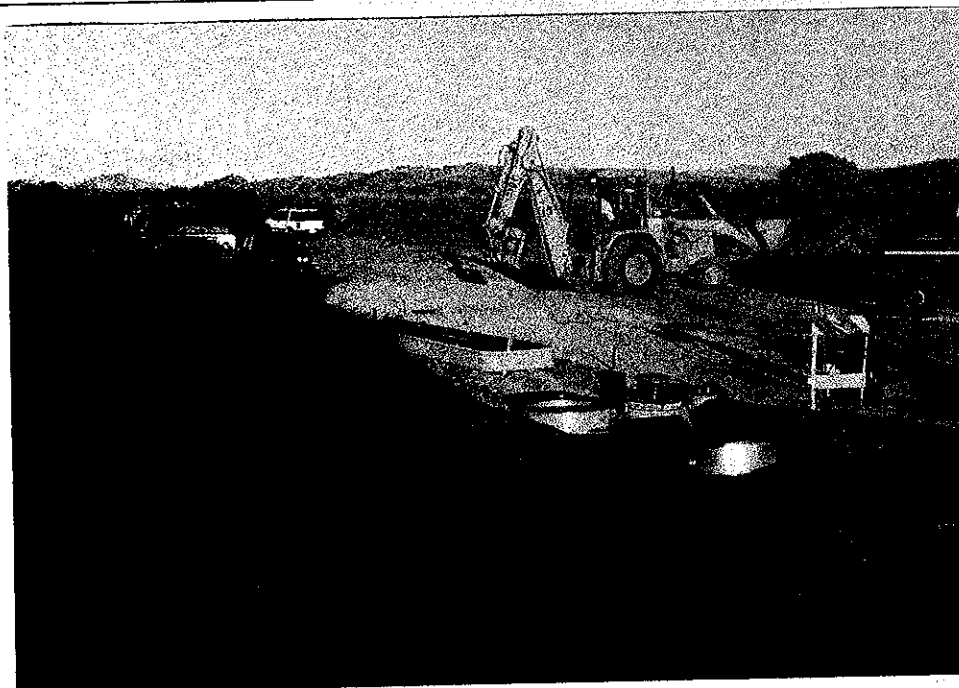
Subject: View of site restoration progress January 8, 1999.

Final site restoration will include installation of fuel dispensing equipment and surface paving. It is anticipated that those activities will be conducted by February 1999.
