**HUMAN HEALTH RISK ASSESSMENT WORK PLAN
6701-6707 SHELLMOUND STREET
EMERYVILLE, CALIFORNIA**

OCTOBER, 2016

**SLR International Corporation
110 11th Street, 2nd Floor
Oakland, CA 94607**

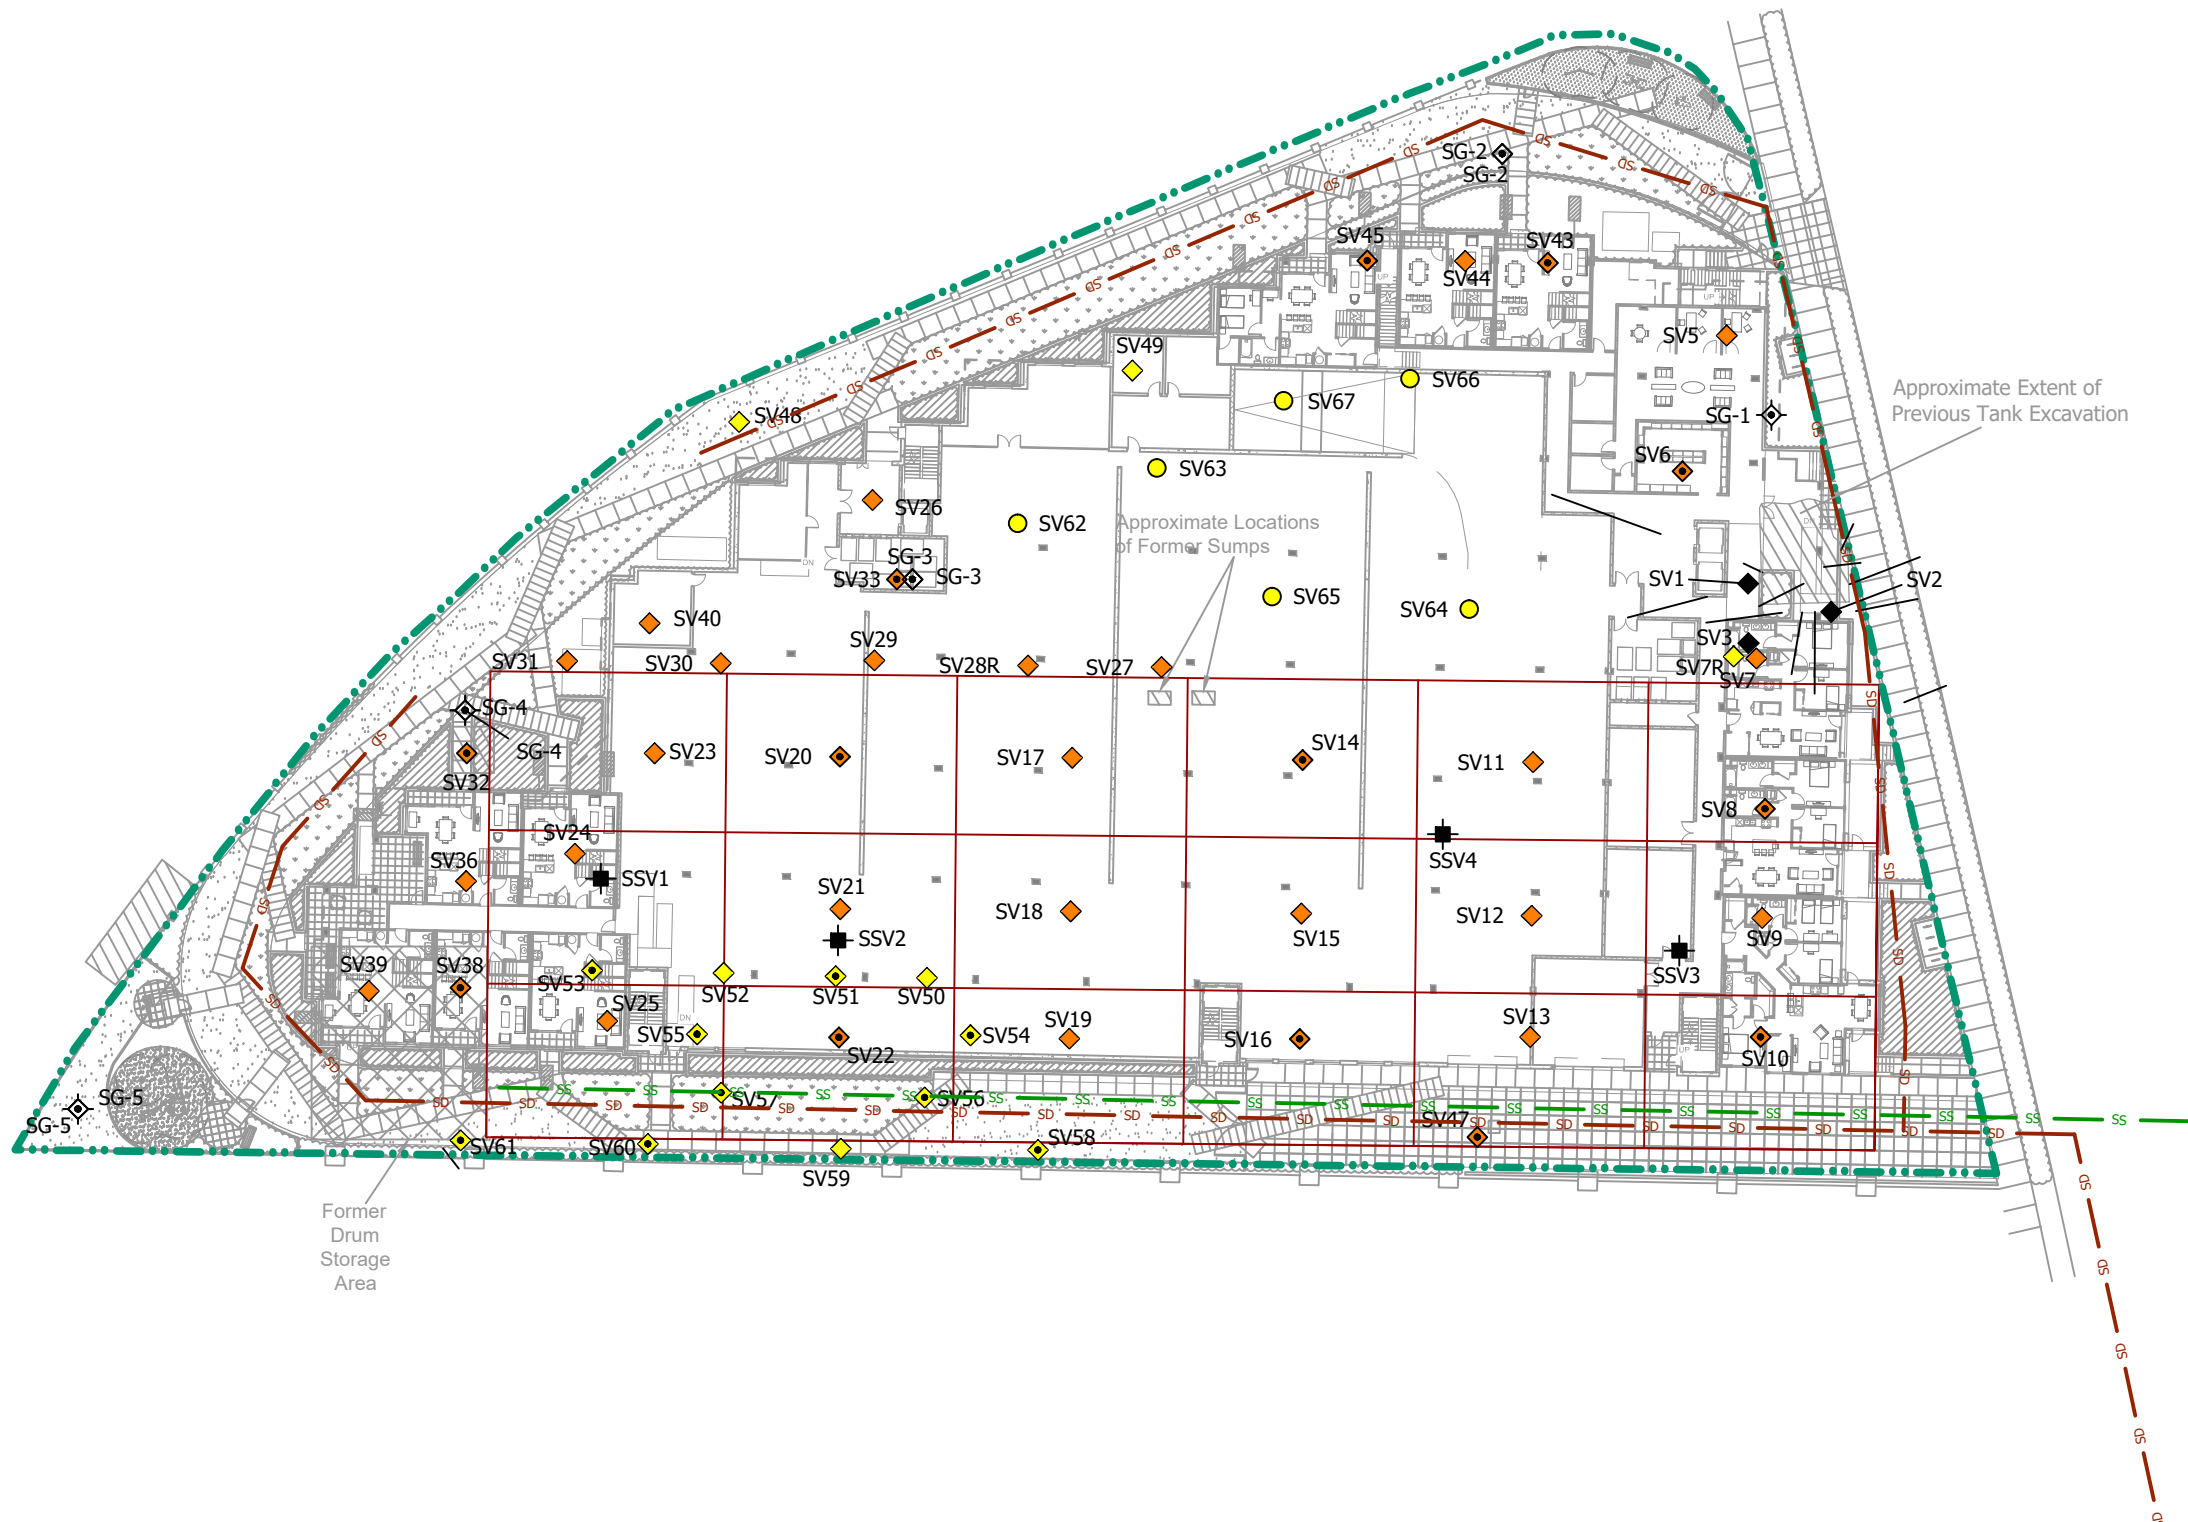
Soil Vapor Sample Locations and Proposed Ground Level Development Plan
 Human Health Risk Assessment Work Plan
 6701, 6705, and 6707 Shellmound Street
 Emeryville, California

Additional soil gas sampling activities were conducted in November and December of 2015 to further address potential vapor intrusion concerns beneath former industrial features, existing buildings, and proposed future building areas including first-floor residential units and common areas; and to assess conditions associated with VOCs or elevated laboratory detection limits for VOCs reported for soil gas and subslab vapor samples collected in April 2015. Samples were collected from a depth of five feet bgs. Samples were also collected from a depth of 10 feet bgs at most locations, and from eight feet bgs at one location. Twenty VOCs were detected in at least one of these samples; four of these (trichloroethene [TCE], vinyl chloride, 1,1,2,2-tetrachloroethane, and benzene) were detected at concentrations above soil gas ESLs protective of vapor intrusion concerns for residents.

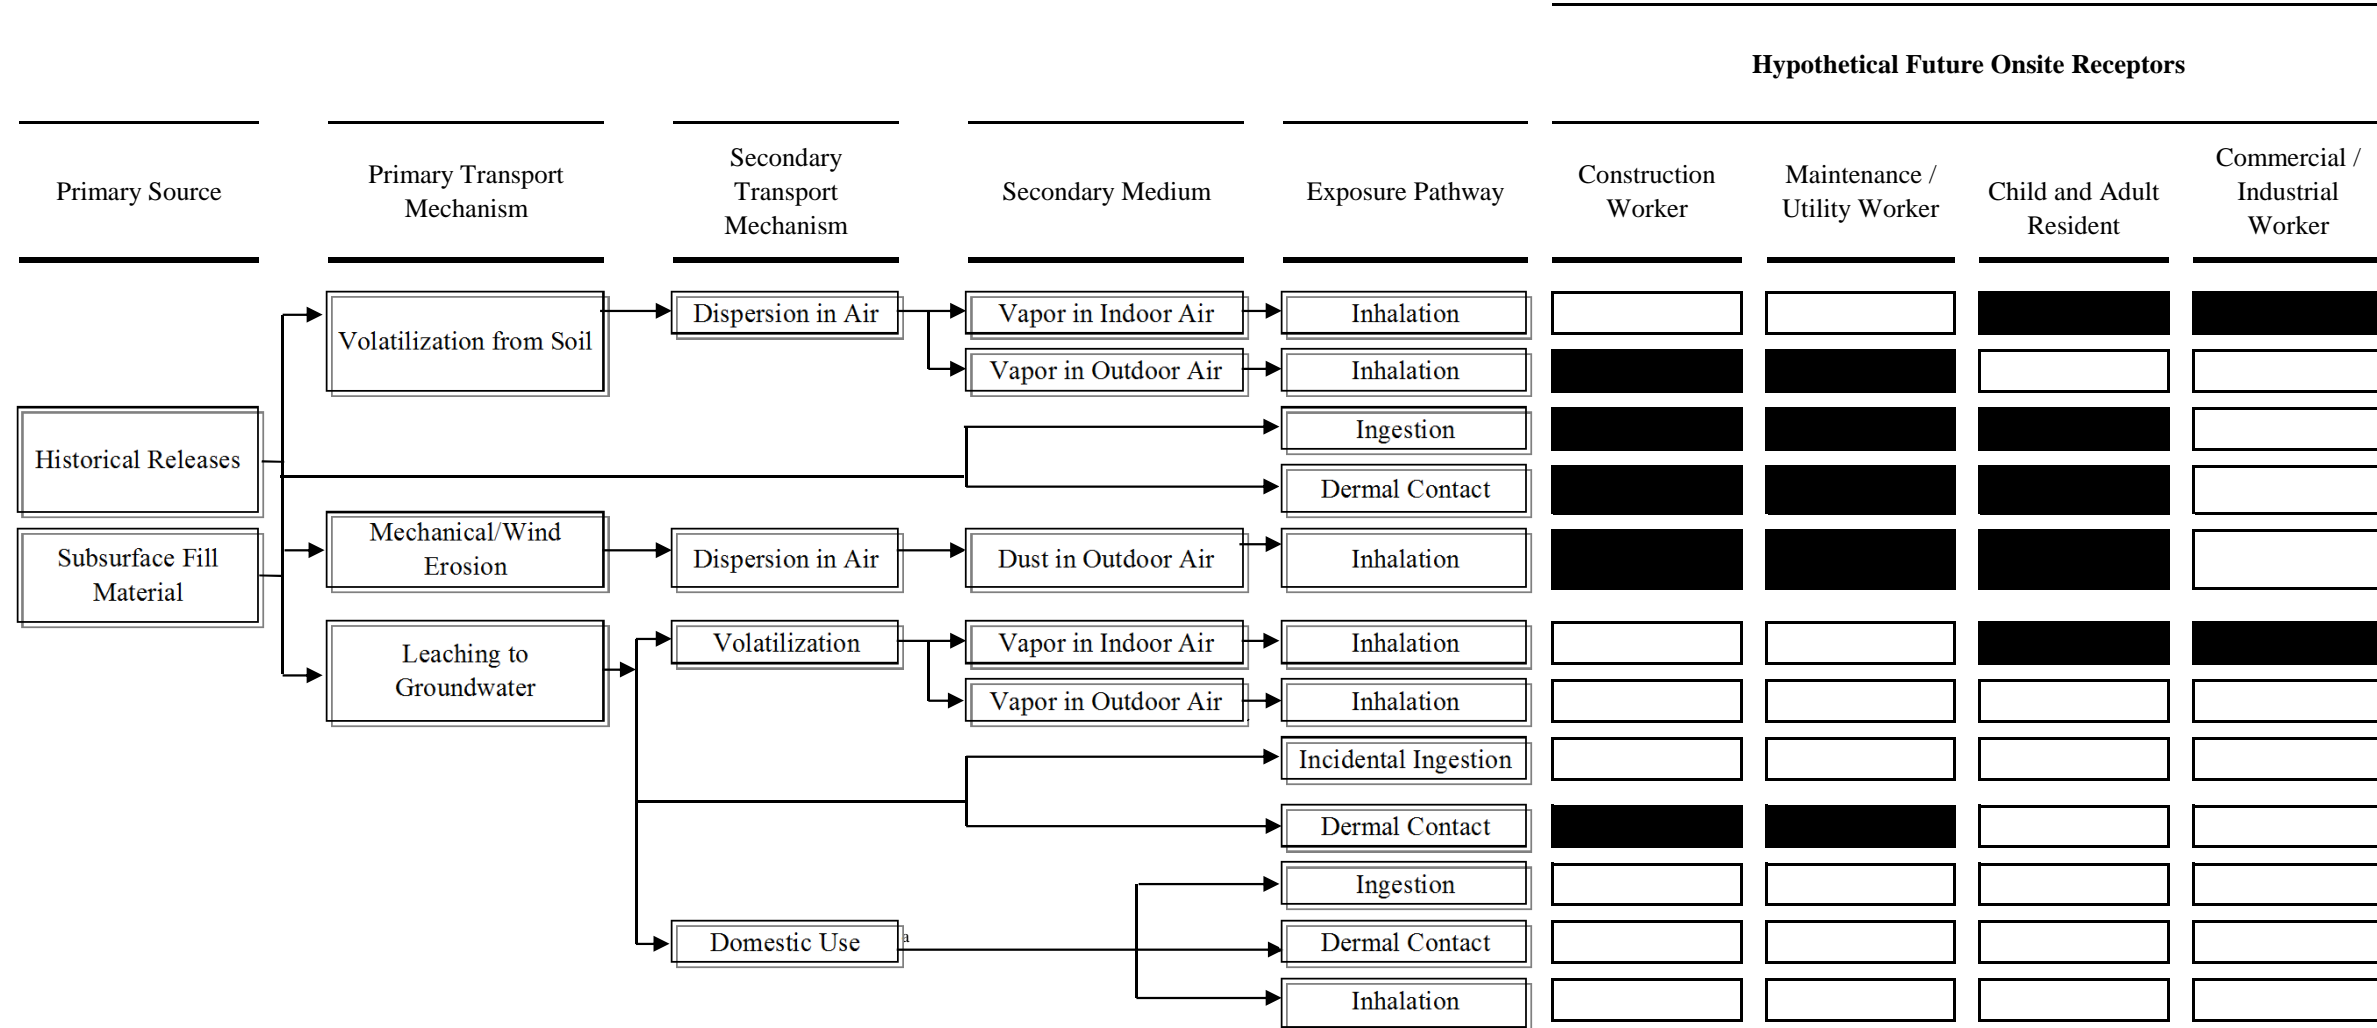
Plate 7
Conceptual Site Model Diagram
Human Health Risk Assessment Work Plan
6701, 6705, and 6707 Shellmound Street
Emeryville, California

- █ Exposure pathway is considered potentially complete and will be evaluated in Tier 1
- Pathway is incomplete

^a City of Emeryville Ordinance No. 07-006 prohibits extraction of groundwater for drinking, industrial or irrigation purposes. Domestic water in Emeryville is supplied by the East Bay Municipal Utility District.

Exposure to chemicals in soil can occur directly through incidental ingestion and dermal contact and inhalation of dust or indirectly through inhalation of vapors from the subsurface. All receptors were assumed to be exposed to vapors in air originating from the subsurface, as discussed further below. The site redevelopment plans call for the site to be fully paved upon completion except for landscaped areas, which will include a minimum of two feet of clean fill above the site soils (PES, 2015b). However, to evaluate potential conditions without a clean fill cap, residential receptors were assumed to be directly exposed to soil beneath proposed exterior landscaped and play areas. Inhalation of dust or vapors in outdoor air was also identified as a potentially complete exposure pathway for this receptor. Construction and maintenance worker receptors can reasonably be assumed to be exposed directly to chemicals in soil. Exposure to chemicals in dust or vapors is possible during excavation activities. Although monitoring and dust suppression will be conducted as part of planned redevelopment activities, dust or vapor inhalation is considered to represent a potentially complete exposure pathway for invasive workers. Retail workers were assumed to spend the majority of their time indoors while at the site; therefore, no potentially complete soil exposure pathways were identified for this receptor.

First encountered groundwater at the site has historically been as shallow as 5.15 bgs (1995), and more recently ranged from 11 to 13.5 feet bgs (PES, 2015b, 2016a). The maximum depth of the excavation for utility trenches will be approximately 12 feet bgs. The construction of the building foundation system will utilize drilled displacement piers and the building will be constructed with an at grade 24-inch thick concrete slab. Deeper excavations will be limited to those conducted for utility trenches. Therefore, groundwater could be encountered in some locations during utility trench excavations. However, redevelopment activities will require dewatering in the event groundwater is encountered during excavation, and the SMP for the site will also require actions to be taken should groundwater be encountered, so direct contact with groundwater is not anticipated to be a complete exposure pathway. However, in consideration of historically shallow groundwater levels and in order to evaluate potential exposures without planned institutional/engineering controls, this exposure pathway is conservatively identified in the CSM as potentially complete for maintenance/utility workers and construction workers. Groundwater at

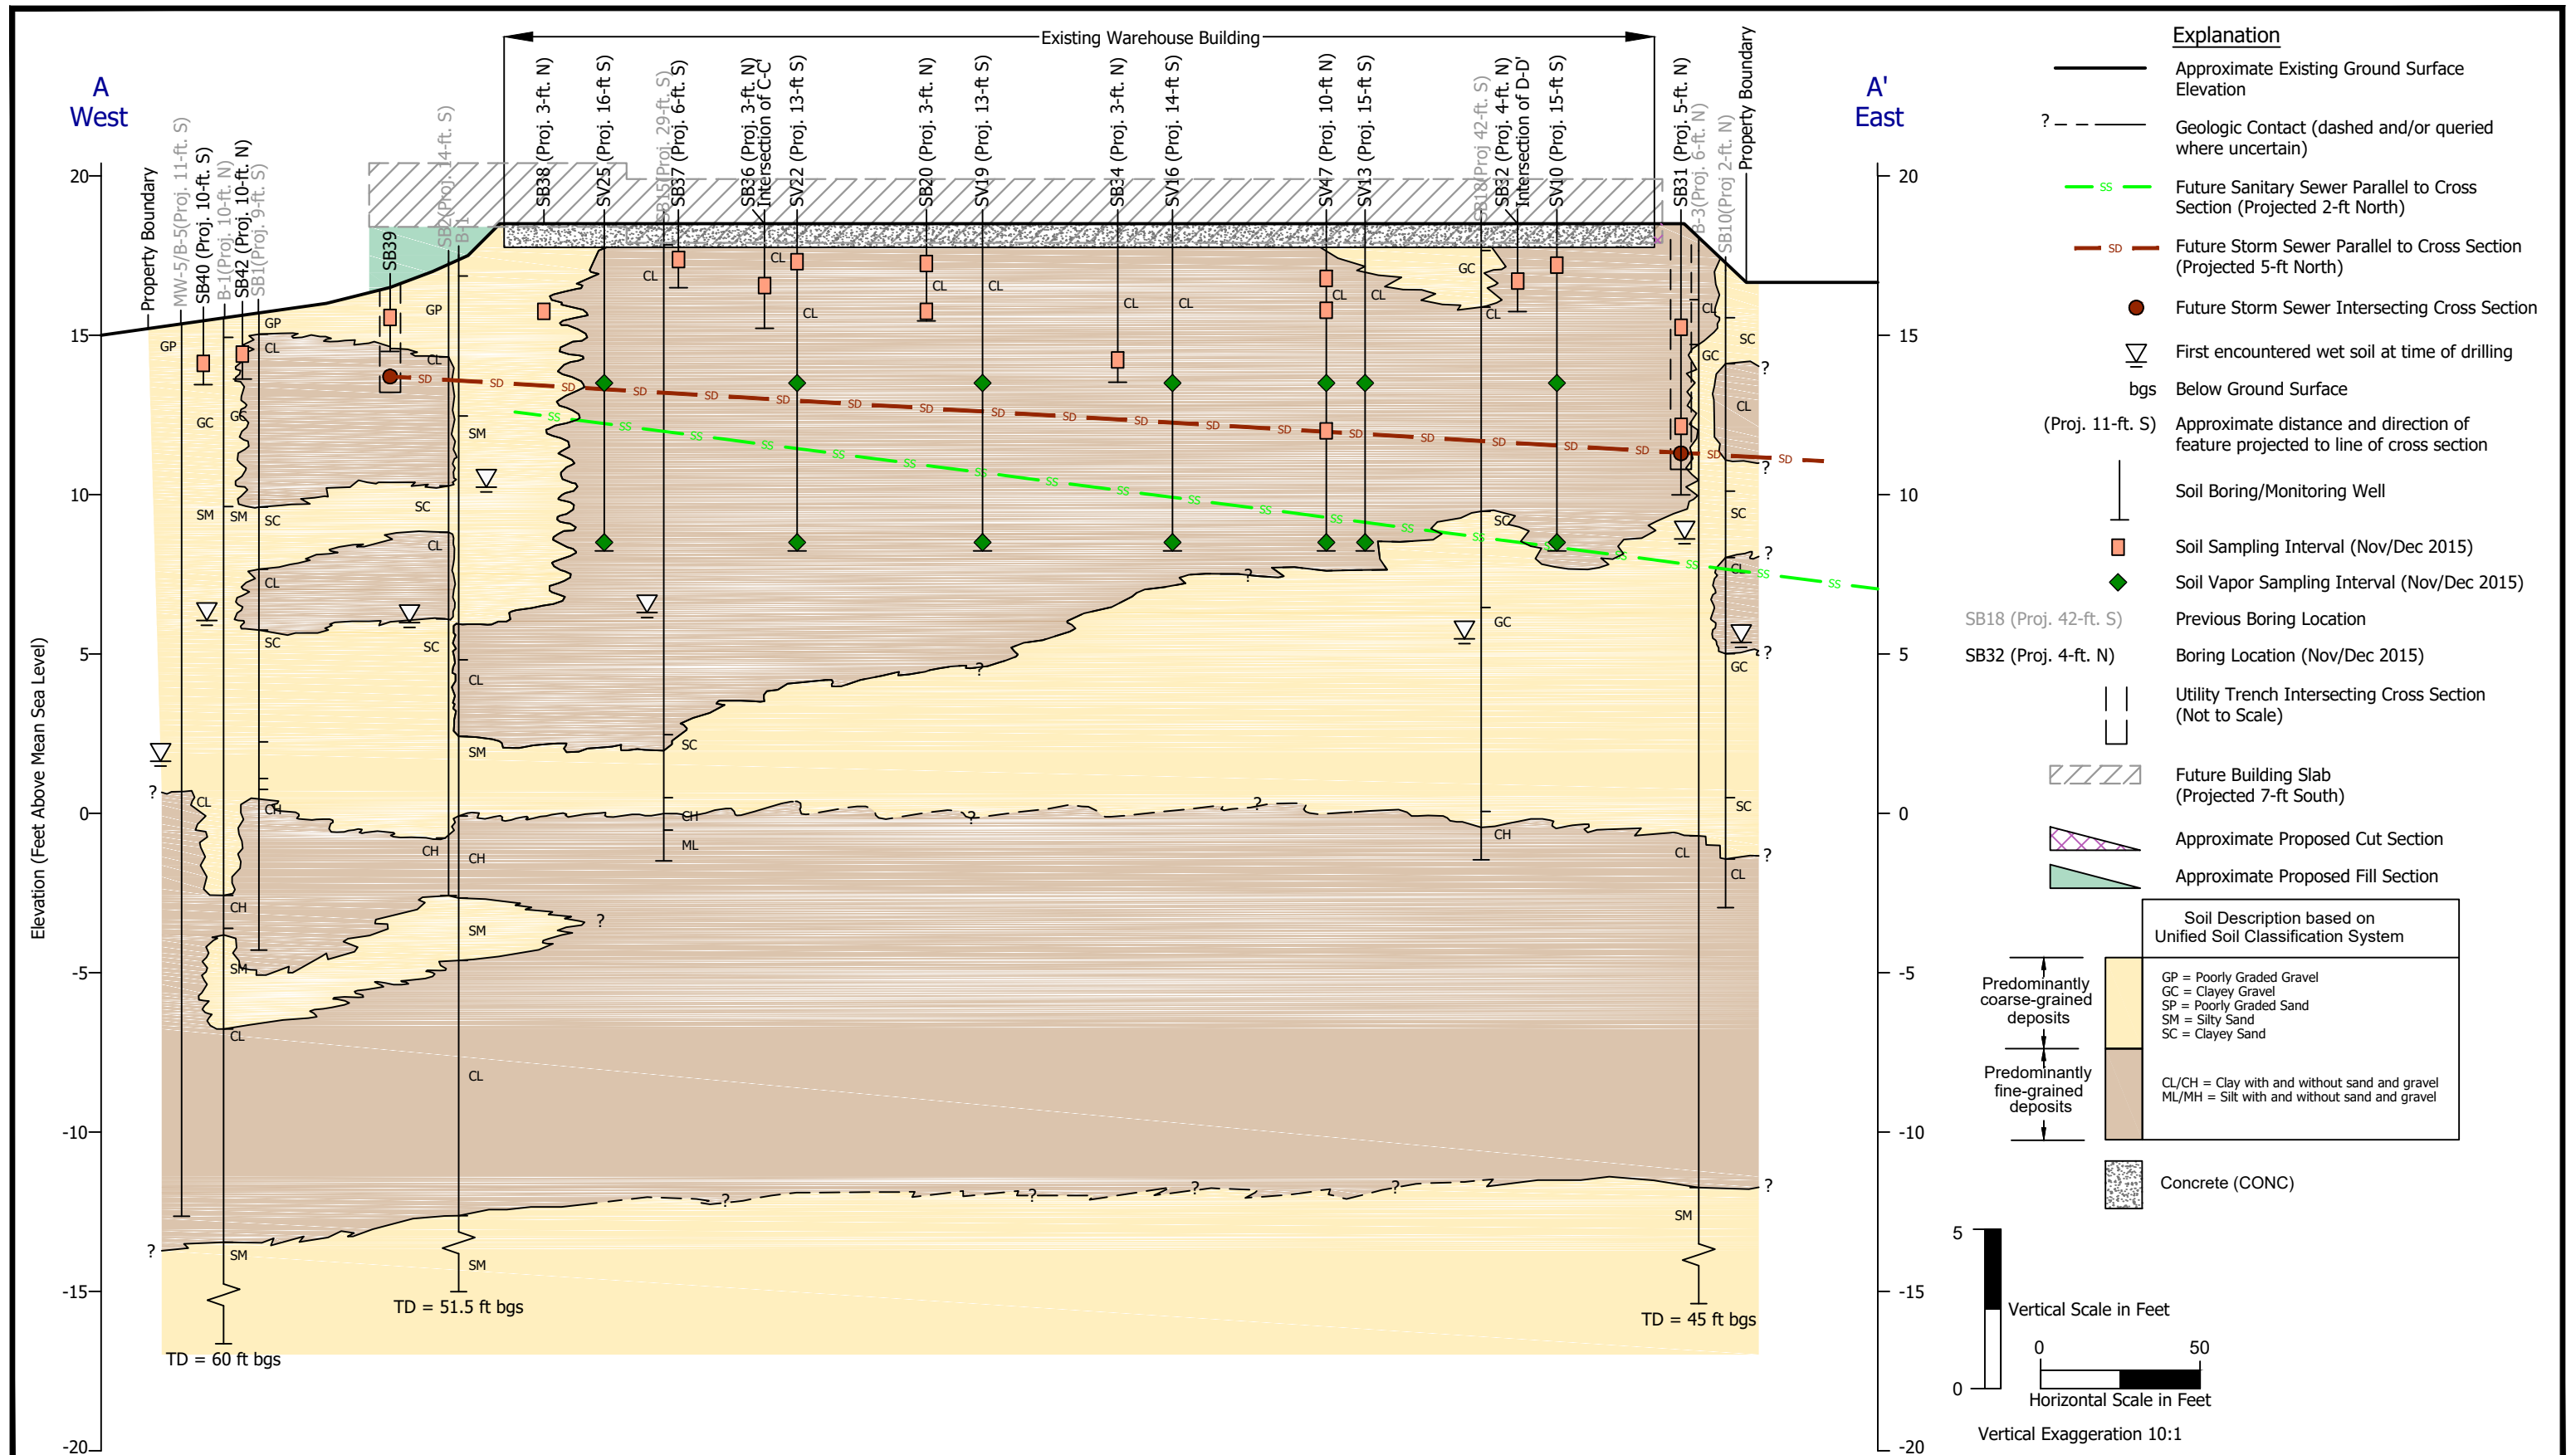
Cross Section A-A' Showing Soil Sample Locations, Proposed Building Slab, and Utility Alignments
 Human Health Risk Assessment Work Plan
 6701, 6705, and 6707 Shellmound Street
 Emeryville, California

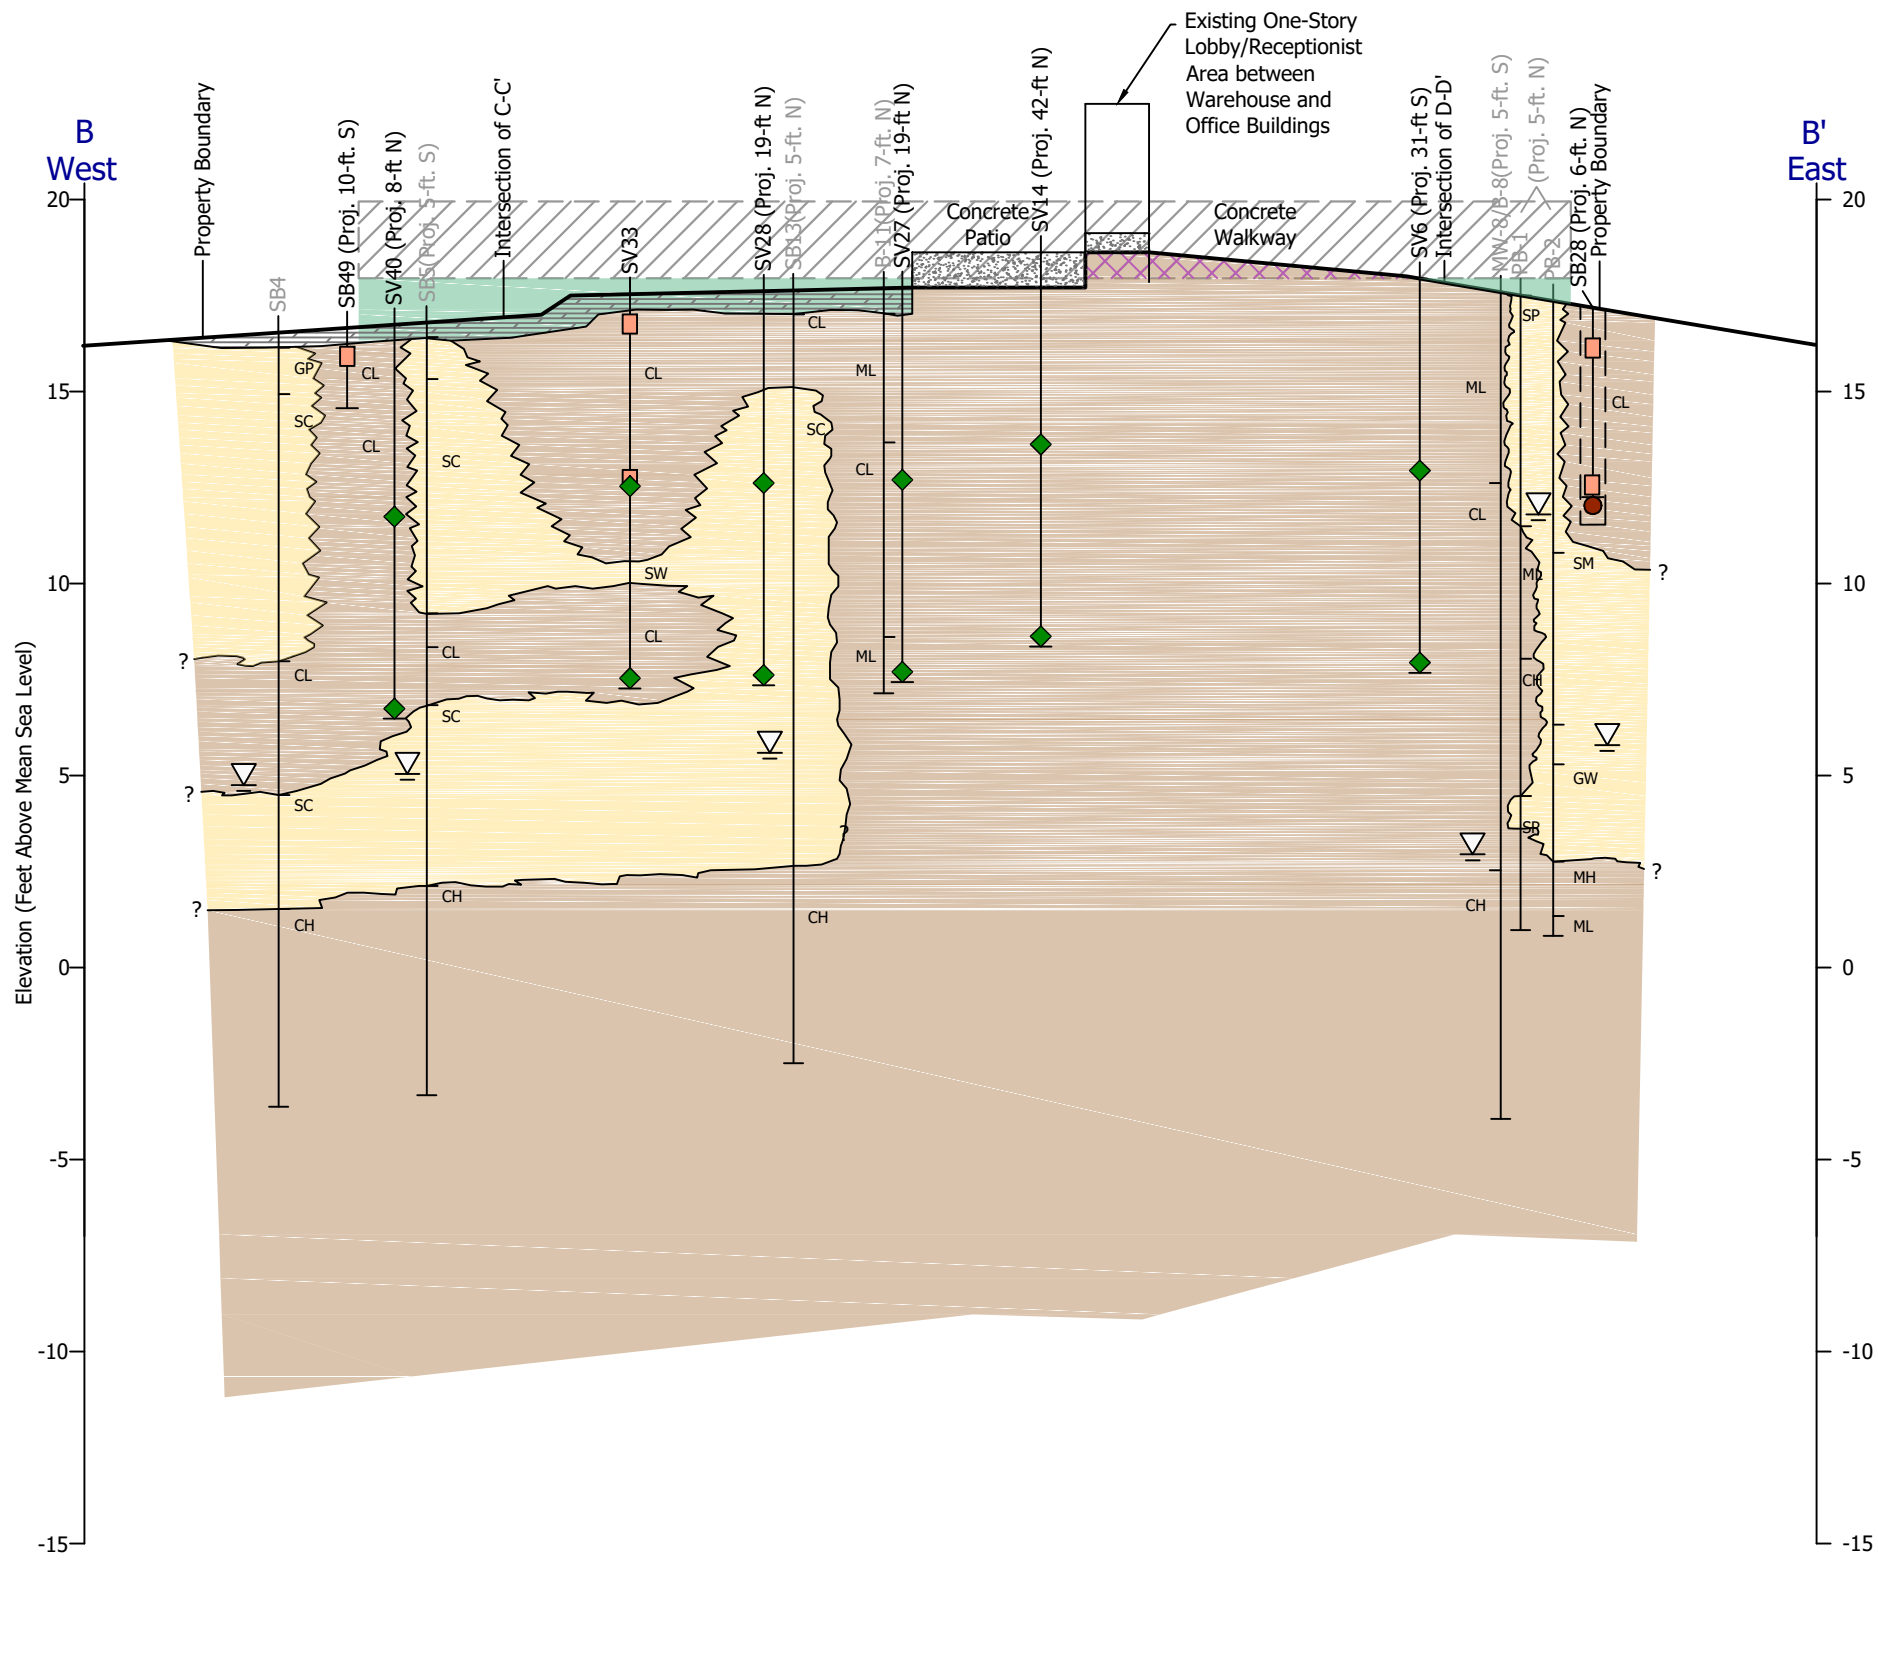
Cross Section B-B' Showing Soil Sample Locations, Proposed Building Slab, and Utility Alignments
 Human Health Risk Assessment Work Plan
 6701, 6705, and 6707 Shellmound Street
 Emeryville, California

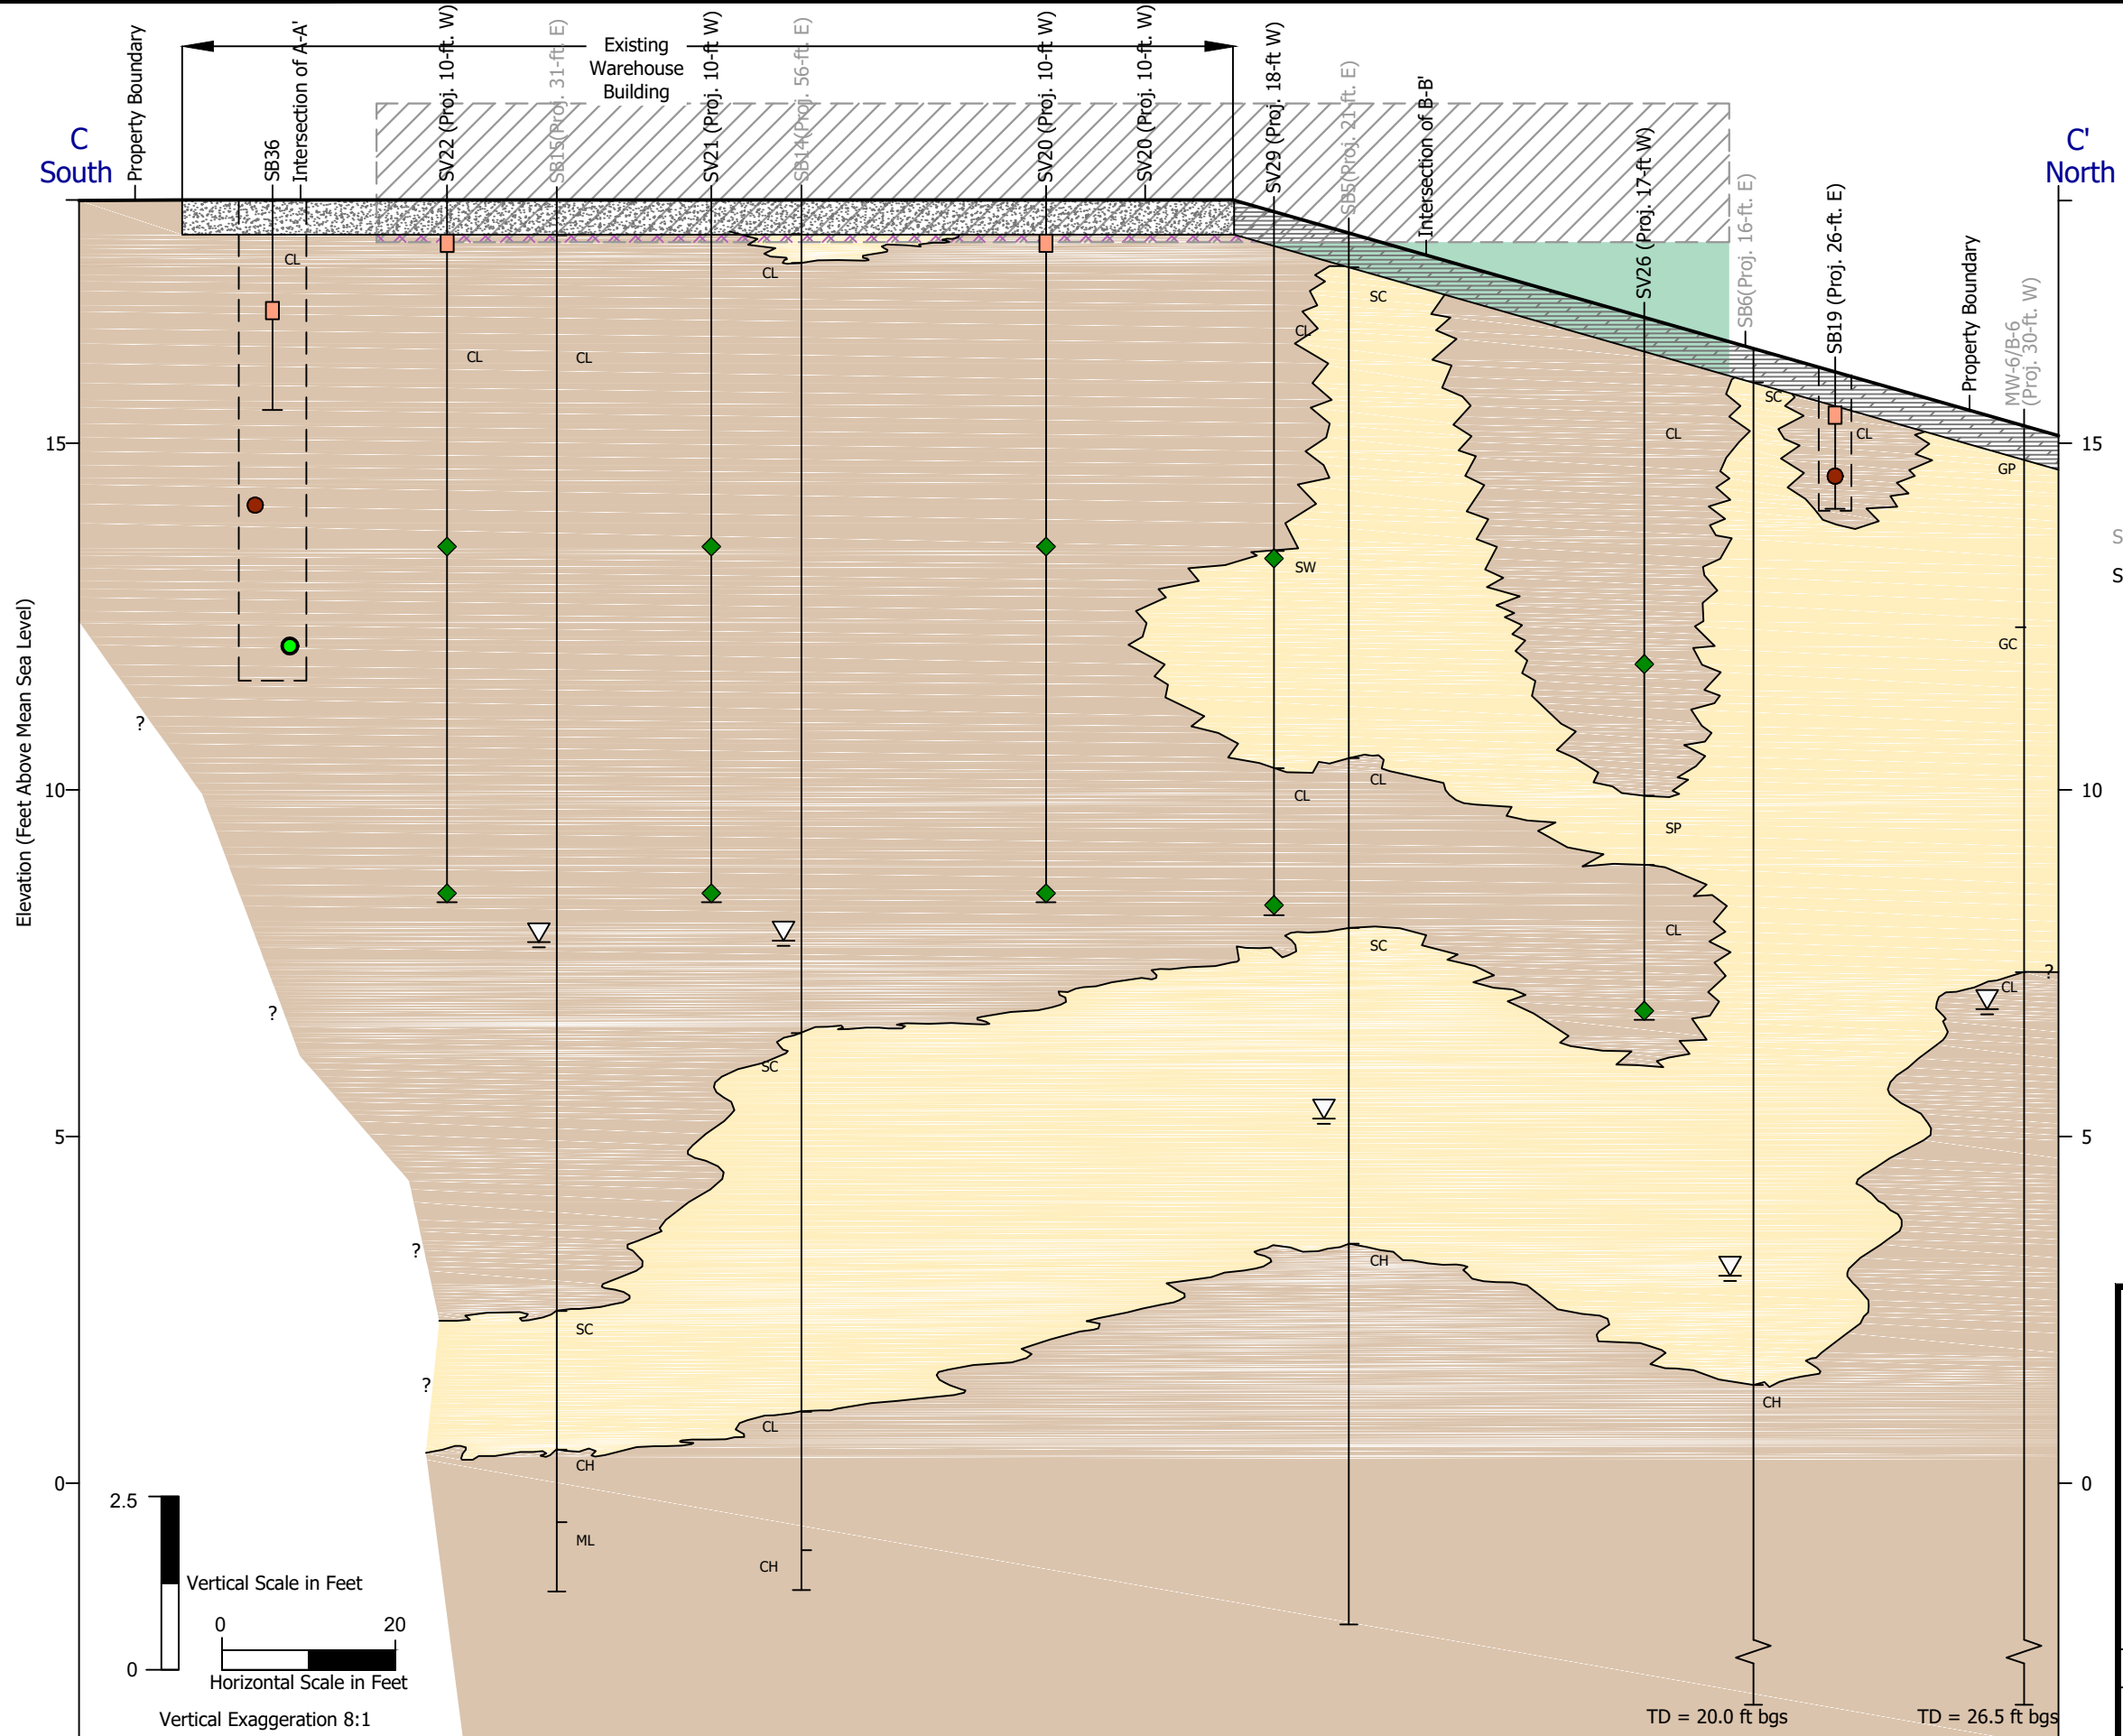
PLATE
10

Cross Section C-C' Showing Soil Sample Locations, Proposed Building Slab, Utility Alignments
 Human Health Risk Assessment Work Plan
 6701, 6705, and 6707 Shellmound Street
 Emeryville, California

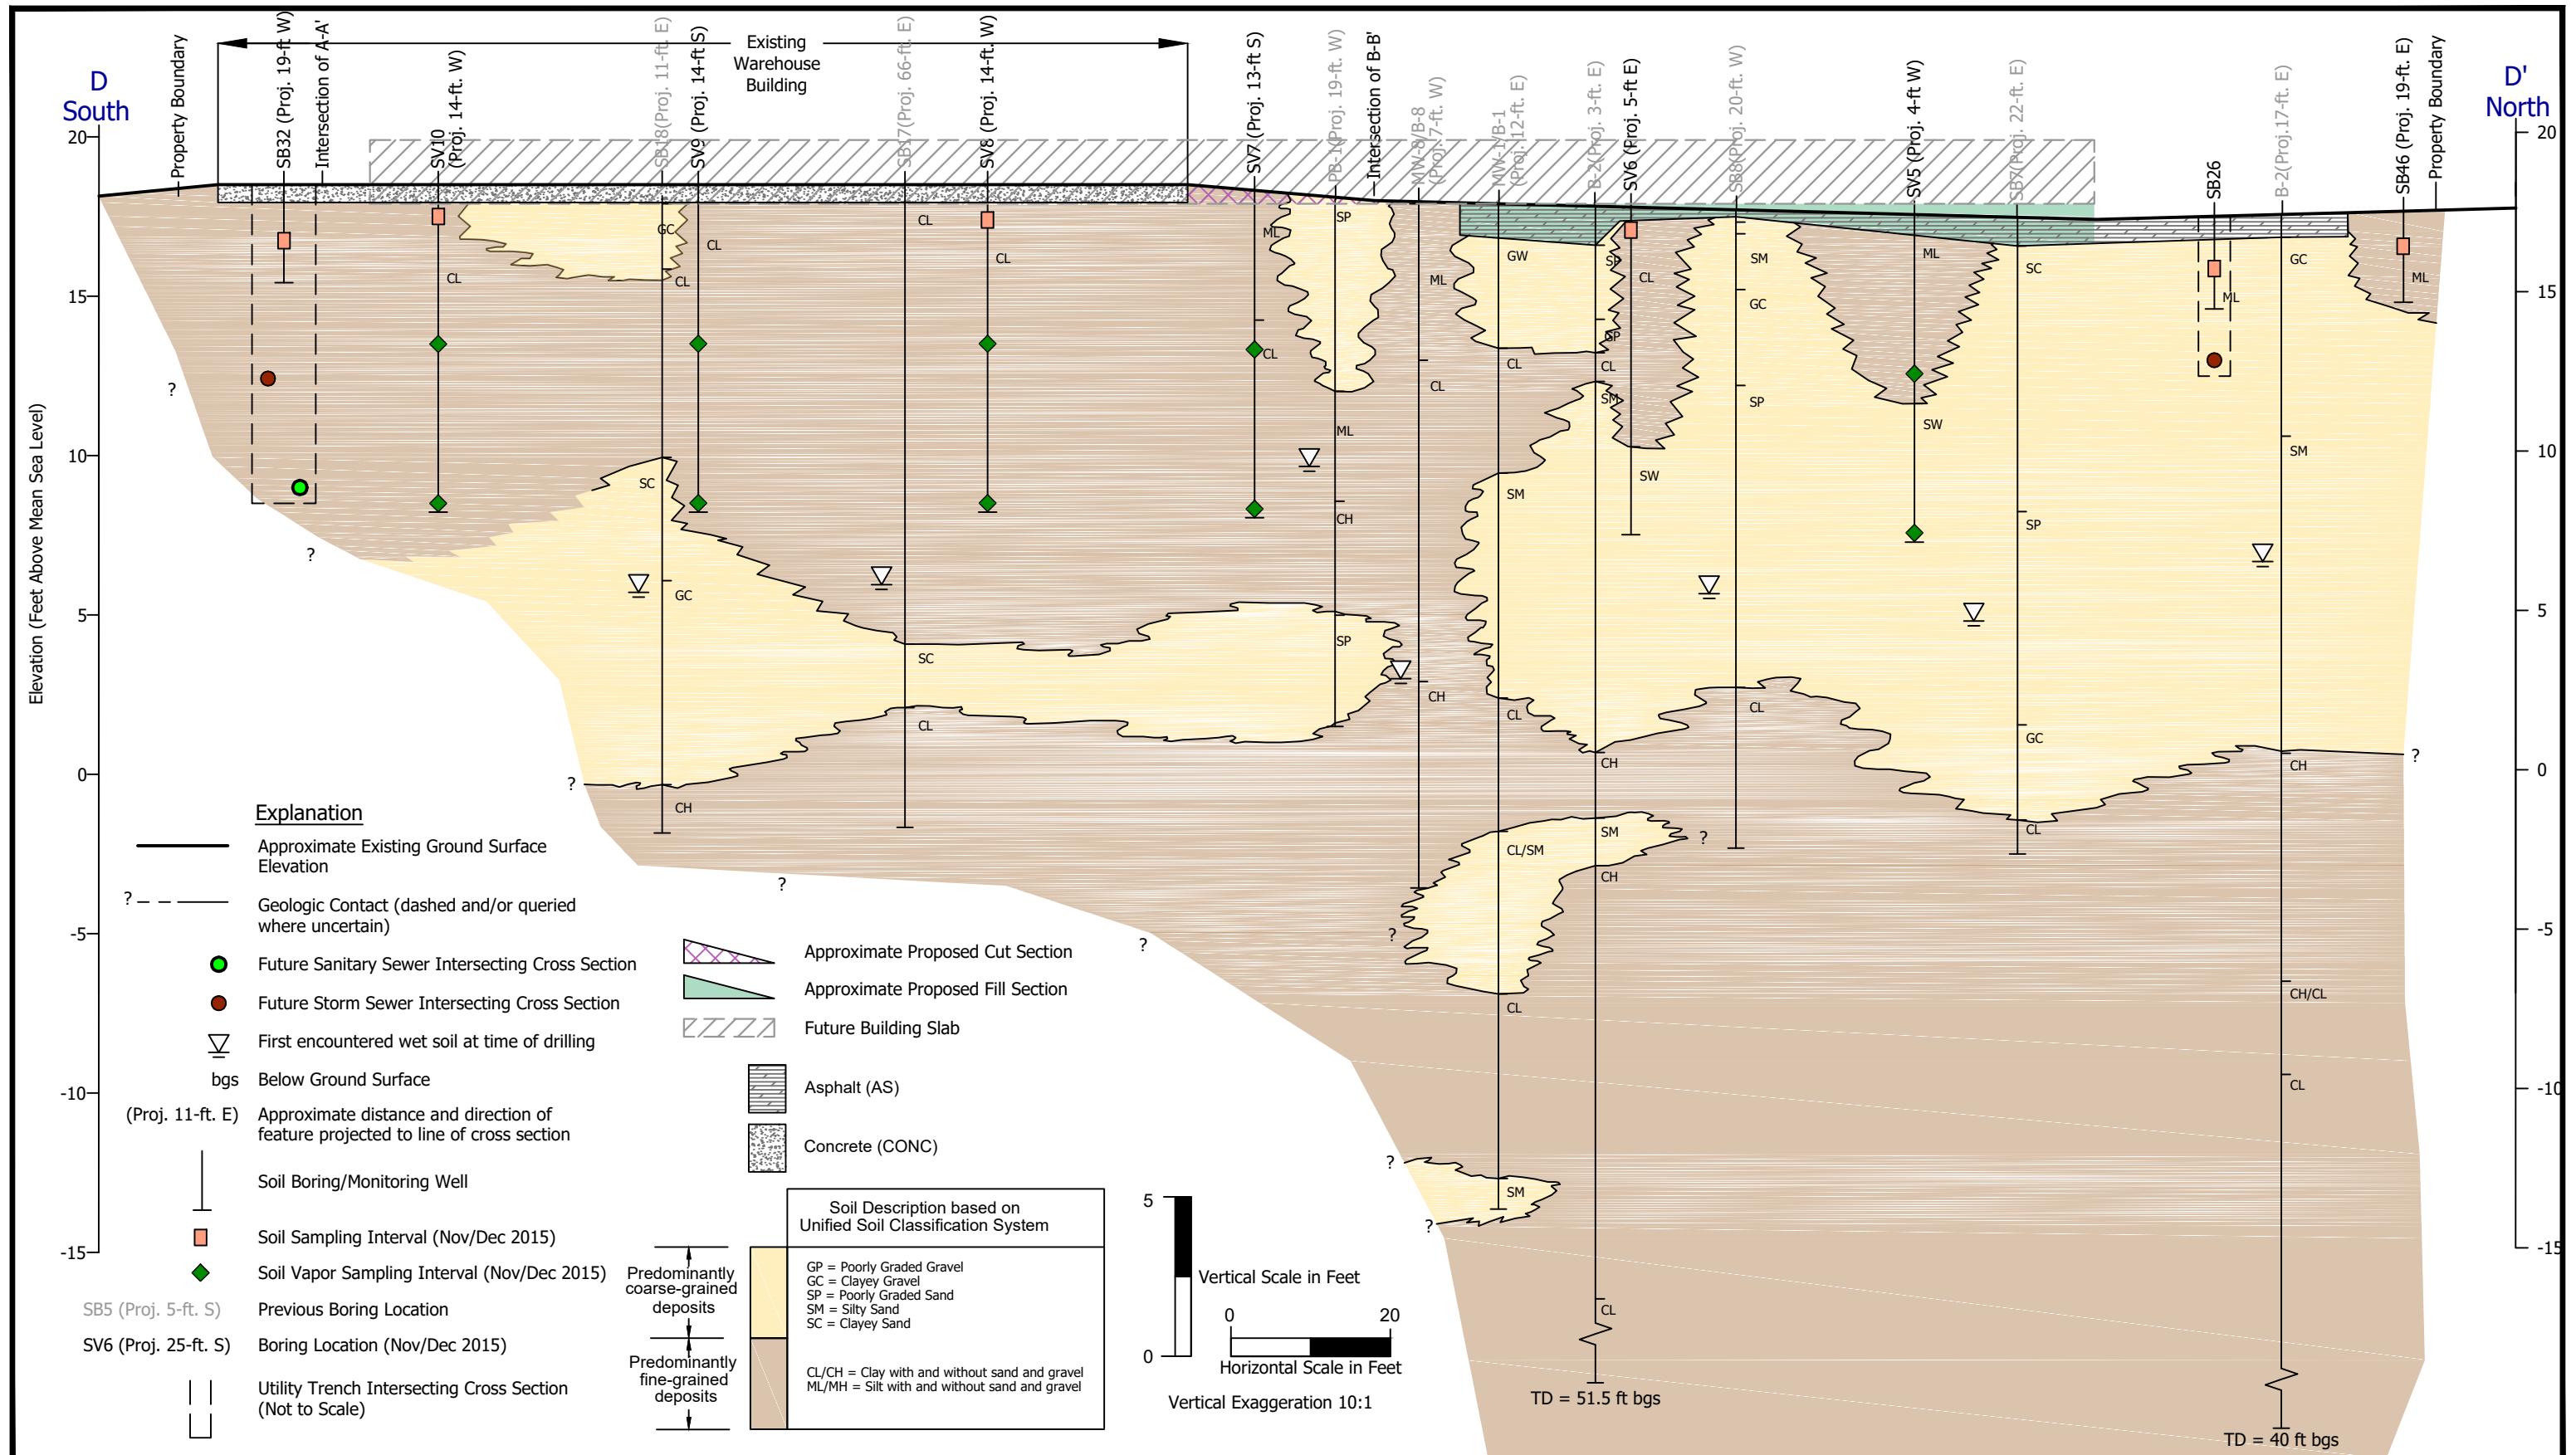
Cross Section D-D' Showing Soil Sample Locations, Proposed Building Slab, Utility Alignments
Human Health Risk Assessment Work Plan
6701, 6705, and 6707 Shellmound Street
Emeryville, California
