LOG OF BORING MW-1A

Former Standard Brands Paint Store #147

4343 San Pablo Avenue

Emeryville, California

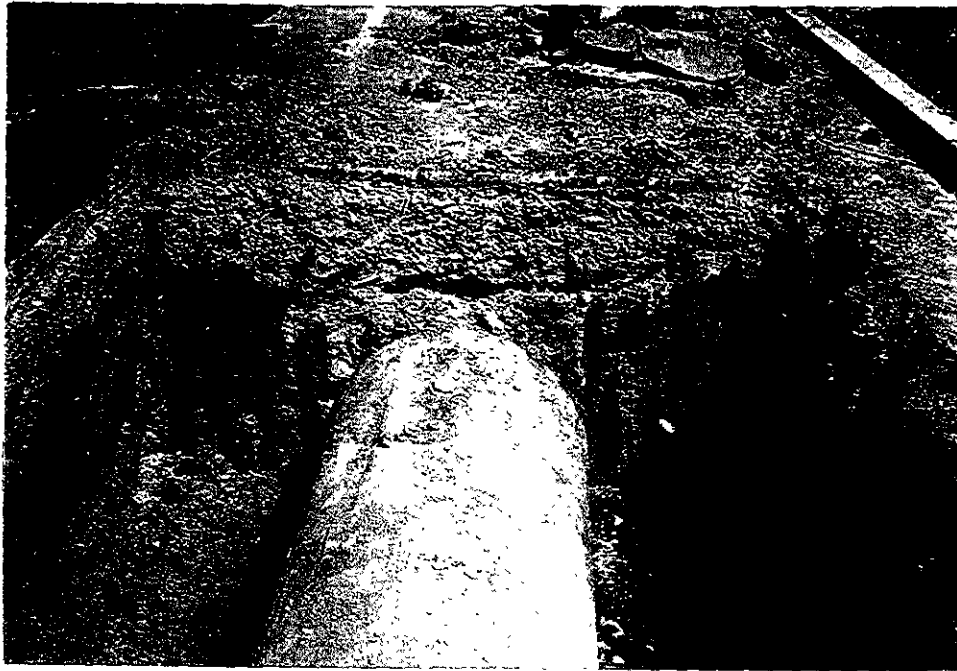
Underground Storage Tank # 1 In Place Just Before Removal
Photo R1-F0 - View: North

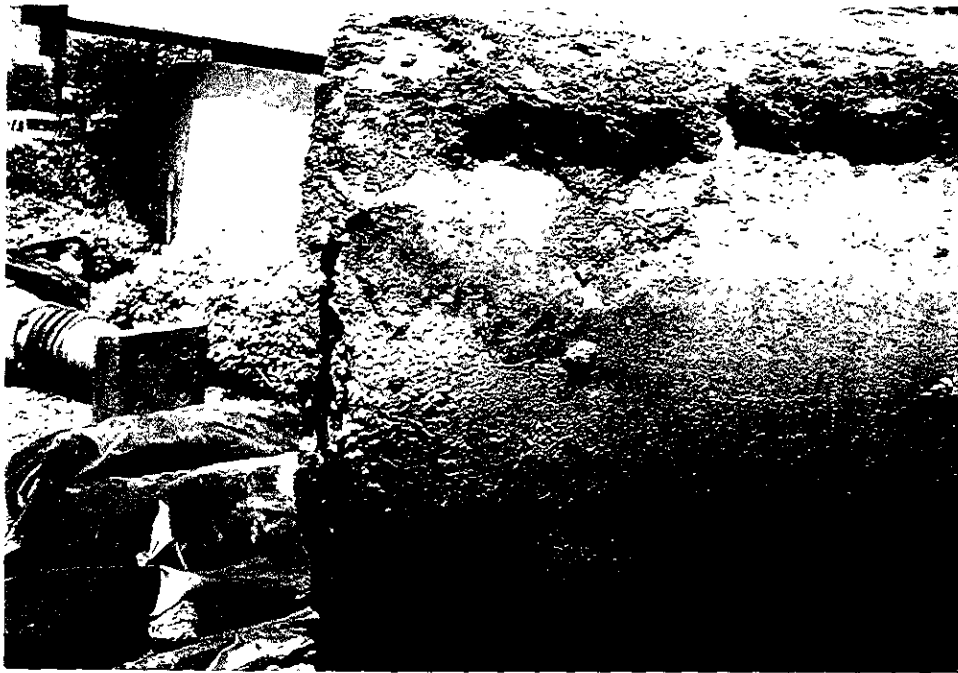
On July 10, 1997 at approximately 2:30 p.m. the tank was removed from the excavation and placed on plastic sheeting at the ground surface for inspection to determine the tank's condition. Two large holes were noted at the ends of the tank along the end seams at the bottom portion of the tank. Each of the two large holes was approximately 18 inches to 24 inches in length and approximately 2 inches to 3 inches wide. The tank was heavily corroded with numerous holes of approximately 1/2 inch to 1 inch in diameter distributed

along the tank bottom. Photo documentation of the tank removal, tank condition, and condition of soil below the tank is contained in Appendix B as Figures 4 through 6.

UST # 1: Large Hole at North End
Photo R1-F7

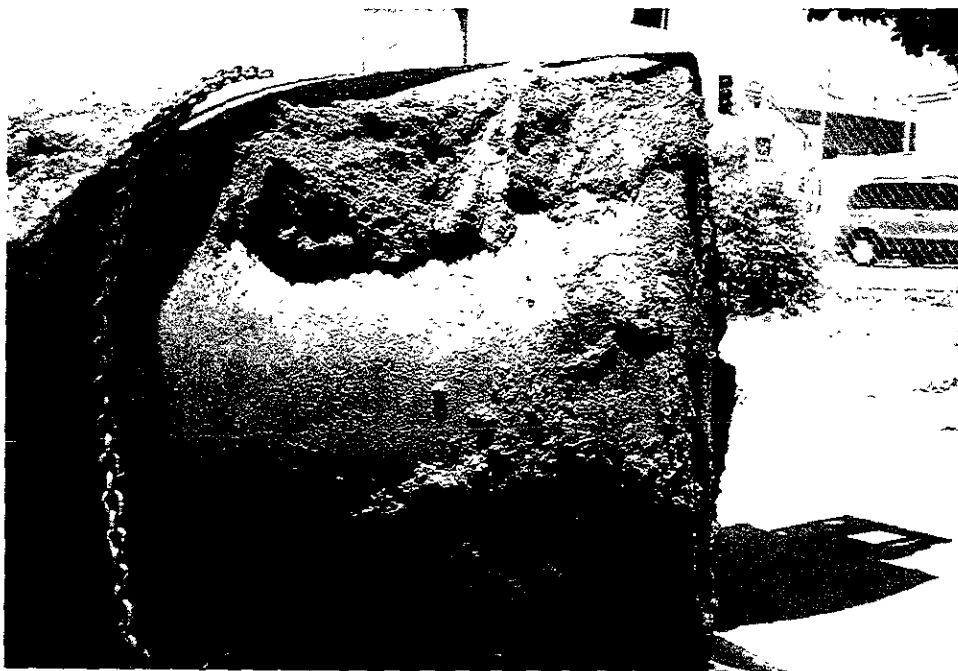
UST # 1: Holes at South End
Photo R1-F8

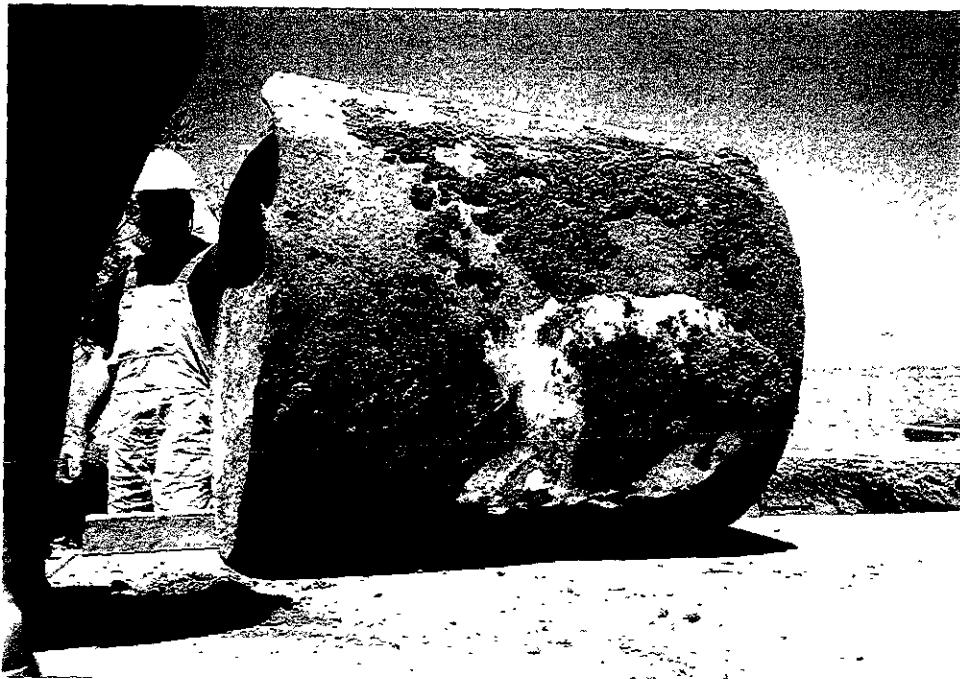
On August 1, 1997 at approximately 12:10 p.m. and approximately 12:25 p.m., tank #3 and tank #4, respectively, were removed from the excavation and placed on plastic sheeting at the ground surface for inspection to determine the condition of the tanks. Tank #3 was heavily corroded with approximately 5 to 10 small holes of approximately 1/4 inch to 1

UST # 3: Bottom in Fair Condition
 Photo R5-F12

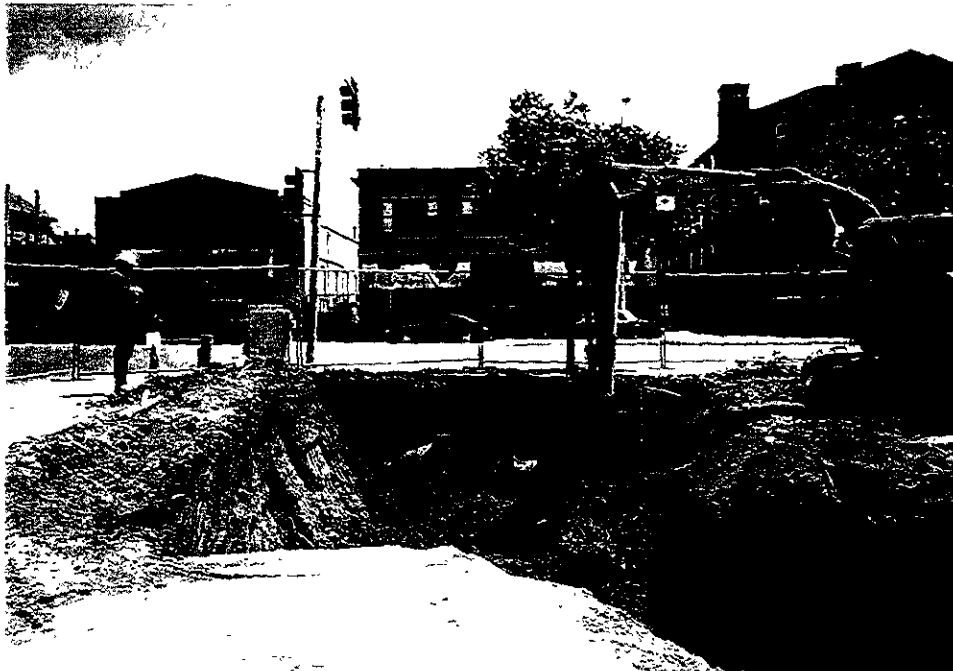
UST # 3 and UST # 4 In Place as Discovered
 Photo R3-F30 - View: East

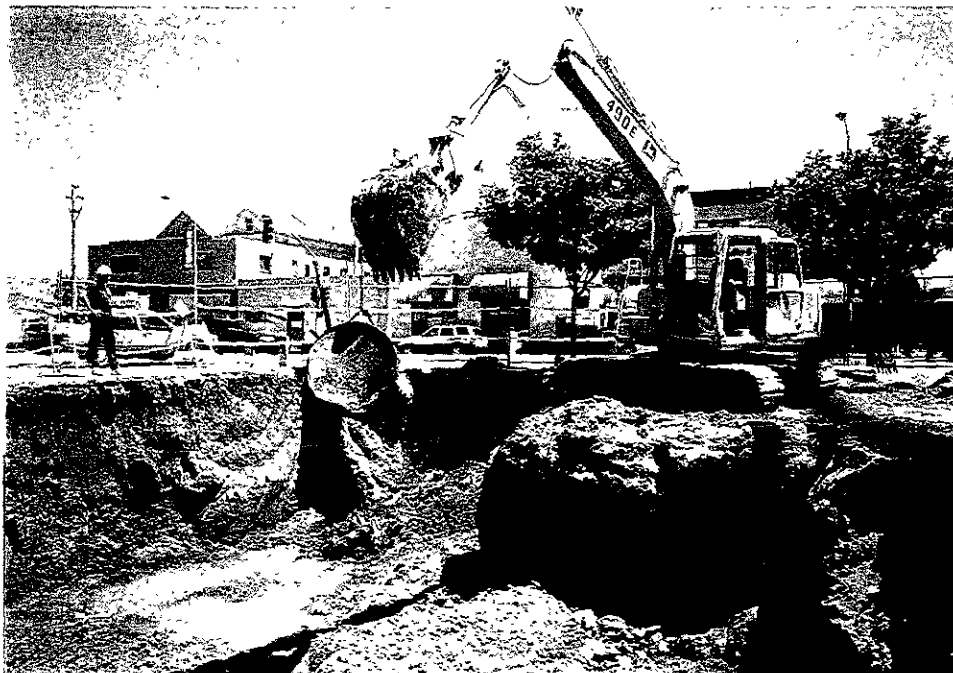
UST # 4 Being Removed From the Excavation: Soils Below UST Not Obviously Impacted
 Photo R5-F15 - View: Northeast

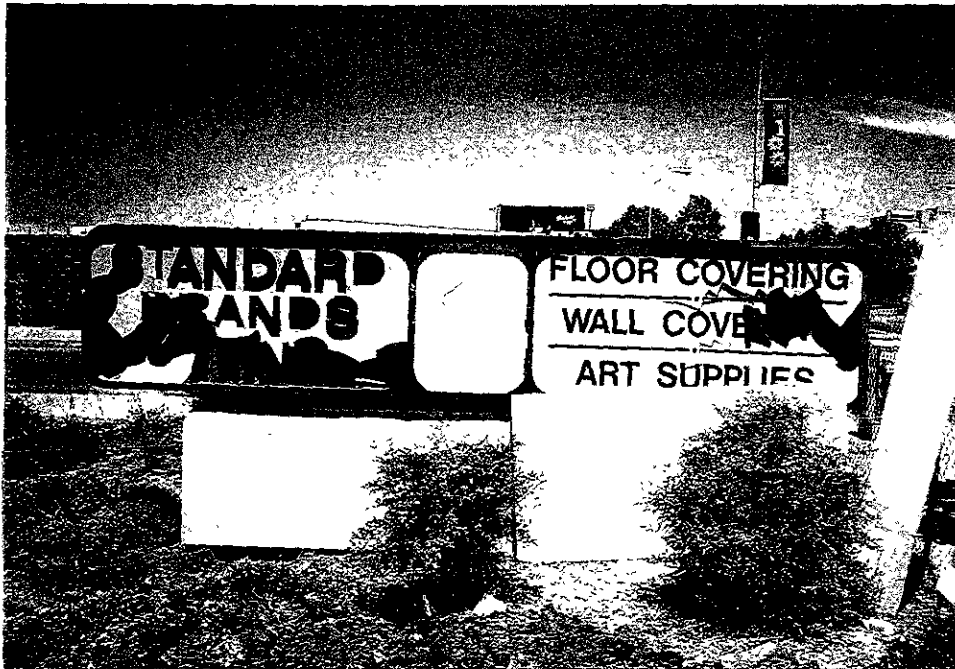
Standard Brands Paint Sign: Condition of South Side Before it Was Moved
 Photo R2-F10

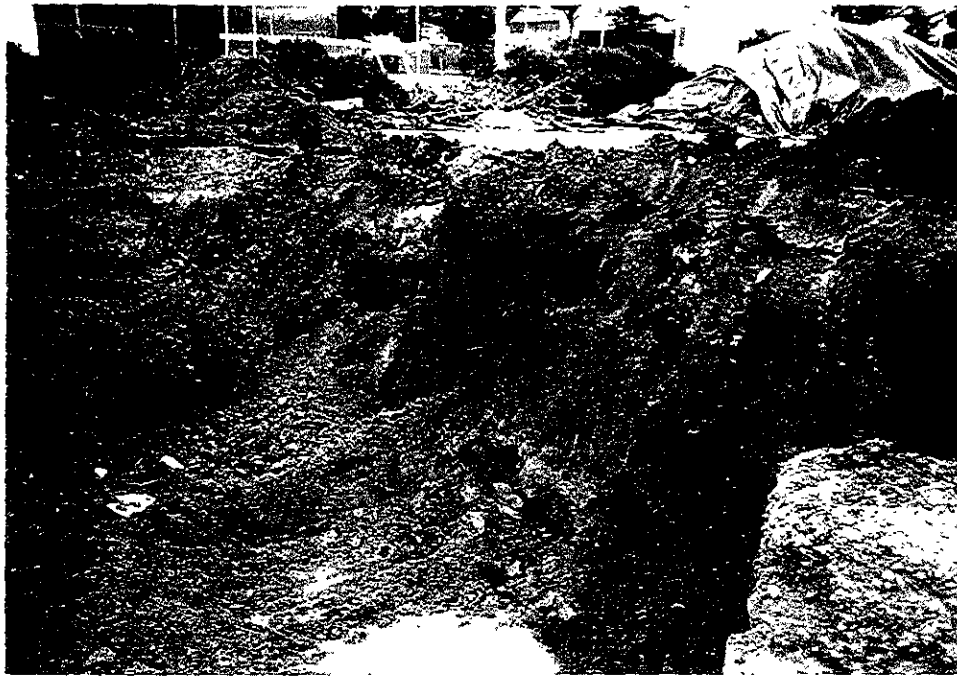
Excavation: Clean Floor and Southeast Wall
Photo R3-F2 - View: Southeast

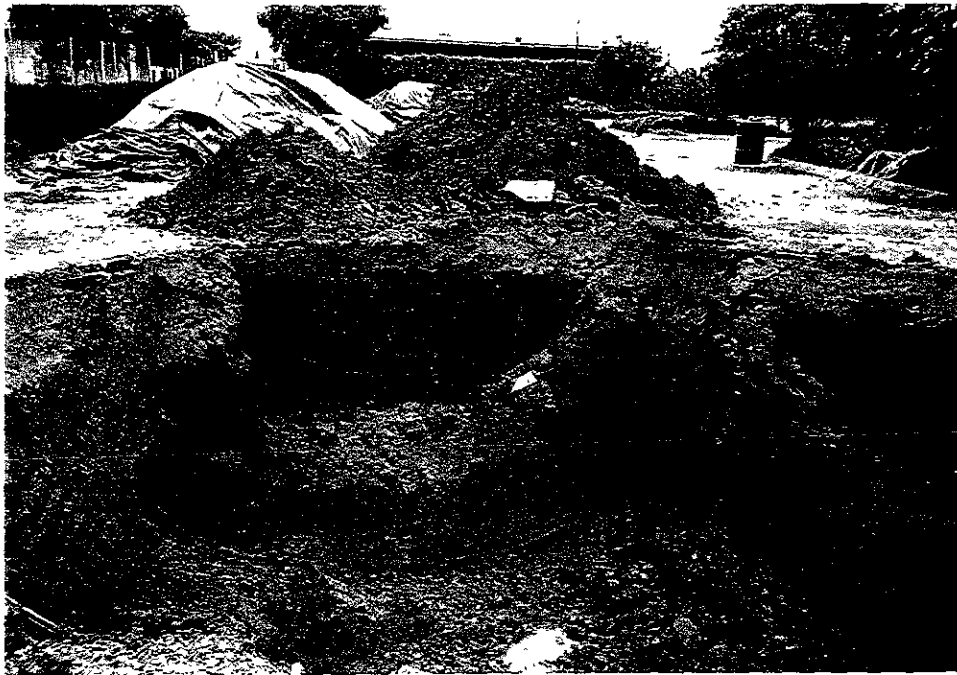
Excavation: Clean Floor and South Wall
Photo R3-F3 - View: South

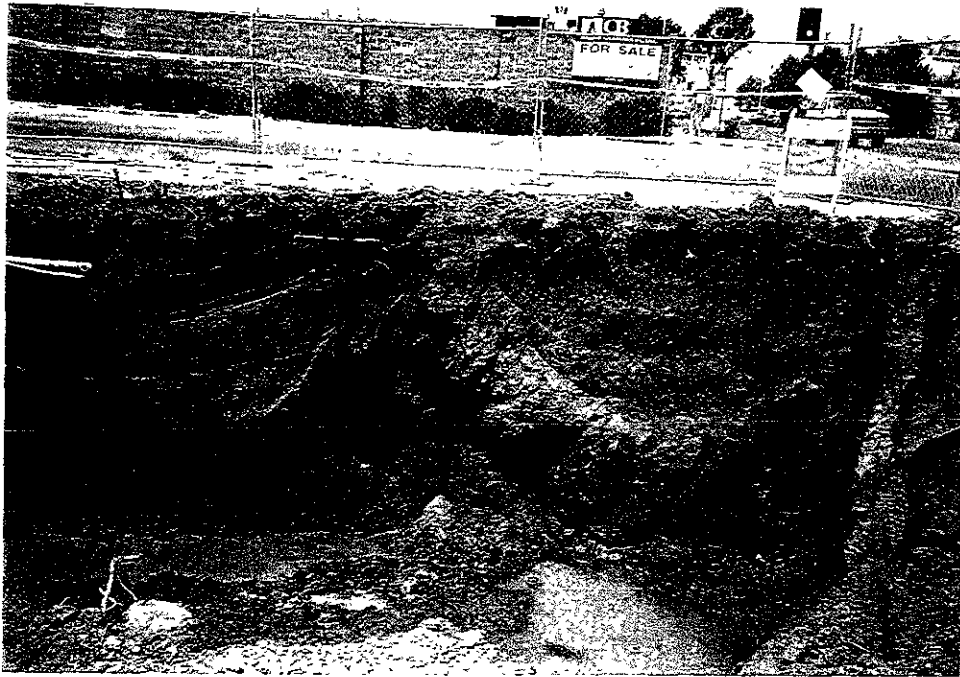
Dark Gray Gravel Seam In North Excavation Wall Bounded to the East by Clean Soil
Photo R3-F34 - View: Northeast

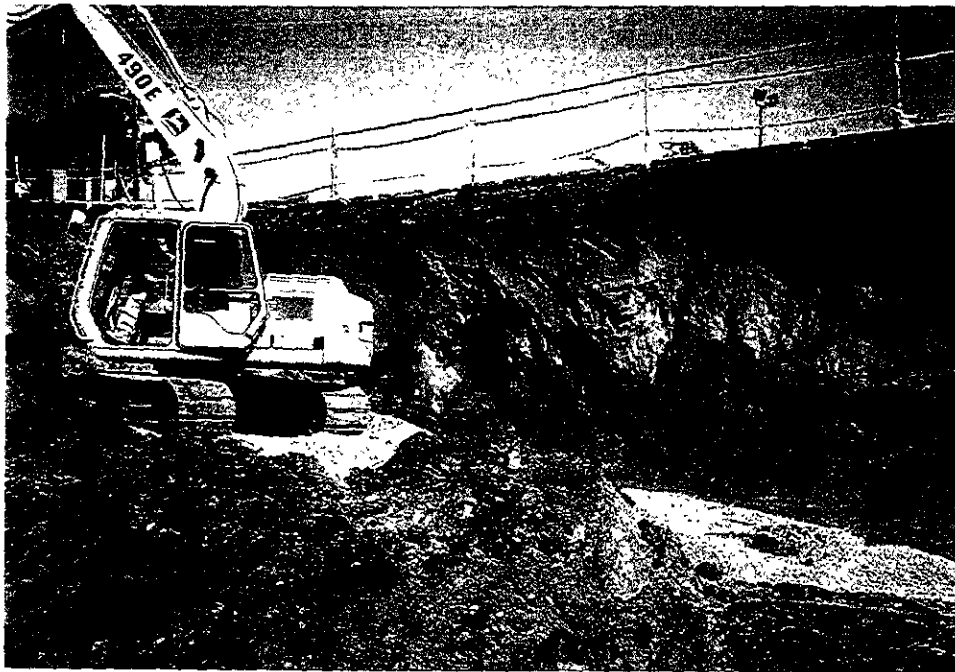
Dark Gray Gravel Lens in North Excavation Wall
 Photo R6-F18 - View: Northwest

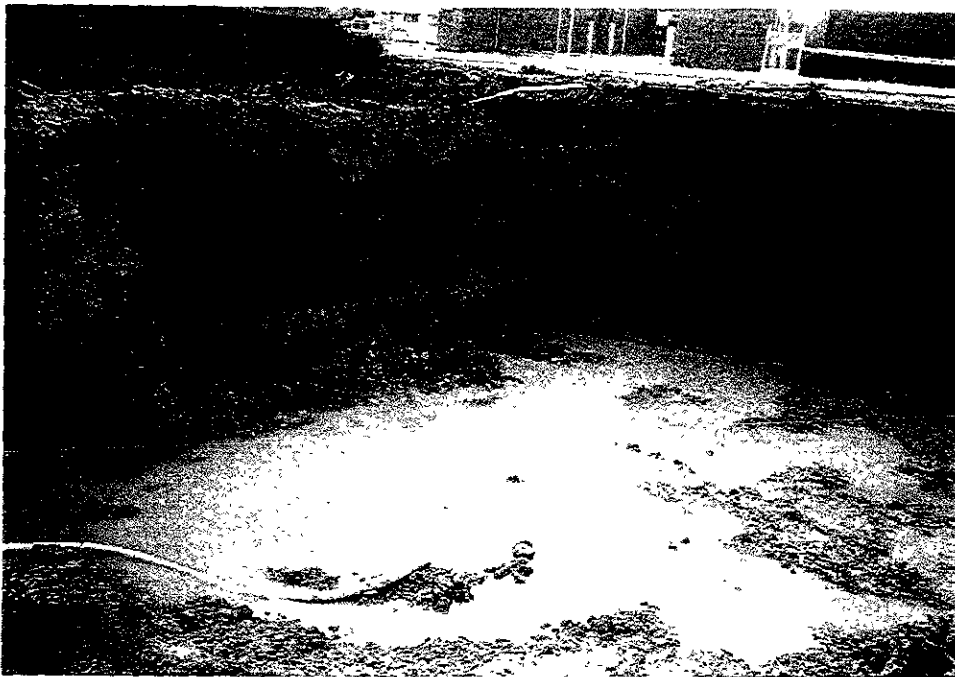
Dark Gray Gravel Seam Thickening Westward Along North Excavation Wall
 Photo R4-F22 - View: Northwest

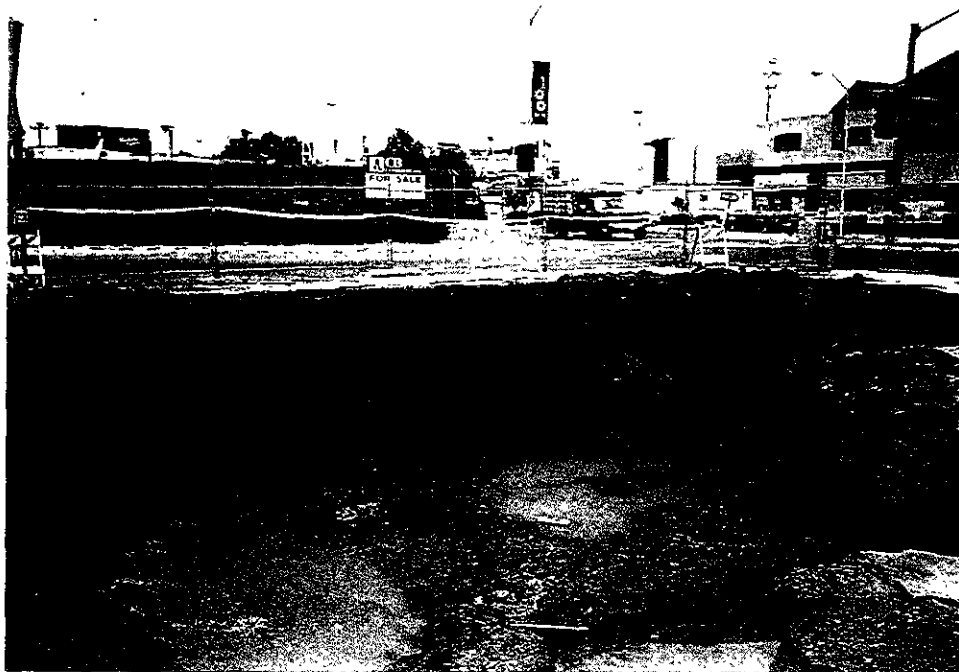
Portions of Excavation Dammed Off for Water Control
 Photo R4-F5 - View: North

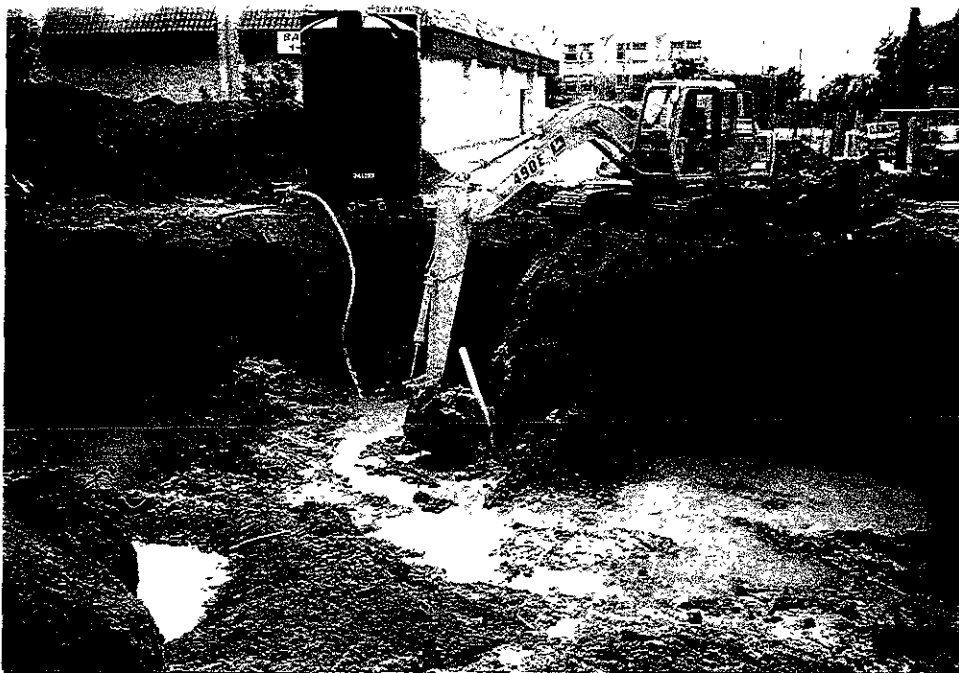
Detruction of Groundwater Monitoring Well MW-1
 Photo R4-F7 - View: West

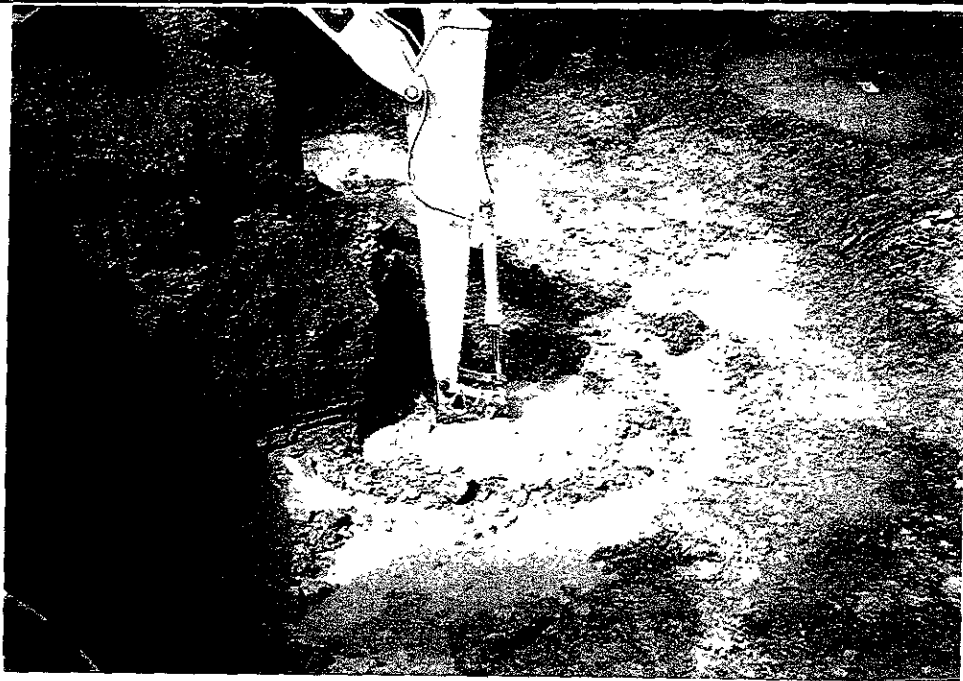
Over-excavation of Monitoring Well Filter Pack
Photo R4-F14 - View: North

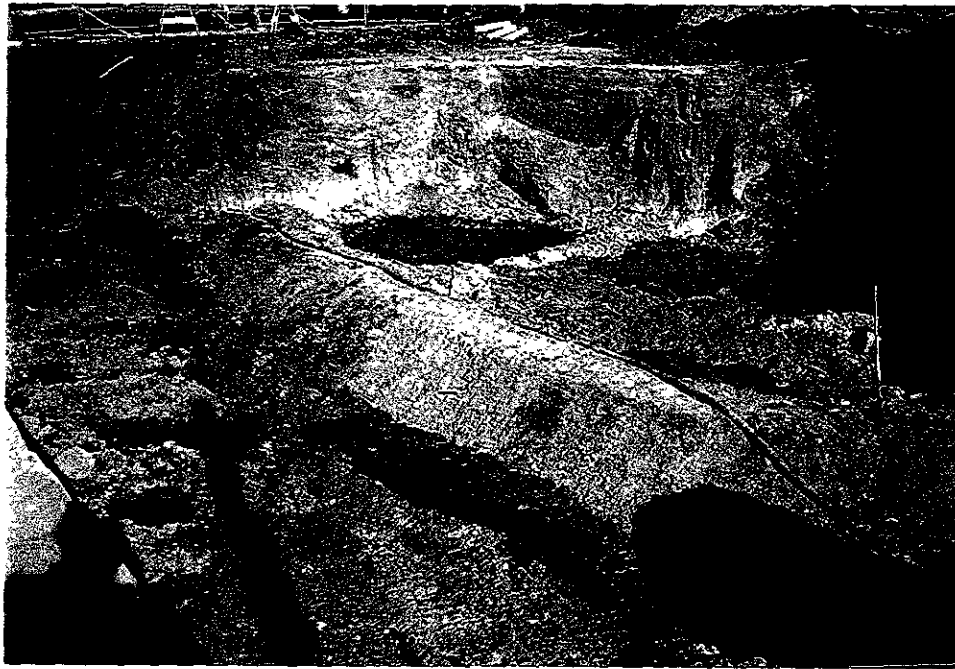
Soil Berm In Excavation
Photo R6-F0 - View: Southeast

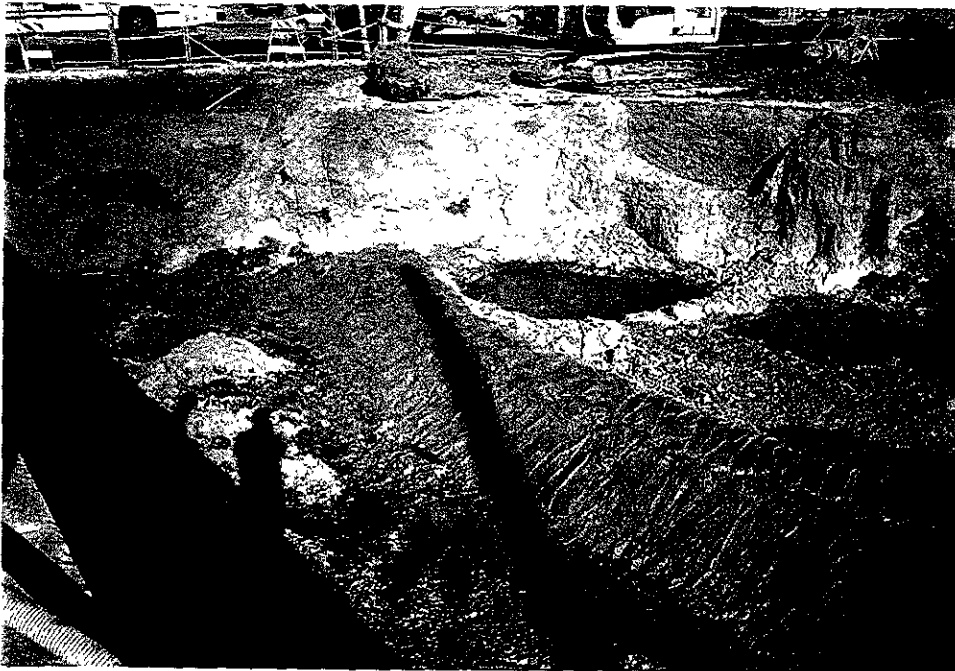
Concrete Layer Placed Over Soil Berm
Photo R6-F6 - View: East

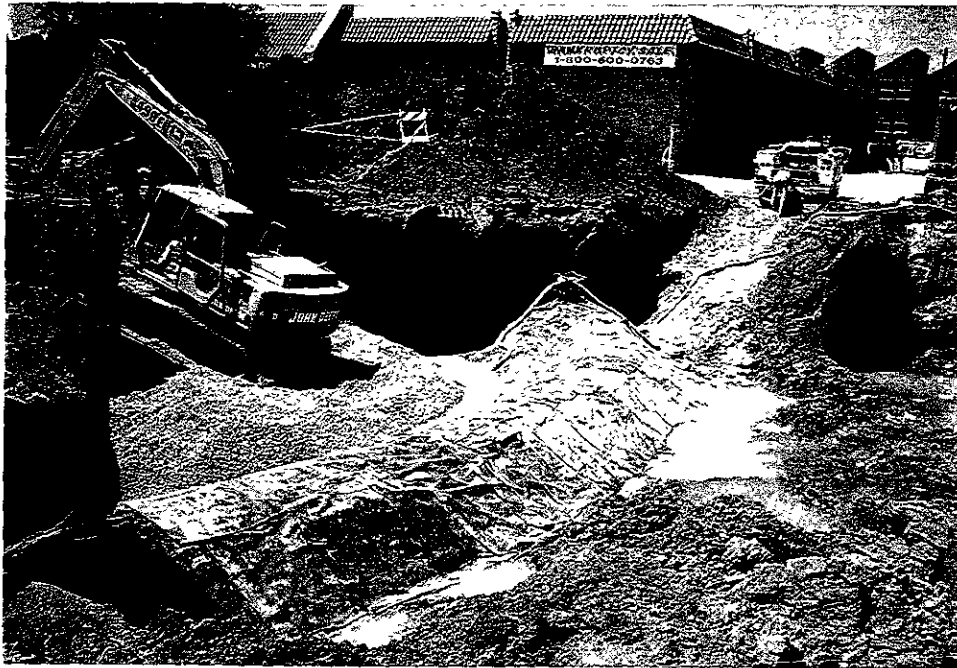
Polyethylene Liner with Bentonite Back Placed Over Berm and Concrete Layer
 Photo R6-F13 - View: Southwest

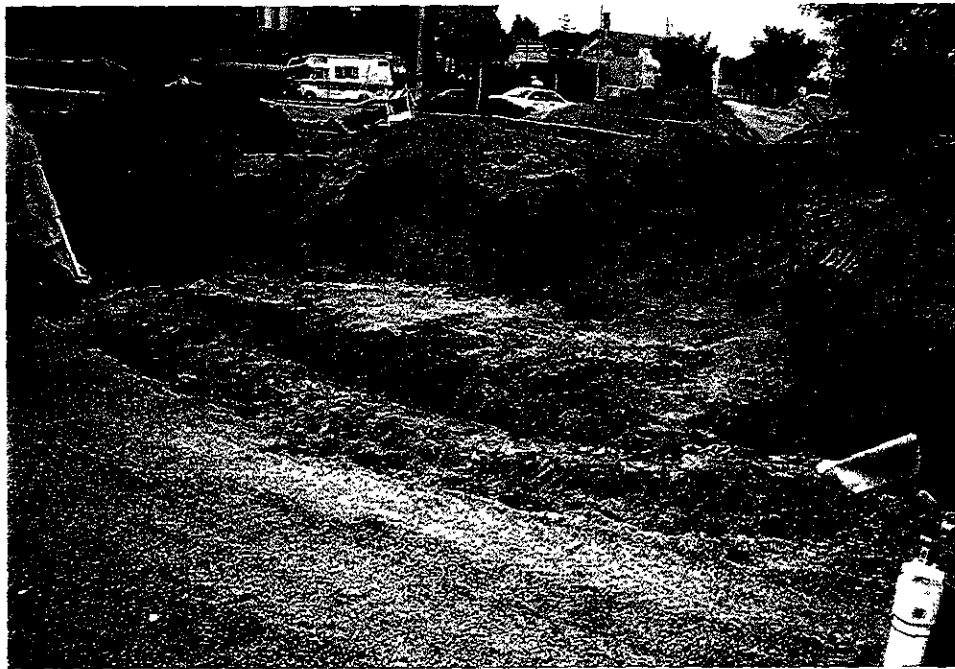
Crushed Rock Backfill Adjacent to and Approximately 1 Foot Below Top of Groundwater Barrier
 Photo R6-F26 - View: Southeast

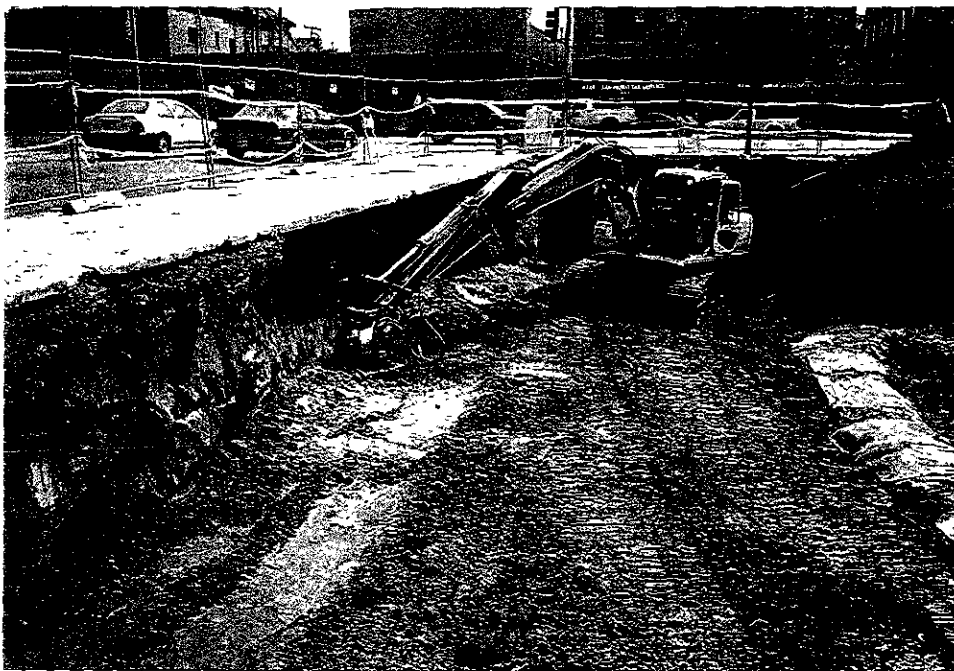
Soil Backfill Being Compacted Along Edges of Excavation with Vibrating Plate Compactor
 Photo R6-F27 - View: East

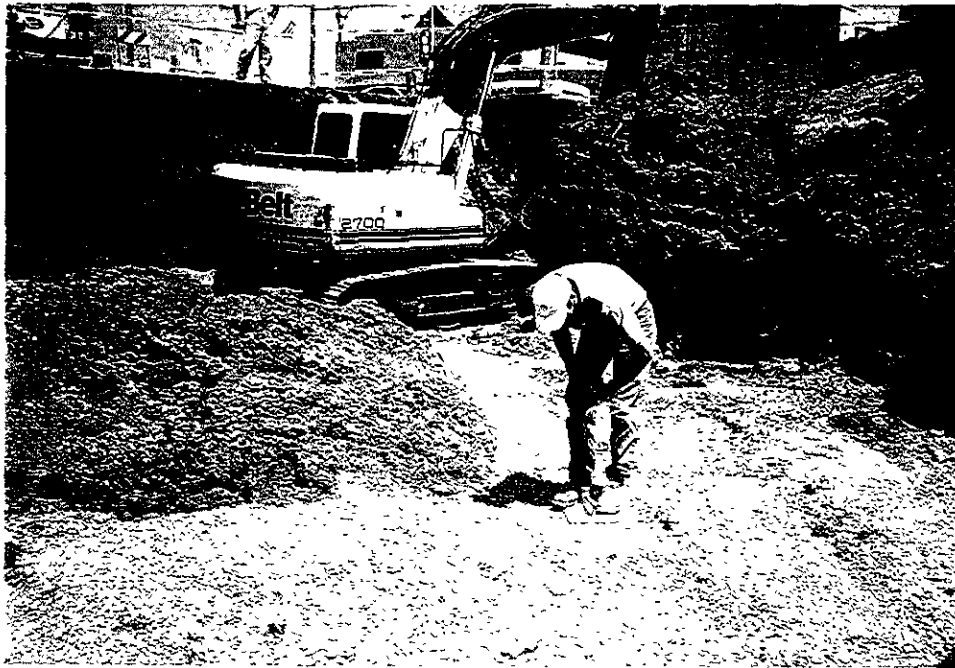
Compaction Testing Being Conducted by Miller Pacific Engineering Group, Inc.
 Photo R6-F22 - View: Northeast

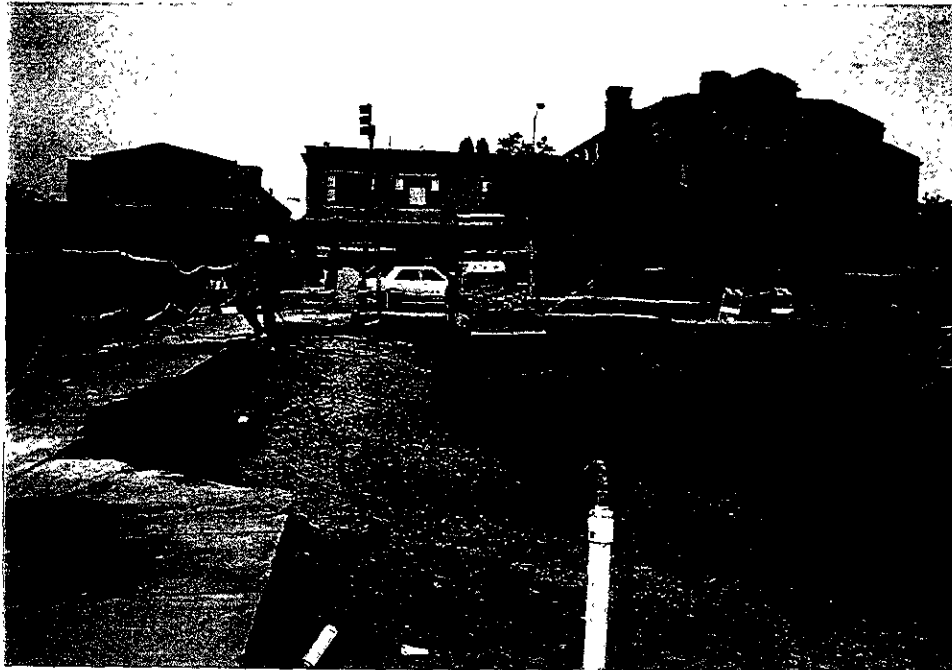
All Clean Soil Used as Backfill: Continue Backfill and Compaction Using Imported Recycled Base Rock
 Photo R7-F3 - View: East
