**UNDERGROUND  
STORAGE TANK  
CLOSURE AT THE  
OAKLAND  
FACILITY**

Continental Baking Company  
Checkerboard Square  
St. Louis, Missouri

October 11, 1993

Subject: Continental Baking Facility, 1010 46th Street, Oakland, CA  
Underground Storage Tank Removal and Closure Report

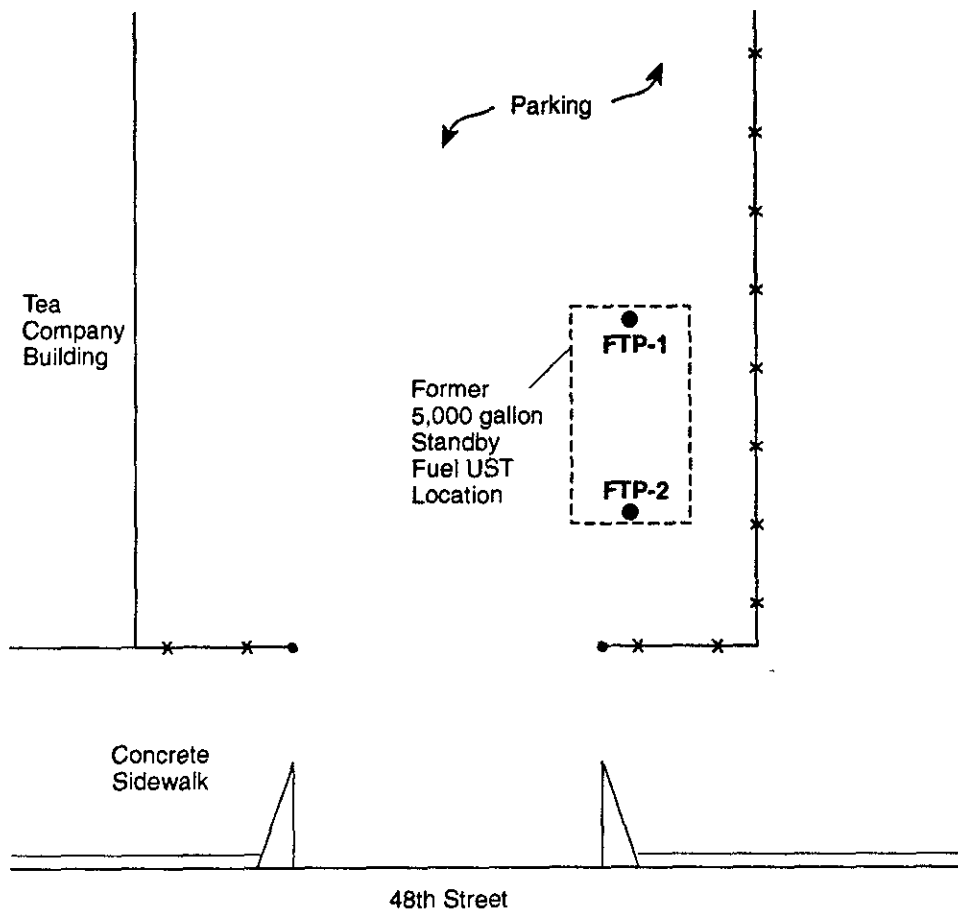
Project No. 92CB040	Continental Baking Company 1010 46th Street Oakland, California	<b>CLOSURE SAMPLE LOCATIONS FOR THE STANDBY FUEL UST</b>	<b>Figure 3</b>
<b>Woodward-Clyde Consultants</b>

Samples were collected and analyzed in accordance with the Tri-Regional Board Staff Recommendations for Preliminary Evaluation and Investigation of Underground Tank Sites. At the excavation of the 10,000-gallon standby diesel fuel UST, two samples of native soil were collected from the bottom, near the former locations of the ends of the tank. Both samples consisted of brown clay with grey mottling. These samples were identified as FTP-1 (from the northernmost end of the excavation) and FTP-2 (from the southernmost end) and they both were collected at approximately 14 feet below grade (Figure 3).

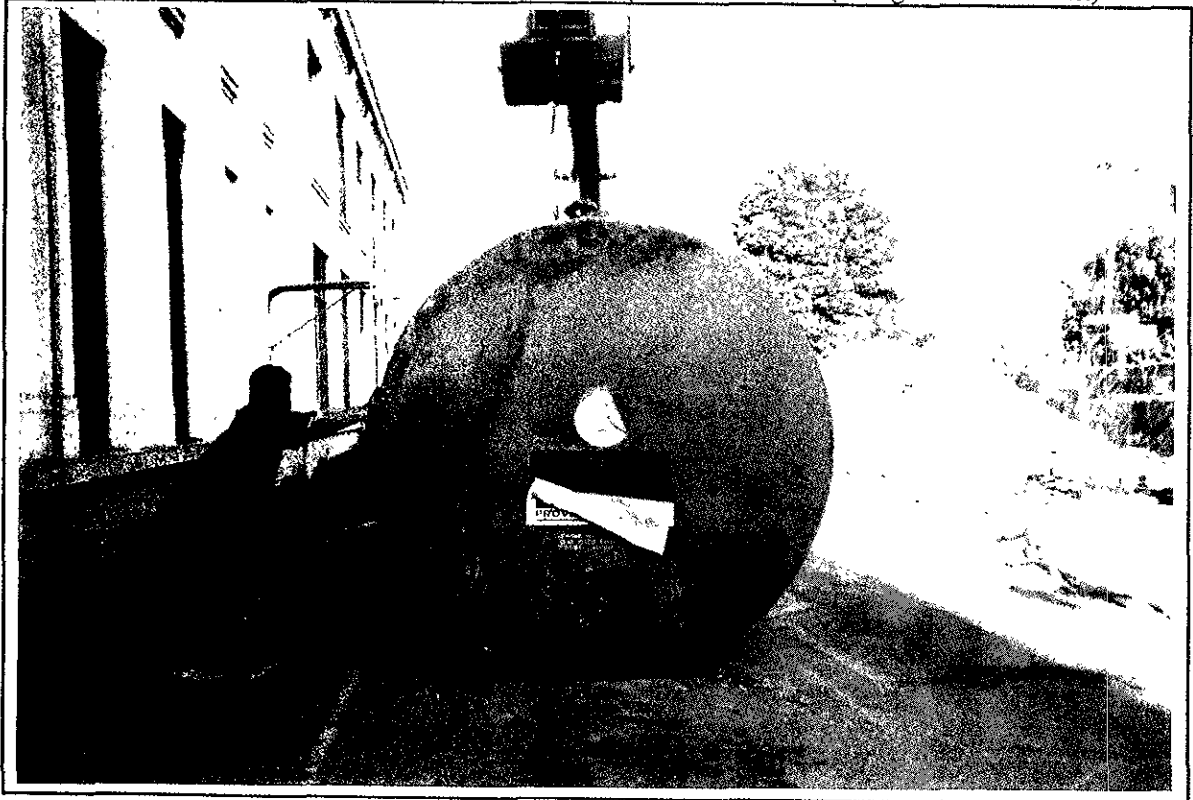
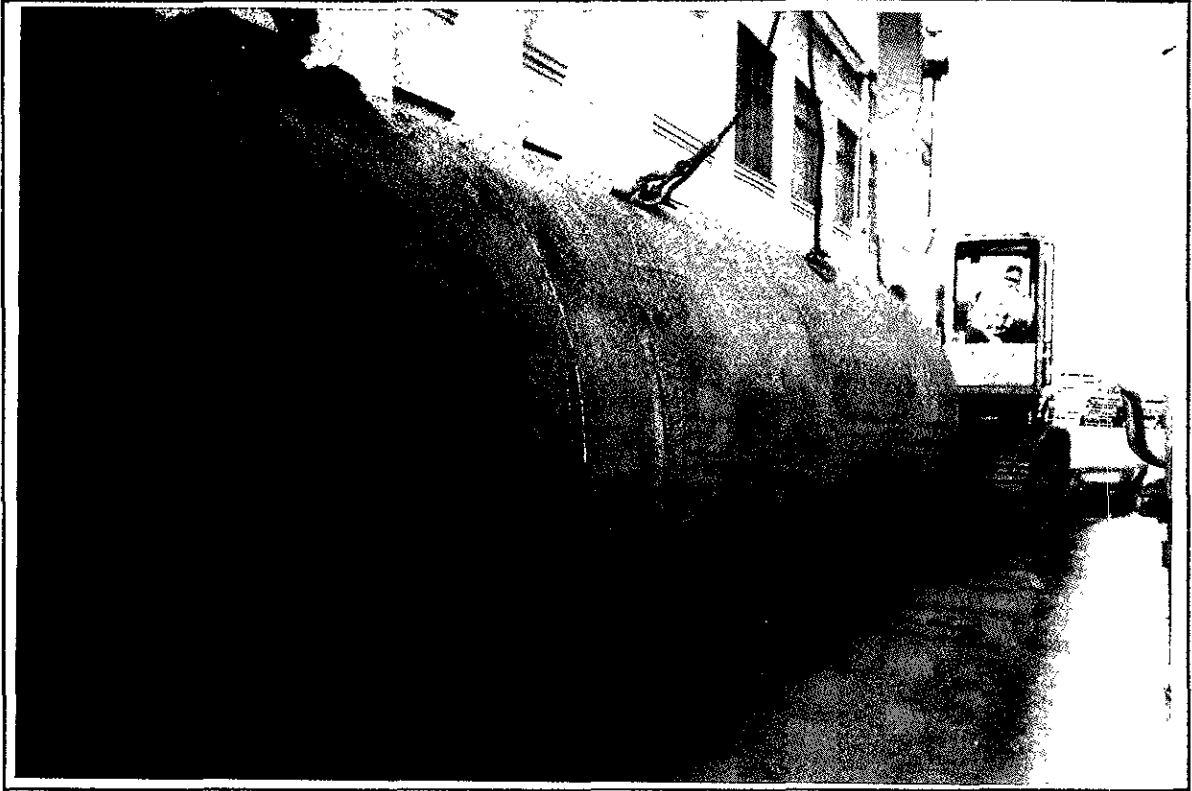
One UST was a 10,000-gallon single-walled steel standby fuel storage tank formerly located beneath the parking lot behind the former bakery building. No holes were found in the UST during the above-ground inspection. No odors or evidence of soil staining were observed at this excavation. Two closure samples were collected from the sidewalls of this excavation and they were analyzed for petroleum hydrocarbon constituents. The samples did not contain detectable concentrations of petroleum hydrocarbons.

December 22, 1992: Exposed Tea Company Building Backup Fuel Steel UST (facing East)

December 22, 1992: Southwest End of Excavated Backup Fuel Steel UST (facing North-Northeast)

December 22, 1992: West Side of Excavated Backup Fuel Steel UST

December 22, 1992: Northeast End of Excavated Backup Fuel Steel UST

December 22, 1992: East Side of Excavated Backup Fuel Steel UST

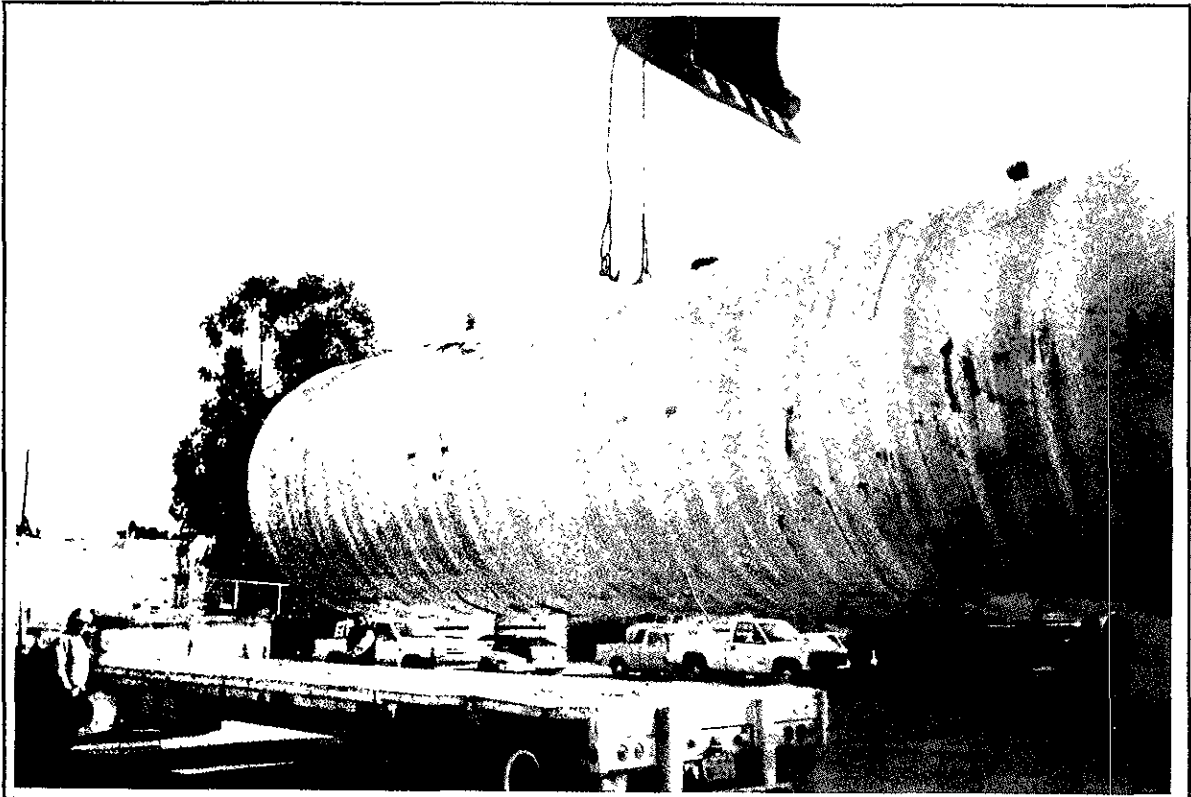
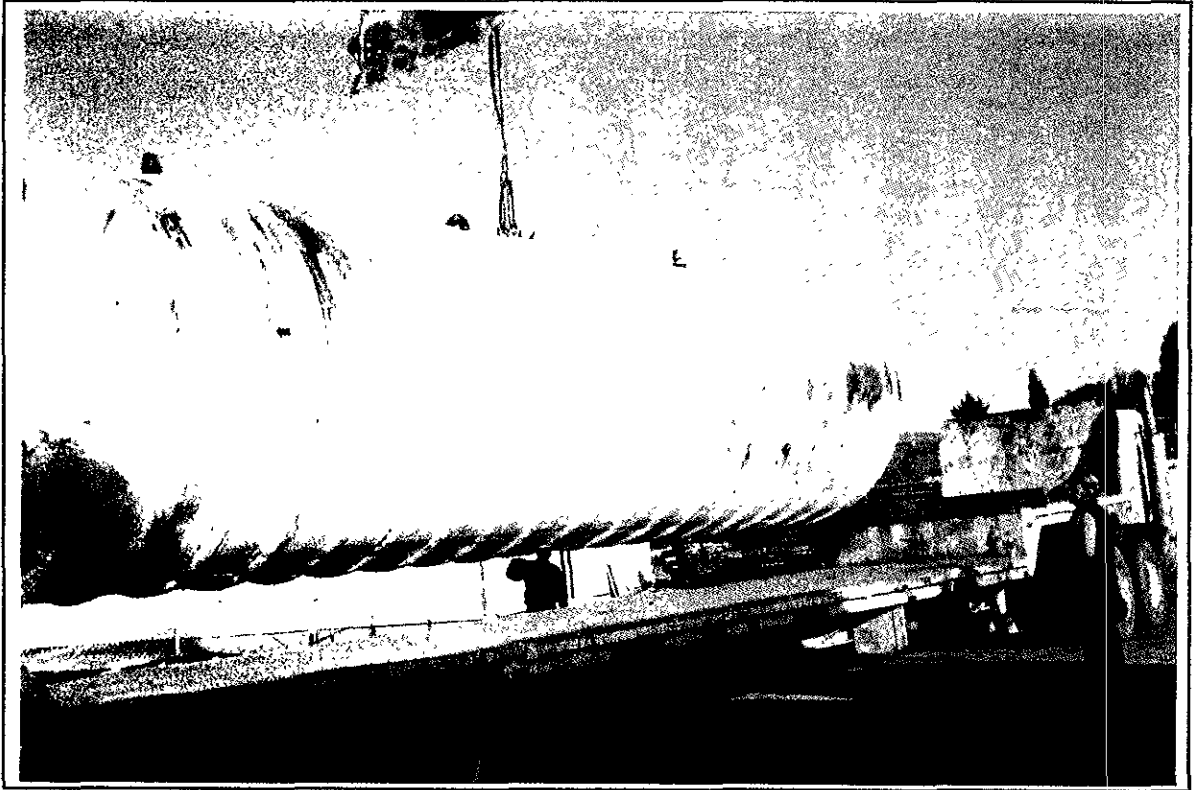
The remaining three USTs were formerly located in a cluster near the facility garage. As a result, the three USTs were removed from the same excavation. The inspection of the 10,000-gallon fiberglass gasoline UST, conducted immediately following removal from the excavation, revealed no apparent holes. The two closure samples collected from the excavation sidewalls at the ends of the gasoline UST did not contain detectable concentrations of petroleum hydrocarbons. No holes were observed during the inspection conducted immediately following removal of the 8,000-gallon steel diesel UST from the excavation. However, an odor of gasoline and/or diesel was noticed and the analytical results for one of the two soil samples collected from the excavation sidewalls contained low volatility (kerosene and oil range) total petroleum hydrocarbons at 58 and 120 mg/kg. Although benzene was not detected, the other aromatic hydrocarbon constituents of toluene, ethyl benzene, and xylenes were detected above their respective analytical reporting limits.

December 22, 1992: North Side of Excavated FRP Gasoline UST

December 22, 1992: South Side of Excavated FRP Gasoline UST

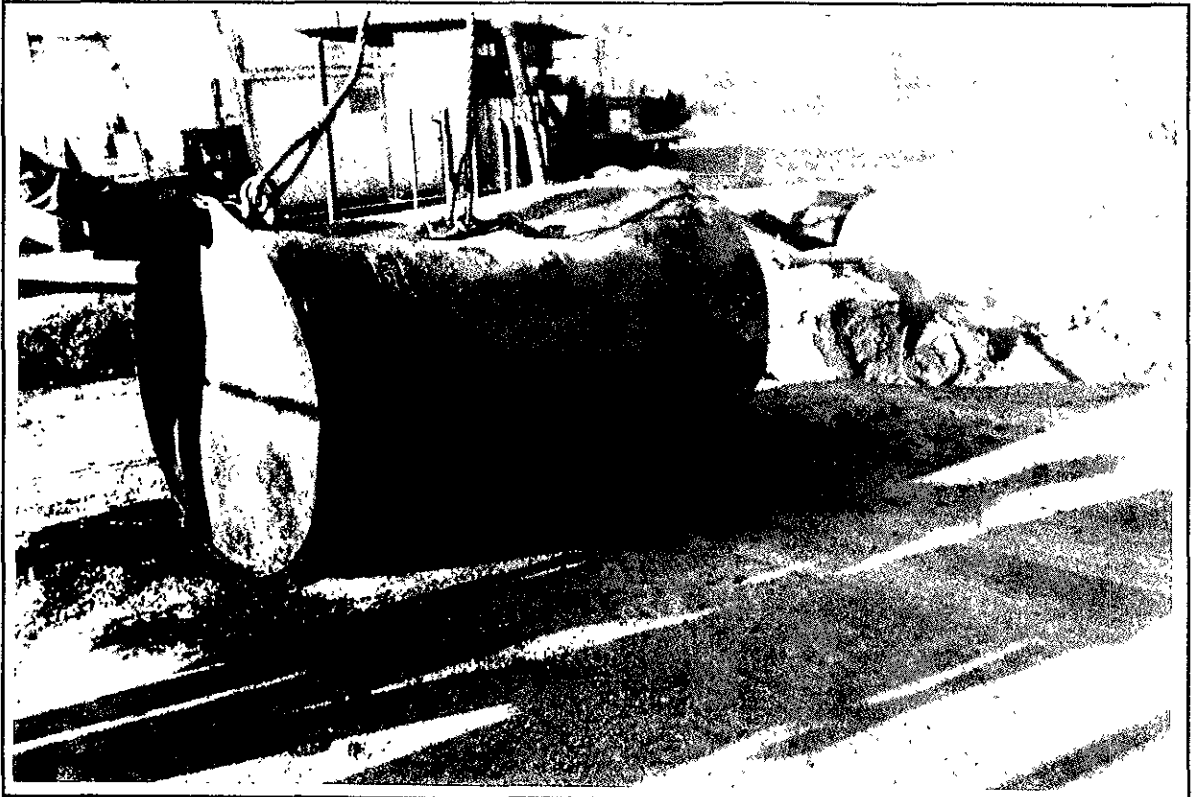
The 200-gallon used oil UST was heavily dented at the top and large holes were observed at the top. However, the foreman had disclosed that the dents and holes at the top of the tank had been inflicted by the excavation contractor during the tank uncovering process. No other holes were observed on the used oil tank.

December 22, 1992: East Side of Excavated Waste Oil UST

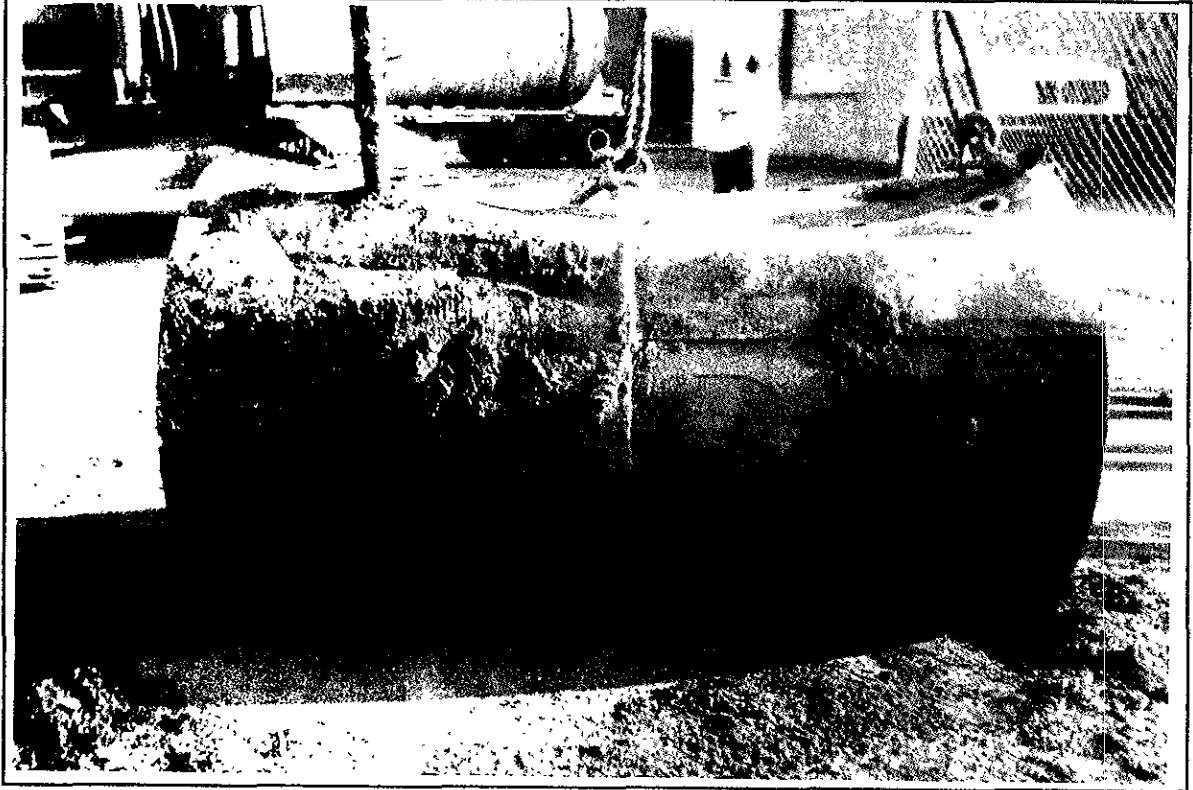
December 22, 1992: West Side of Excavated Waste Oil UST

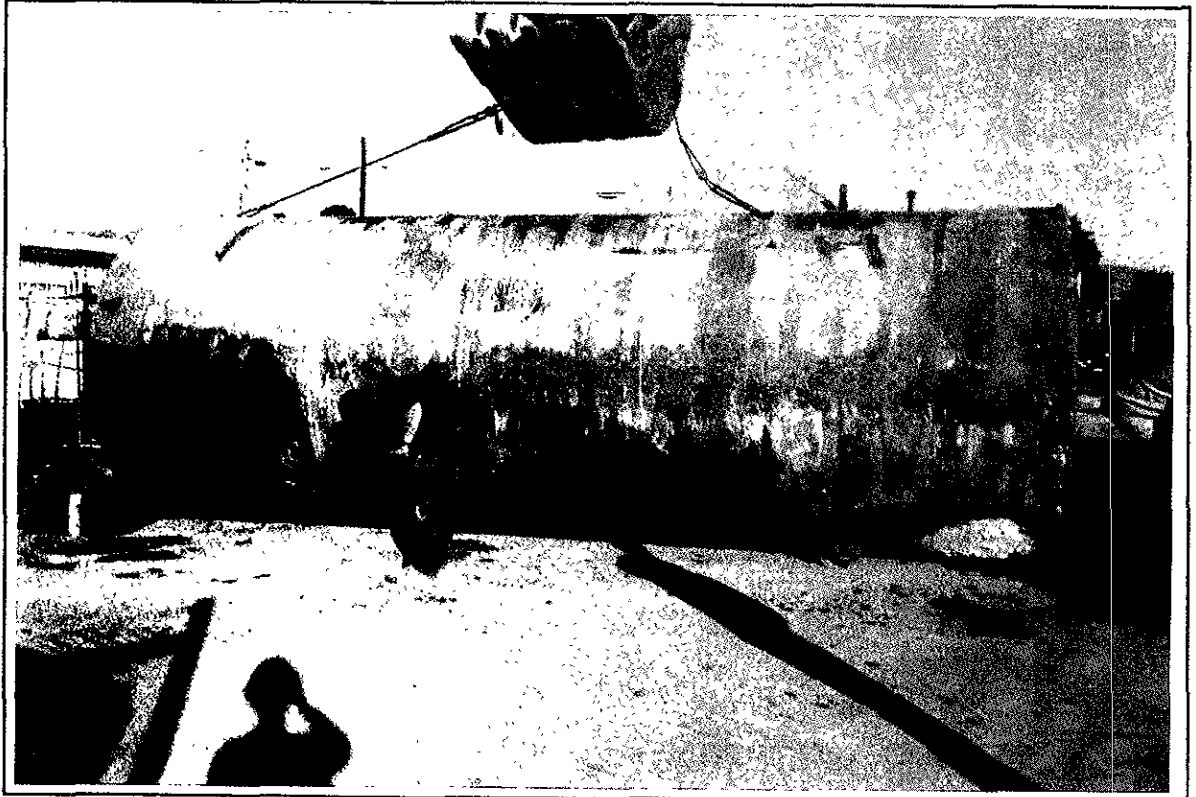
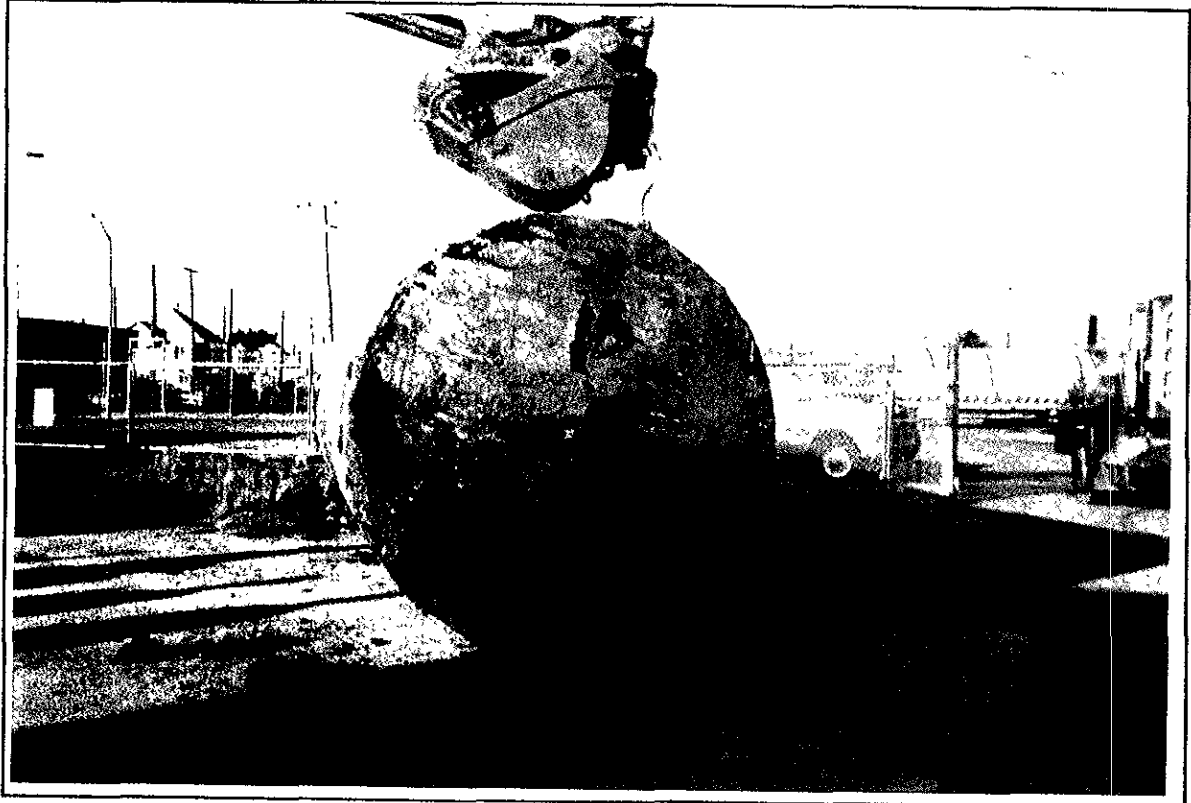
December 22, 1992: South Side of Excavated Steel Diesel UST

December 22, 1992: North Side of Excavated Steel Diesel UST

December 22, 1992: East End of Excavated Steel Diesel UST

December 22, 1992: Bottom and West End of Excavated Steel Diesel UST

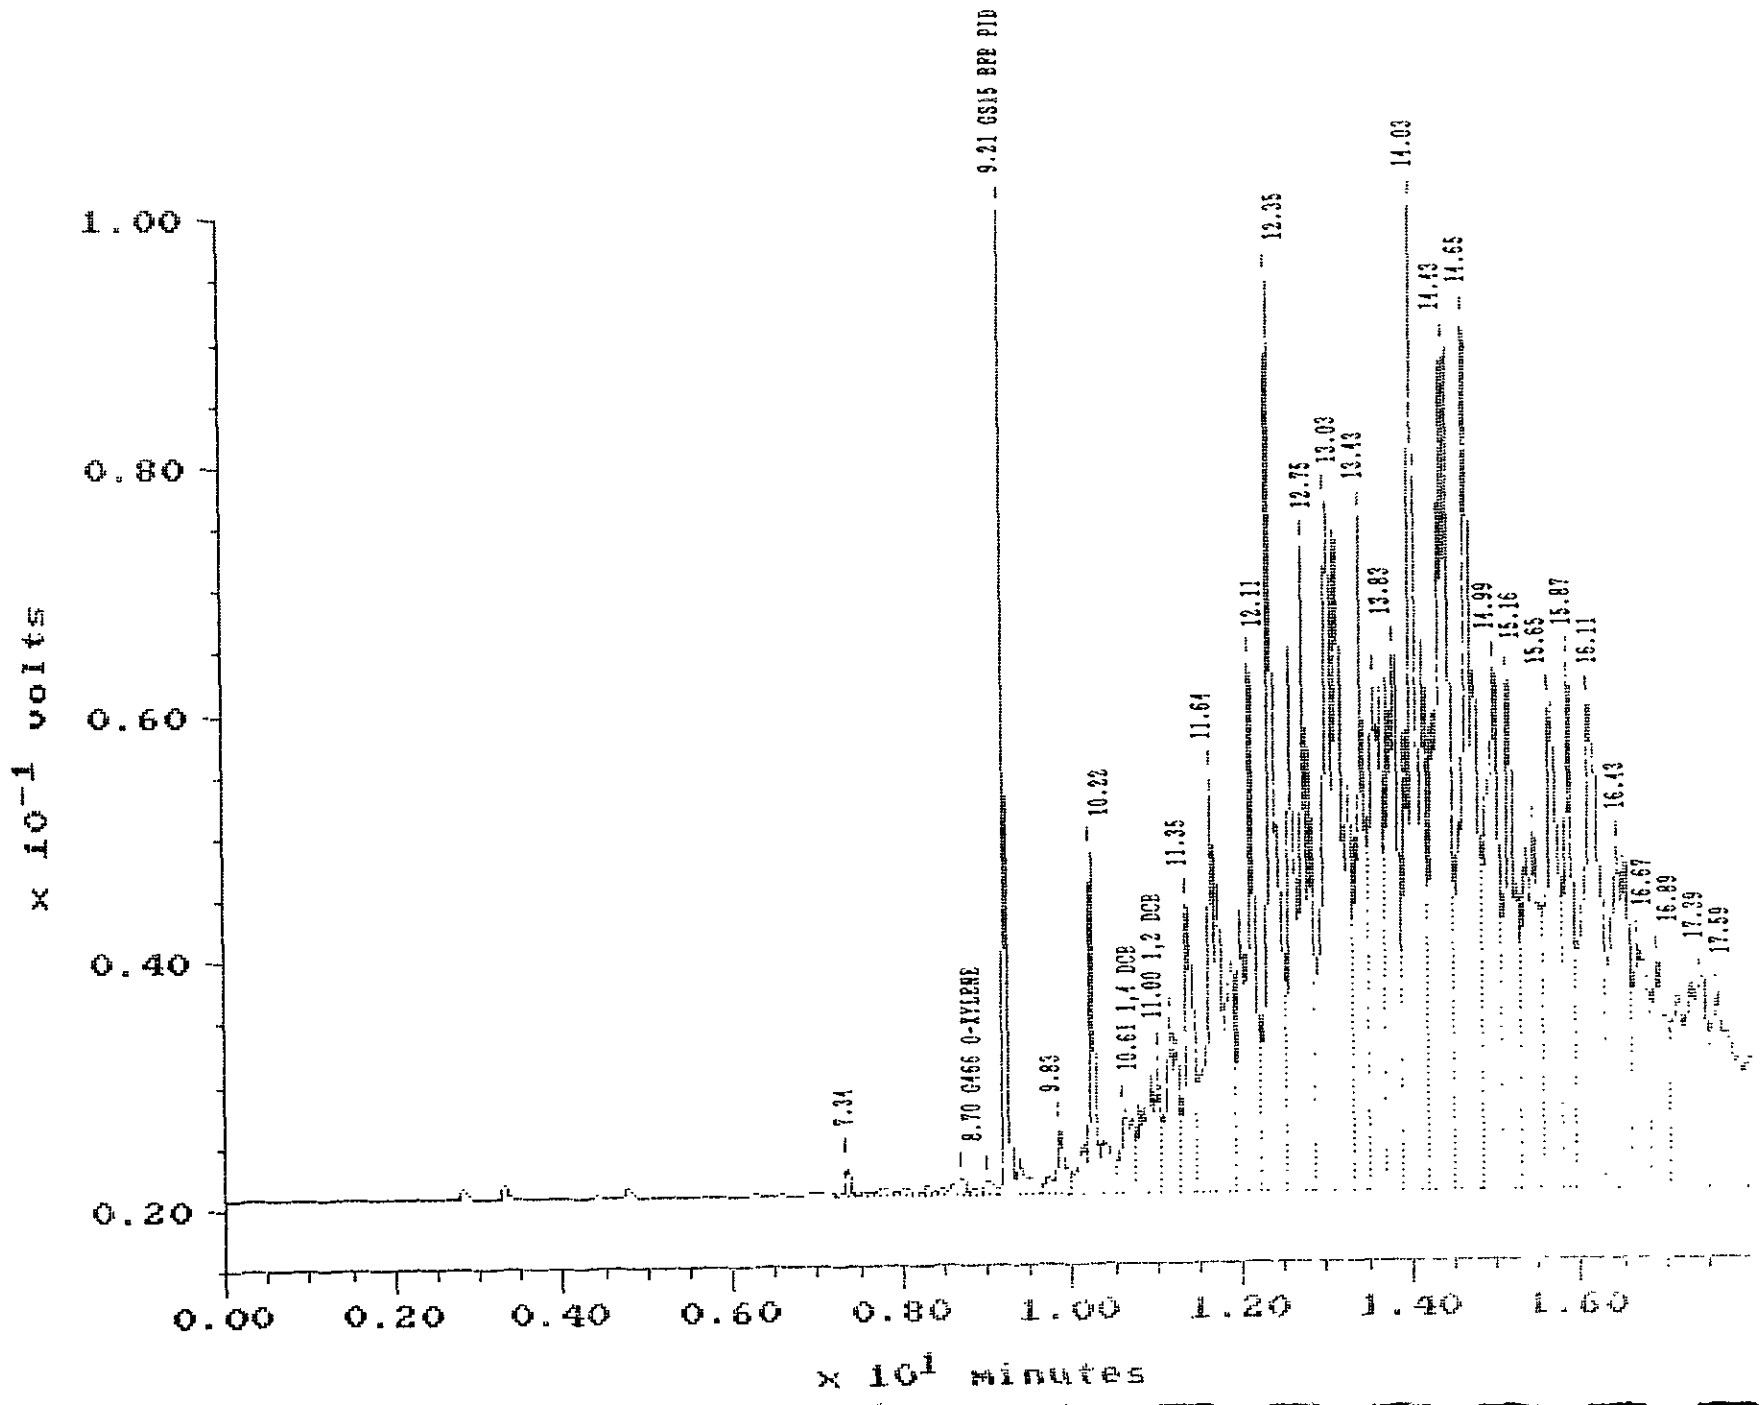
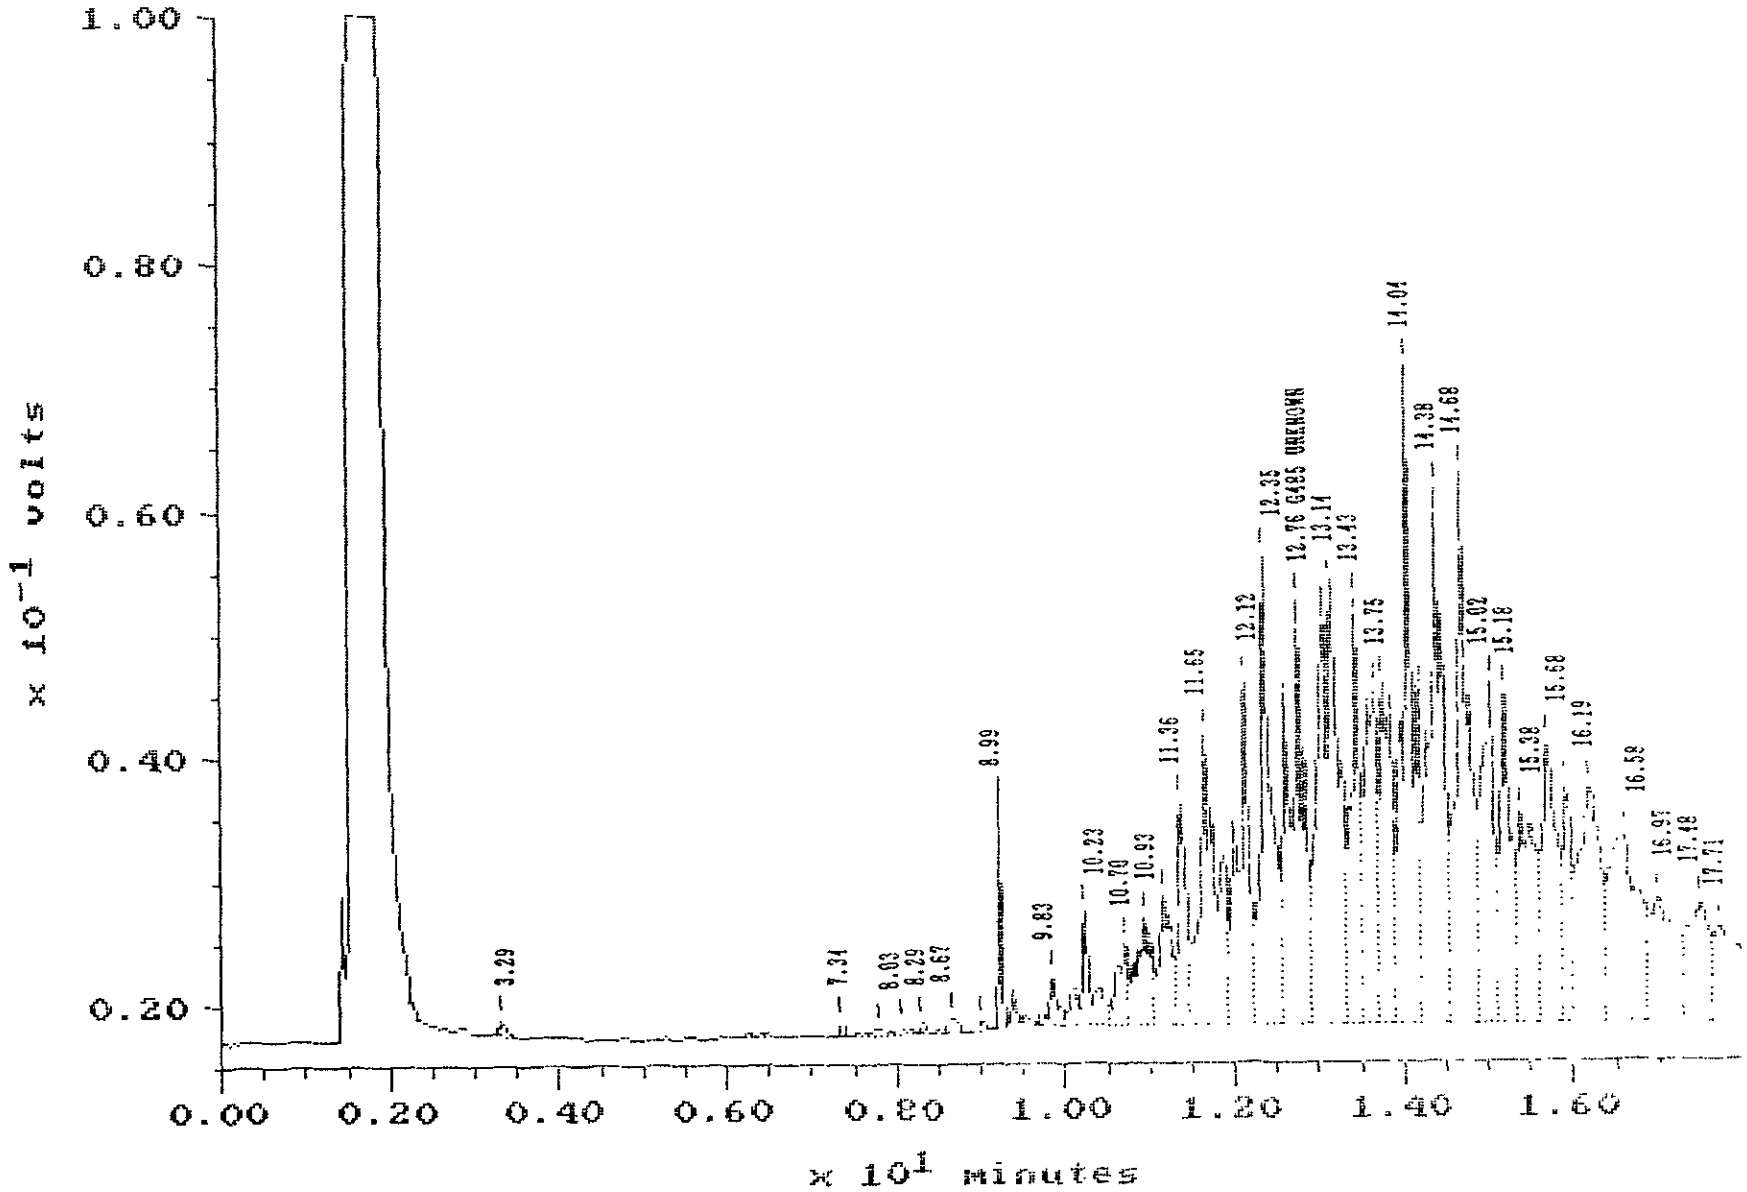
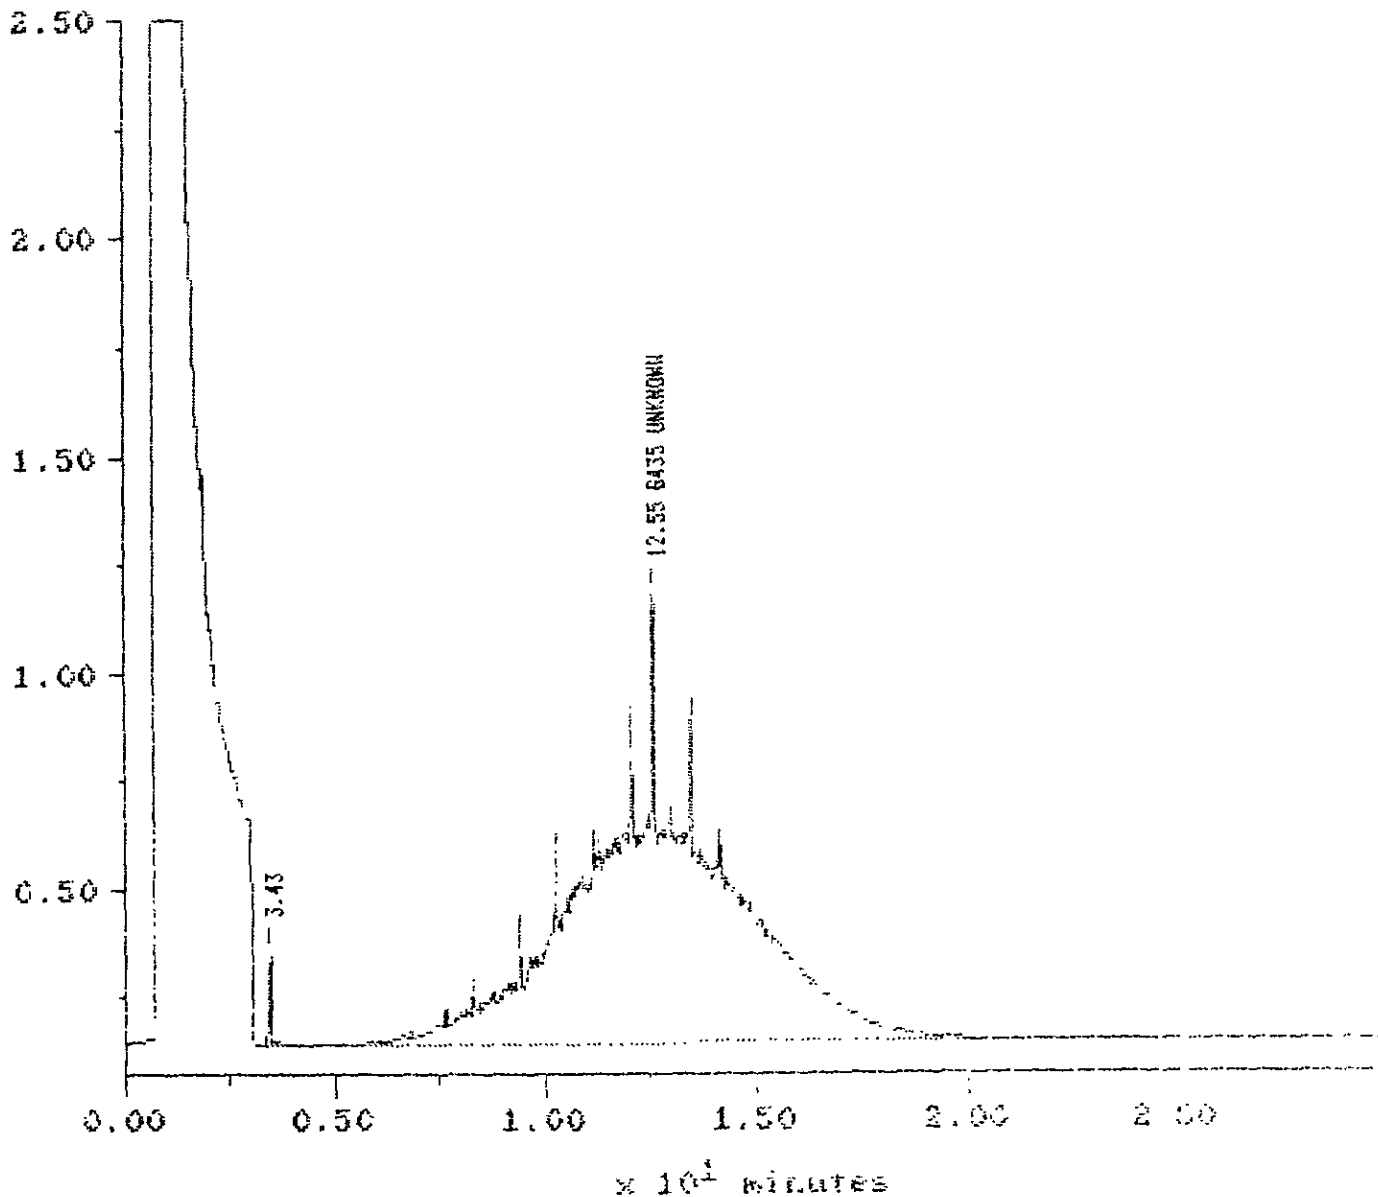
D-1 (TPH-Gas/BTEX PID)

D-1 (TPH-Gas/BTEX FID)

D-1 (TPH-Diesel)

Sample D-1: In both of the analyses for TPH-Diesel and TPH-Gasoline/BTEX, chromatographic patterns are observed that do not match the pattern of any of our in-house standards for these methods. These components are semi-quantitated by comparison with the diesel standard and gasoline standard respectively and reported as "unknown hydrocarbons". The unknown appears in the TPH-Diesel scan as a pattern similar to that of Diesel. In the TPH-Gasoline/BTEX scan the pattern elutes late in the gasoline elution profile which is consistent with the findings in the TPH-Diesel scan.
