Accutite Environmental Engineering

**RE: REMEDIAL SOIL INVESTIGATION REPORT FOR
711 CLEVELAND STREET, ALBANY, CA 94710**

**REMEDIAL SOIL INVESTIGATION REPORT FOR
711 CLEVELAND STREET, ALBANY, CA 94710**

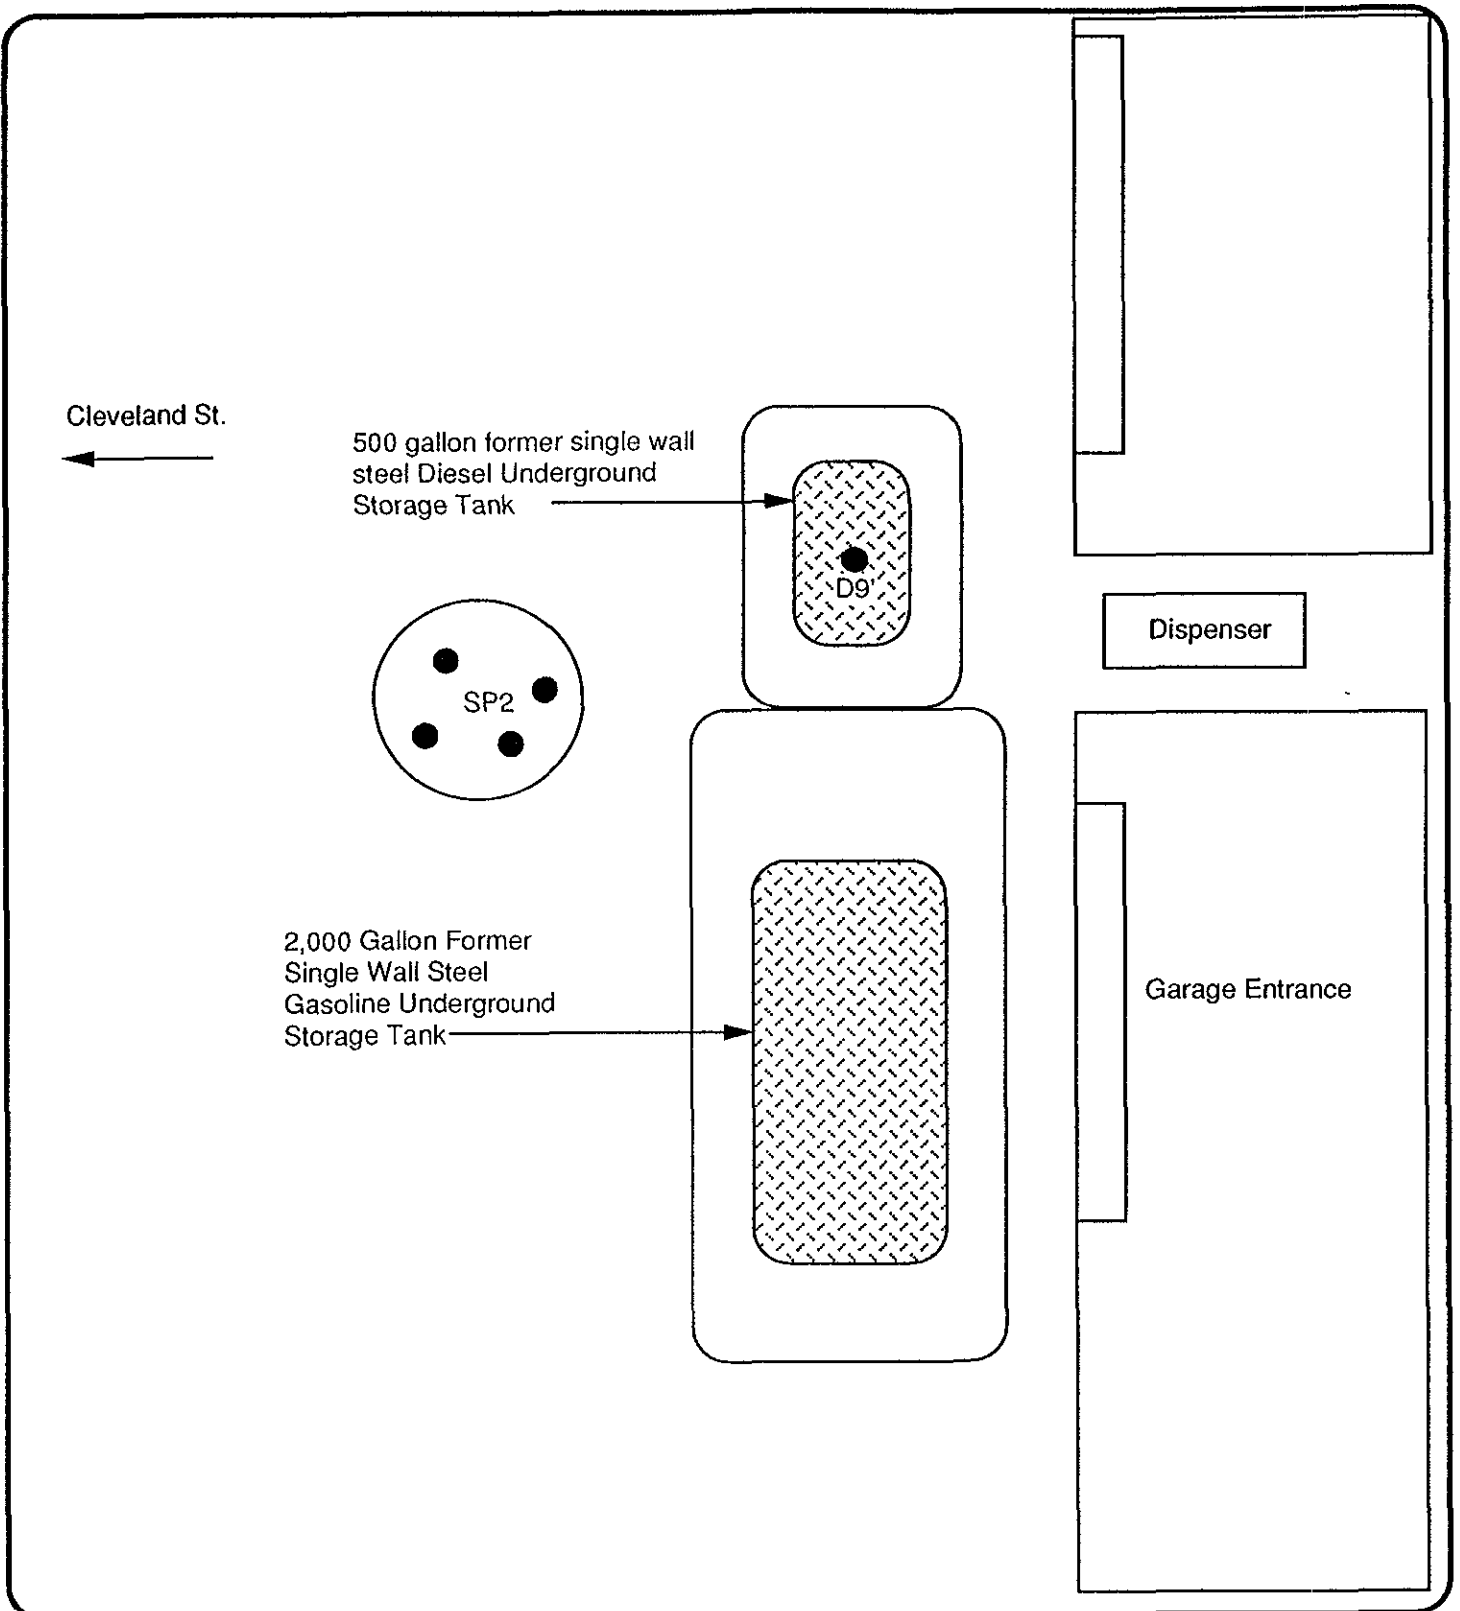
SCALE	1" = 5'	Key: ● Soil sample location	35 South Linden Avenue South San Francisco California 94080
	Fig. 1

On May 19 & 21, 1993, Accutite Environmental Engineering removed one 2,000 gallon gasoline and one 500 gallon diesel underground storage tank respectively, from the subject site. Upon removal of the tanks, five soil samples were collected, three samples from the excavations, 2 feet beneath tank bottom (labelled on the site maps as N10', S10', and D9'), and two composite samples from the excavated stockpile soil (labelled SP & SP2). Soil in the excavation consisted of sandy backfill material, and underlying clays. Hard sandstone was encountered at approximately 11 feet below surface grade beneath each tank. The two excavated stockpiles, approximately 30 cubic yards, contained hydrocarbon staining and odor. Soil samples SP, N10', and S10' were analyzed for Total Petroleum Hydrocarbons as Gasoline (TPH-G) with Benzene, Toluene, Ethyl Benzene, and Total Xylenes (BTEX) distinctions. Soil samples SP2 and D9' were analyzed for Total Petroleum Hydrocarbons as Diesel (TPH-D) and BTEX. (see Table 1 for summary of results) The excavations were backfilled with excavated soil and imported clean drain rock separated by visqueen on the same day of each removal.

The 2,000 gallon gasoline tank contained several 3/8" size holes on the top flat end of the tank. The 500 gallon diesel tank was found in good condition with no holes. Ground water was not encountered in the excavations.

Revisions	Date	Page	Site: Z Rental 711 Cleveland Street Albany, CA	By: ACCUTITE ENVIRONMENTAL ENGINEERING
	Tank Removal	1		
1	19 May 93	of 2		
NORTH

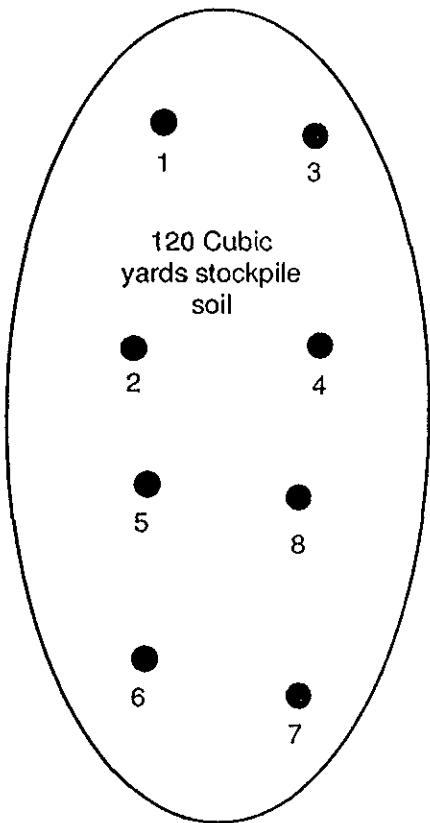
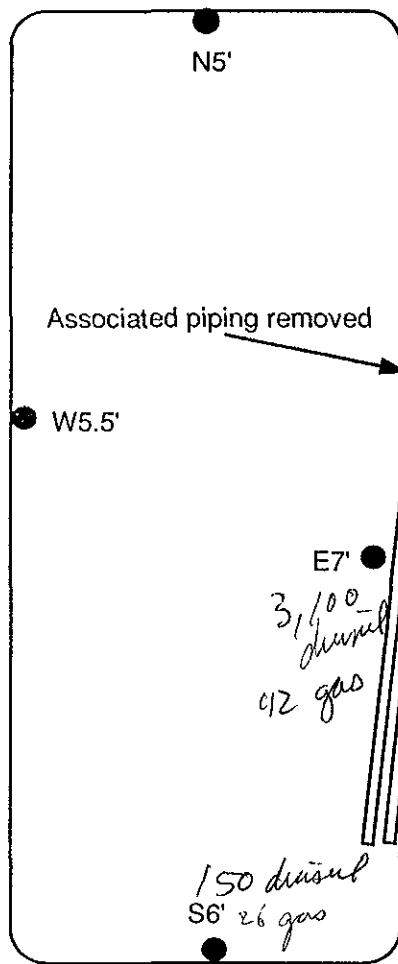
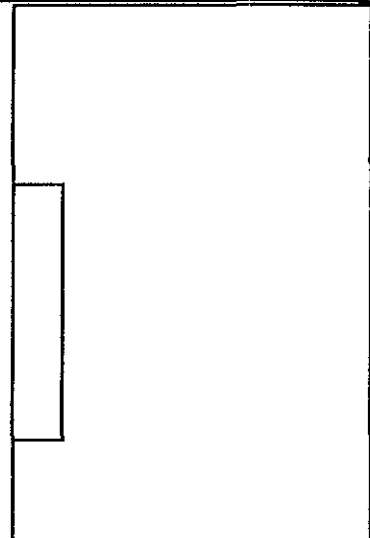
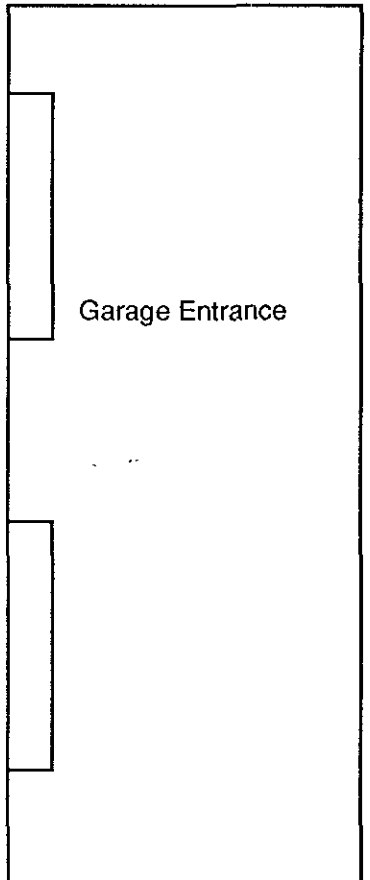
Fig. 3

The final size of the excavation measured was 26 feet long by 9 feet wide and 10.5 feet deep. Approximately 120 cubic yards of soil and 10 cubic yards of drain rock were excavated in one day.

Sidewall soil samples were collected and labelled as N-5', S-6', E-7' and W-5.5' where:

Revisions	Date	Page
	Over Dig	1
	17 Aug 93	of
		1

Accutite recommends over-excavation in an attempt to remove contaminated soil from the south and east sidewalls of the excavation down to 10.5' below surface grade (bsg). In order to remove the contaminated soil from the east sidewall, the building and foundation would have to be demolished. Sidewall samples will be required every 20 linear feet and efforts should be made to collect bottom samples of the sandstone during excavation.

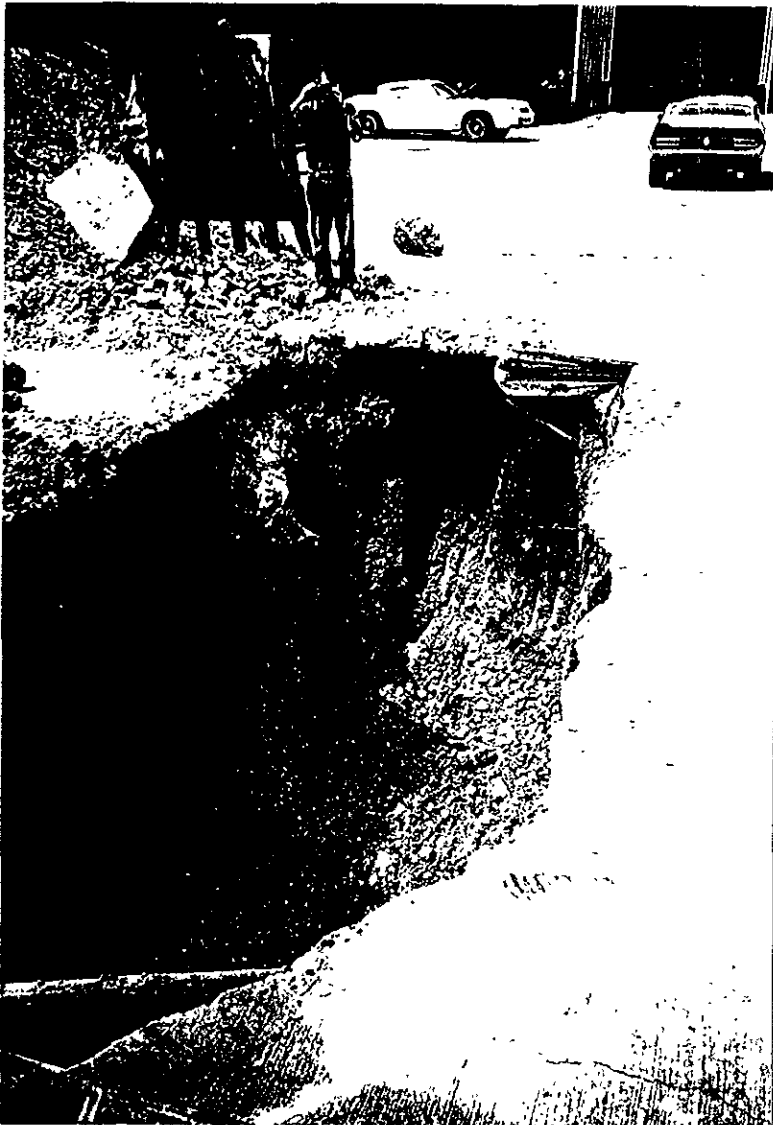
#1- North/West corner of excavation

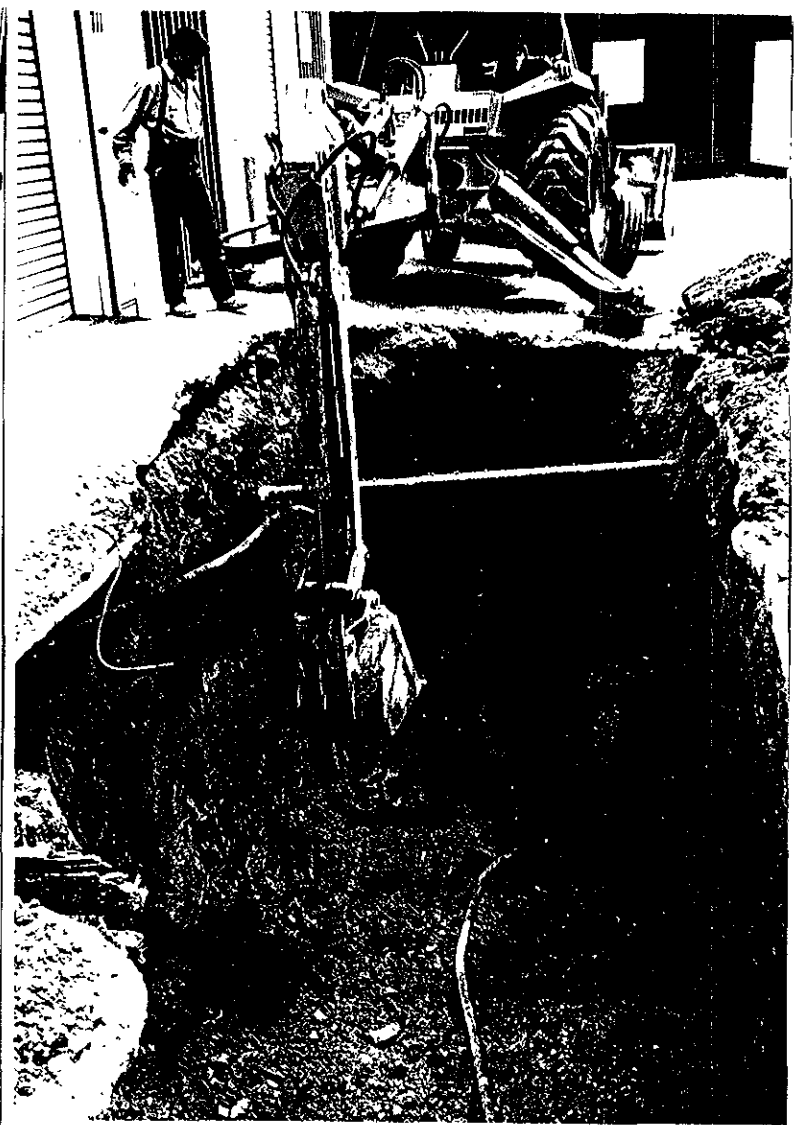
#2 - South sidewall of excavation
