SUMMARY REPORT

JEAN R. LARKIN  
(PACIFIC PROPERTIES)  
1628 WEBSTER STREET  
ALAMEDA, CALIFORNIA

Project No. 4358F  
May 1990

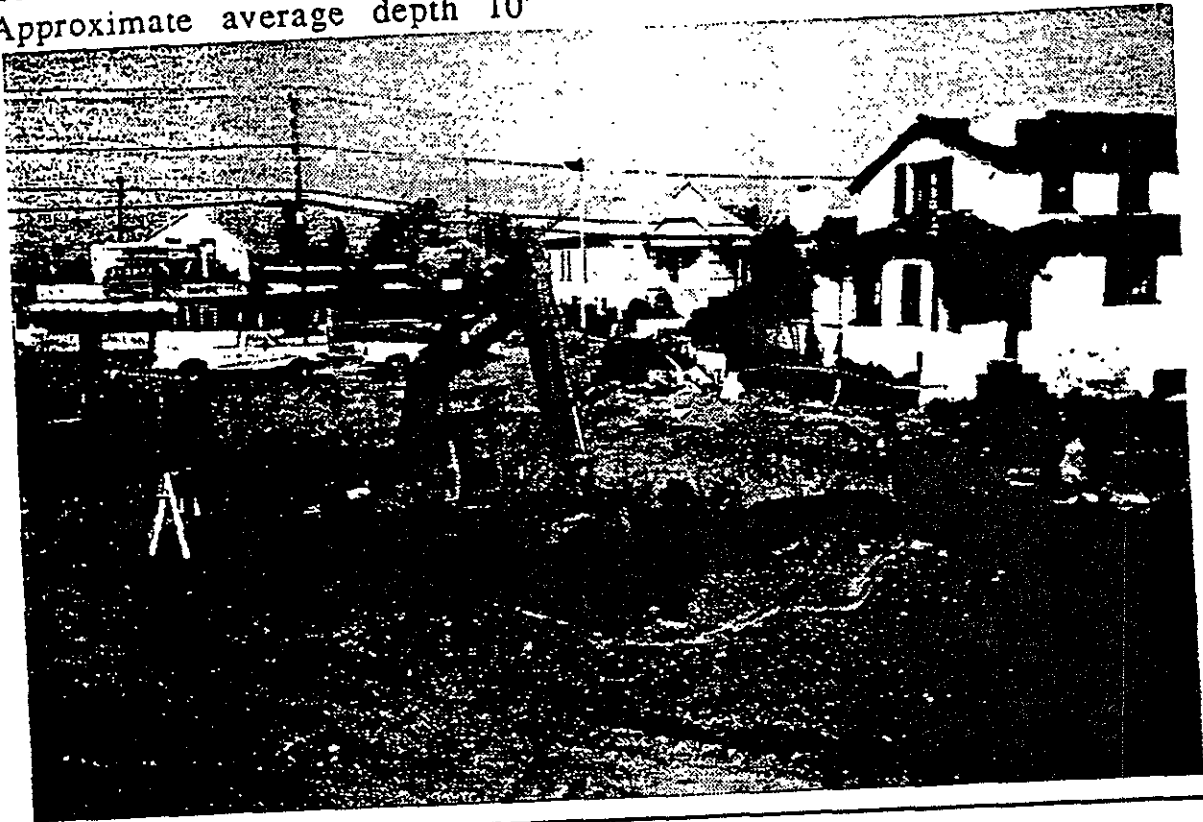
Photo #1

Orientation of Phase II excavation looking north.  
Approximate average depth 10'

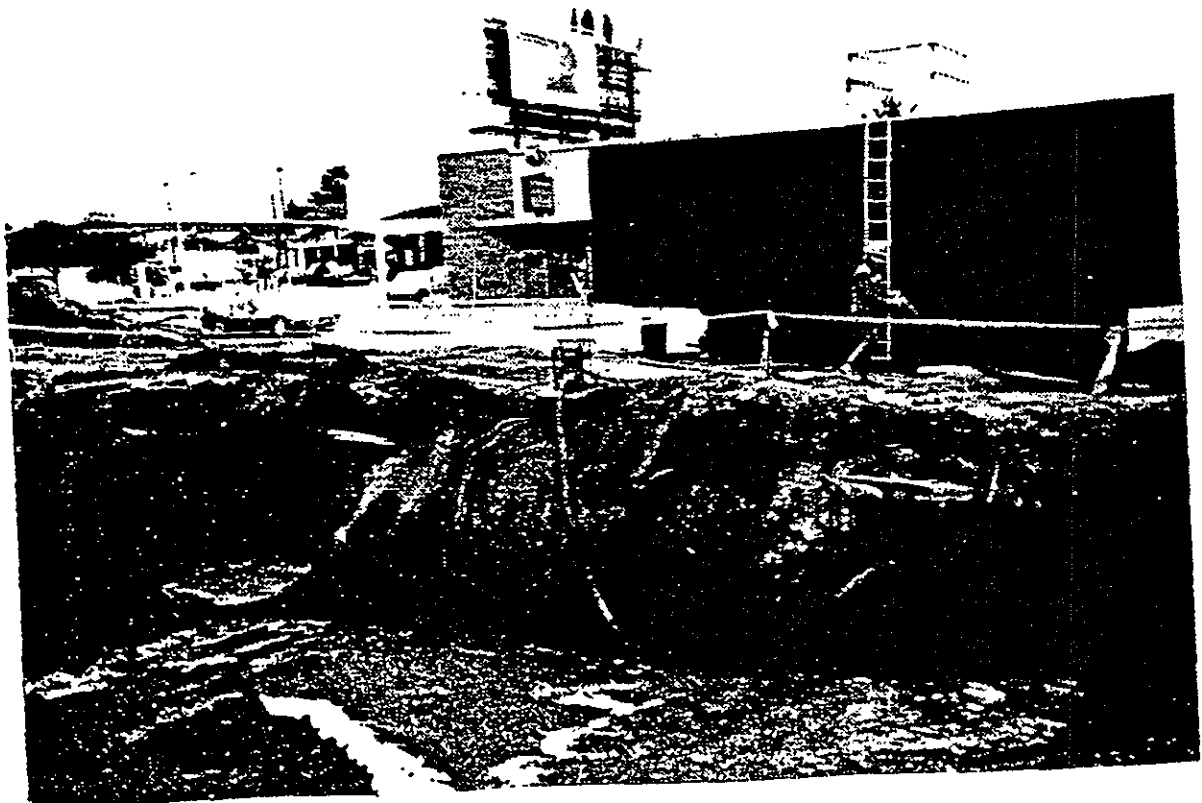
Photo #2

West wall of Phase II excavation.

Note: Fiberglass product line, steel product lines in place.

The Phase II excavation led to the discovery of product lines, a second possible source of contamination. Both fiberglass and steel lines were exposed and removed (see photo documentation). Site Map 3 shows the approximate location of these lines.

Some of the lines were contained in the same trench, with the fiberglass lines situated above the steel lines. Staining, visible beneath some trench areas, indicated contamination. It was not apparent whether the lines had been properly capped; however, none of the lines had been grouted closed.

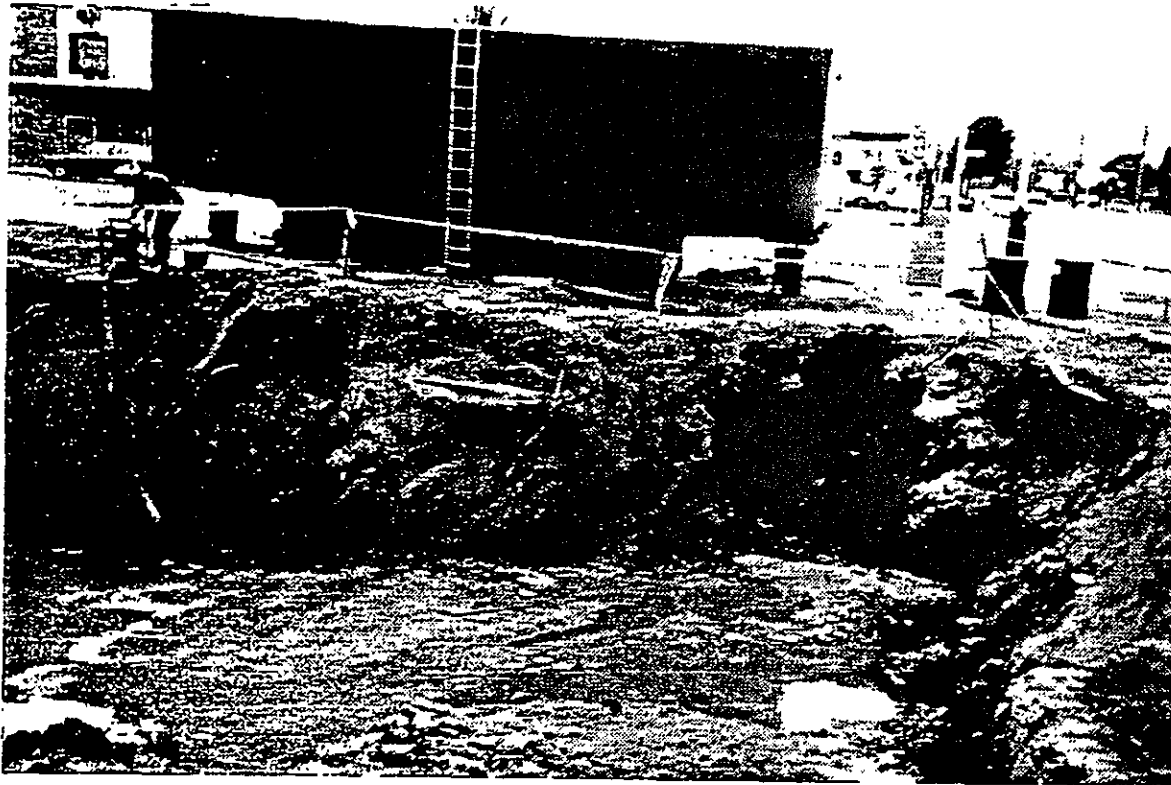
Photo #3

Northwest corner of excavation: Please note discoloration (contaminated soils) and debris in the corner.

During the excavation, large amounts of asphalt and concrete rubble were encountered. This material may have been used as backfill when the underground tanks were removed. The largest amounts were found in the northwest corner extending approximately 20 feet east and 50 feet south. On several occasions, we encountered both fiberglass and steel product lines. Often the trenches had both types of product lines, with the steel below and fiberglass above. On April 18, 1990, Exceltech Staff Geologist, Douglas T. Young took soil samples from around the excavation (Appendix C). Two of the three samples had very high levels of gasoline and diesel fuel and moderate levels of oil and grease contamination.
