31 January 2008
Project 3433.13

Subject: Cap Disturbance and Repair
Mandela Gateway
1440 Seventh Street
Oakland, California

MANDELA GATEWAY
Oakland, California

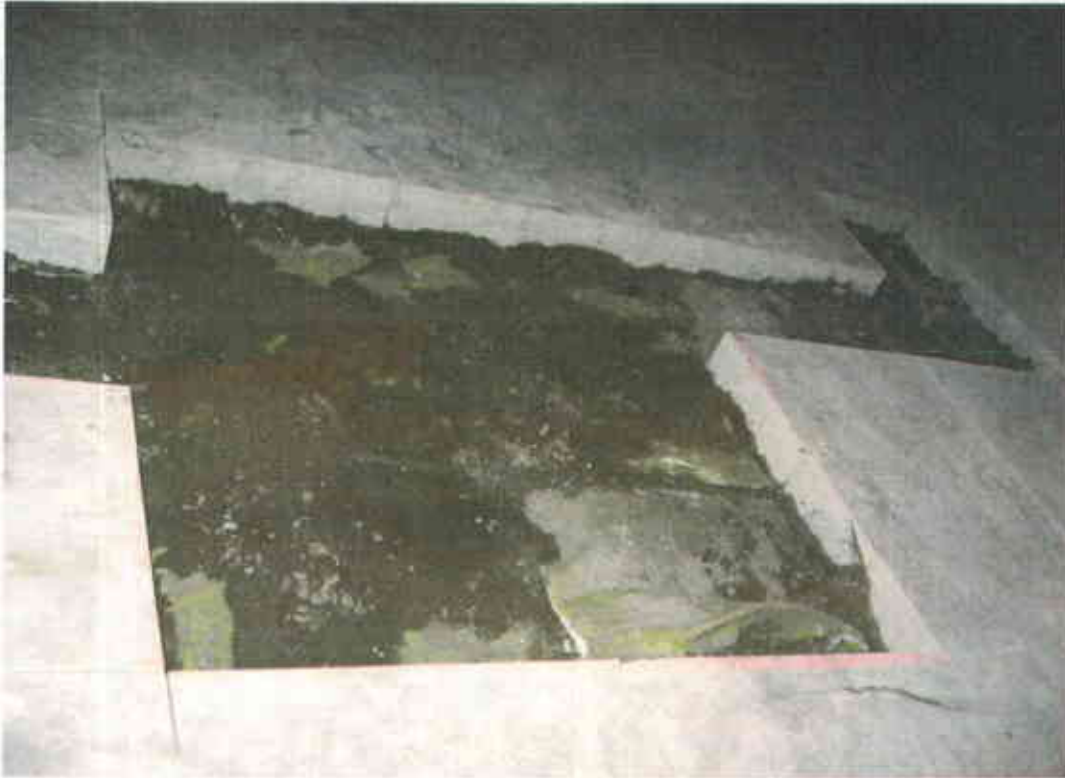
Photograph 1

View of sawcut trench (prior to excavation). Visqueen is visible in the trench.

On 3 October 2007, Treadwell & Rollo, Inc. met with Triton Interiors ("Triton") (the general contractor) and RGA Environmental ("RGA") (third party in-charge of preparing a health and safety plan) to discuss the project. The concrete slab had been sawcut and removed. The visqueen liner, which was previously installed to serve as cap protection, was visible and intact. The thickness of the concrete slab was measured at approximately ±5 inches (Photos 1, 2, and 3).

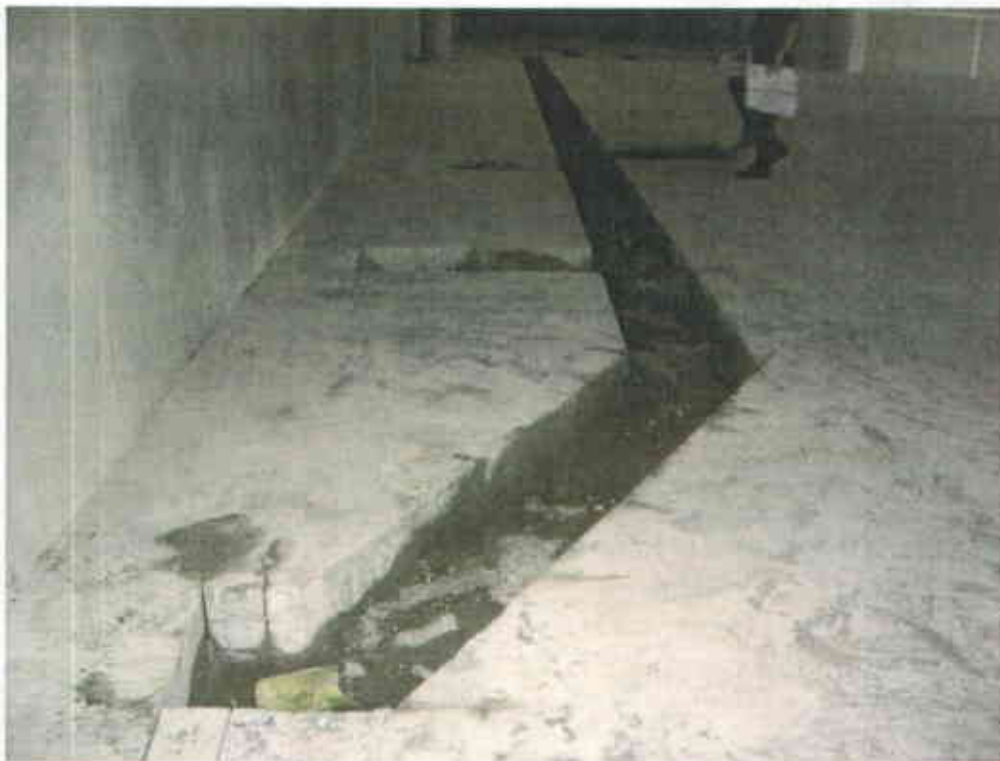
Photograph 2

Photograph of sawcut trench (prior to excavation). Visqueen visible in the trench.

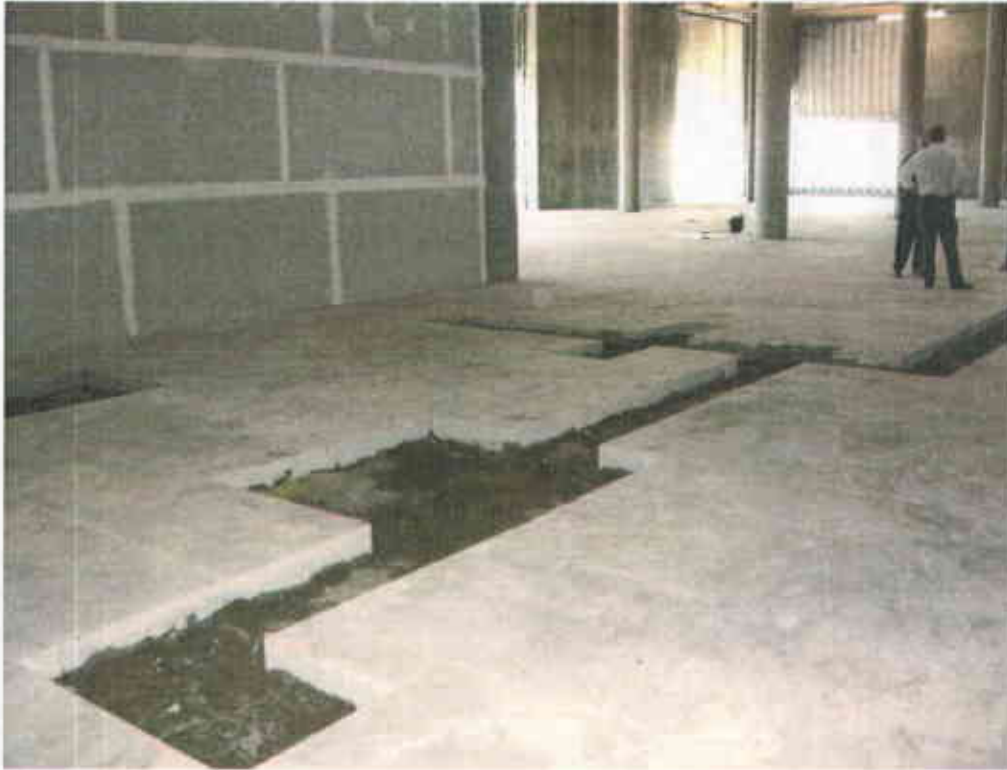
Photograph 3

Photograph of sawcut trench (prior to excavation).

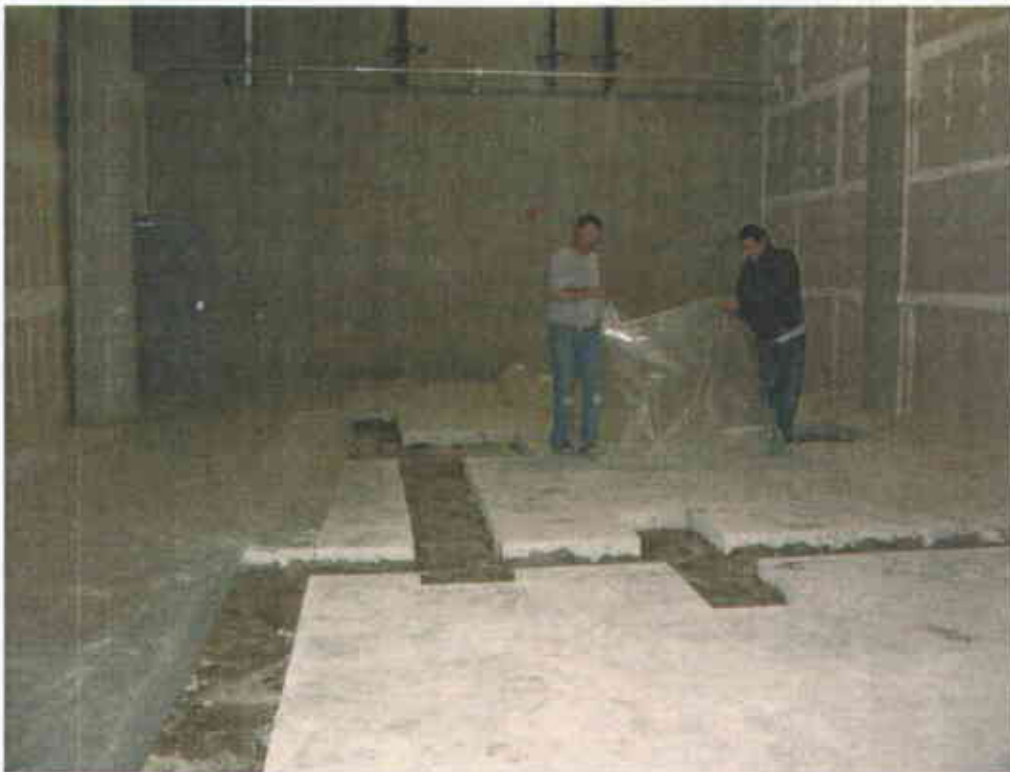
Photograph 4

Photograph of Triton workers laying visqueen for the stockpile.

On 5 October 2007, T&R conducted oversight for the initial excavation and stockpiling of soil. Triton laid visqueen liner around the area of excavation (Photo 4). When the whole area was covered Triton cut through the vapor barrier. Soil was excavated to a depth of approximately 3 feet from the top of the concrete slab. Groundwater was not encountered during the activities. Excavated soils were stockpiled on the visqueen liner (Photos 5 and 6). Triton's workers wore proper personal protection equipment (PPE) during the activities. An RGA representative was present to conduct health and safety monitoring.

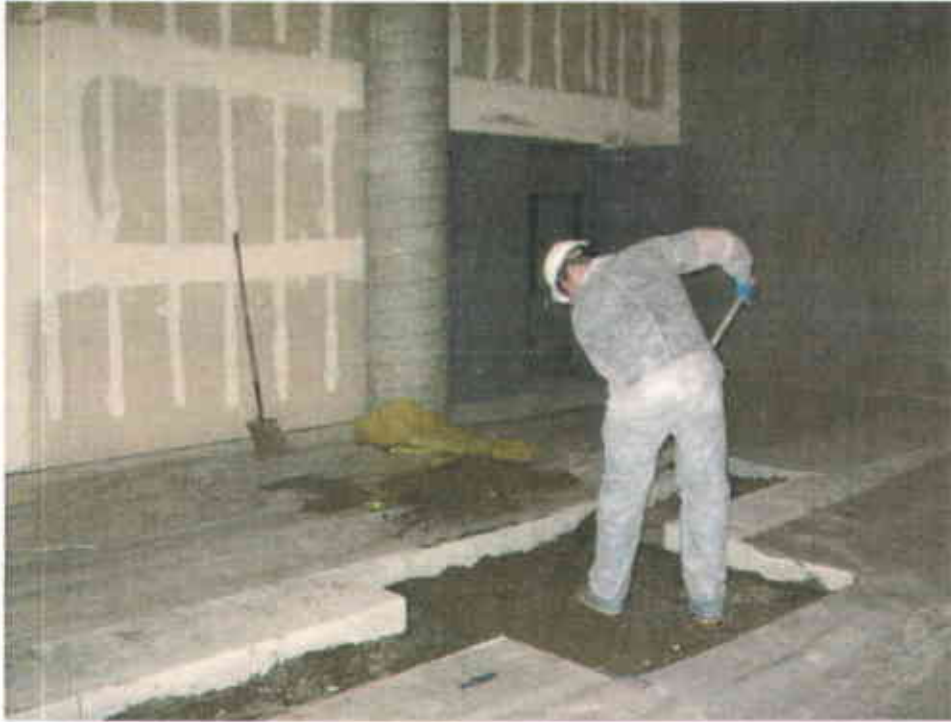
Photograph 5

Photograph of Triton worker cutting the visqueen cap. The removed visqueen is seen near the wall in the photo. The worker is wearing the appropriate protective equipment.

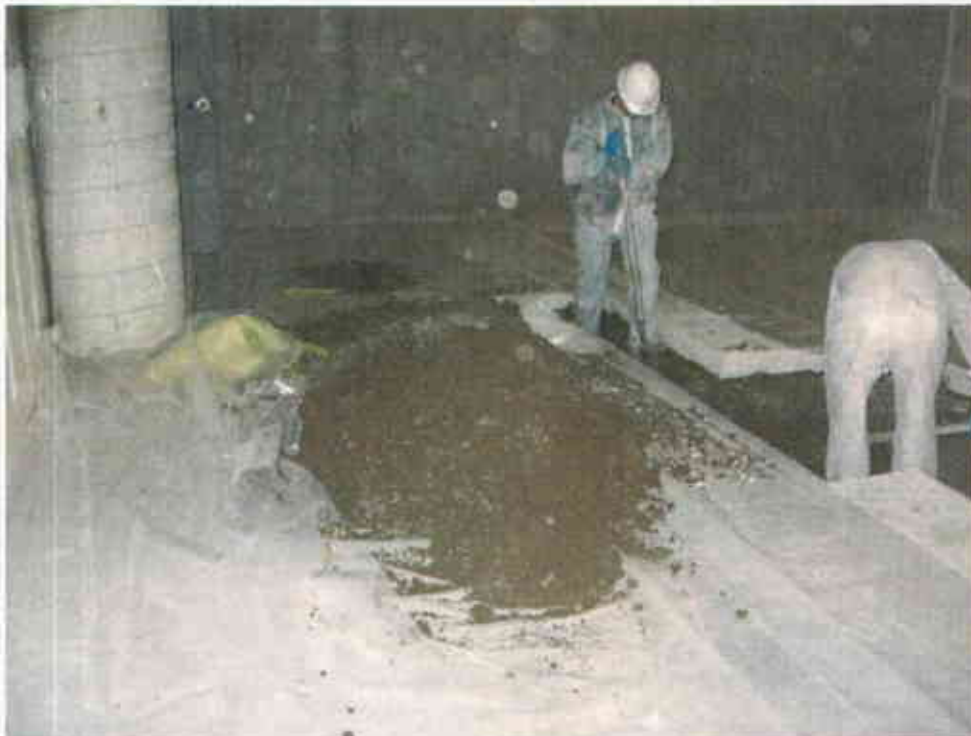
Photograph 6

Photograph of stockpile of excavated soil on visqueen.

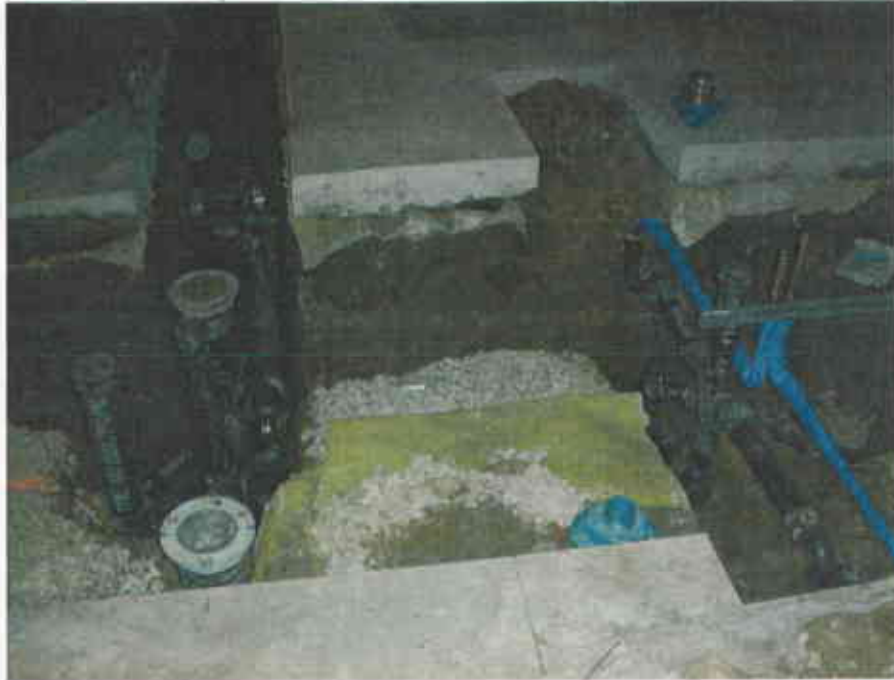
Photograph 7

Photograph of new drain lines plumbed to approximately 2 to 2.5 feet below the bottom of the concrete slab.

On 15 October 2007, T&R conducted oversight for the installation of the new drain line works. The drain line was plumbed to depths of approximately 2 to 2.5 feet below the concrete slab (Photo 7).

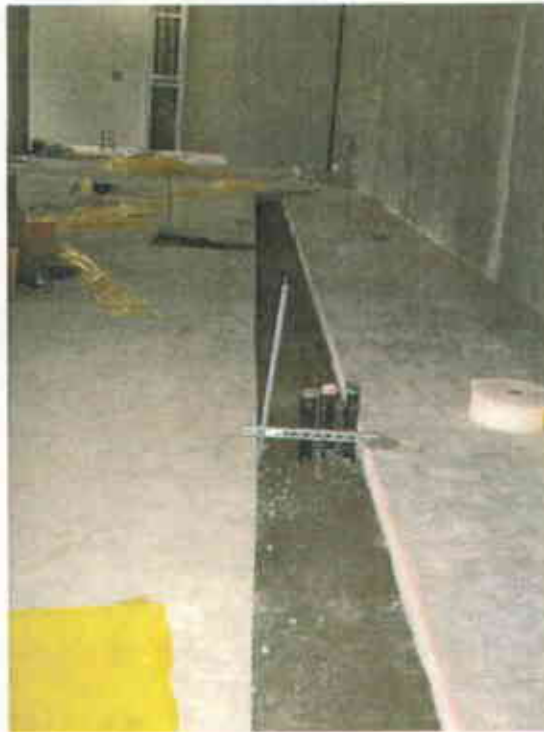
Photograph 8

Photograph of trench after backfill and compaction.

On 18 October 2007, the total volume of excavated soil (approximately 375 cubic feet) was backfilled into the trench. No excess soil was removed from the Site. The soil was replaced to the bottom of surrounding concrete and a new visqueen liner was tied into the surrounding visqueen membrane (Photos 8 and 9). On 22 October 2007, T&R conducted a final site visit. The concrete was replaced over the former excavation. The replacement concrete matched the thickness of the surrounding slab (Photo 10).

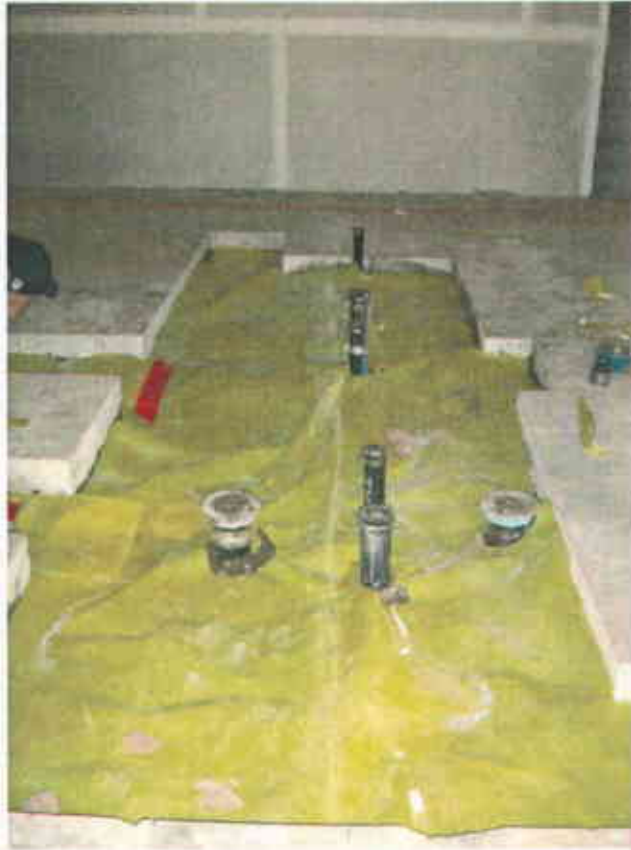
Photograph 9

Photograph of trench after visqueen cap is replaced before the concrete slab is repoured. The red tape visible in the photograph is used to adhere separate sheets together.

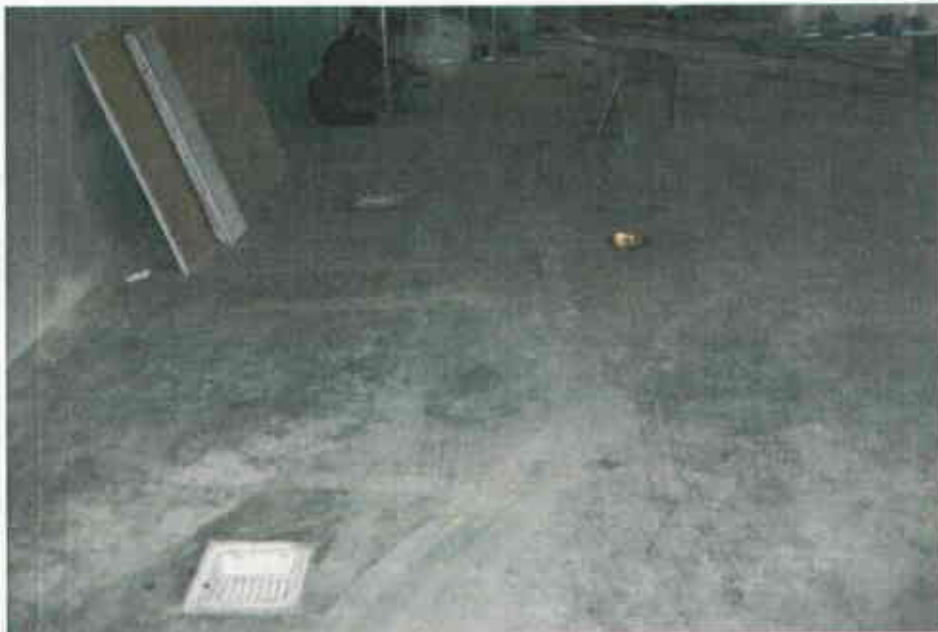
Photograph 10

Photograph of project completion after repouring the concrete slab.

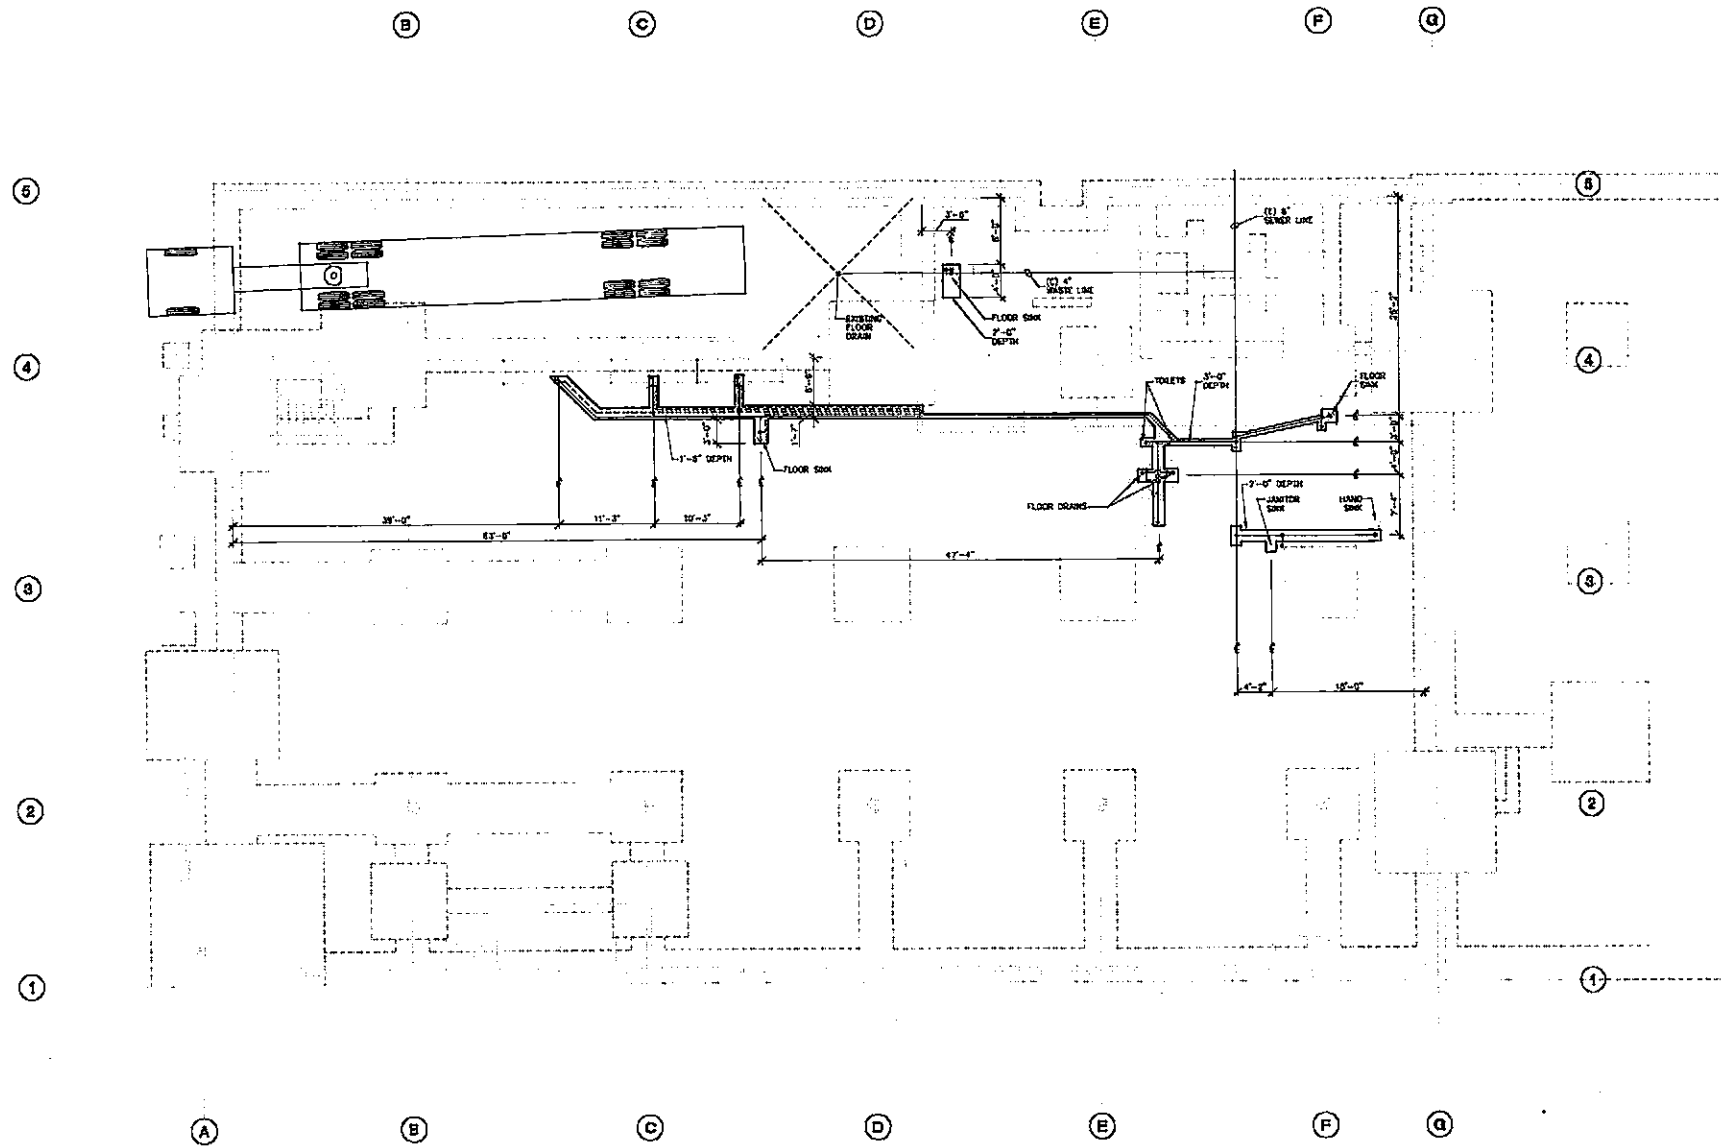
Sheet
TRENCHING PLAN
TP

Attachment B: Plan of Cap Disturbance Activities

NOTE:
EXISTING SEWER LINE LOCATIONS
BASED ON AS-BUILT DRAWINGS
OBTAINED FROM OWNER HISTORIC
CONTRACTS. NEW SEWER LINES TO
EXISTING SEWER LINES AS SHOWN.
CONTRACTOR TO VERIFY ACCURATE
LOCATIONS OF EXISTING SEWER
LINES AND ADJUST TRENCH
ROUTING TO ENSURE NECESSARY
CLEARANCES TO EXISTING LINES.
