**Subject: Corrective Action Completion Report
Source Area Soil and Groundwater Removal, April 2011**

**Reference: Earthgrains Baking Companies, Inc.
955 Kennedy Street
Oakland, California 94606
RO #0002569**

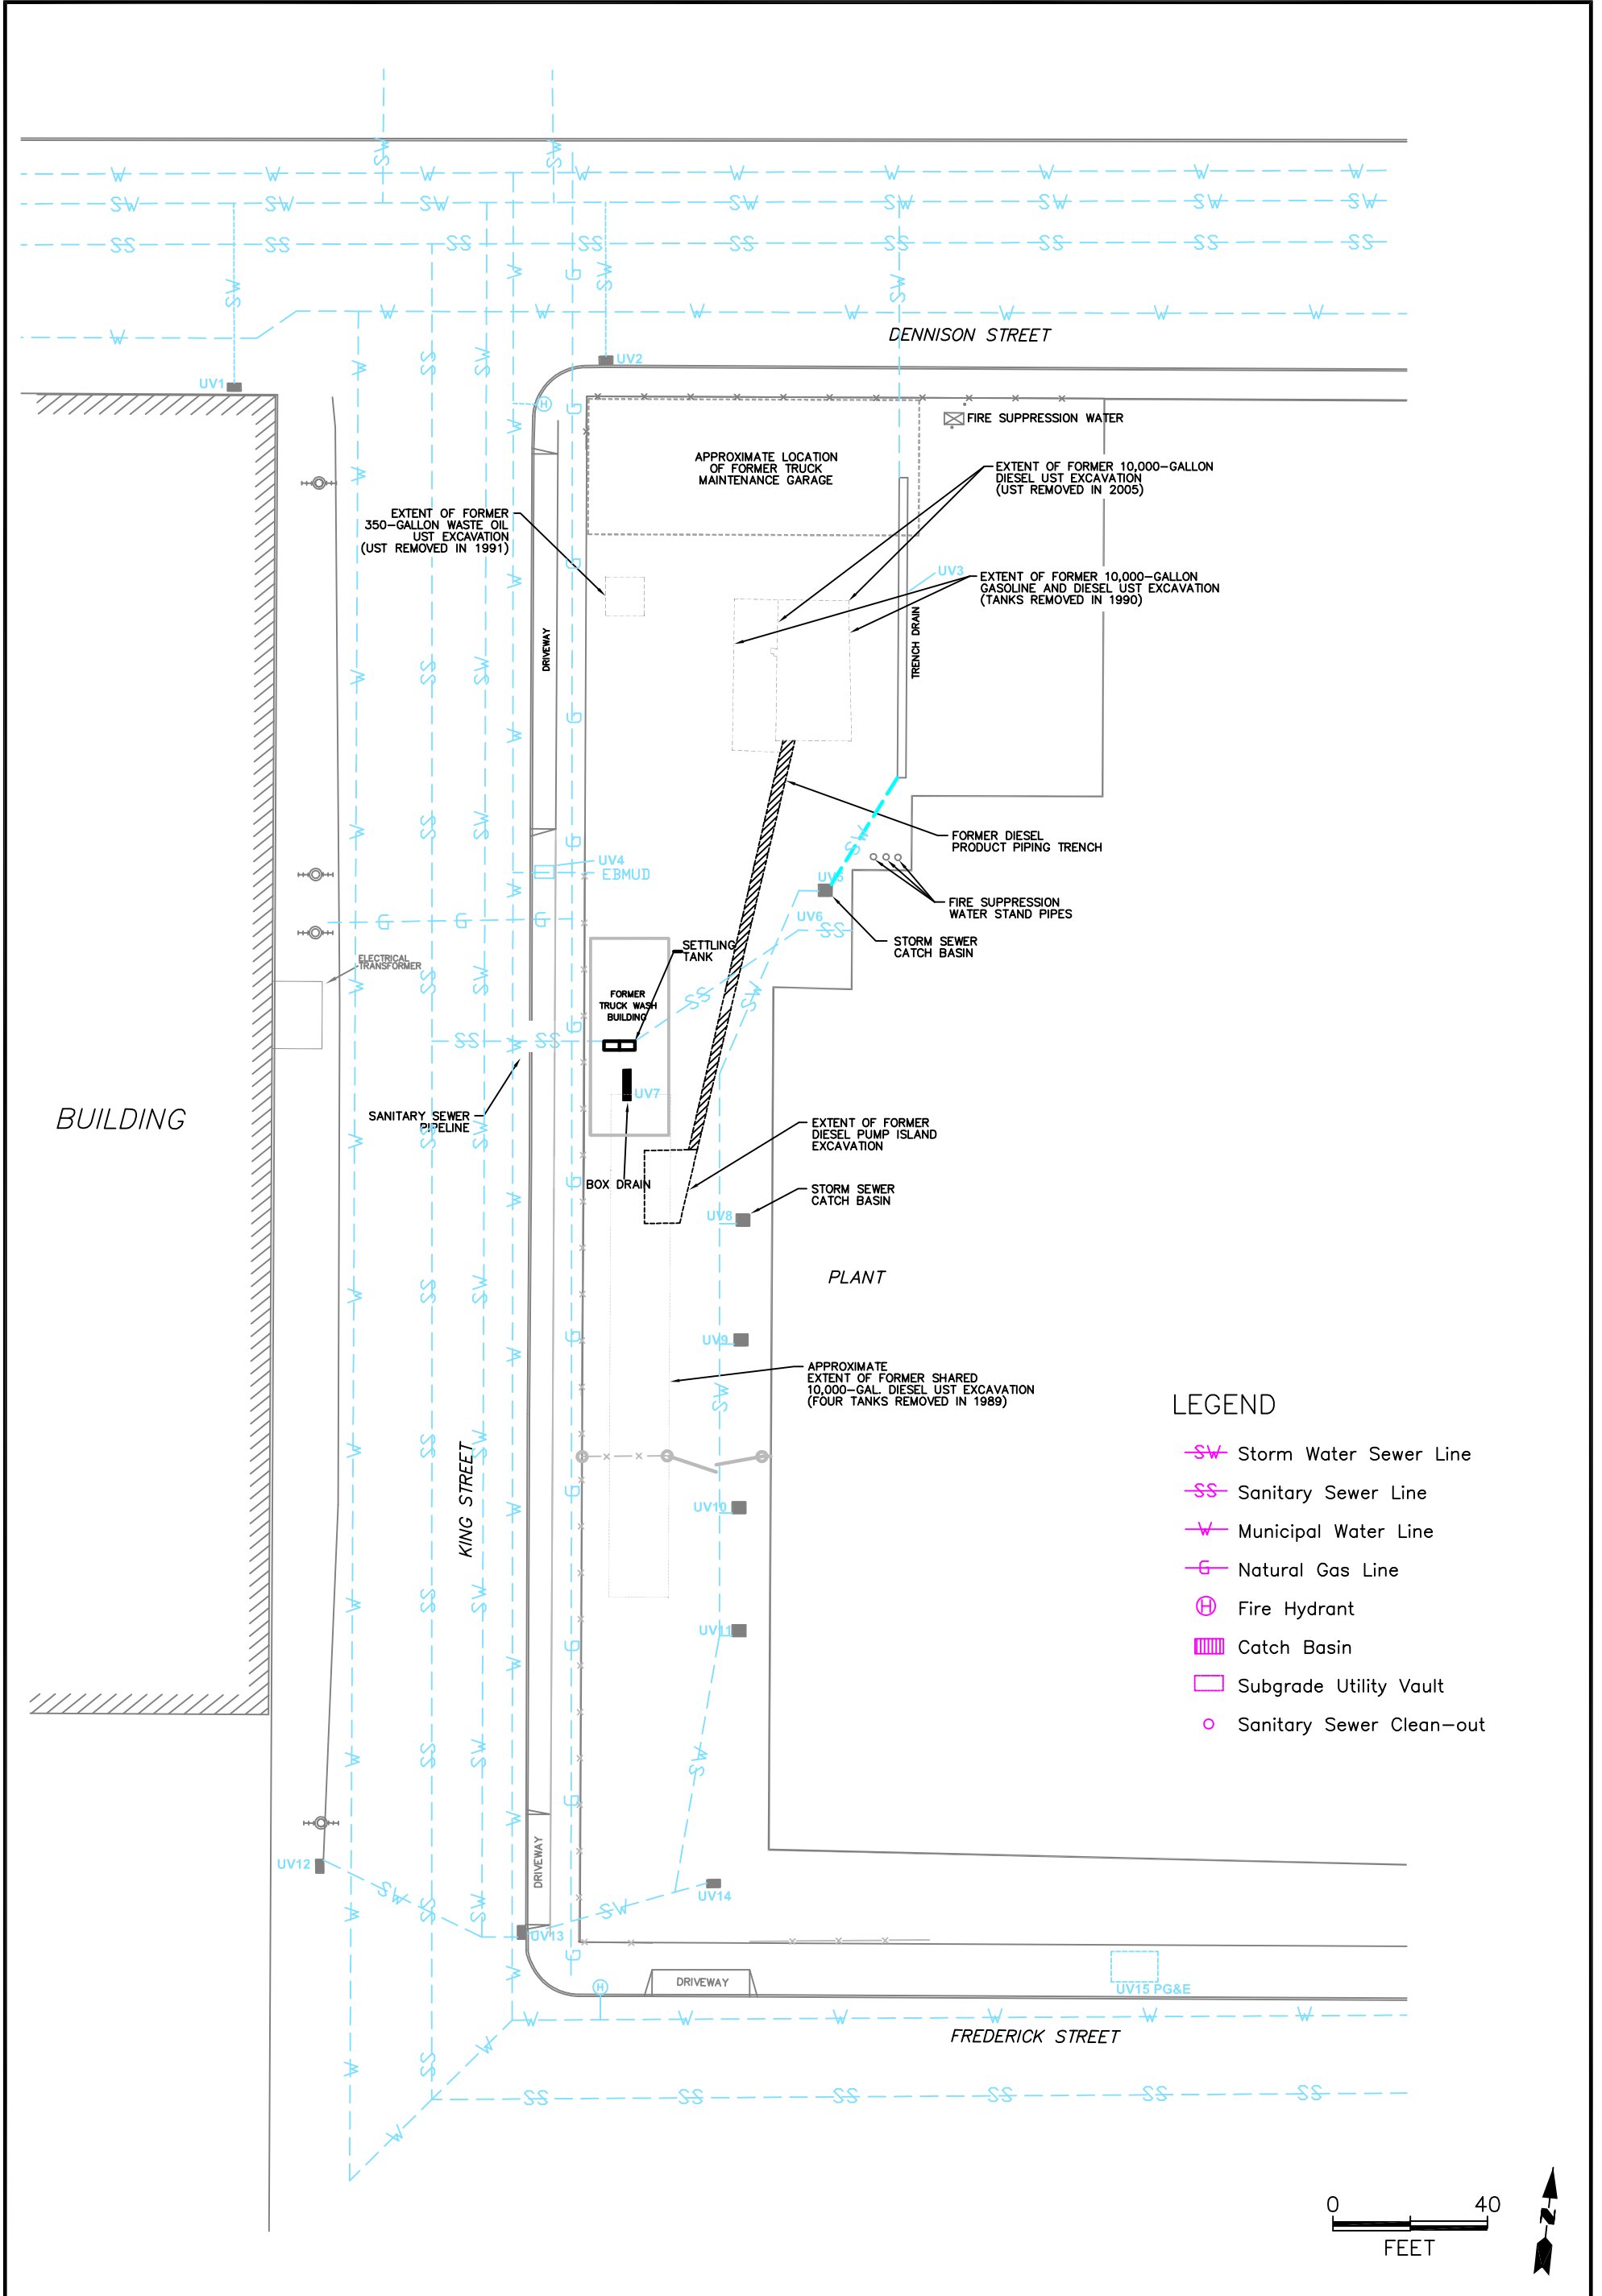
FIGURE 1

TITLE:
 SITE MAP SHOWING SUBSURFACE UTILITIES
 PRIOR TO SOURCE AREA REMOVAL

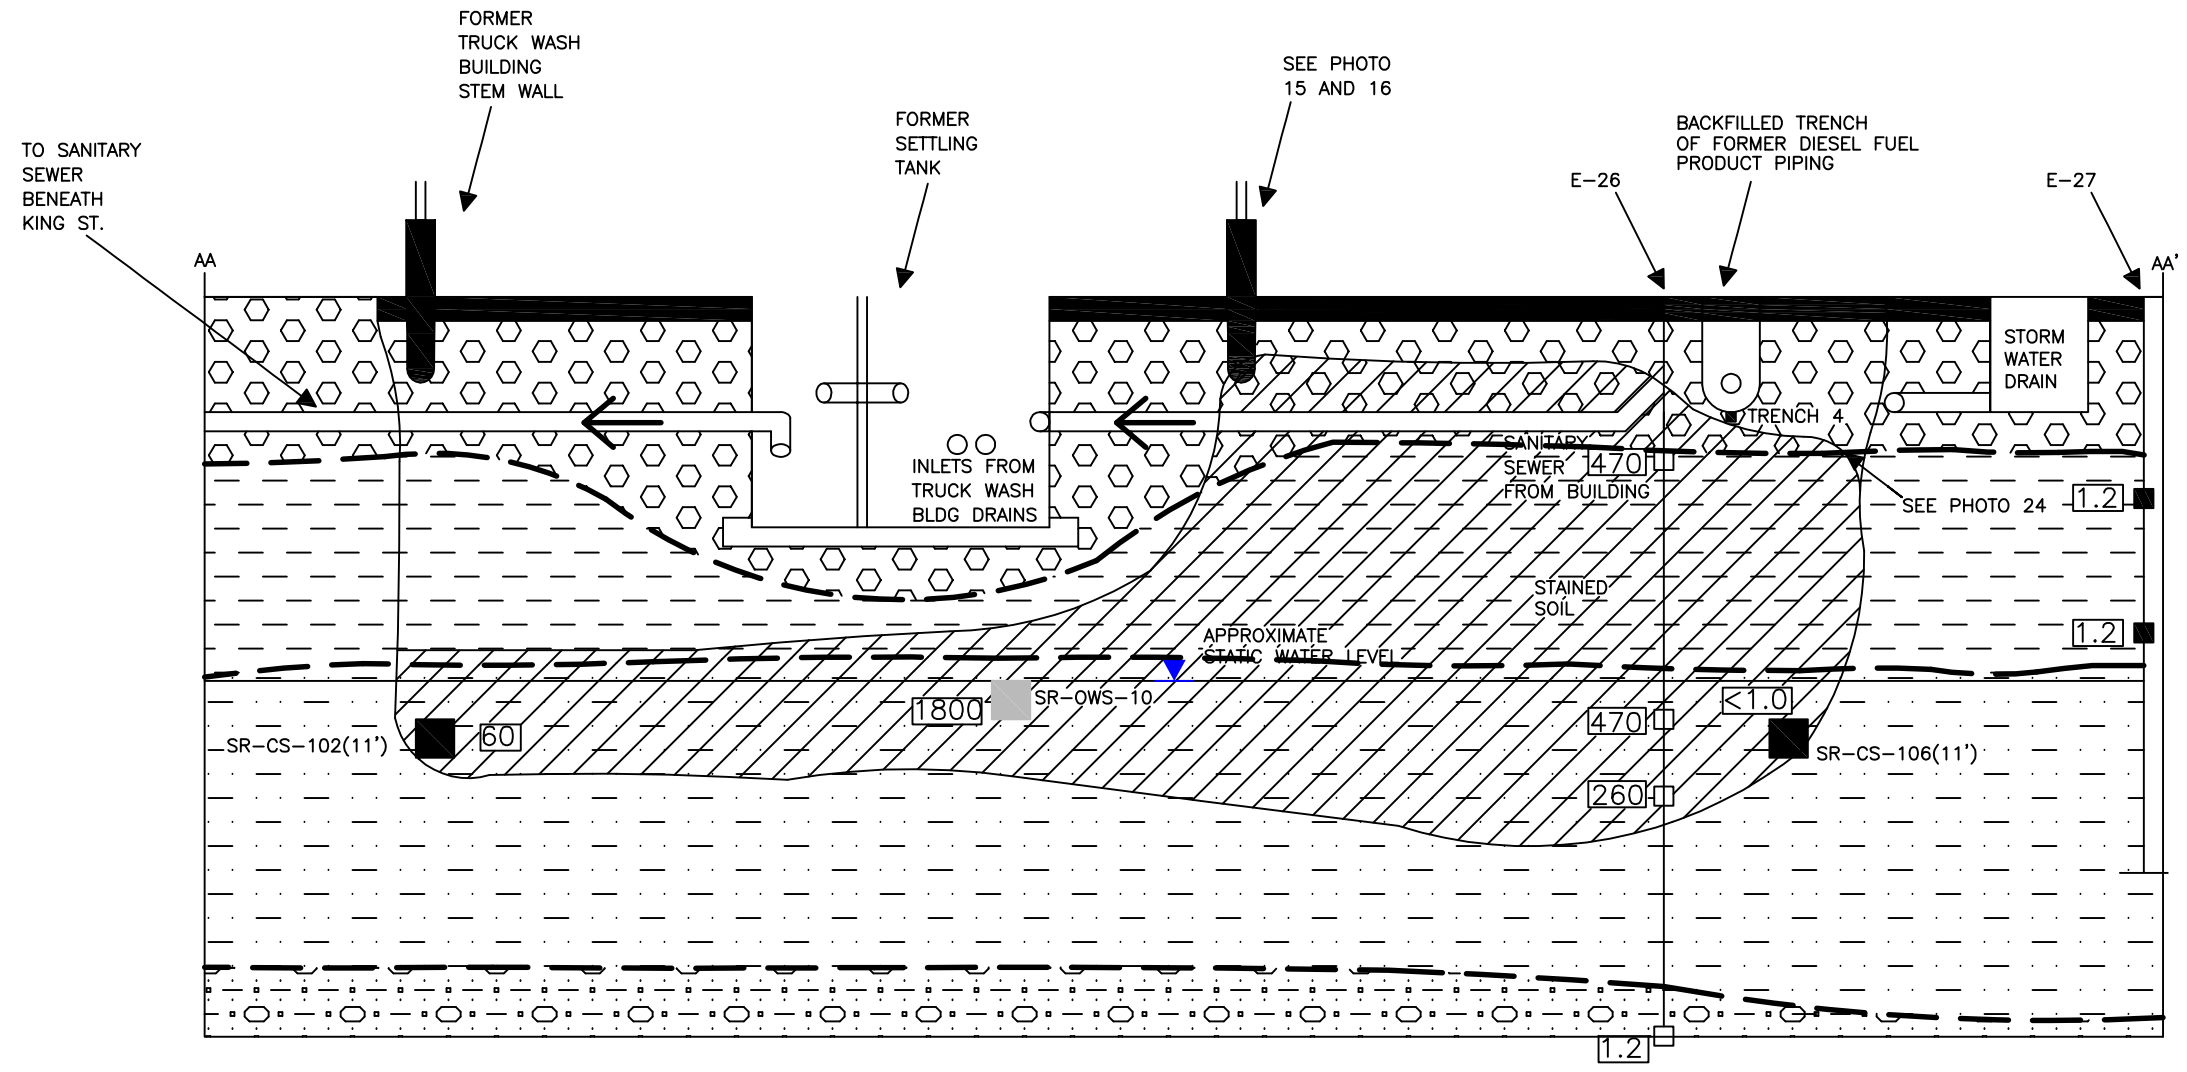
PROJECT NO.: 62402797
 EARTHGRAINS
 OAKLAND, CALIFORNIA
 FIGURE 4

The sanitary sewer line connecting the Bakery Building to the former Truck Wash Building was removed. No significant staining was observed beneath this sewer pipe. The area beneath the former diesel UST pipe chase was then excavated. The piping in the area had been removed and the pipe chase appeared to be over-excavated to a depth of approximately 4 feet bgs. The excavation was backfilled with sand. No staining was observed in this former excavation. Staining was observed along the sides of the pipe chase between the building stem wall or footing and the former delivery piping (Photos 23 and 24). The extent of the final excavation is shown on **Figure 4**. Cross-Sections of the excavation are presented on **Figures 5, 6, and 7**.

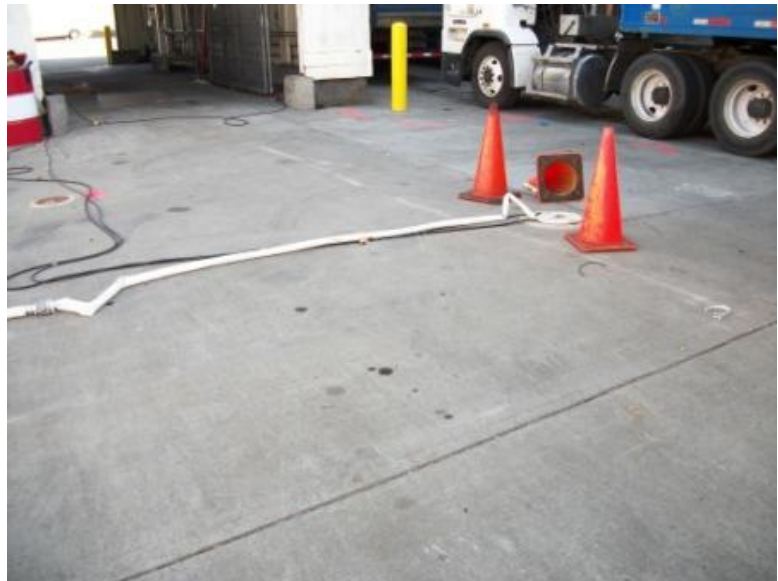
Photo Number: 1

Description: New, larger diameter de-watering well installed in source excavation to replace DW-1.

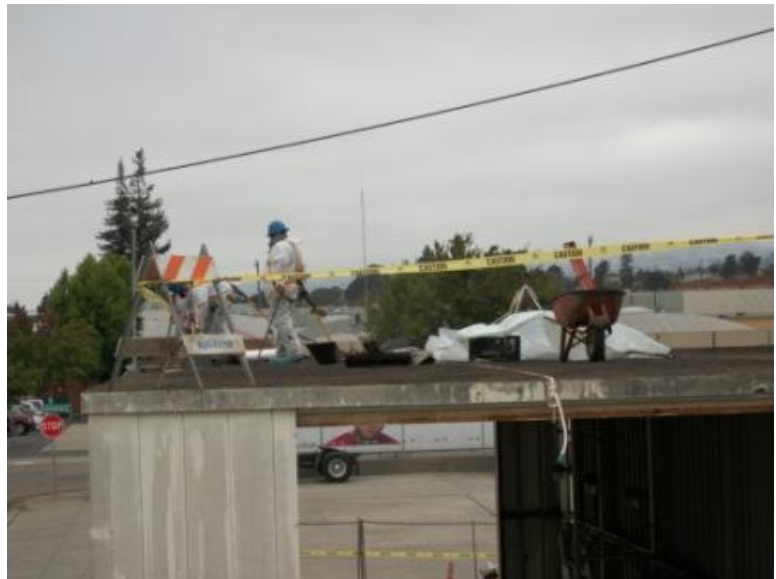
Photo Number: 3

Description: Asbestos-containing roofing materials on the Truck Wash Building including mastic, felt, and membrane.

An asbestos material survey was required by California law and the City of Oakland prior to demolition or dismantling the Truck Wash Building. Millennium Environmental services of Pleasant Hill, California performed an asbestos survey on September 10, 2010. The survey found asbestos containing material in the roofing mastic, moisture barrier, and foam core. Bluewater Environmental Services Inc. of San Leandro, California was contracted for asbestos abatement. Asbestos abatement activities were completed on October 4, 2010 (Photos 3 and 4). The Asbestos Survey Report, Bluewater's abatement plan, and personnel certifications, as well as a certificate of completion are presented in **Appendix D**.

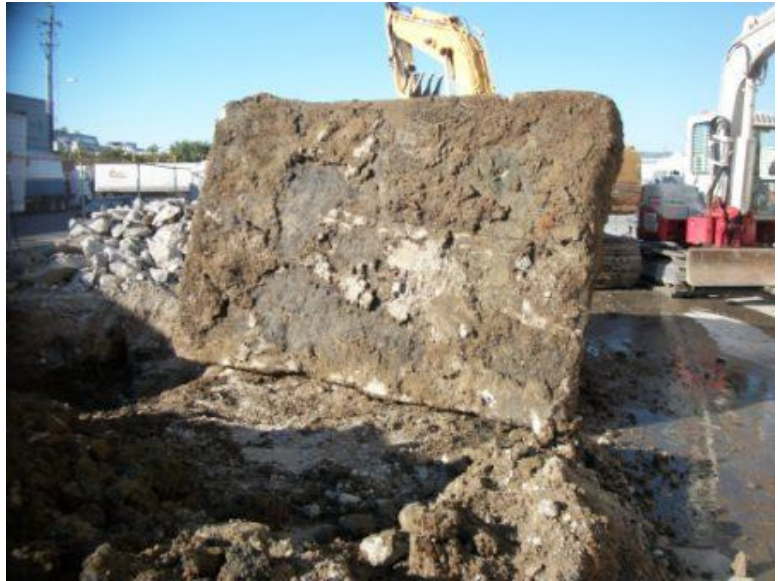
Photo Number: 13

After the reinforced concrete floor was removed (Photo 10), the settling tank was removed in one piece. The piping connecting the Bakery Building to the settling tank was inspected and no staining from oil was observed beneath the pipe (Photo 11). The structure was removed by the excavator and inspected for signs of a release. No evidence of a release from this concrete structure was noted (Photos 12 and 13).

Description: Excavation soil beneath clarifier/settling tank. Indicating no staining or evidence of a release. Stained soil visible at top of photo is from the surface along east footer wall of former Truck Wash Building.

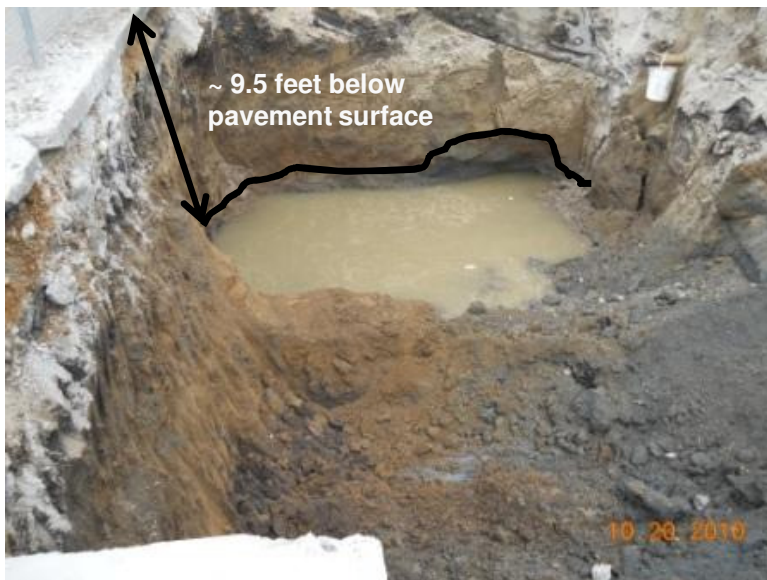
Photo Number: 15

Description: Excavation sidewall beneath east footer wall of former Truck Wash Building. Soil staining visible at ~ 3 feet below pavement surface.

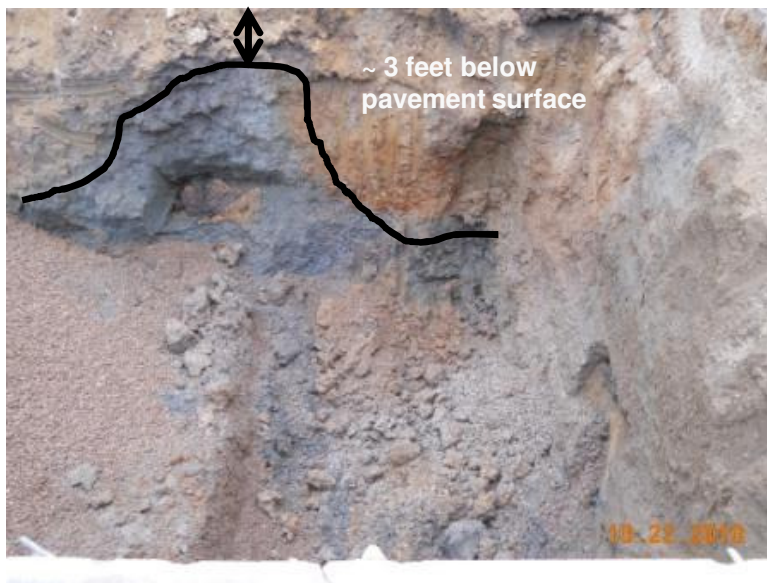
Photo Number: 17

Description: Source area excavation beneath south end of former Truck Wash Building.

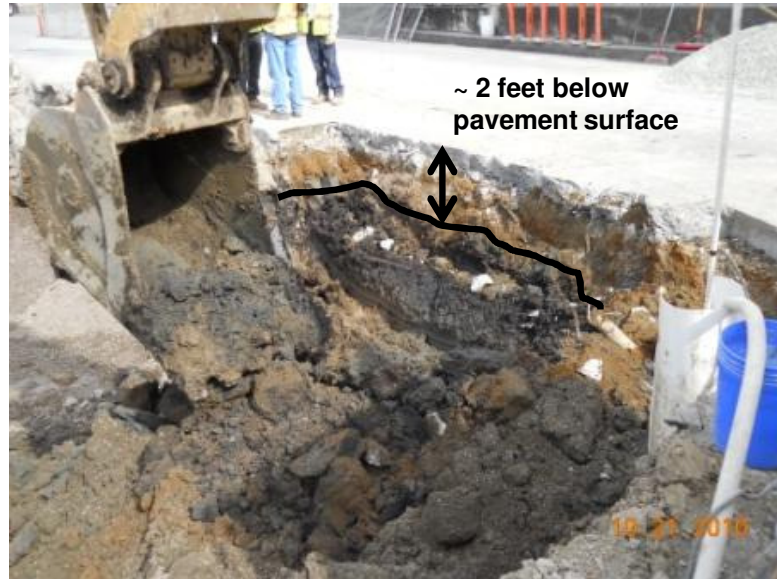
Photo Number: 19

The area south and outside the former Truck Wash Building was excavated to a depth of approximately 16 feet bgs because of observed staining. Impacted soil was encountered at approximately 2 feet bgs near the former diesel pump island (Photos 19, 20, 21, and 22). A thick, 2 to 3 foot deep, slab of concrete was encountered beneath the dispenser island. The excavation of this area was completed after the original dewatering well DW-1 and the replacement dewatering well were removed.

Description: Soil staining visible in source excavation area beneath the former diesel pump island.

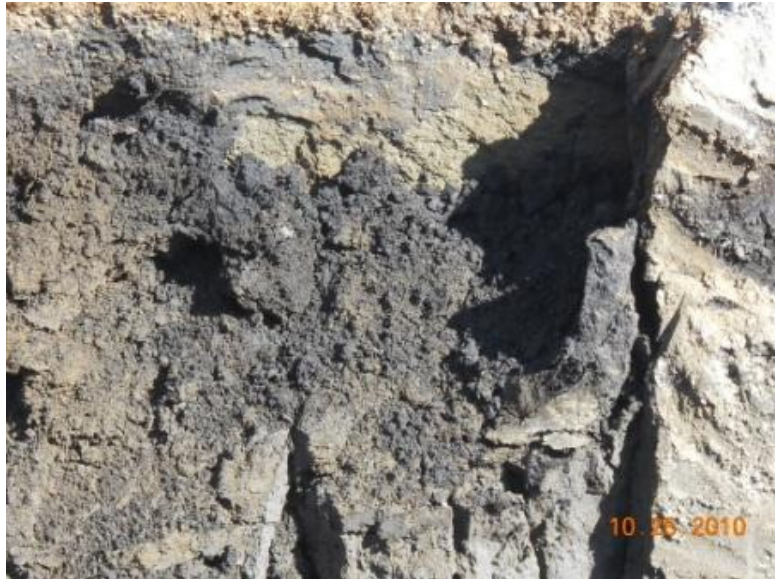
Photo Number: 21

Description: Source excavation area with impacted soil on east side of the former diesel pump island.

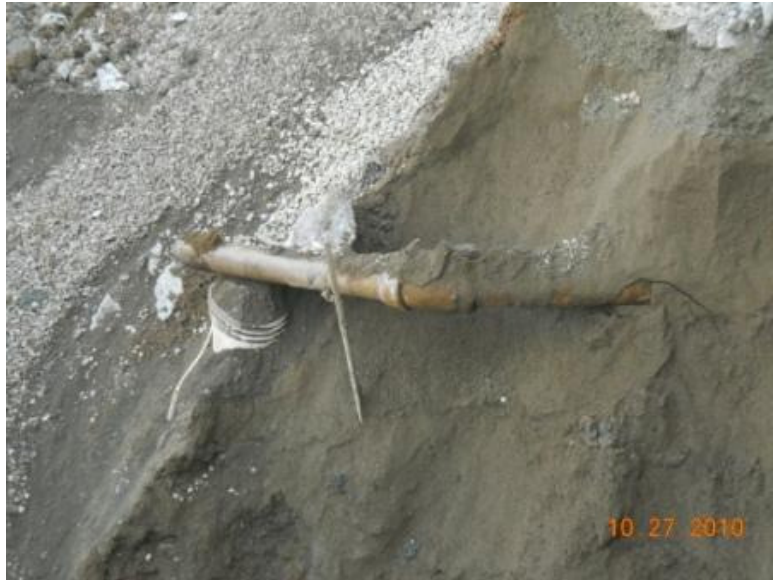
Photo Number: 23

Description: Sand backfill of the former diesel UST piping chase with heaviest impact near the footer wall of the former Truck Wash Building.

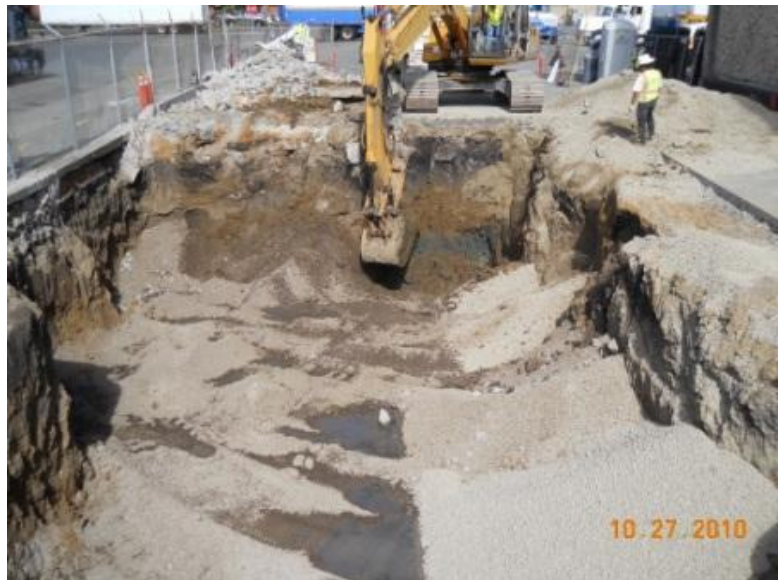
Photo Number: 25

Description: Placement of clean, aggregate base course to backfill source excavation.

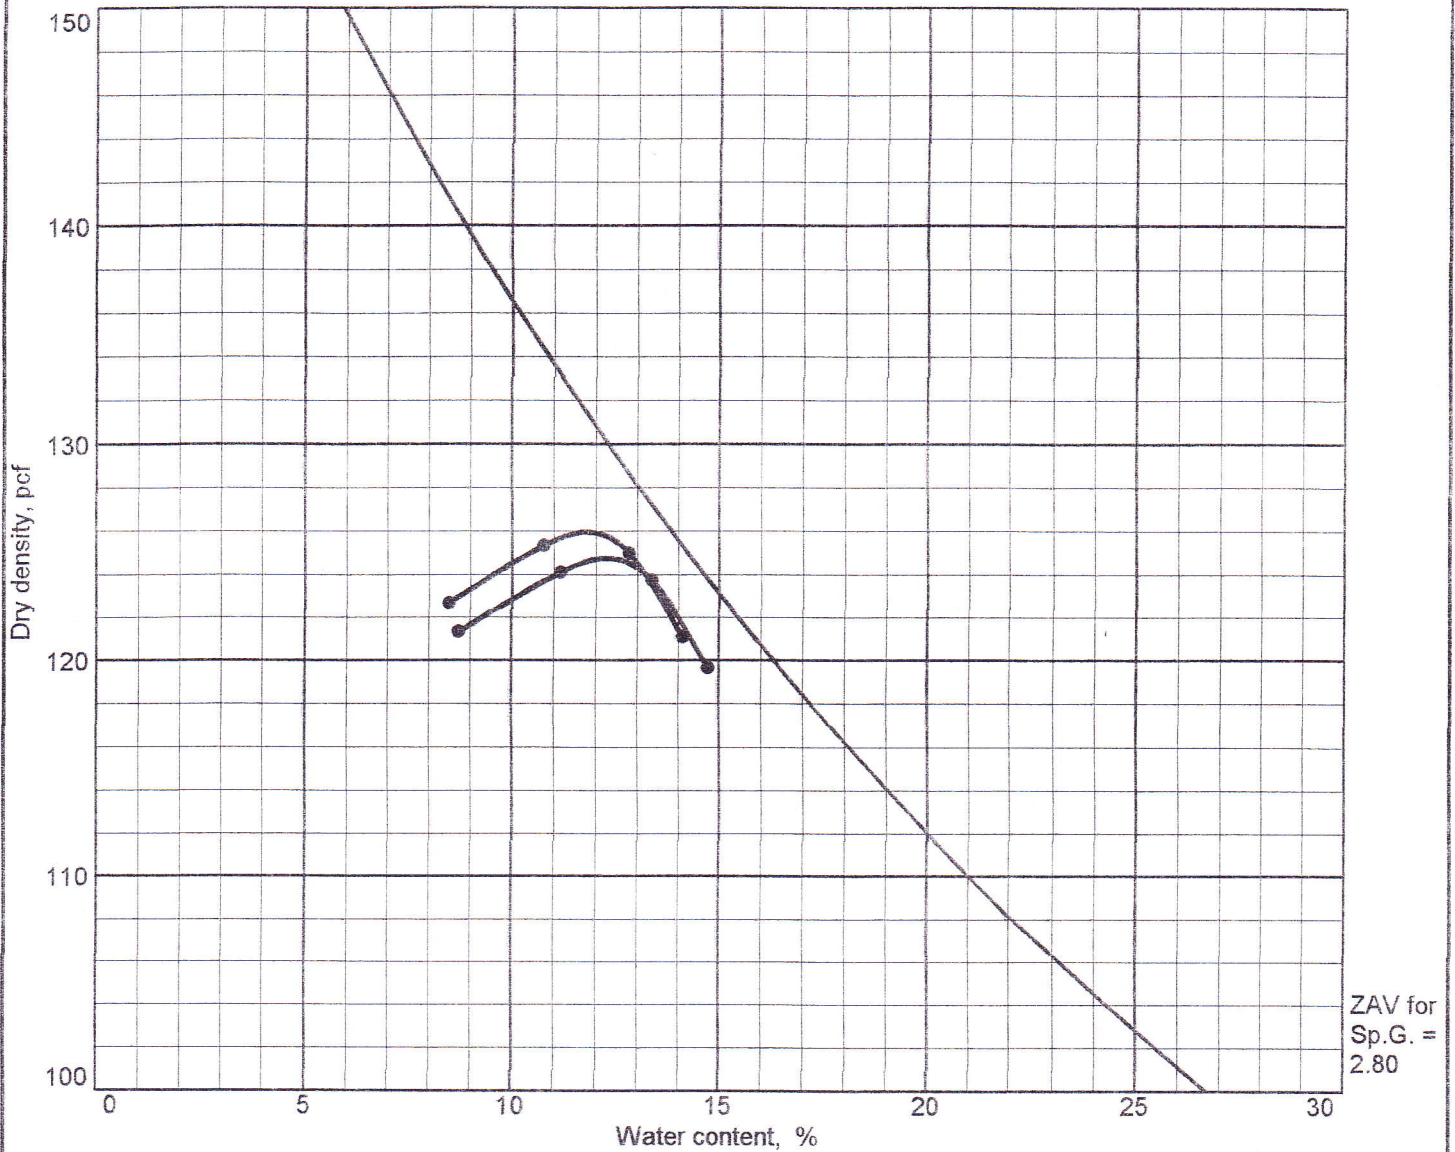
COMPACTION TEST REPORT

Test specification: ASTM D 1557-02e1 Procedure C Modified

Elev/ Depth	Classification		Nat. Moist.	Sp.G.	LL	PI	% > 3/4 in.	% < No.200
	USCS	AASHTO						
							6.0
