**From:** [Liles, Joe](#)  
**To:** [Detterman, Karel, Env. Health](#)  
**Cc:** "[Kaye, Bruce](#)"; [Haux, Michael](#); [Roe, Dilan, Env. Health](#)  
**Subject:** RE: Former Sears Retail Center - 2633 Telegraph Avenue - Table 1 Well Status and Figure 2 Plot Plan  
**Date:** Friday, June 27, 2014 2:13:43 PM  
**Attachments:** [image002.png](#)  
[Table 1 Well Status.pdf](#)  
[Fig 2 Plot Plan Aerial.pdf](#)

**Table 1**  
**Groundwater Monitoring Well Conditions**  
**Former Sears Retail Center #1058A**  
**Oakland, California**

<b>PLOT PLAN</b>	
Project: FORMER SEARS RETAIL CENTER #1058A 2633 TELEGRAPH AVE., OAKLAND, CA	
Project No.: 25363708	Figure 2
Date Wells Sampled: November 14, 2008

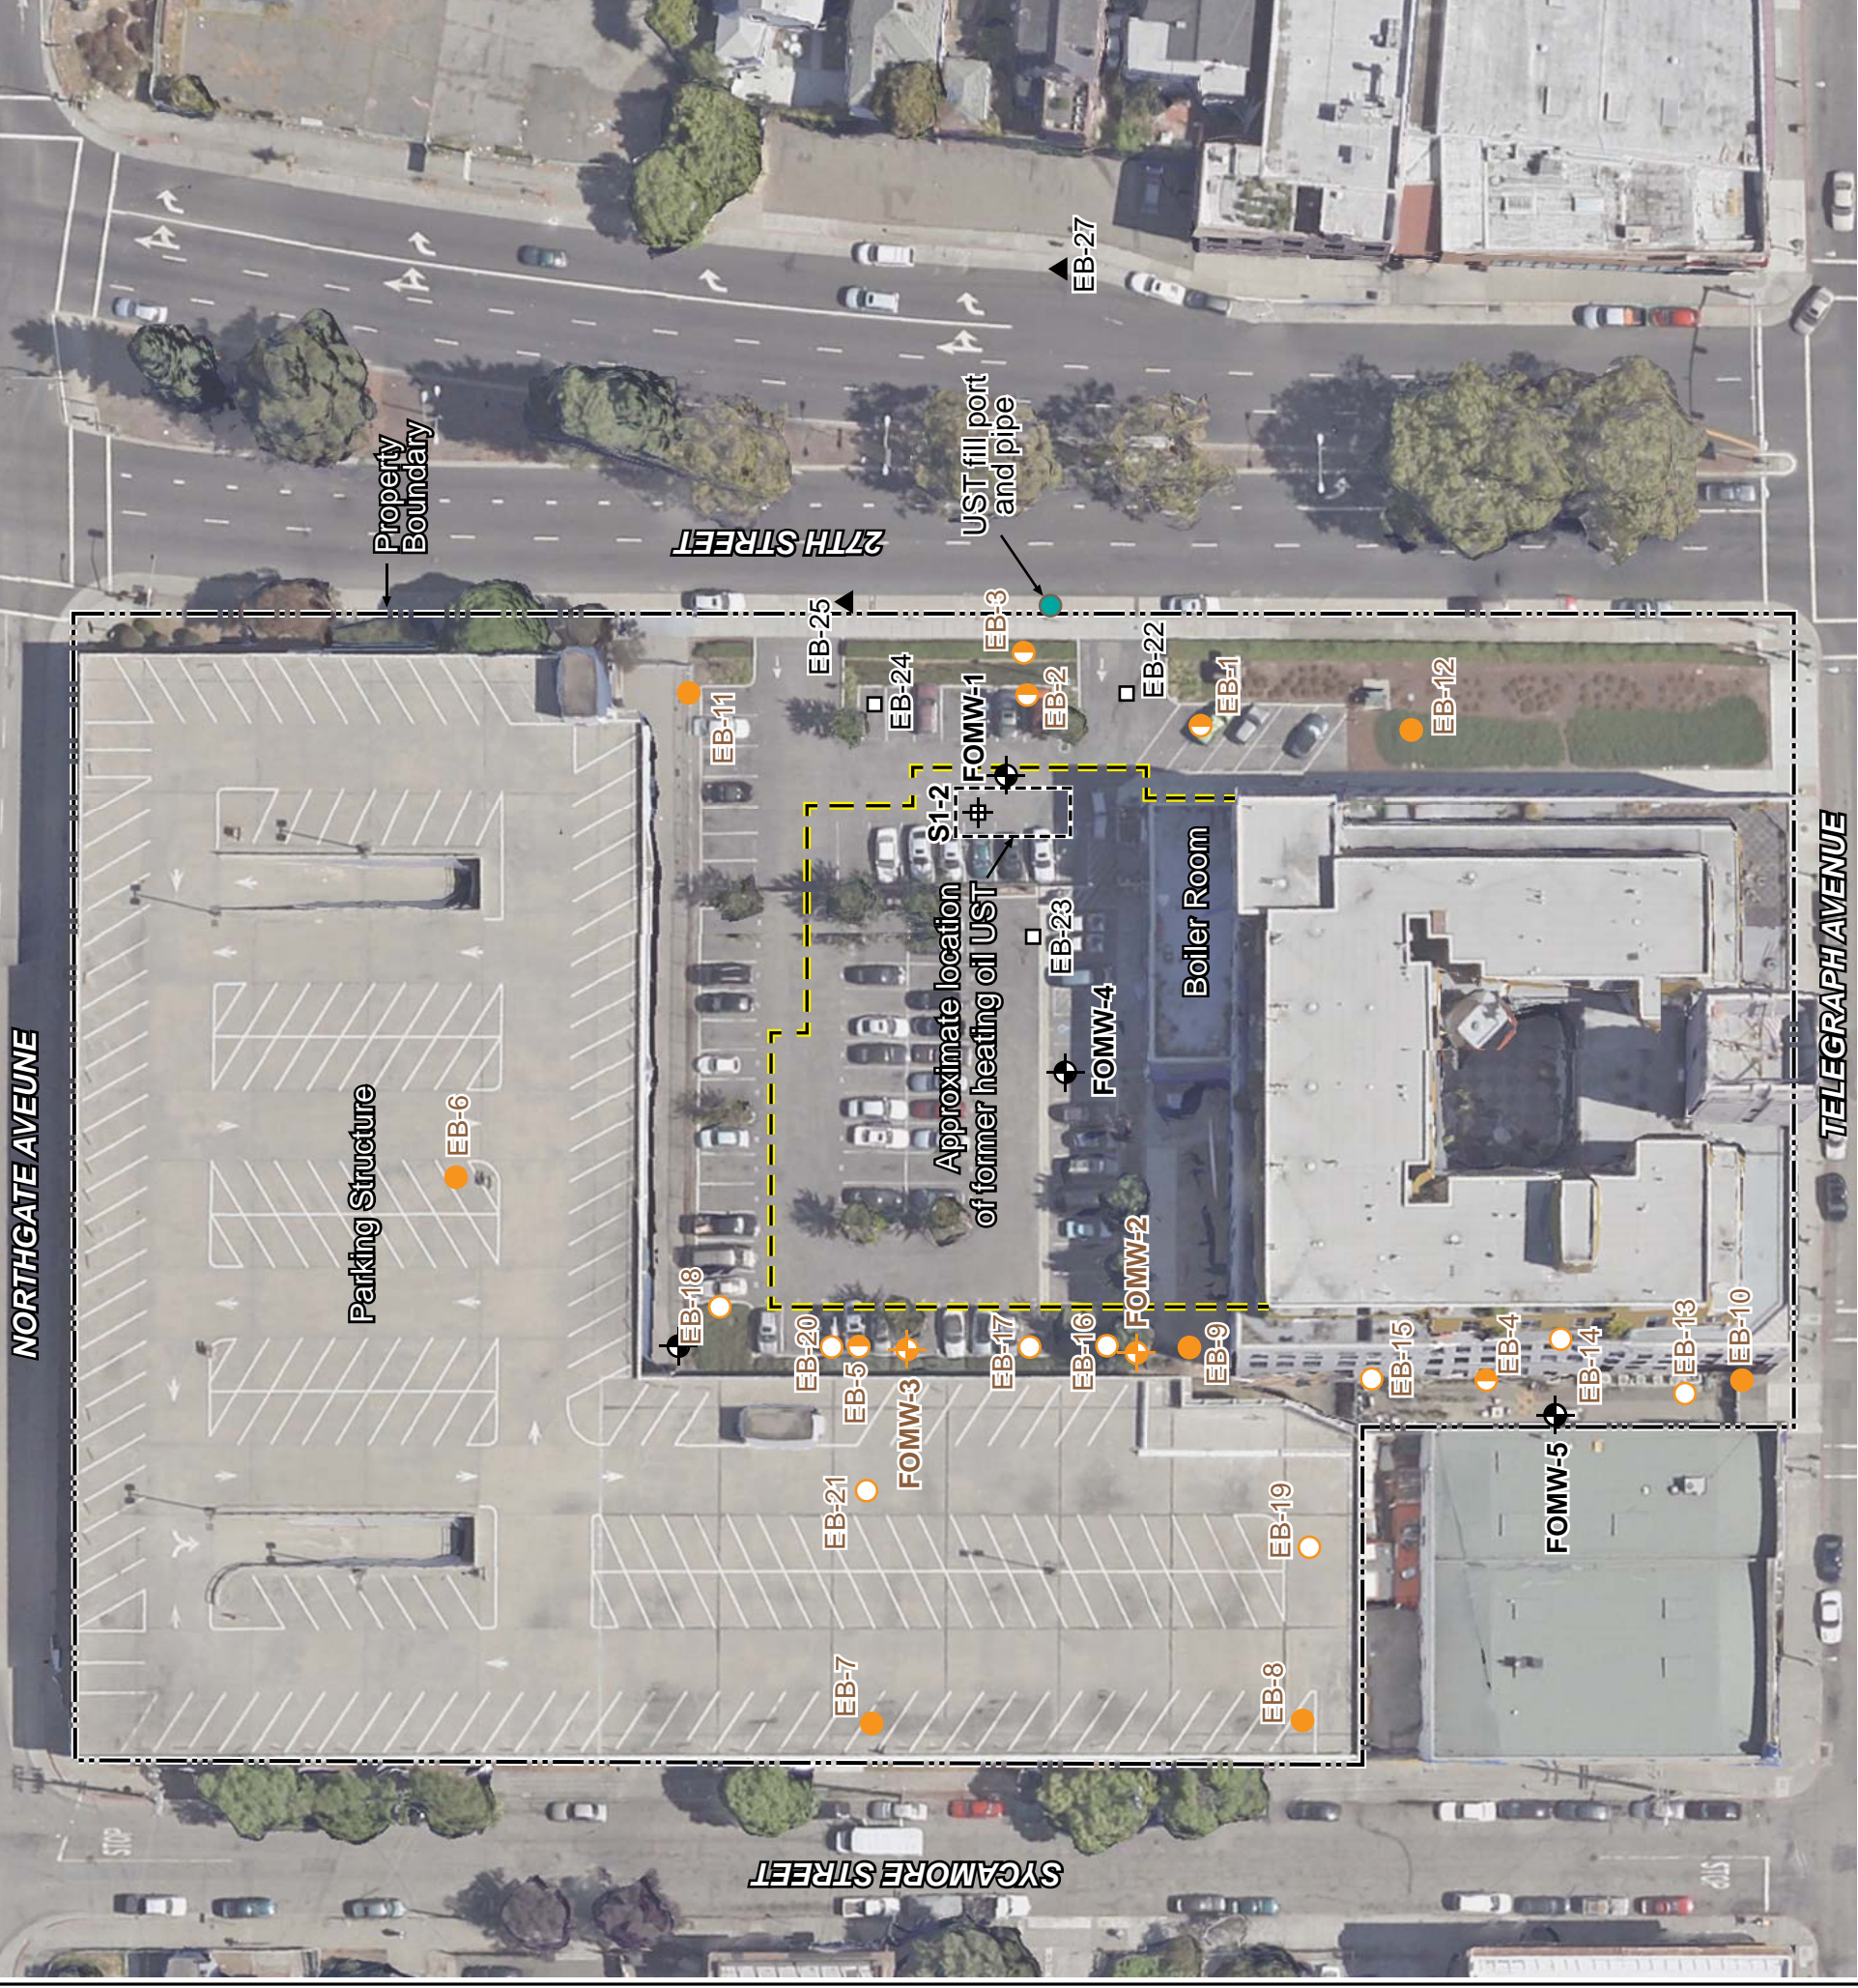
As requested, I have attached Table 1 (Groundwater Monitoring Well Conditions) that includes the current well status of the five monitoring wells, and Figure 2 (Plot Plan) that shows the former building footprint next to the current building. Please contact me if you have any comments or questions.

As discussed during our call late last year, you requested a revised figure for the former Sears Retail Center at 2633 Telegraph Ave. The attached figure shows the current building layout and location of the former heating oil UST, historical borings and current monitoring wells. Note the location of the former UST is 30 feet from the footprint of the existing building.
