**Re: Overview of Human Health Risk Assessment
Proposed Emeryville Village Center
Emeryville, California
(ENVIRON Project No. 03-7277A)**

Technical Overview: Human Health Risk Assessment for the Proposed Emeryville Village Center

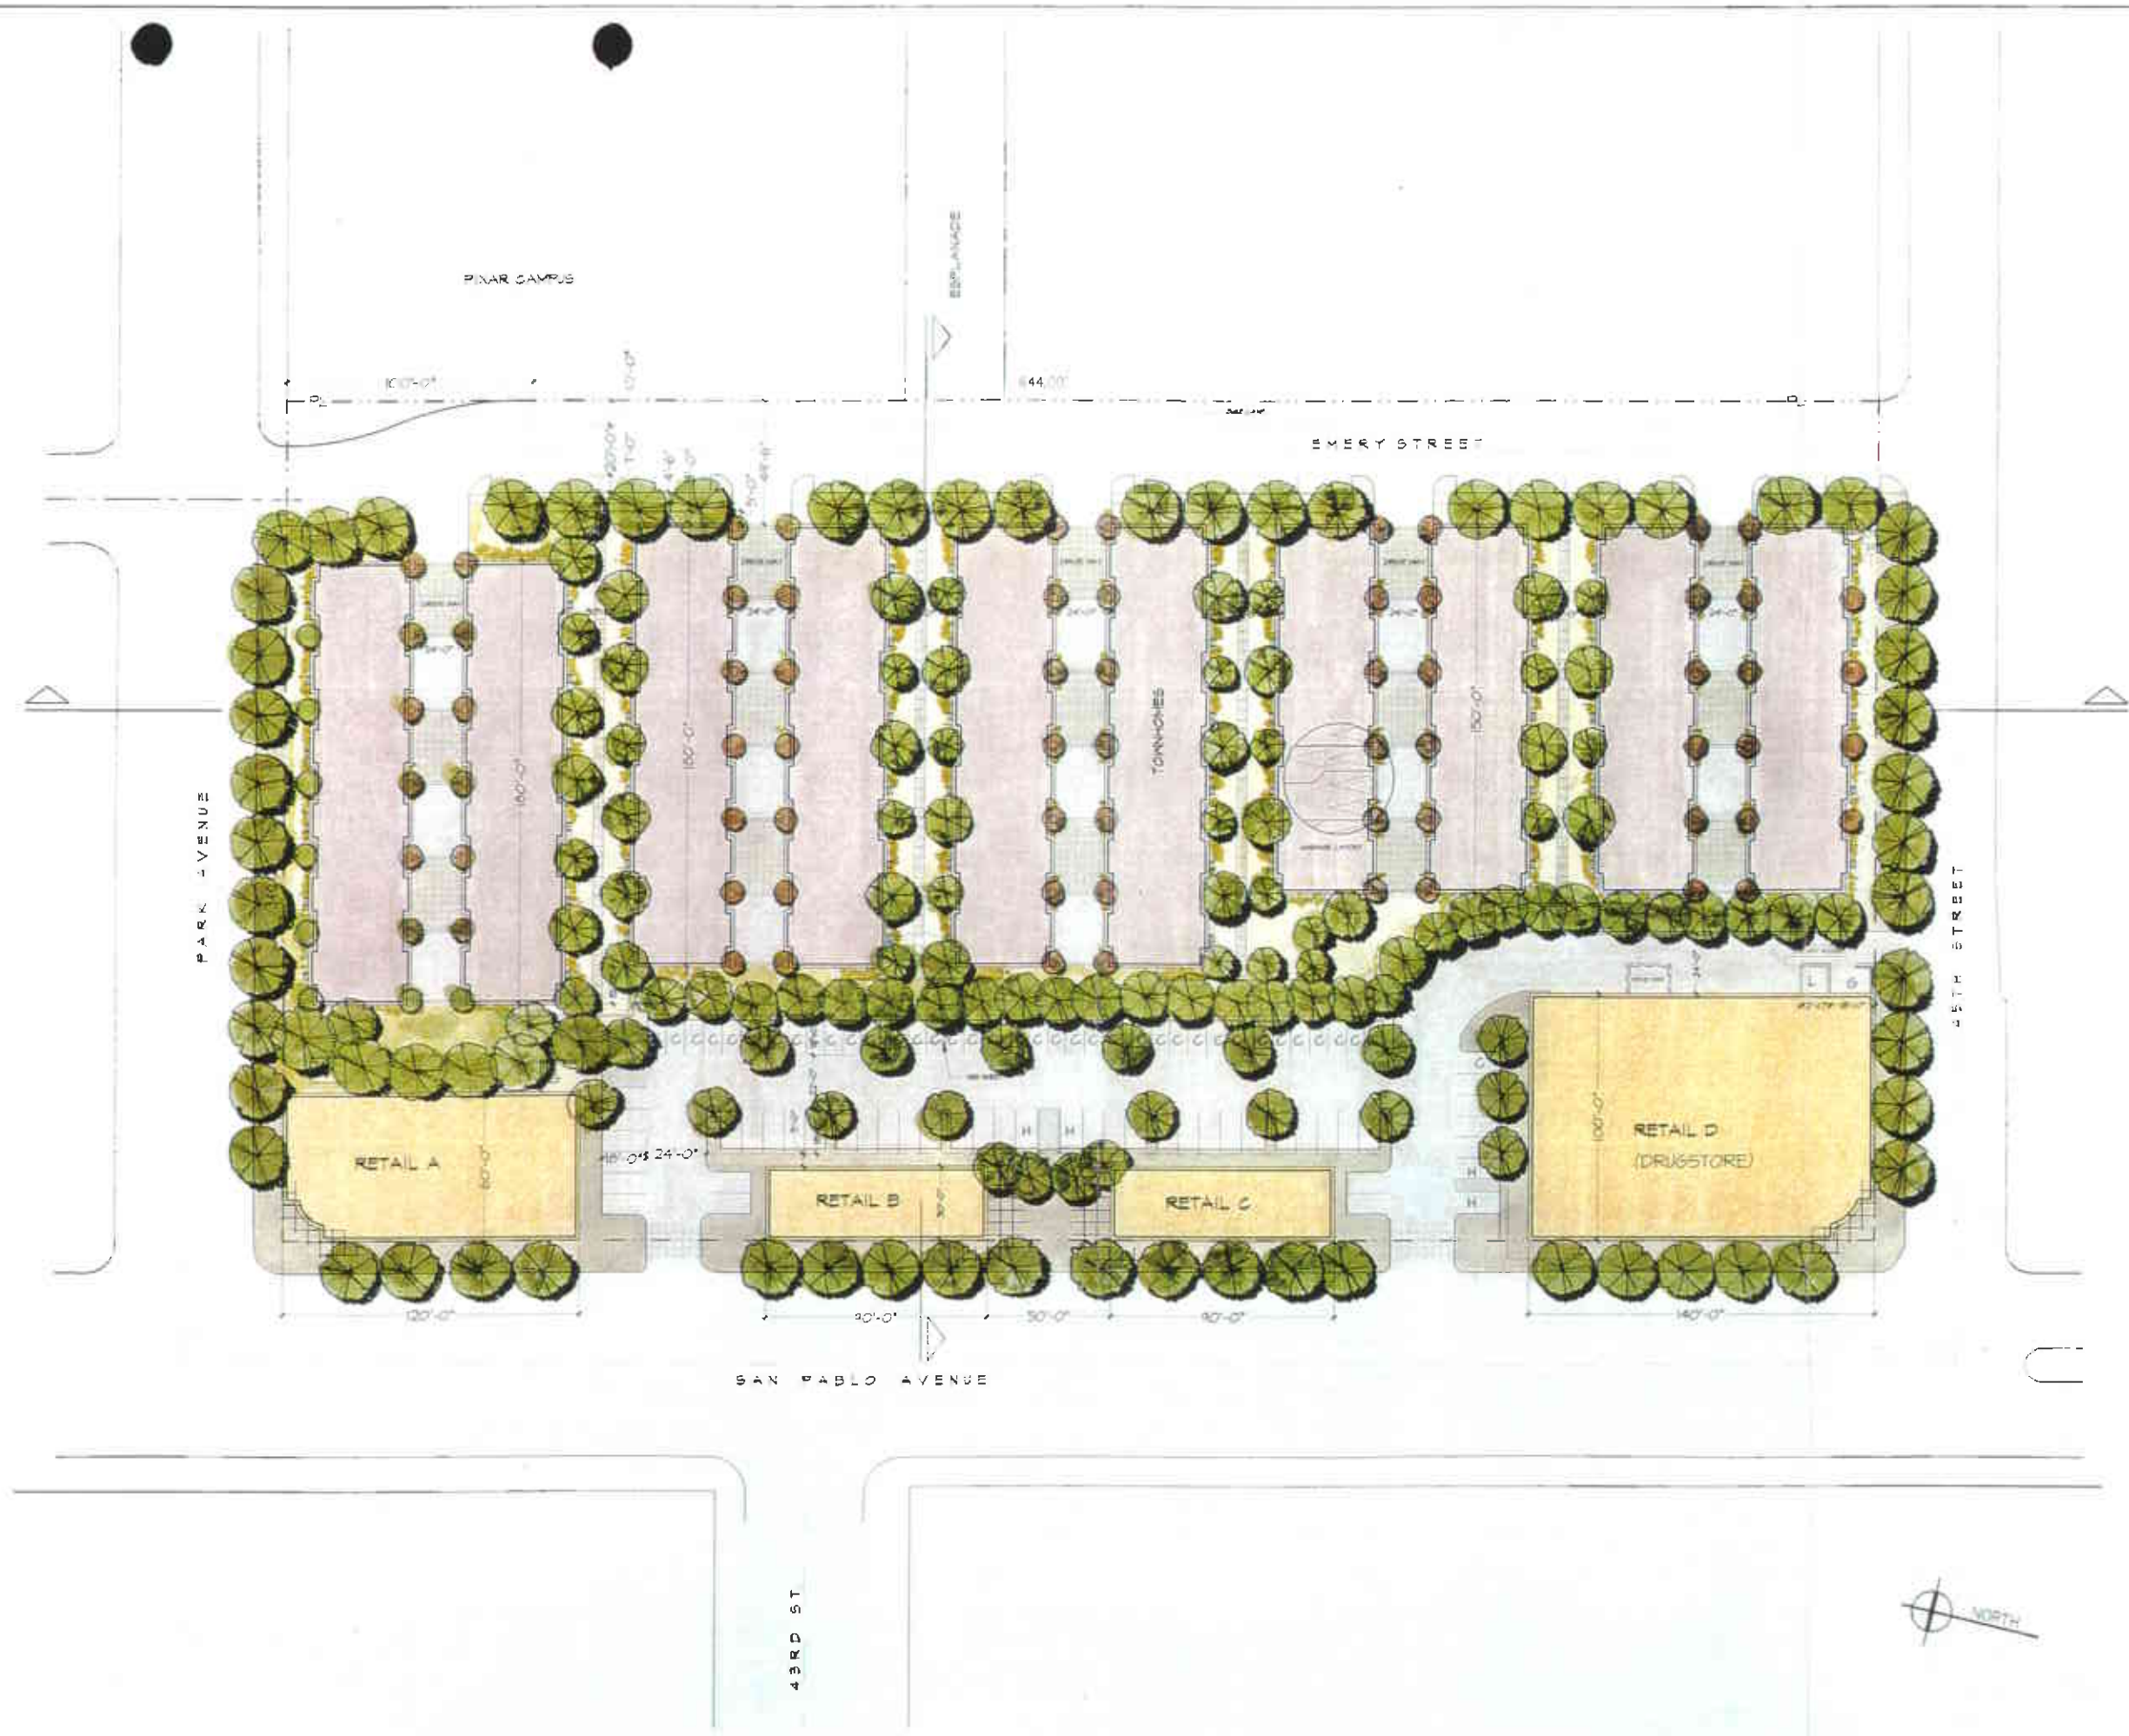
FIGURE
1A

CONCEPTUAL
SITE PLAN

- Junction of San Pablo Avenue, Emery Street, Park Avenue, & 45th Street (Emeryville, CA)
- Proposed Layout – 112 Townhouses (No Private Lawn Areas) Constructed Over Private 2-Car Garages, Communal Landscaped Areas, 4 Commercial Buildings, and Parking Areas (*Figures 1A, 1B, 1C, & 1D*)
- Former Occupants - Standard Brands Paints, New Century Beverage Company, Emeryville Fire Station, Mason's Lodge, Ho, Shin, Kentucky Fried Chicken (formerly ARCO) (*Figure 2*)

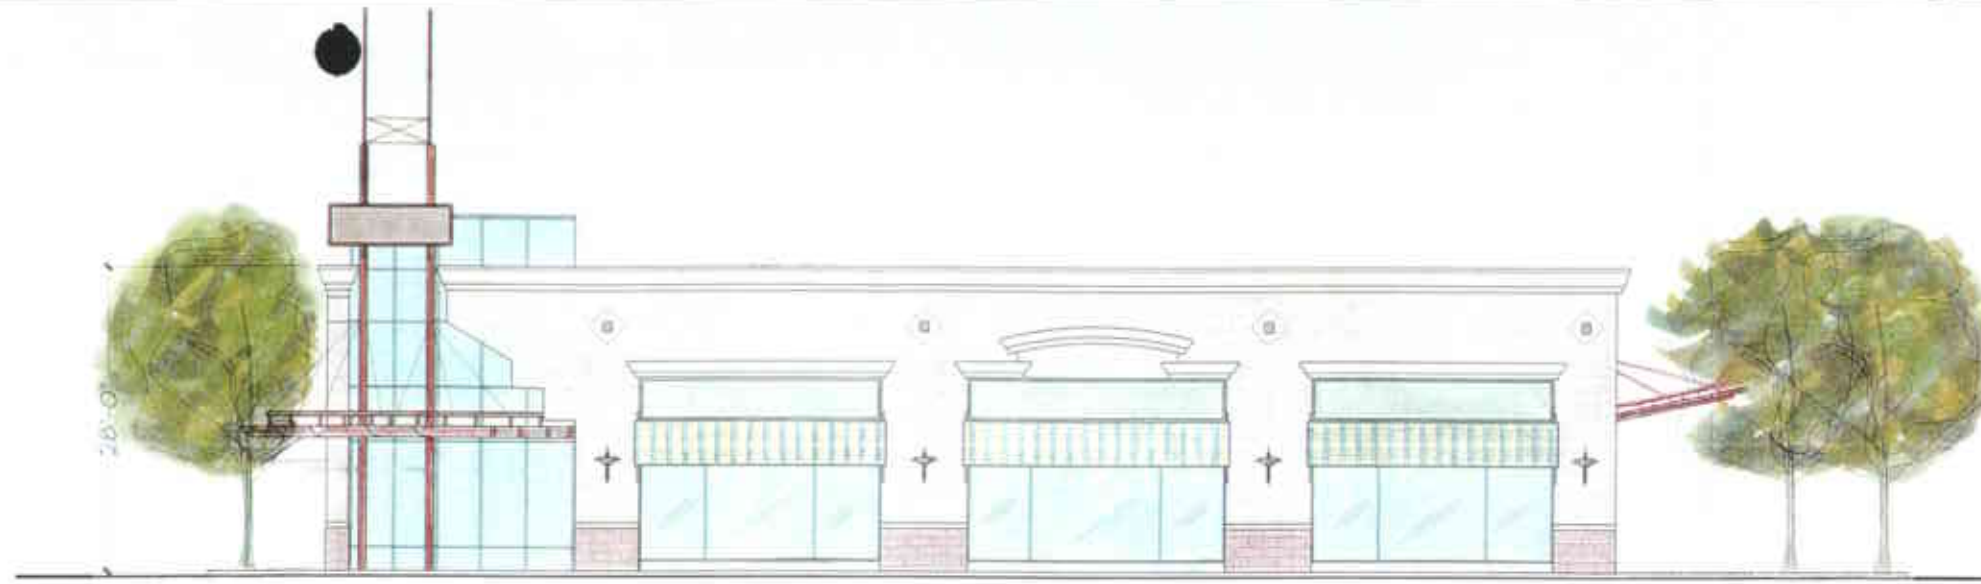
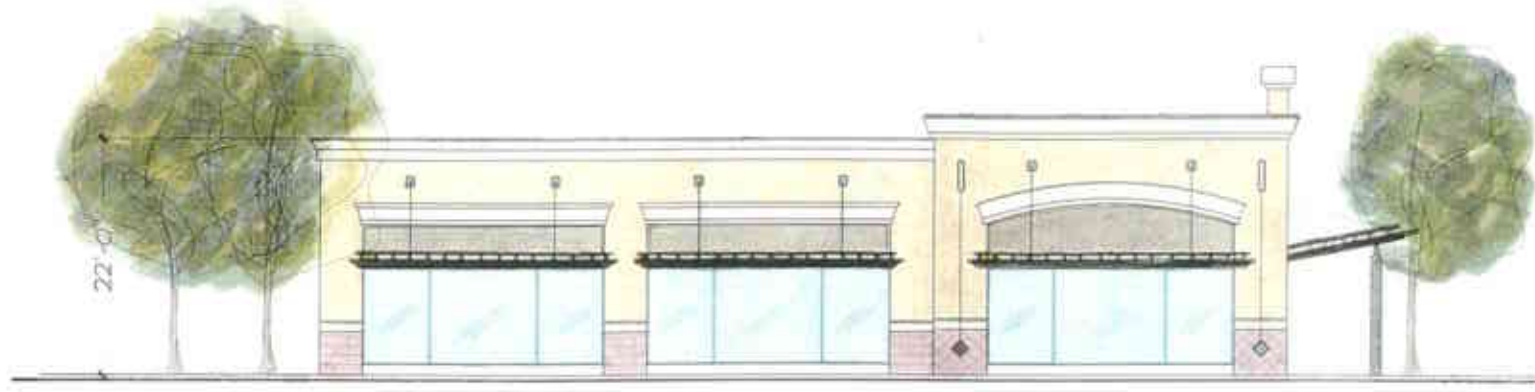
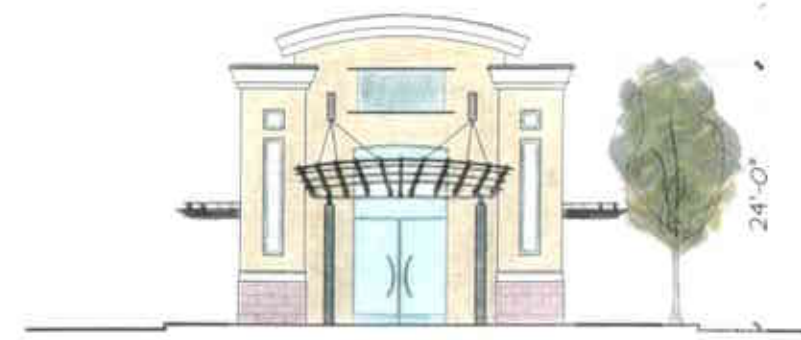
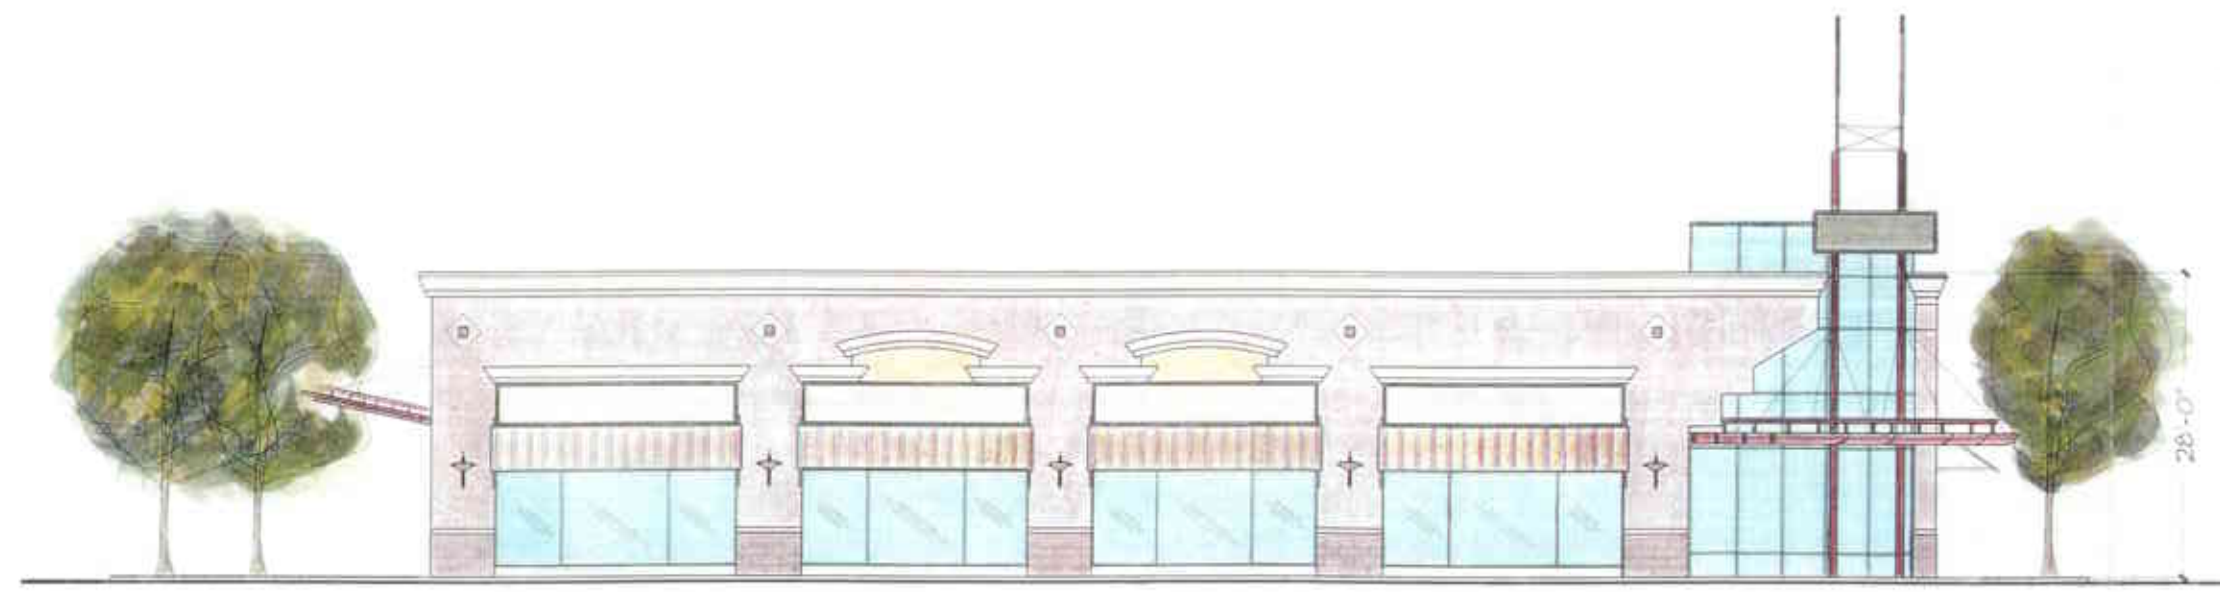
FIGURE 1B

RETAIL A- EAST ELEVATION

SHEET TITLE:
CONCEPTUAL RETAIL ELEVATIONS

RETAIL B- EAST ELEVATION

RETAIL B- NORTH ELEVATION

RETAIL D- EAST ELEVATION

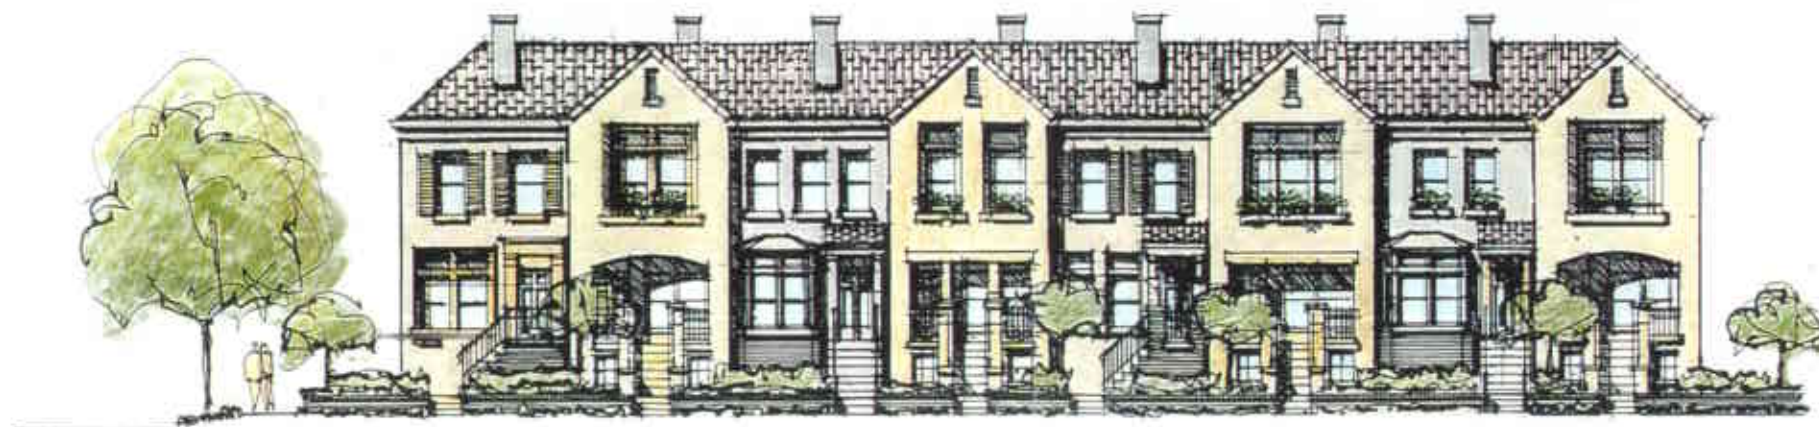
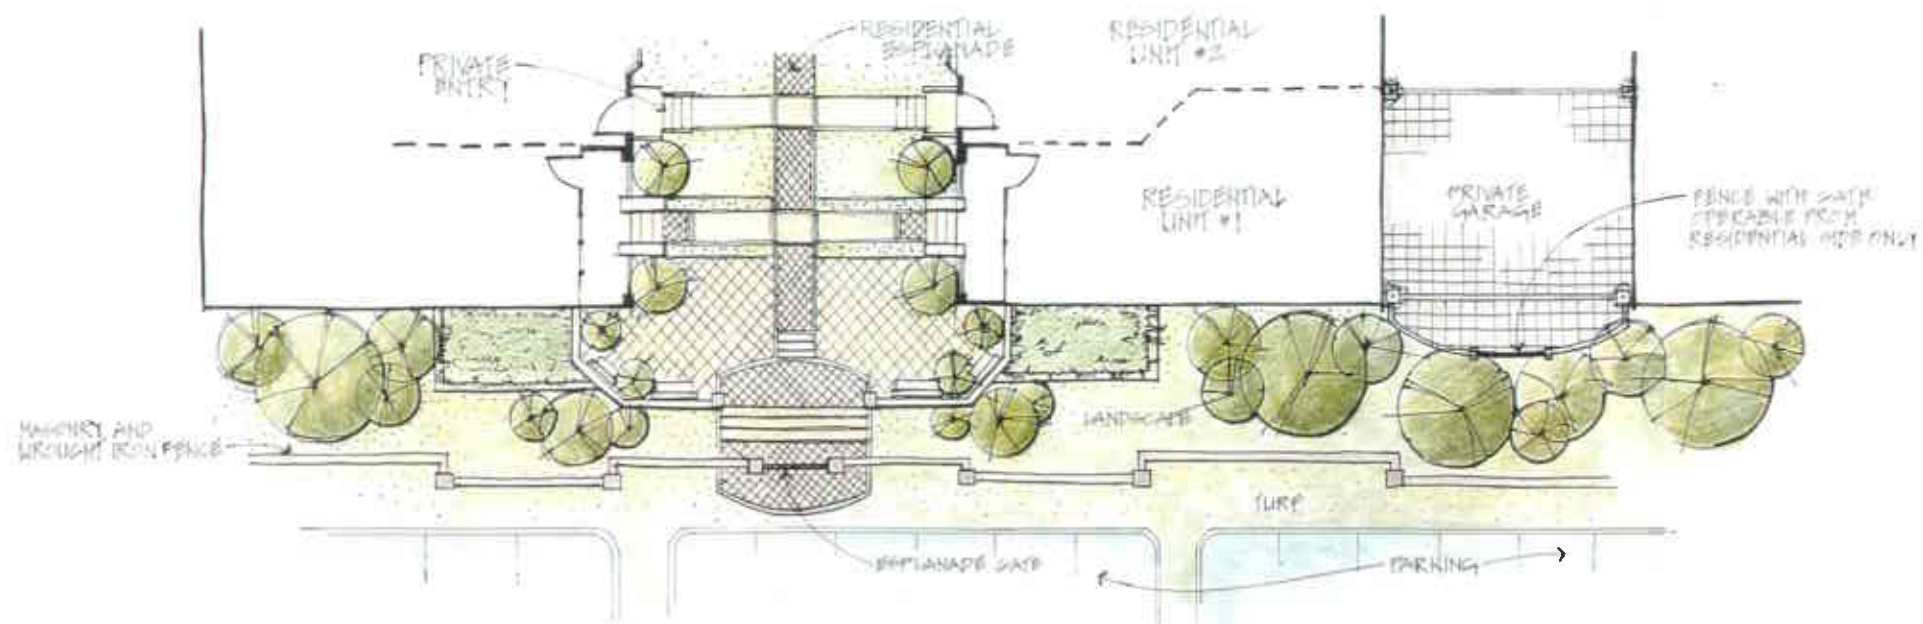
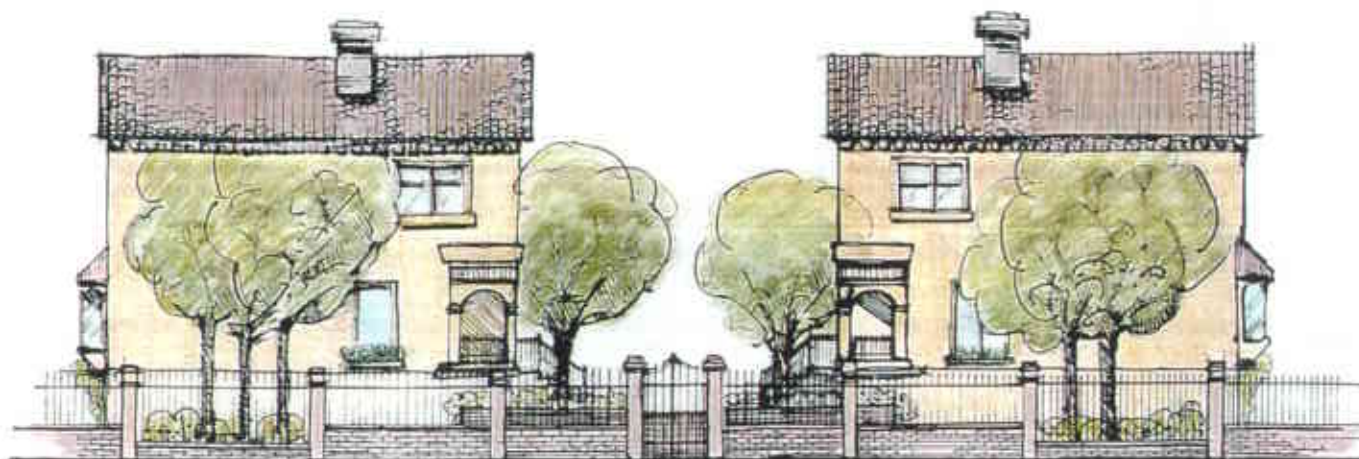
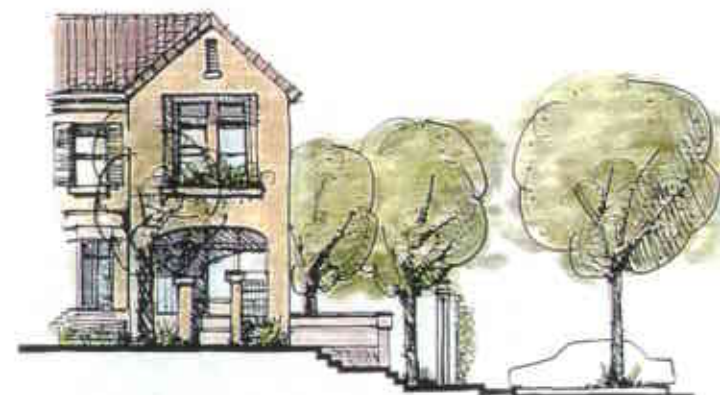
FIGURE
1C

TOWNHOME BUILDING ELEVATION

SITE DETAIL: PLAN

SITE DETAIL: ELEVATION

SITE DETAIL: SECTION

RESIDENTIAL
TOWNHOMES
ELEVATION AND
SITE DETAILS

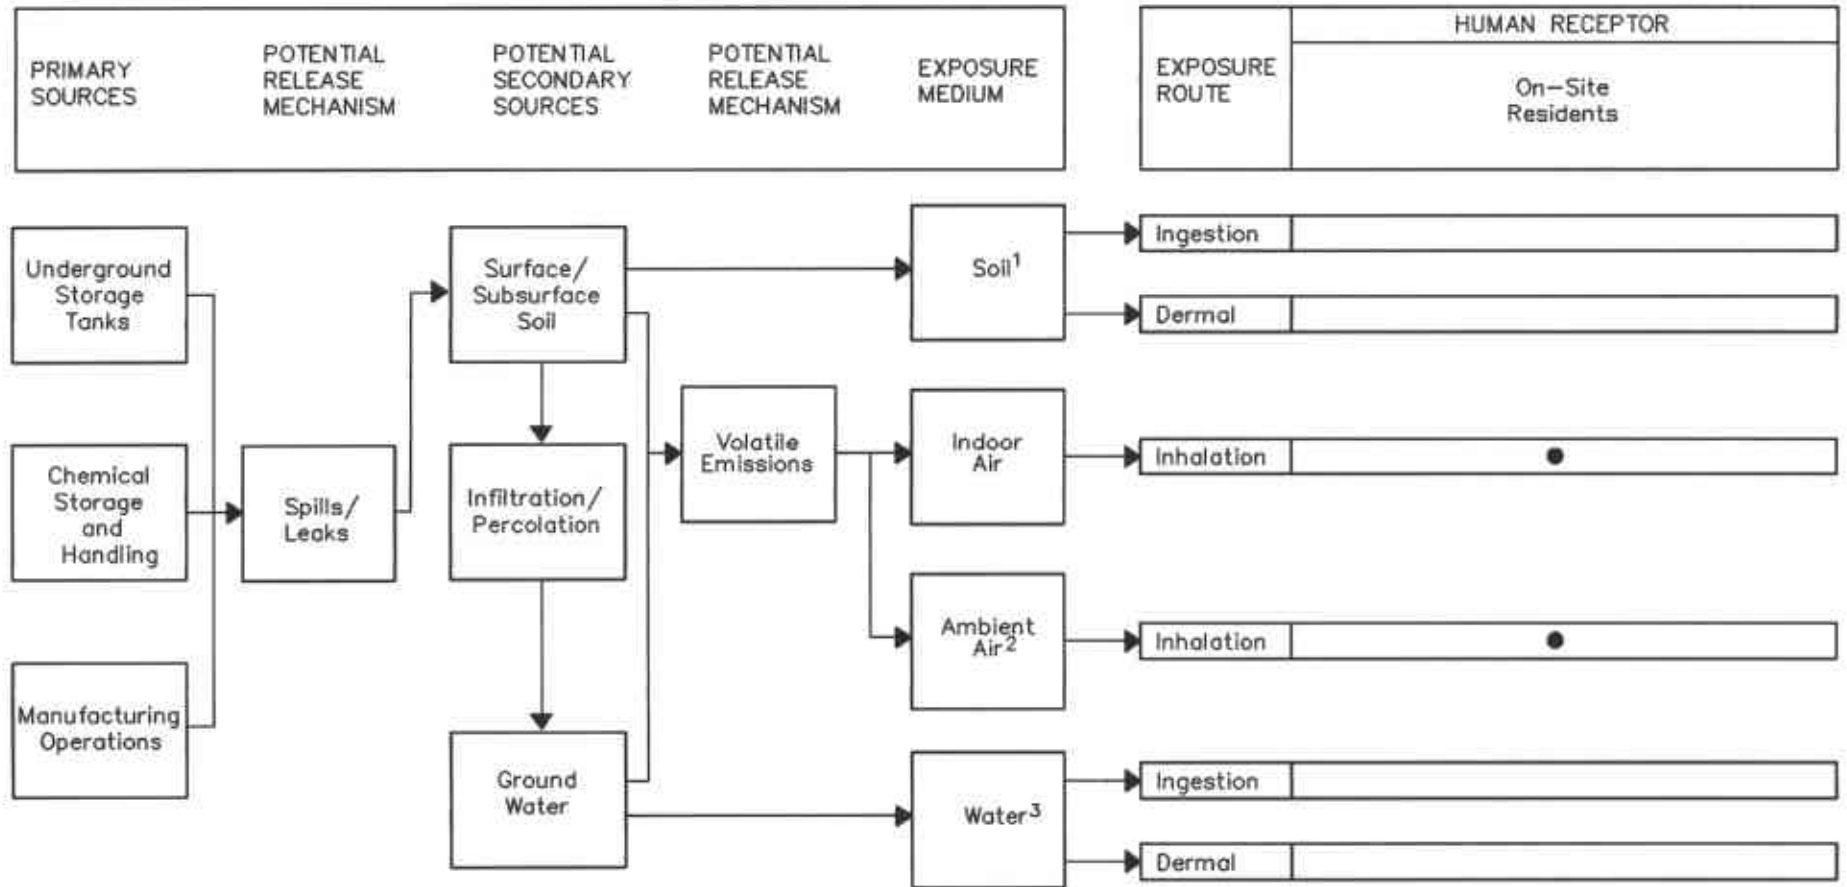
3

● Potentially complete exposure pathway for further consideration.

1. No direct contact with soil is anticipated as the redevelopment plan is established for urban townhomes without private lawn areas. In addition, deed restrictions will prevent future contact.
2. While exposure to outdoor air is a complete pathway, indoor levels are expected to be higher than outdoor levels, such that indoor exposures will be protective of outdoor exposures.
3. Dermal contact with or ingestion of ground water is not anticipated as property deed restrictions will be in place to prevent direct contact.

Conceptual Site Model Diagram for the Proposed Emeryville Village Center
Emeryville Redevelopment Agency
Emeryville, California

3.0 Potentially Exposed Populations and Pathways (*Figure 3*)

- On-Site Residents: Adult and Child
- Complete Exposure Pathways: Inhalation of Volatiles from Soil and Ground Water
- Incomplete Exposure Pathways: Direct Contact (e.g., Dermal Contact, Ingestion) With Soil and Ground Water
 - Land Use Restrictions Recorded in Deed
