Monitoring Well Installation Work Plan

Case No. RO0002621 5885 Hollis Street Emeryville, California

Subject: Monitoring Well Installation Work Plan

5885 Hollis Street Emeryville, California

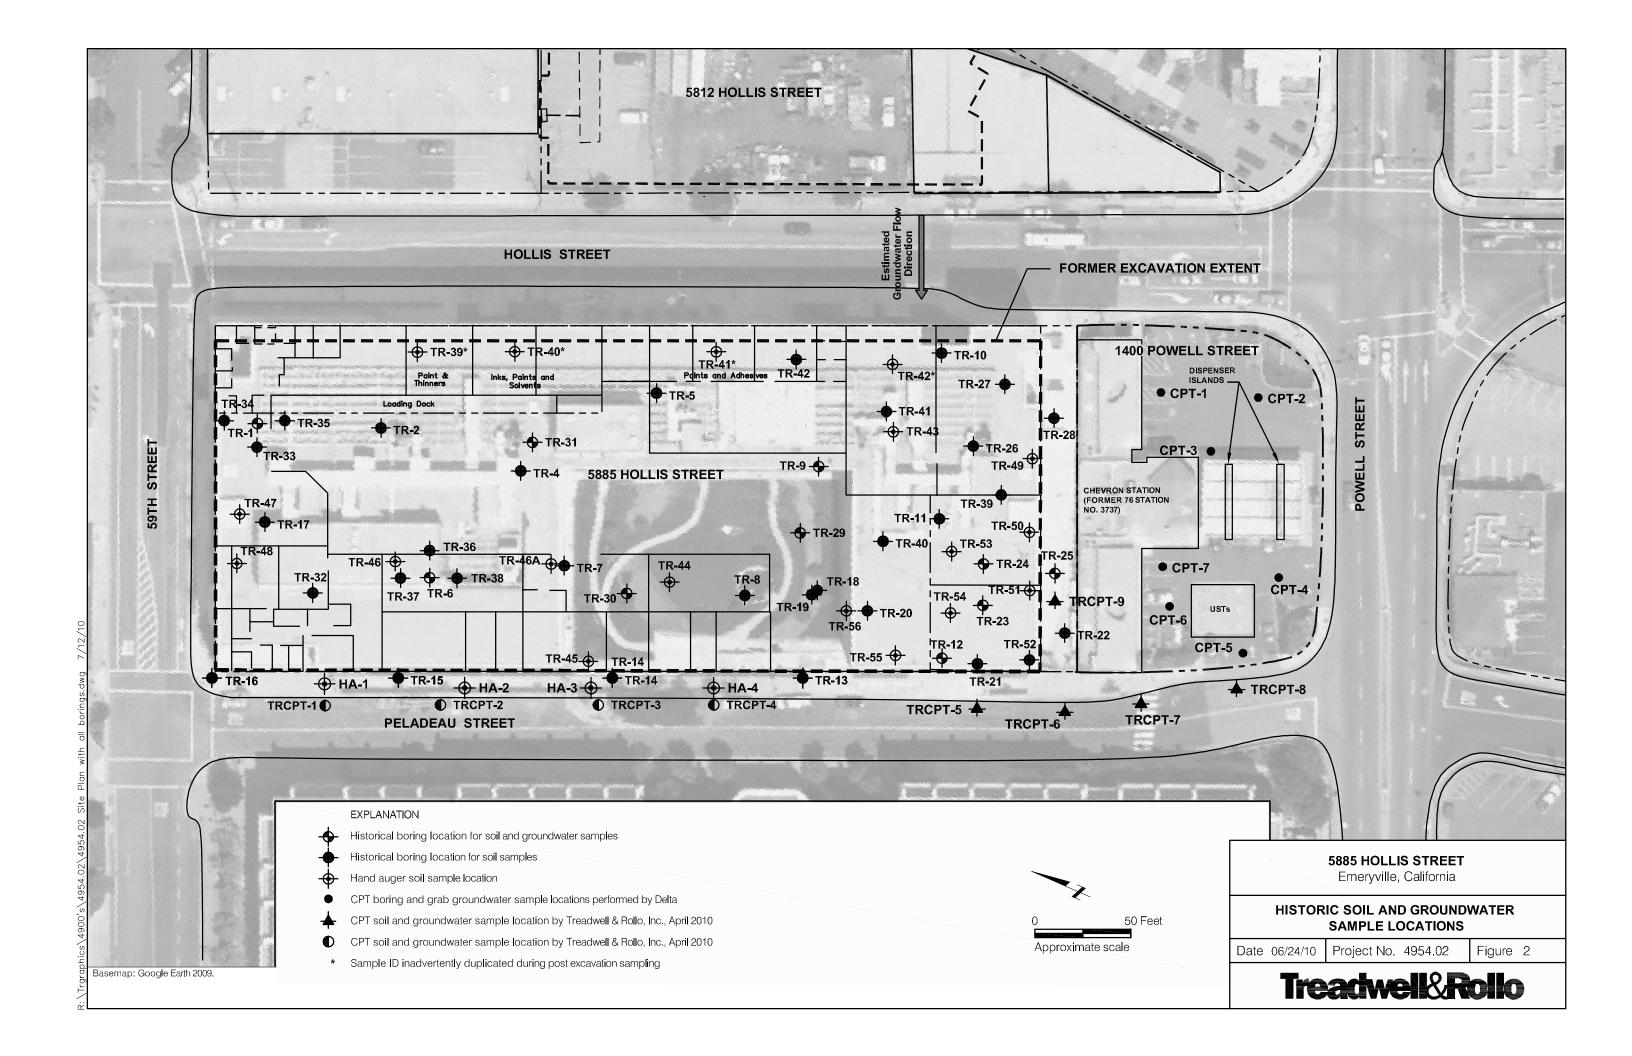
for the purpose of delineating the lateral extent of soil and groundwater contamination. The locations of the proposed borings are shown on Figure 2.

Treadwell & Rollo will advance three exploratory borings TW-1 through TW-3 at the Site. One of the borings (TW-1) will be advanced and constructed as a monitoring well within the loading dock near the southwestern corner of the property. Two of the borings (TW-2 and TW-3) will be advanced and constructed as monitoring wells within Peladeau Street in a cross gradient and a downgradient direction,
