**Groundwater Monitoring Report
July to December 2004
and Cap Status Report**

**64th Street Properties
Emeryville, California**

Erler & Kalinowski, Inc.
(EKI 990016.05)

Subject: Groundwater Monitoring Report and Cap Assessment
July to December 2004
64th Street Properties, Emeryville, California
(EKI 990016.05)

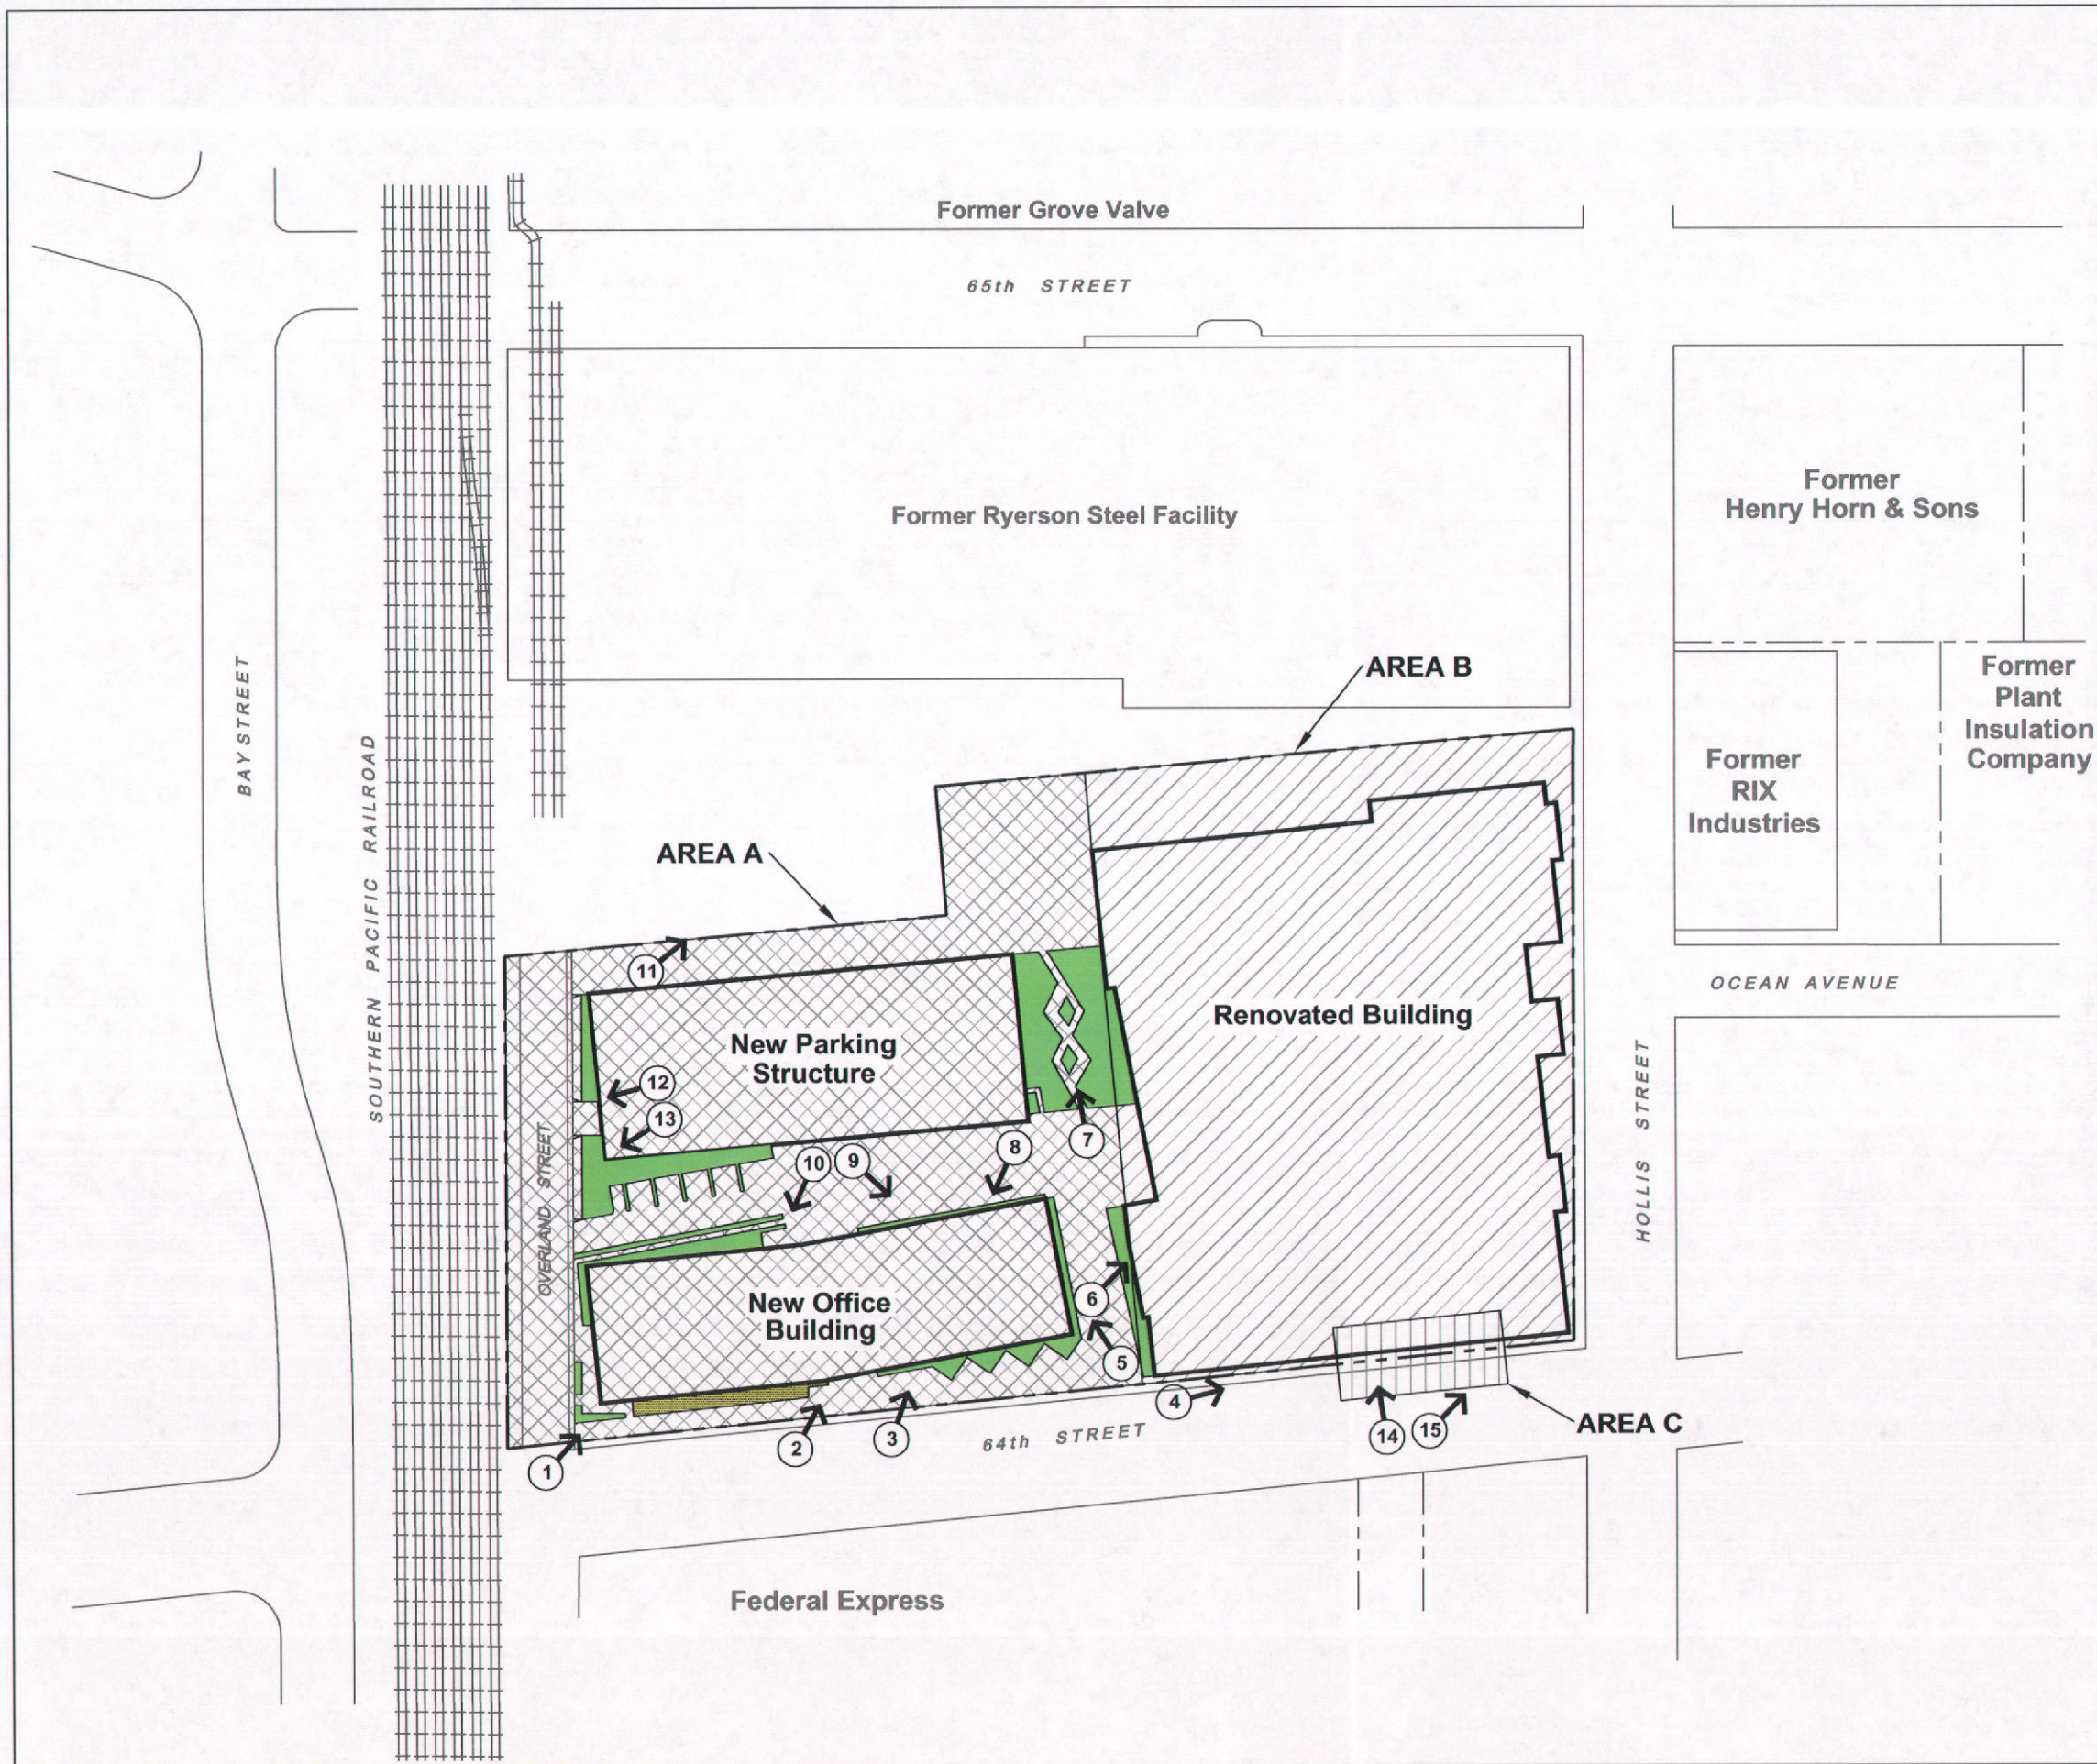
In accordance with the RMP, Areas A and C are required to be capped with buildings, asphalt, concrete, or 3 feet of clean fill in landscaped areas. Areas A and C are shown on Figure 5. In accordance with the RMP, EKI observed the Site landscaped and paved areas to assess whether the cap materials are significantly damaged or disturbed. On 4 August 2004, EKI conducted a visual cap assessment. The landscaping appeared to be in place as it was 3 years ago with no visible signs of degradation. Photographs taken for the cap status assessment can be seen in Appendix C. Refer to Figure 5 to identify photograph locations.

1. All locations are approximate.
2. Basemap taken from Sanborn maps dated 1911 and 1967.
3. Within 2 feet of the edges, clean fill thickness varies between 1 and 3 feet. Clean fill is thinnest at the edge of this landscape area.
4. See Appendix C of Groundwater Monitoring Report, July to December 2004, for photographs.

Cap Status Assessment
Photograph Locations

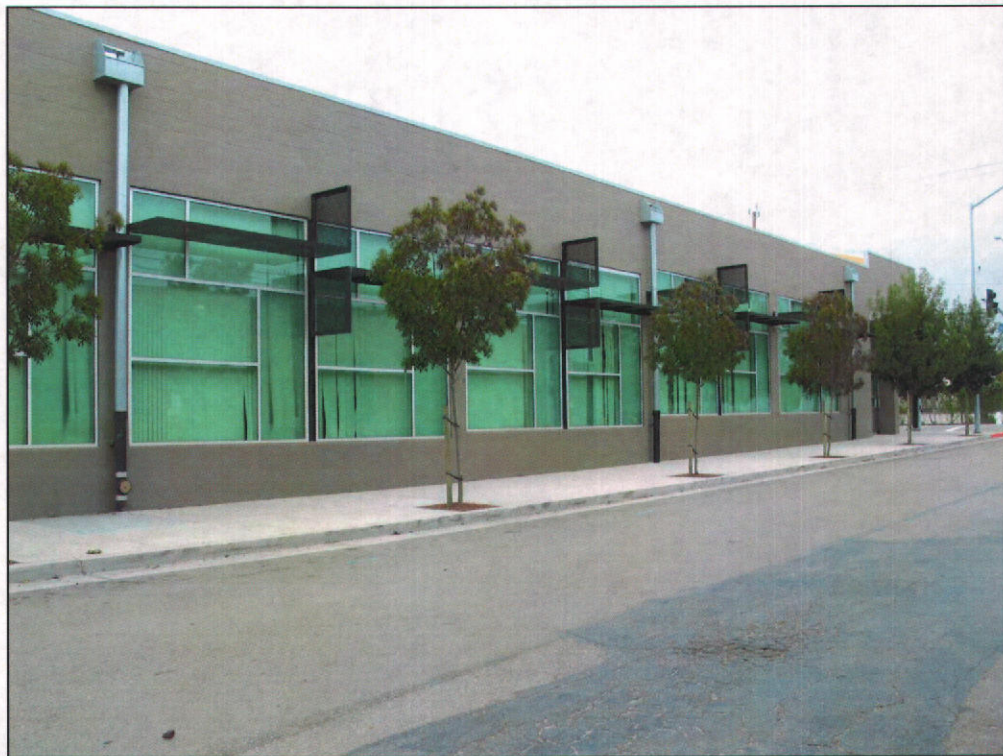
In addition to the visual assessment, EKI spoke with Barbara Wells, Simeon's property manager for the Site, on 4 August 2004 to identify possible subgrade repairs or construction activities that may have damaged or disturbed the cap materials. Ms. Wells stated that, to her knowledge and except as indicated below, there were no subgrade utility repairs, broken irrigation lines, dead tree or bush removal or replacement, or erosion that exposed the potentially impacted, underlying soil. Ms. Wells stated that a rainwater leader was repaired on the 6401 64th Street property, on the southern side of the building facing 64th Street. The repair necessitated a portion of the sidewalk pavement to be replaced. Photographs of the repaired leader and replaced sidewalk pavement can be seen in Appendix C (Photos 14 and 15).

Photo 14 (Left-most leader in photo repaired)
