**REQUEST FOR SITE CLOSURE  
WITH REGARD TO  
CHLORINATED VOCs**

**45 - 89 REVIEW WAY  
HAYWARD, CALIFORNIA**

7 May 1997  
EKI 970033.00

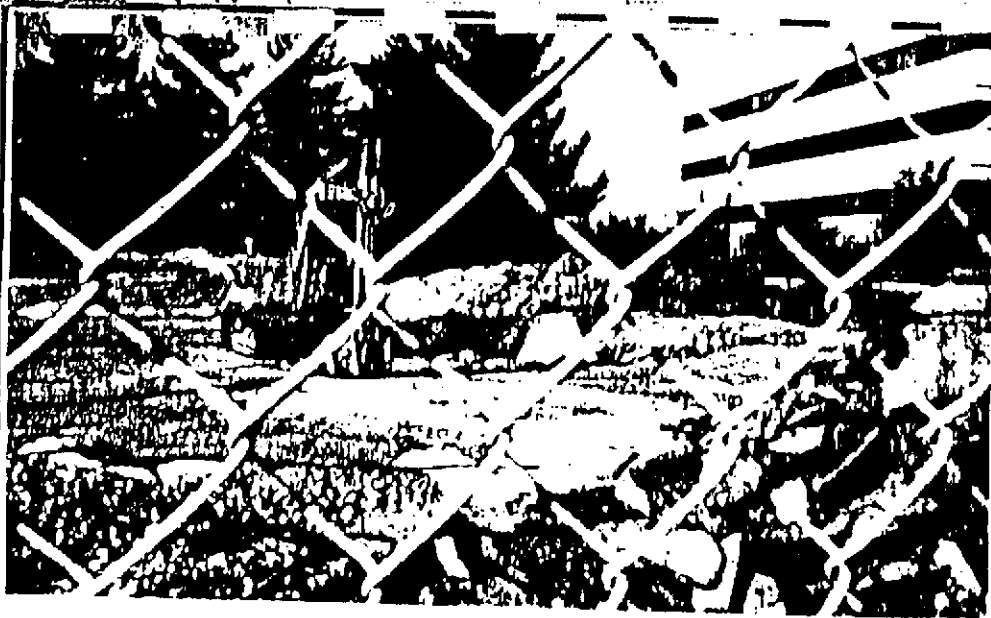
6A

FIGURE 6  
PHOTOGRAPHS OF SITE VICINITY  
(taken 12/89)

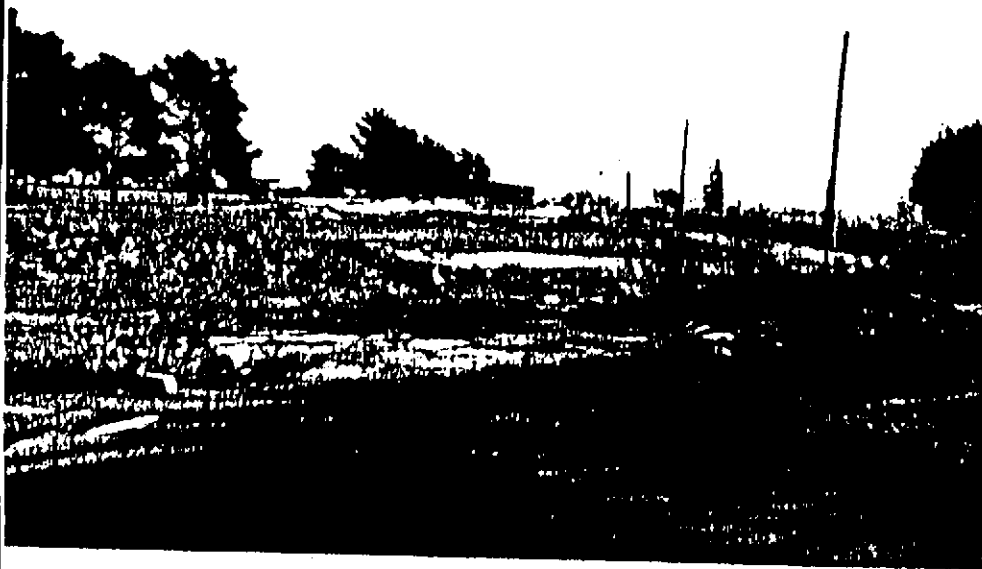
6C

Reconnaissance of the site vicinity identified a recently demolished structure located approximately 200-feet southeast of the site (Figure 6C). Mr. James Beatty of Iron-Oak Plumbing Supply indicated that a large fire burned the existing structures to the ground, between March 1988 and the present. He also indicated that the structures had been used as a pickle factory and a paper recycling plant. Further inquiry identified a file on this site at the Hayward Hazardous Materials office. The site, located at 15 Cannery Court, is owned by the Haar Pickle Factory. The file indicates that a 5000-gallon gasoline tank and a 550-gallon diesel fuel tank were removed by Blymyer Engineers

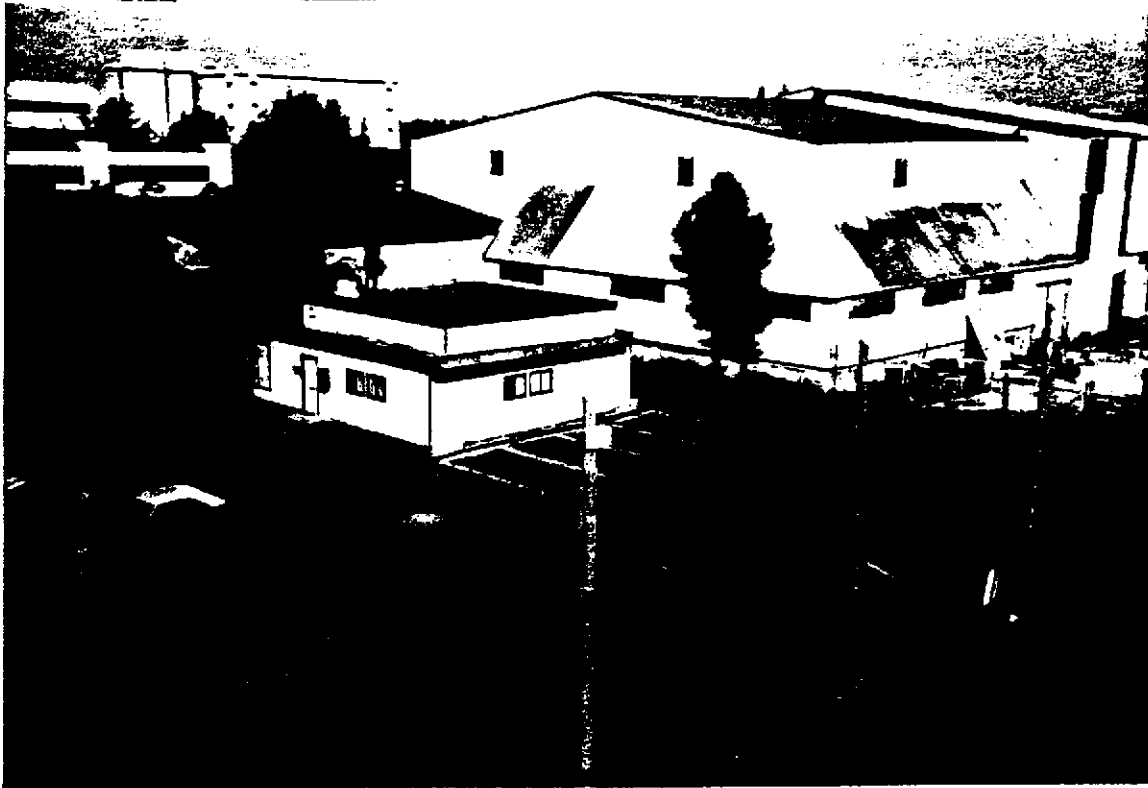
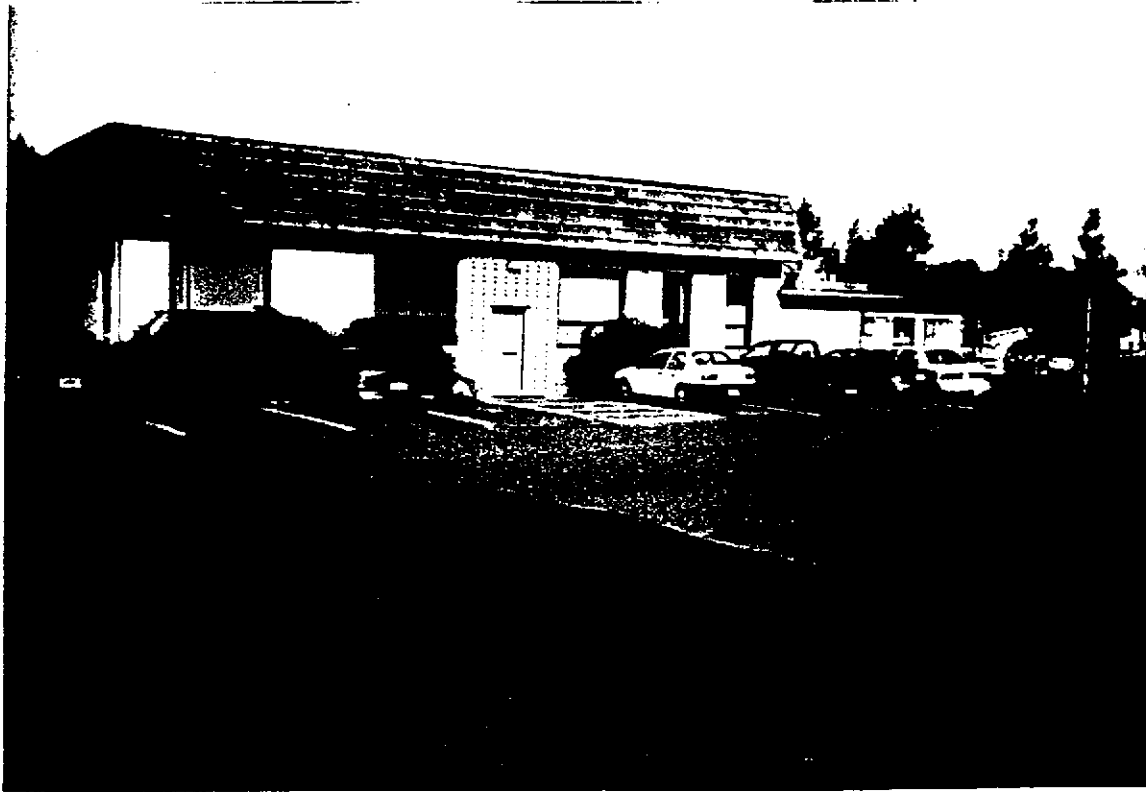
(Top) - View looking toward the northwest at the main warehouse building. The former gas station building now occupied by Data Flow is in the middle center of the photo. (Bottom) - View looking toward the west at 3,400 square foot office building.

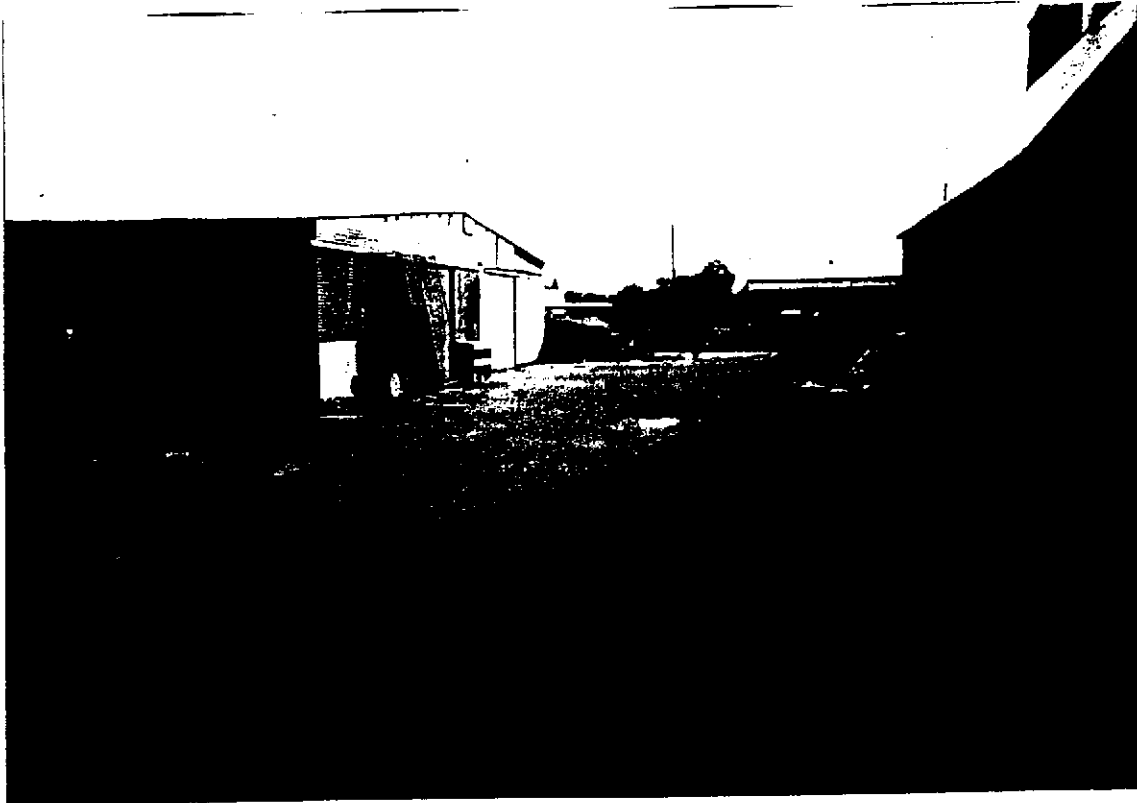
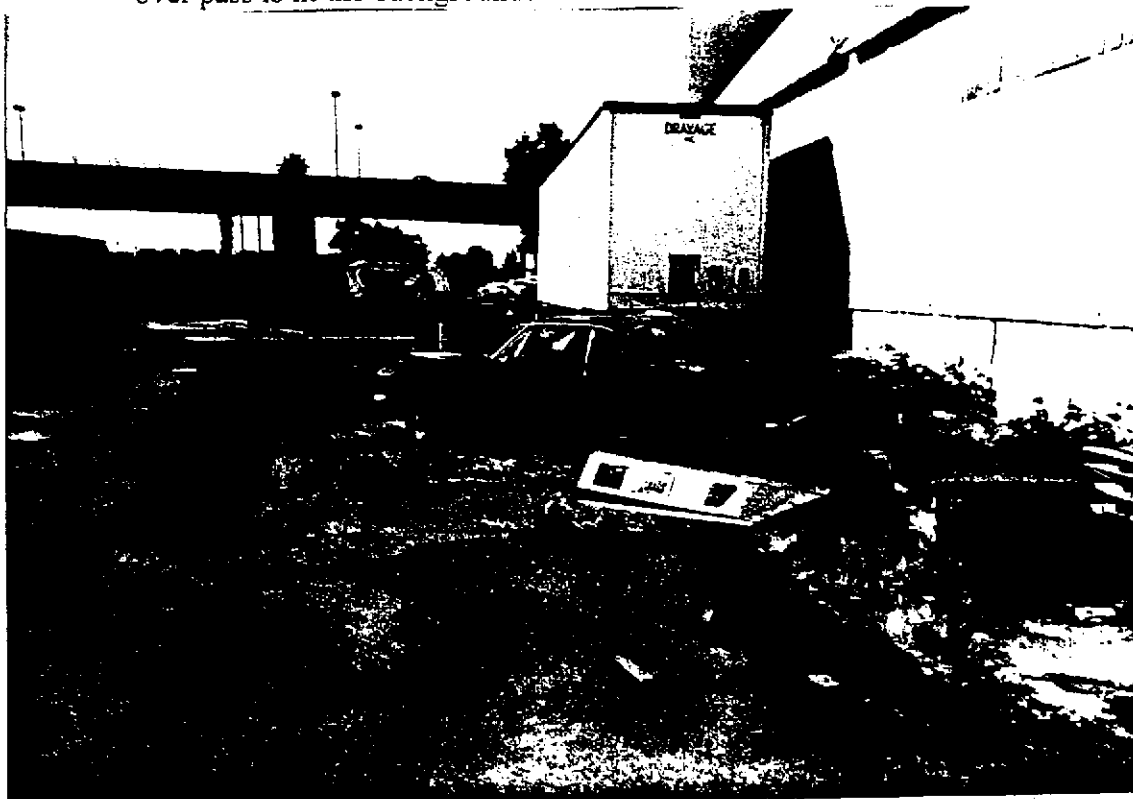
(Top) - View looking toward the east at the small warehouse/shed structure located behind the main warehouse. (Bottom) - View looking toward the south on the east side of main warehouse. West Winton over pass is in the background.

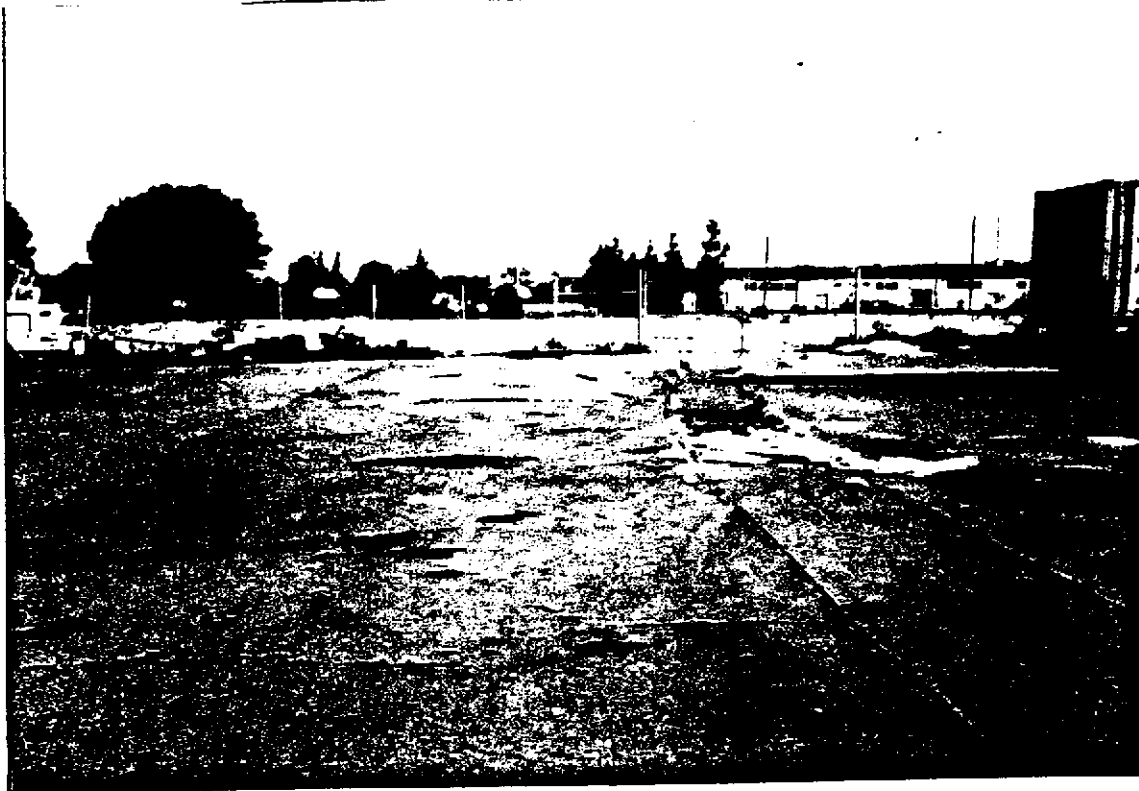
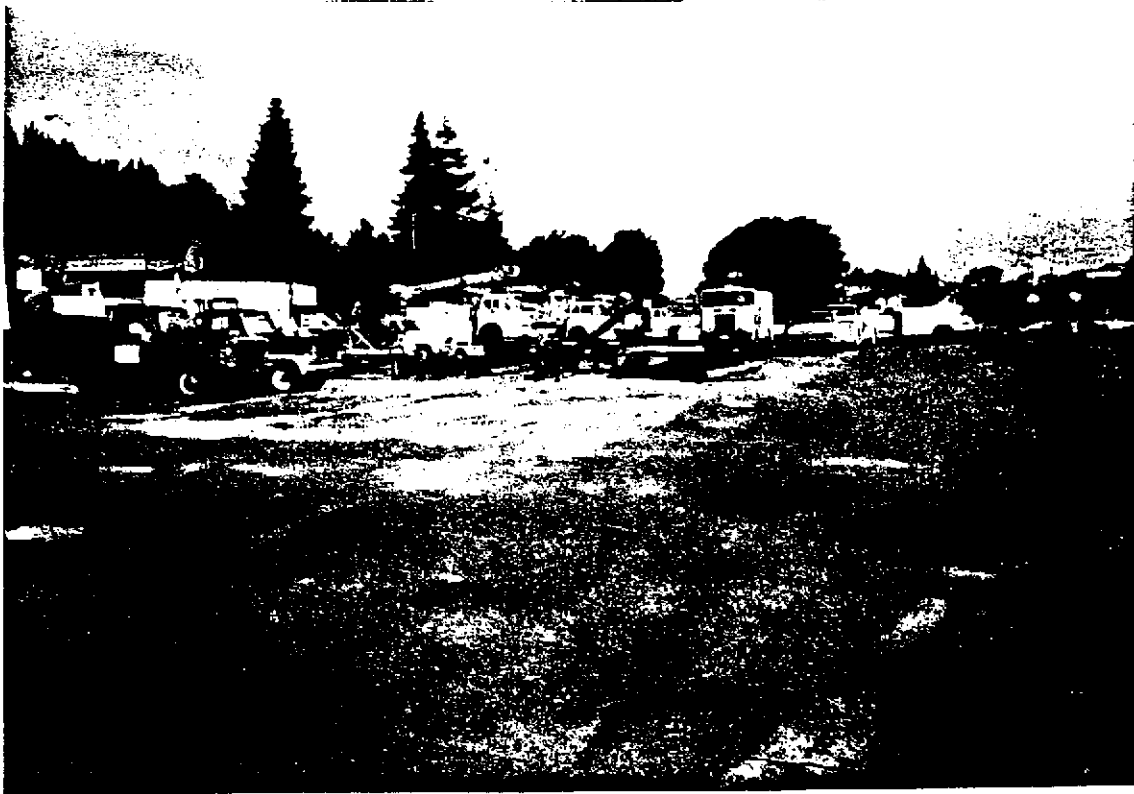
(Top) - View looking toward the north at the vacant lot area. (Bottom) - View looking toward the northwest at parked trucks and equipment belonging Anderson Electric.

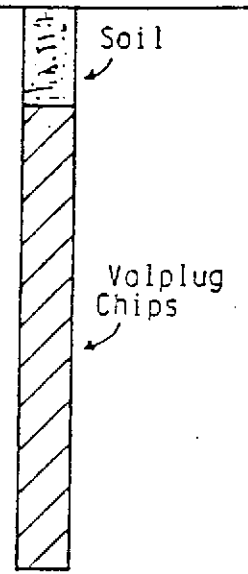
ML	0 - 2' Brown, dry, silt, dense, no odor.	
2				ML	2 - 17' Brown, moist, clayey silt, stiff, no odor.	
4				ML		
6				ML		
8				ML		
10				ML		
12				ML		
14				ML		
6				ML		
18				ML		
Total Depth: 17 Feet
