PHASE I ENVIRONMENTAL ASSESSMENT
TRINITY COURT PROPERTIES
6560 & 6575 TRINITY COURT and
6805 & 6905 SIERRA COURT
DUBLIN, CALIFORNIA

JANUARY 31, 1994

McLaren/Hart Environmental Engineering
11101 White Rock Road
Rancho Cordova, California 95670

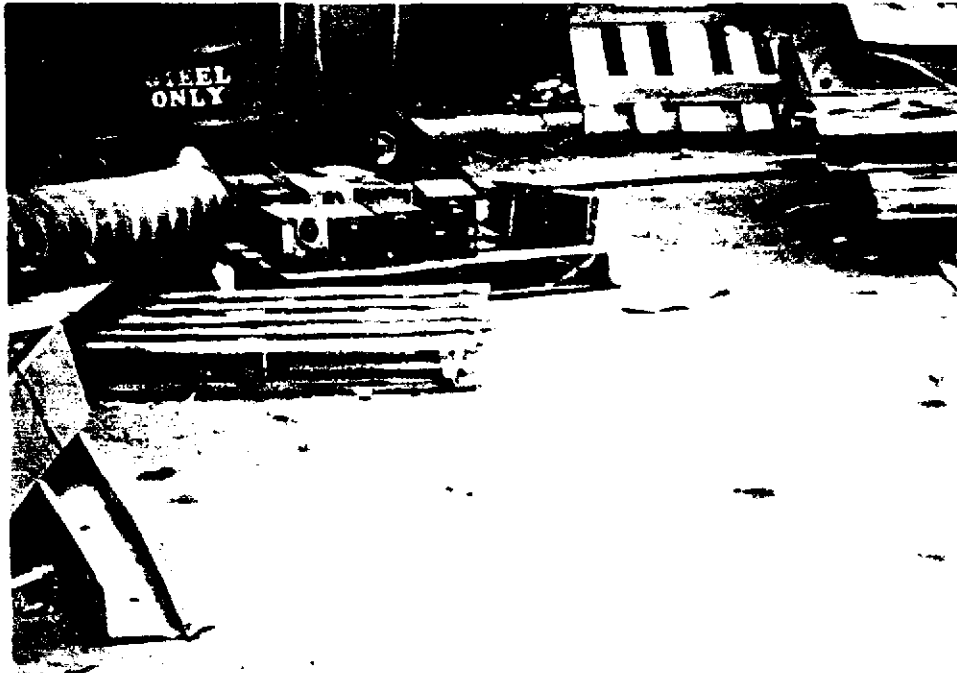
McLaren/Hart observed several small transformers which were stockpiled east of 6805 Sierra Court in the parking lot. A picture of this area is shown in Appendix A. Mr. Jim Rackel indicated that these transformers did not contain PCBs, and that they have never had any transformers on-site which were known to contain PCBs.

Transformers and other debris located south of debris storage area behind Federal Sign (6805 Sierra Court).

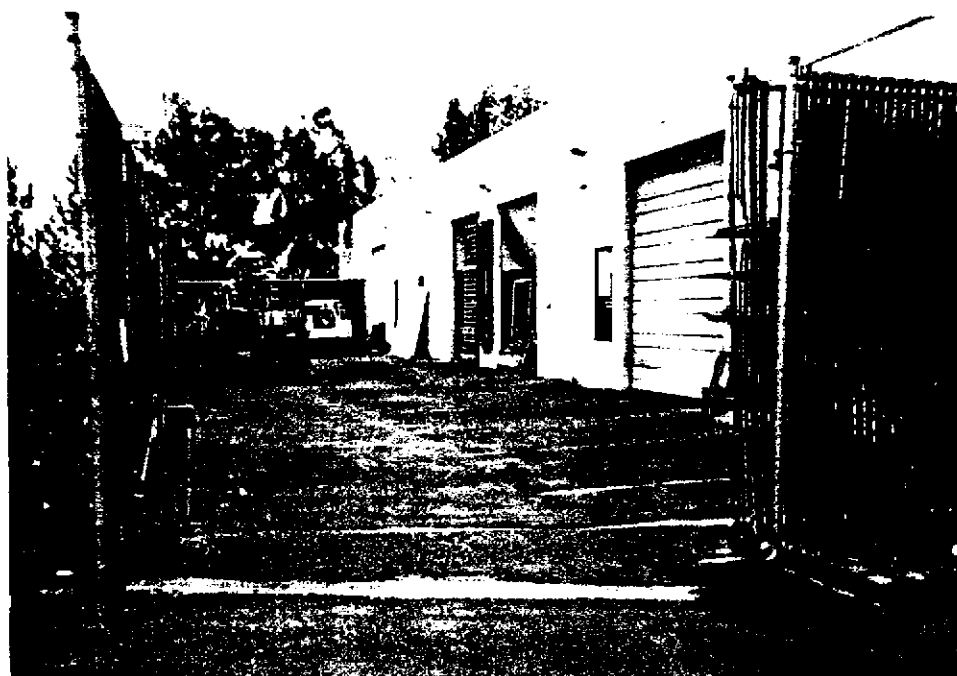
Vehicle lockup and maintenance area behind Federal Sign (6805 Sierra Court).

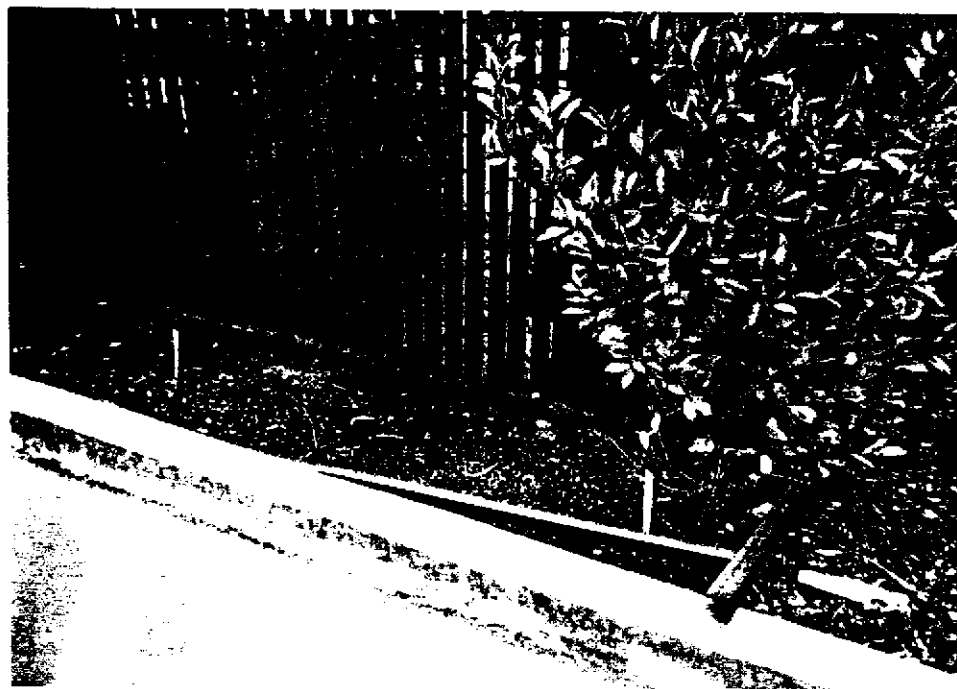
Oil staining was observed on the asphalt in and around the hazardous materials storage area located east of 6805 Sierra Court (see Photograph in Appendix B). This area, which also contained four 55-gallon drums and several 12-volt car batteries, provided the only visual evidence of potential chemical releases at the property.

During the first phase of soil sampling conducted at the HMSA at 6805 Sierra Court, TPH was detected in SB-1 (1 foot) and SB-1 (5 feet) at 58 and 220 mg/kg, respectively. Several different metals were detected in the soil samples, although all metal results were less than State of California Title 22 hazardous waste criteria (TTLC). VOCs were not detected in either soil sample.

Staining on ground adjacent to waste storage area behind Federal Sign (6805 Sierra Court).

Based upon the analytical results of the soil samples collected from SB-1, four additional soil borings (SB-2 through SB-5) were drilled around the HMSA to evaluate the extent of TPH in soil and to assess groundwater conditions. The soil borings were drilled to depths of between 13 to 14 feet below ground surface (BGS). Two soil samples were collected from each boring at 5 feet BGS and immediately above the groundwater (encountered at 11.5 to 13 feet BGS). Grab groundwater samples were collected through the hollow-stem auger at each boring location using a disposable polyethylene bailer. All soil and groundwater samples were analyzed for TPH using EPA Method 418.1. TPH was not detected in soil or groundwater samples analyzed from SB-2 through SB-5.

Based on these results, it appears that groundwater has not been impacted by TPH detected in SB-1 soil. In addition, soil contamination appears to be limited to the landscaped area bordering the northern perimeter of the HMSA. Although it was not possible to locate a soil boring south of the HMSA, oil staining was not observed on the asphalt in this area, and TPH contamination in this area is not anticipated.
