**SOIL EXCAVATION REPORT FOR**  
**OLSON URBAN HOUSING, LLC**  
**Former Impulse Motors**  
**1210 Bockman Road**  
**San Lorenzo, CA**

**February 1, 2007**  
**Project Number 04OT.29222.73**

**RE: SOIL REMOVAL REPORT**  
1245 – 1415 Bockman Road  
San Lorenzo, California (the "Site")

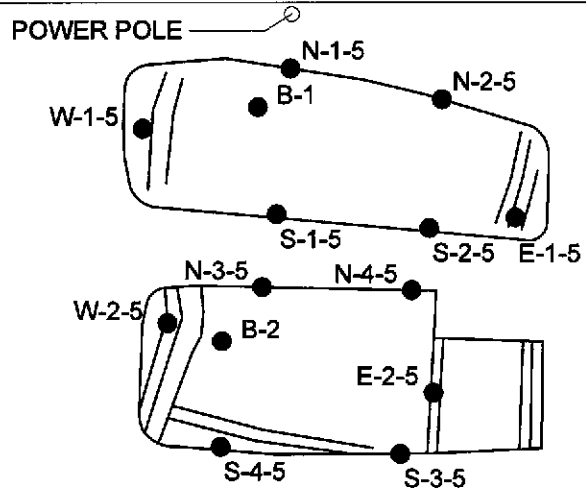
Two remedial excavations were completed in the vicinity of each of the former fuel dispensers. The first excavation (EX-1; northern-most) measured approximately 48 feet (east-to-west) by approximately 16 feet (north-to-south). The second excavation (EX-2; southern-most) measured approximately 44 feet (east-to-west) by approximately 19 feet (north-to-south) to a depth of 10 feet bgs.

Both excavations were limited to a depth of 10 feet bgs vertically, because of the presence of groundwater.

Two remedial excavations were completed in the vicinity of each of the former fuel dispensers. The first excavation (EX-1; northern-most) measured approximately 48 feet (east-to-west) by approximately 16 feet (north-to-south). The second excavation (EX-2; southern-most) measured approximately 44 feet (east-to-west) by approximately 19 feet (north-to-south) to a depth of 10 feet bgs. Both excavations were limited to a depth of 10 feet bgs vertically, because of the presence of groundwater.
