**Additional Site Characterization for Delineation of
PCB-Impacted Soils Beneath the East Parking
Lot Located at 6121 Hollis Street
Emeryville, California**

Project 2180

September 6, 2001

**SOMA Environmental Engineering, Inc.
2680 Bishop Drive, Suite 203
San Ramon, California 94583**

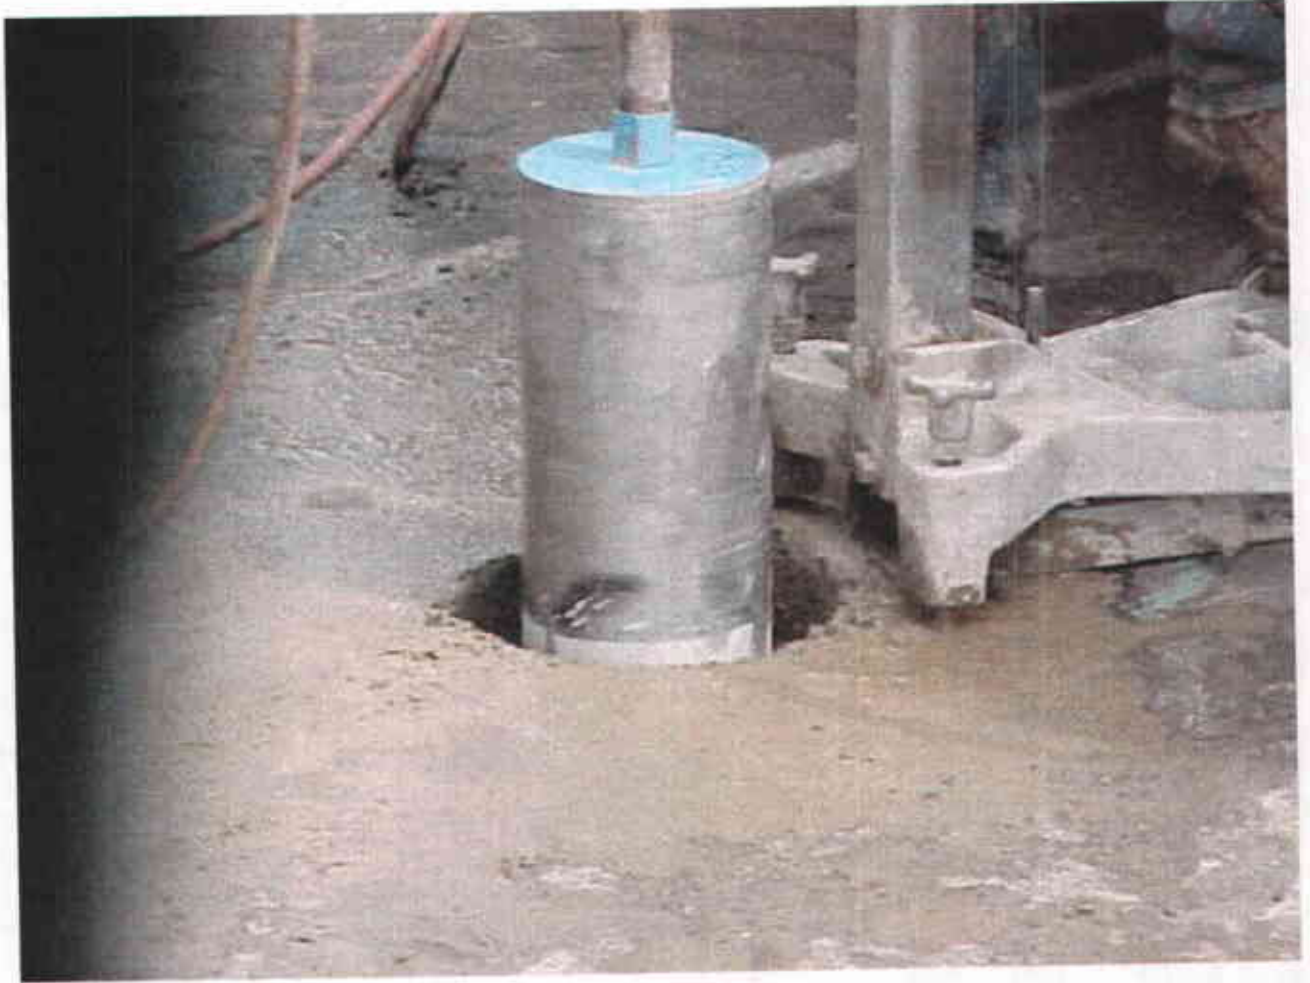
Figure B-1 Concrete Cutting Operation

Prior to drilling the soil borings, a 12-inch diameter asphalt core was cut using a concrete cutter. The approximate thickness of the asphalt core at different locations ranged between 4 and 5 inches. Following the cutting the asphalt core, a soil sample was collected beneath the asphalt pavement at a 6-inch depth. In soil boring locations where a concrete layer was present, after collecting a soil sample at a 6-inch depth, digging the borehole was continued by using a hand shovel. During this process the soil cuttings were completely removed from the borehole until the concrete layer at a 1 to 2 feet depth was exposed. At this time an 8-inch diameter core-bit was used to cut the concrete core and remove it out of the borehole. After removing the concrete core, drilling was continued using a hollow stem auger to an approximate depth of 3.5-feet. Pursuant to the approved workplan, a 6-inch long brass sampling tube was extended to the bottom of the borehole and pushed by using a hammer auger to a 4-foot depth and a soil sample was collected. At locations where the concrete layer was missing, after removing the top asphalt layer and collecting a soil sample at a 6-inch depth, drilling was continued using a hollow stem auger to an approximate depth of 3.5-feet. As it was explained, using a hammer auger, a brass sampling tube was extended into the borehole and a sample at a 4-foot depth was collected.

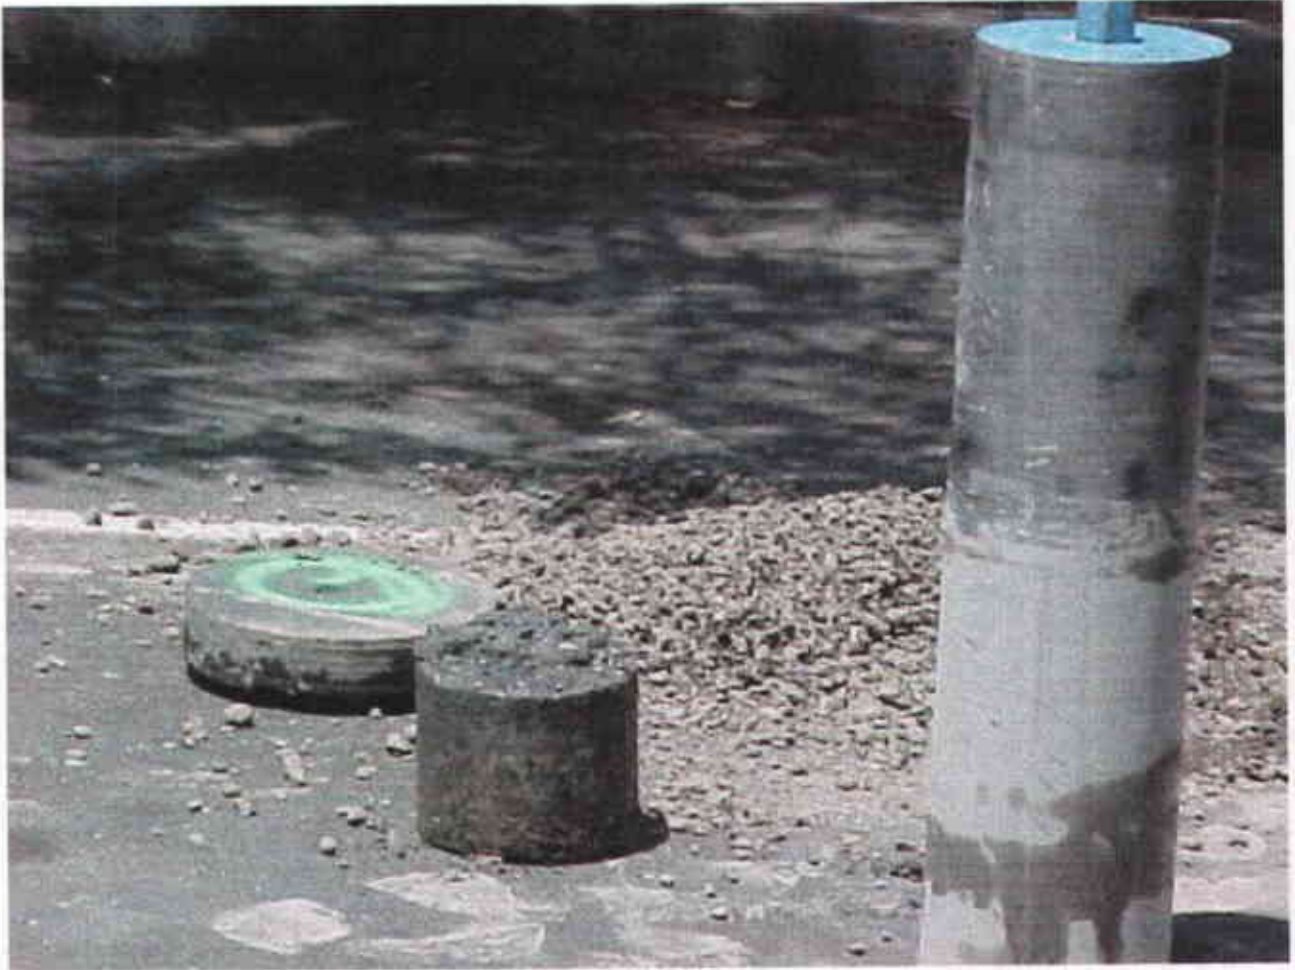
Figure B-2 12-Inch Diameter Asphalt and 8-inch Diameter Concrete Cores

Note: The materials under asphalt and concrete layer are mainly pea gravel

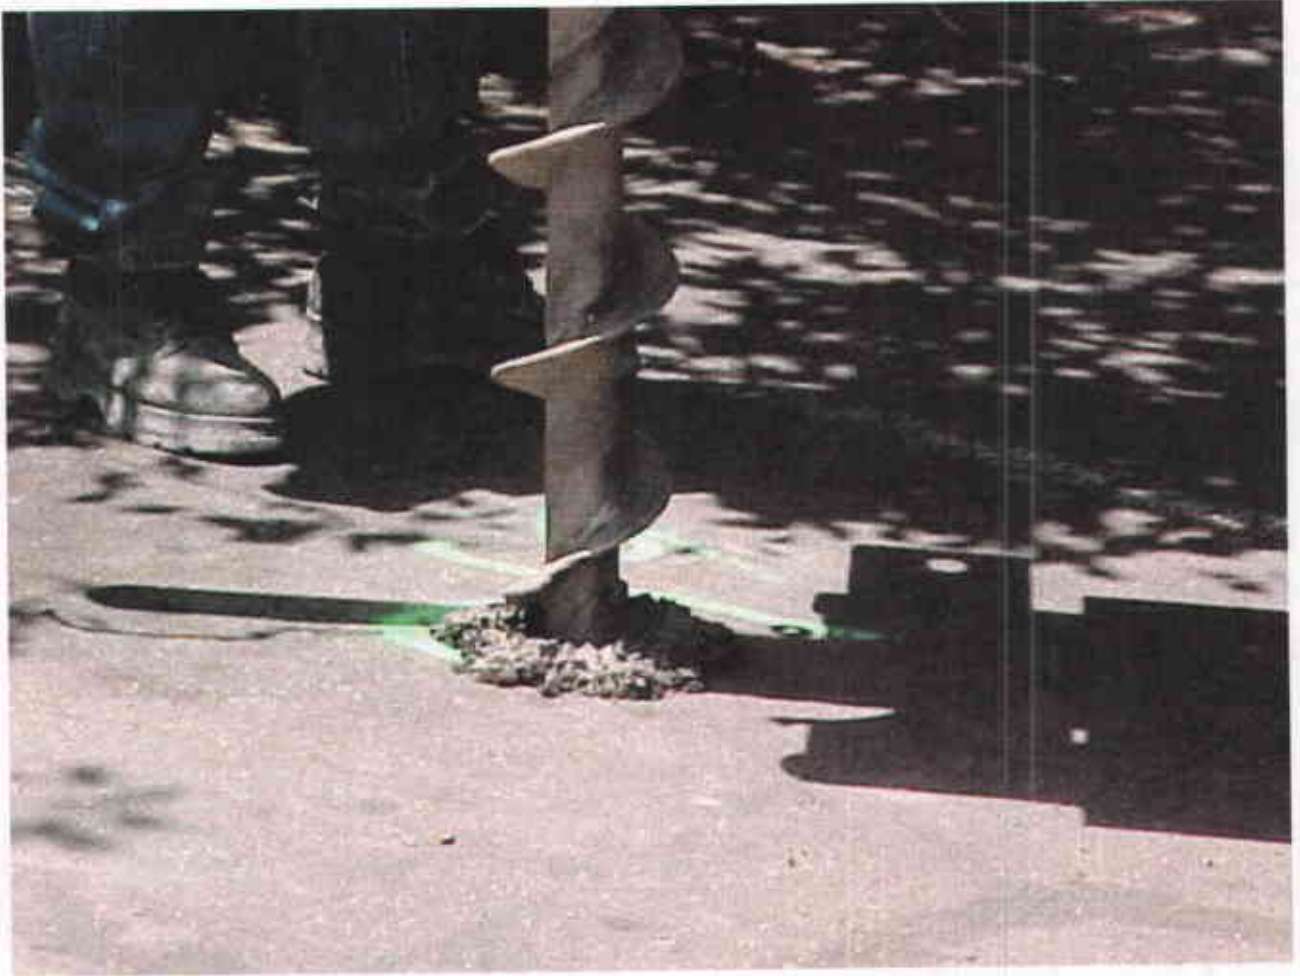
Figure-3 Initial Drilling Operation to Test the Presence of the Concrete Layer

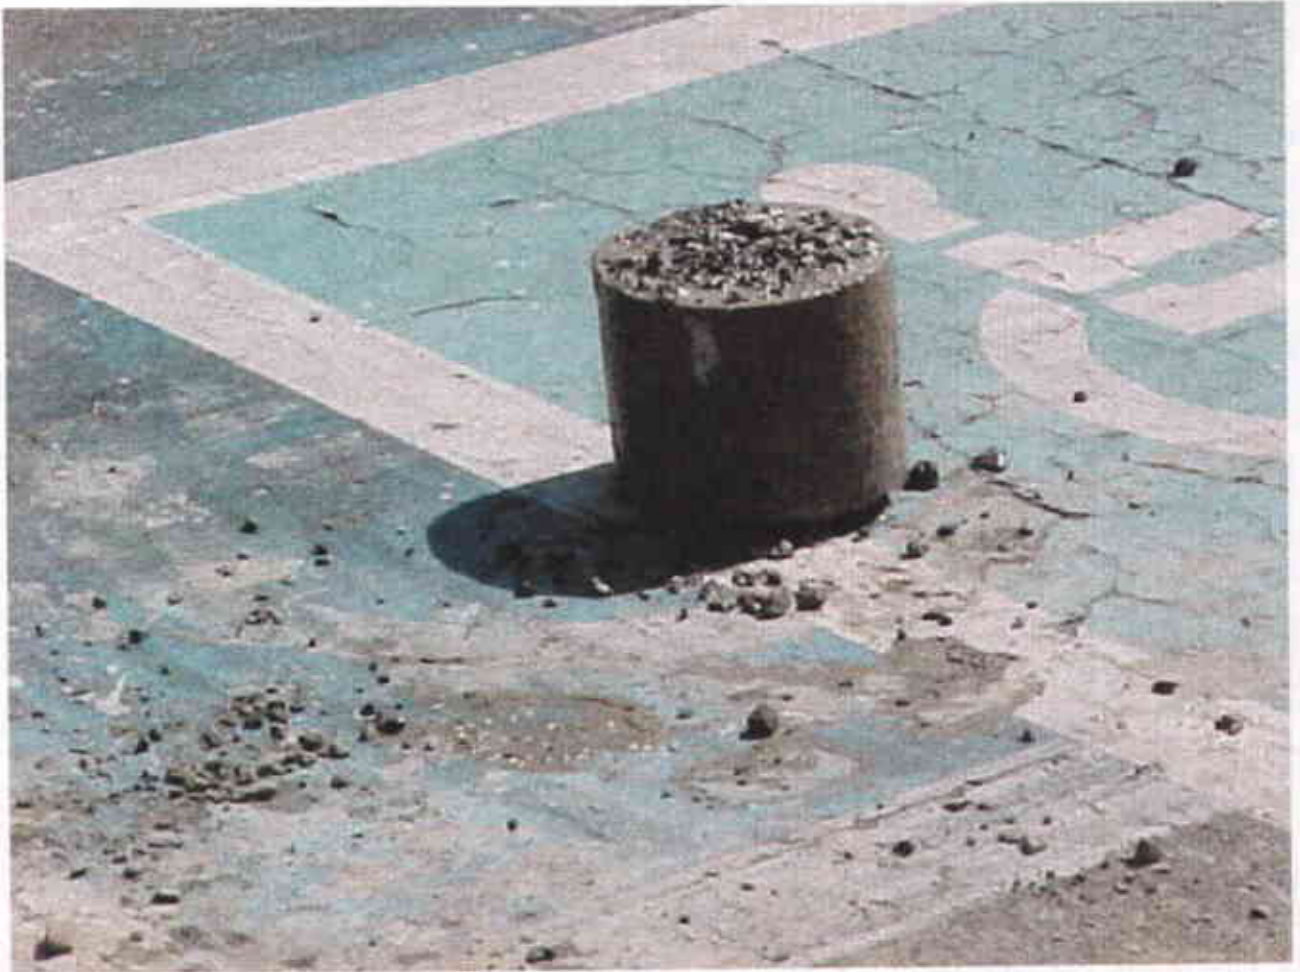
Figure B-4 A Thick Concrete Layer at two feet Depth

During the remediation and excavation activities for landscaping purposes multiple layers of asphalt and concrete layers were encountered. A reinforced concrete layer at a 1 to 2 feet depth was encountered at the central part of the Property. To delineate the approximate extent of the reinforced concrete layer, Cruz Brothers of San Jose, California were hired to conduct a magnetometer survey. Figure-3 shows the approximate extent of the concrete layer at 1 to 2 feet depth interval beneath the Property.
