**FIRST SEMIANNUAL 2013  
GROUNDWATER MONITORING AND  
PRODUCT EXTRACTION REPORT**

**EMERYBAY CONDO PHASE I PARKING GARAGE  
6400 CHRISTIE AVENUE  
EMERYVILLE, CALIFORNIA**

**STELLAR ENVIRONMENTAL SOLUTIONS, INC.  
2198 SIXTH STREET  
BERKELEY, CALIFORNIA 94710**

**June 4, 2013**

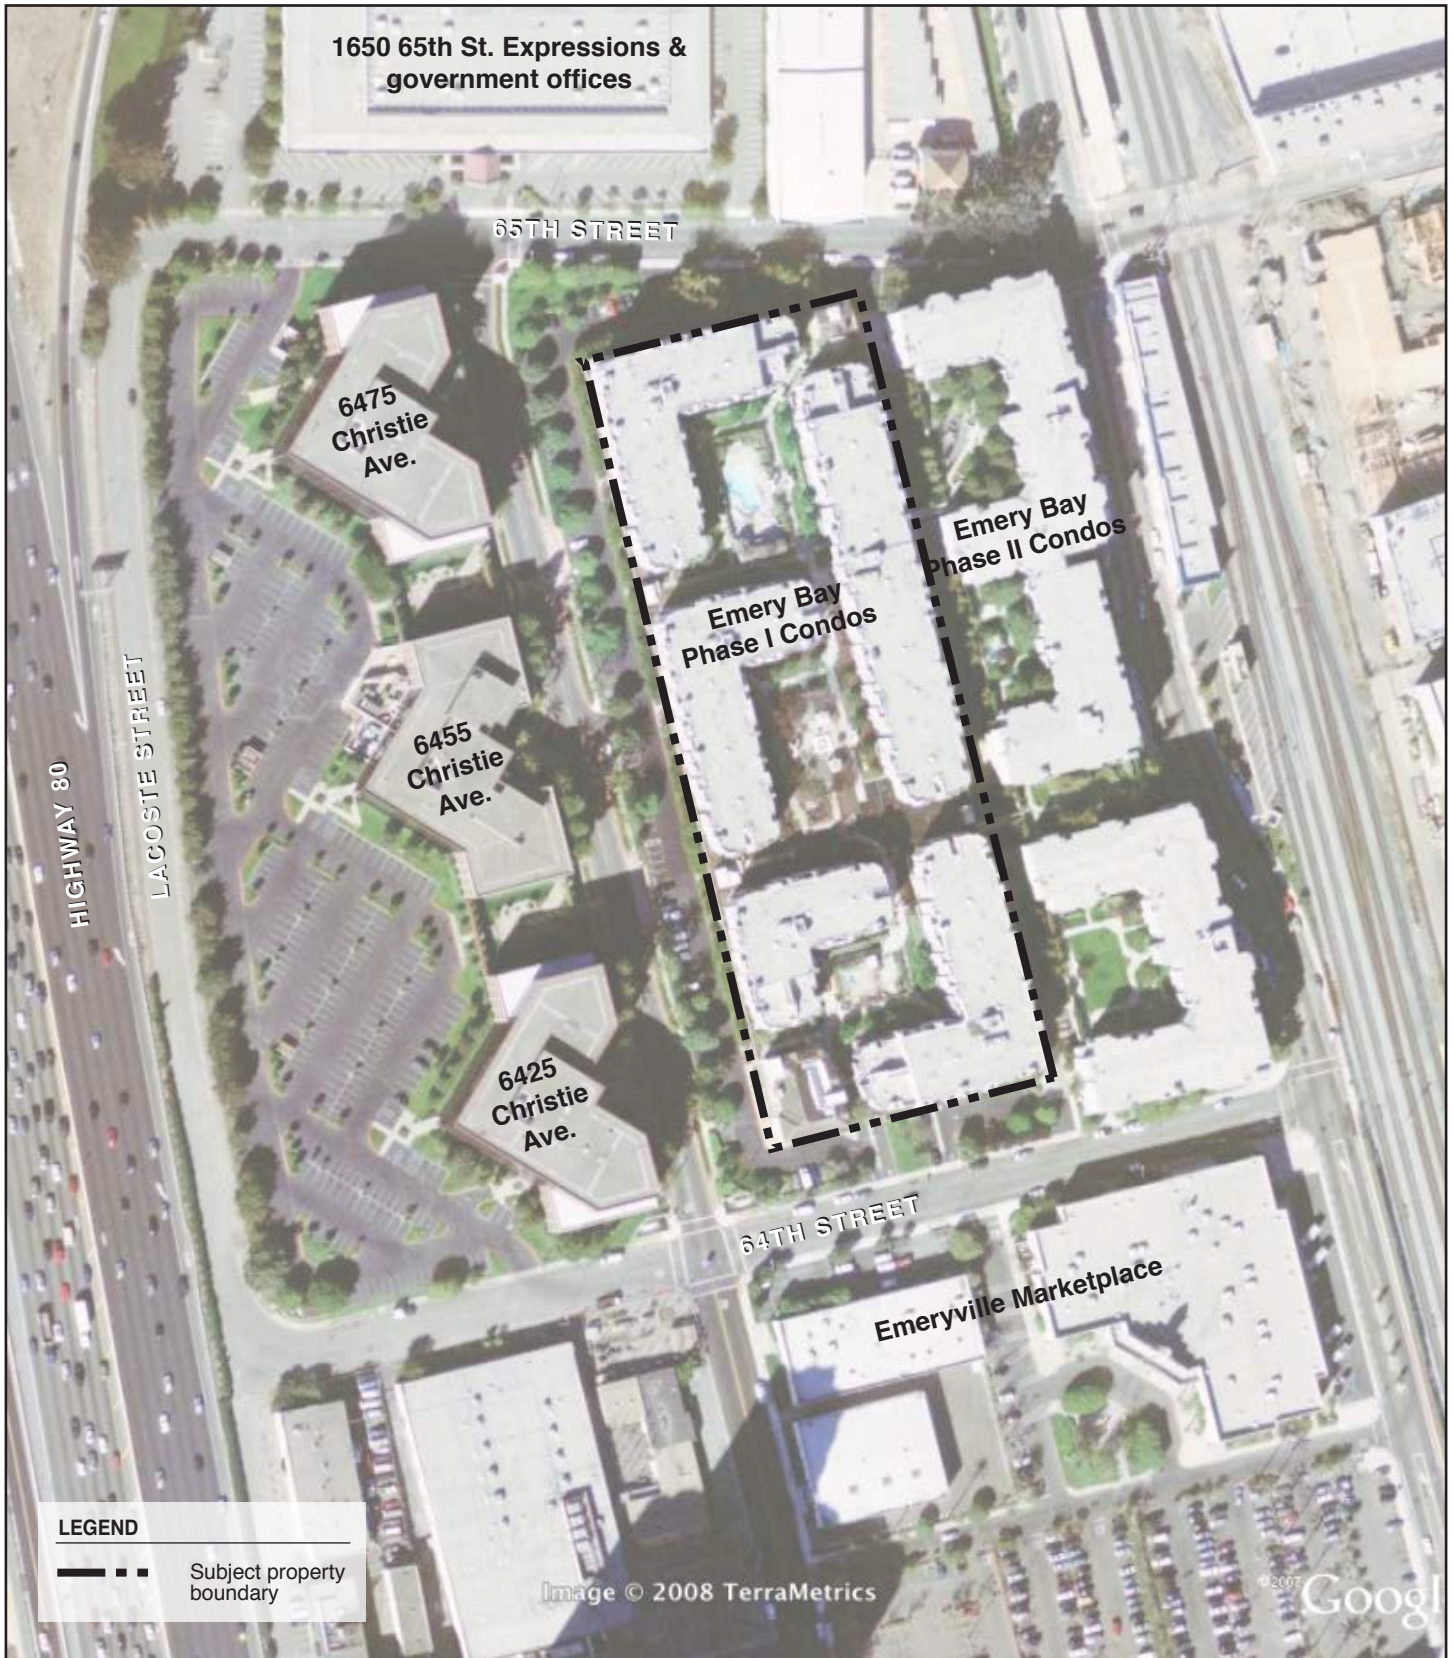
**SITE PLAN AND ADJACENT LAND USE**

6400 Christie Ave.  
Emeryville, CA
