**SECOND SEMIANNUAL 2013
GROUNDWATER MONITORING AND
PRODUCT EXTRACTION REPORT**

**EMERYBAY CONDO PHASE I PARKING GARAGE
6400 CHRISTIE AVENUE
EMERYVILLE, CALIFORNIA**

Project No. 2007-65

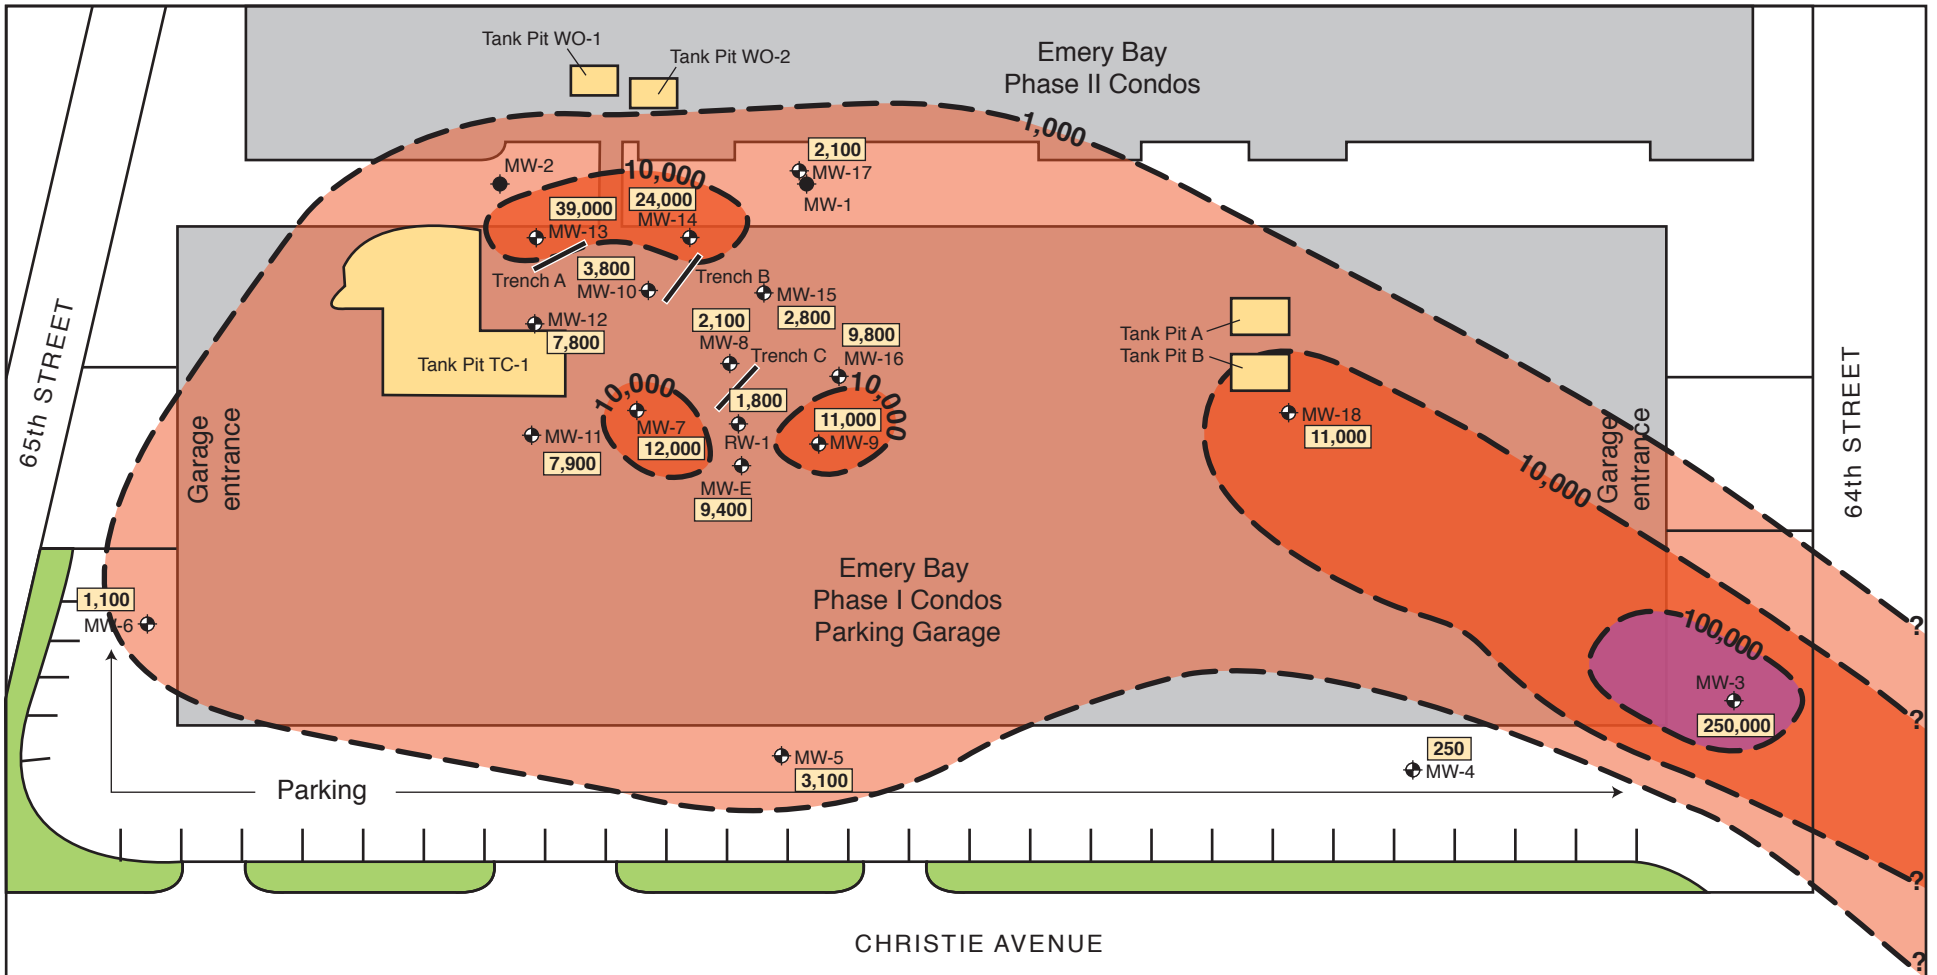
The 6340 Christie Avenue (ACHCSA Case # RO0000057) property immediately south of the garage area across 64th Street has been under construction since 2012. As part of the construction process, there has been what appears to be continuous dewatering to depress the groundwater table and allow for the project subgrade forms and foundations to be placed. The apparent impact of this on the subject site has been described in terms of both the changes to the site hydrology—with the change in the groundwater flow regime from west/northwest to having a southern component—as well as a hydrochemical impact. The hydrochemical impact, as documented in well data described above, has been to draw the hydrocarbon plume southward, increasing the concentrations of THPd by orders of magnitude at well MW-3 near the subject properties north border, compared to the last 5 years of monitoring that showed stable results (see figure 10). The impact to the previous equilibrium of the plume raised a concern both of mobilizing the existing areas of hydrocarbons and likely mobilizing sources of hydrocarbon in area previously indicated to be immobile. The suspect area being mobilized is between the area of wells MW-18 and MW-3, where the historical Tank pits A and B are shown (see Figure 7).

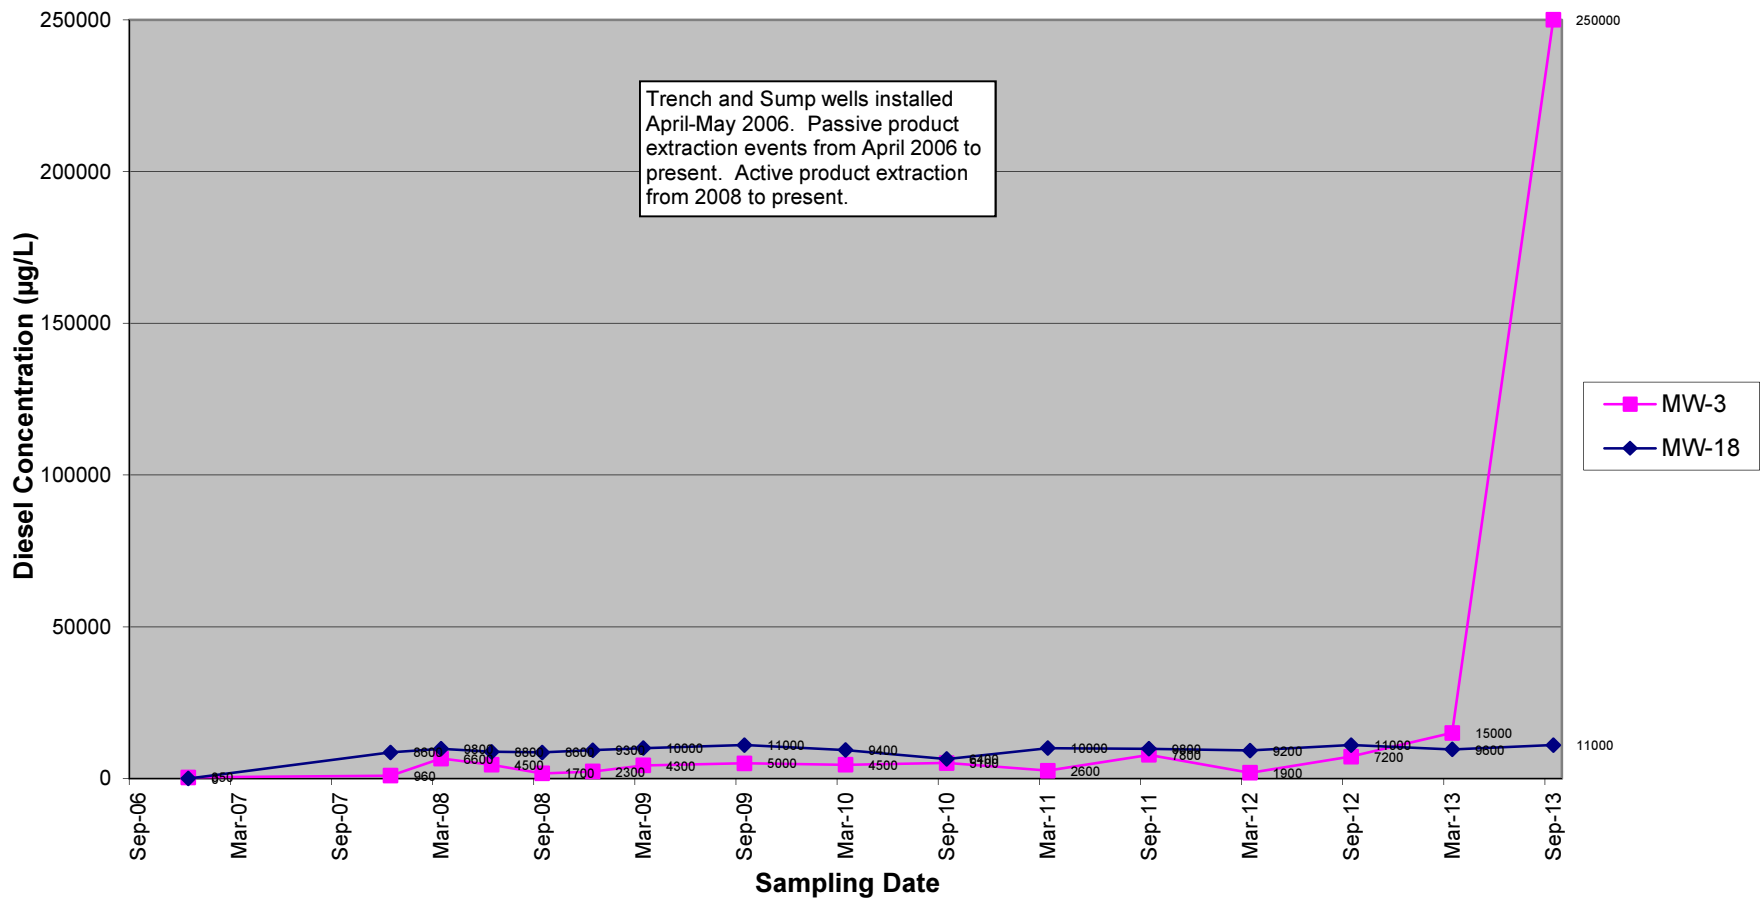
Figure 10
Historical Groundwater Analytical Results
Total Petroleum Hydrocarbons as Diesel (TPHd)
Crossgradient Wells MW-3 and MW-18
December 2006 - September 2013

In addition to the above factors, the increase of diesel concentrations observed in well MW-3 for the past three monitoring events is very likely due to the de-watering activities that have been on-going at the construction site across 64th Street, which has affected the groundwater flow direction and magnitude. Well MW-18, which is the closest upgradient well to MW-3, has shown a relatively stable TEHd concentration over the past three monitoring events, suggesting that an undiscovered area of residual hydrocarbon contamination may exist between MW-3 and MW-18. In general, residual hydrocarbons left in the soil after the USTs were removed from the site in the 1980's, is likely to continue to be a source of contamination to groundwater at the site. More active remediation, including introduction of bio-remedial enhancing products into selected wells may be useful to reduce the concentrations to levels acceptable to the regulatory community and to achieve eventual regulatory closure.
