REPORT
of
SOIL AND GROUNDWATER ASSESSMENT
ASE JOB NO. 3231
at
The Oliver Rubber Facility
1200 65th Street
Oakland, California

AQUA SCIENCE ENGINEERS, INC.
2411 Old Crow Canyon Road, #4
San Ramon, CA 94583
(925) 820-9391

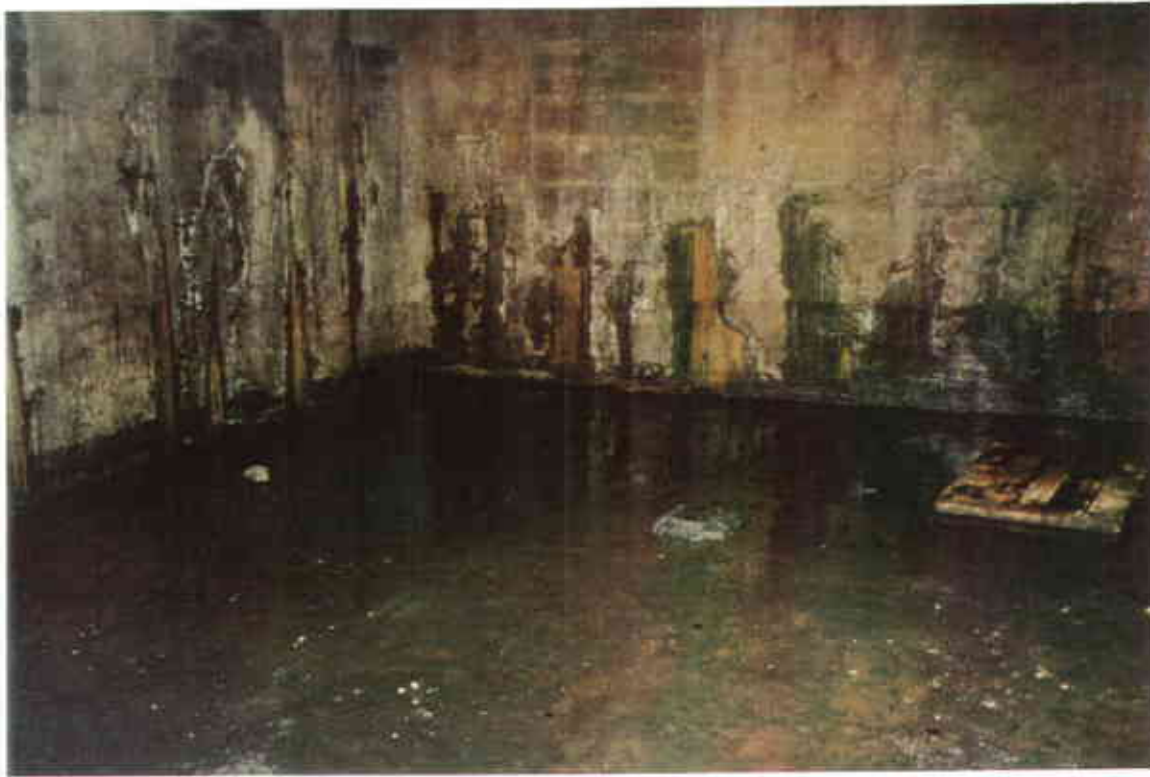
The floor of this vault appeared to be in relatively fair shape without any obvious holes or significant cracks. The walls of the vault did show signs of integrity failure based on the presence of numerous stains that were generated from shallow groundwater weeping through hairline cracks (see Photographs #1 and #2. The RAFFEX product however never came in contact with the hairline cracks observed on the walls of the vault. Cold joints made the transition from the floor to the walls of the vault. Based on the pooled water found within the vault, it was apparent that shallow groundwater was entering the vault through these cold joints. A sump was identified in the low part of the vault floor which was used to pump water out of the vault. Based on the presence of water within the vault, it appeared that the integrity of the vault was suspect (see Photograph #3). It was the opinion of ASE that if groundwater could come into the vault, water and RAFFEX may have the ability to leave the vault. ASE recommended collection of soil samples from this vault. Details of these samples are discussed in a later section of this report.

Photograph 1 - RAFFEX Tank Vault
Groundwater weeping through hairline cracks.

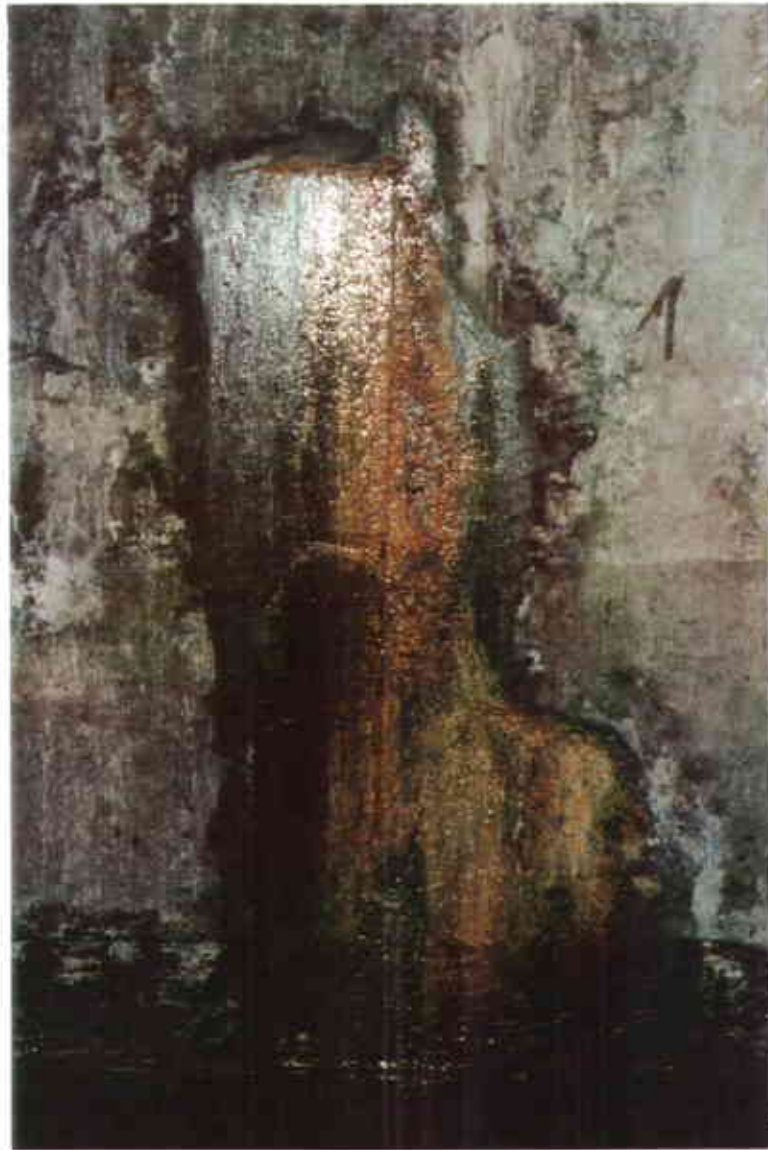
Photograph 2 - RAFFEX Tank Vault
Closeup of weeping crack.

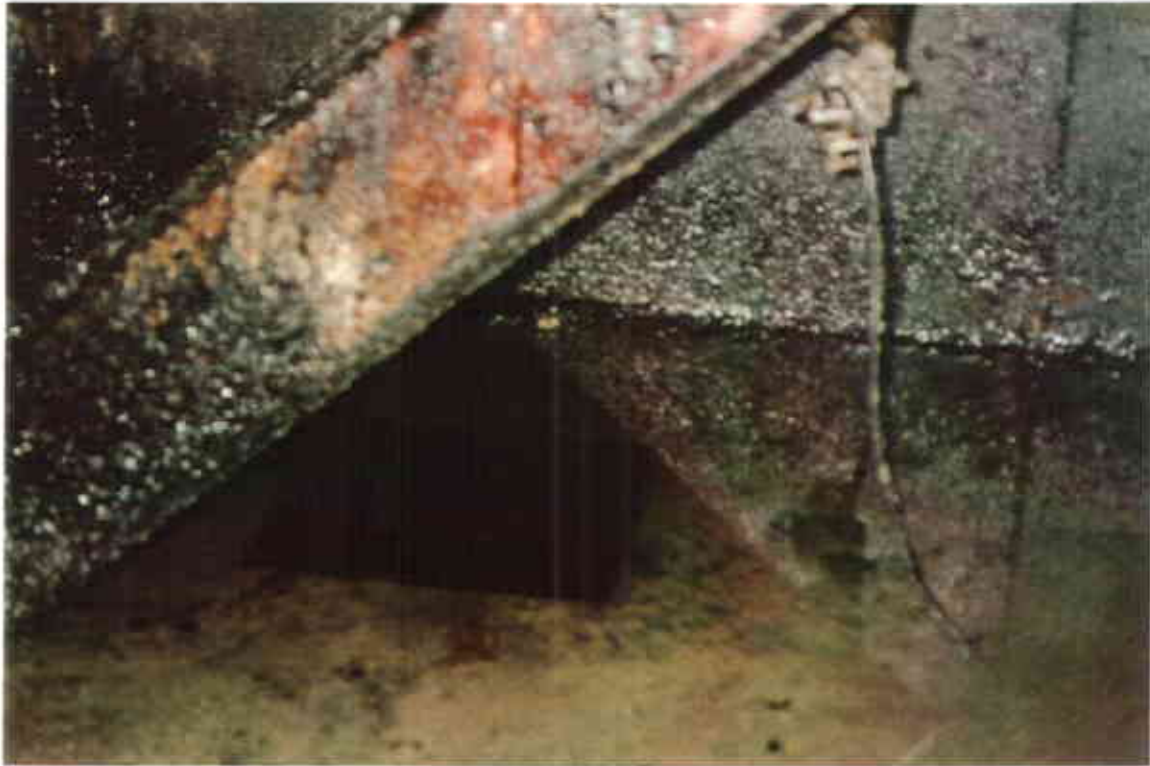
Photograph 3 - RAFFEX Tank Vault Sump

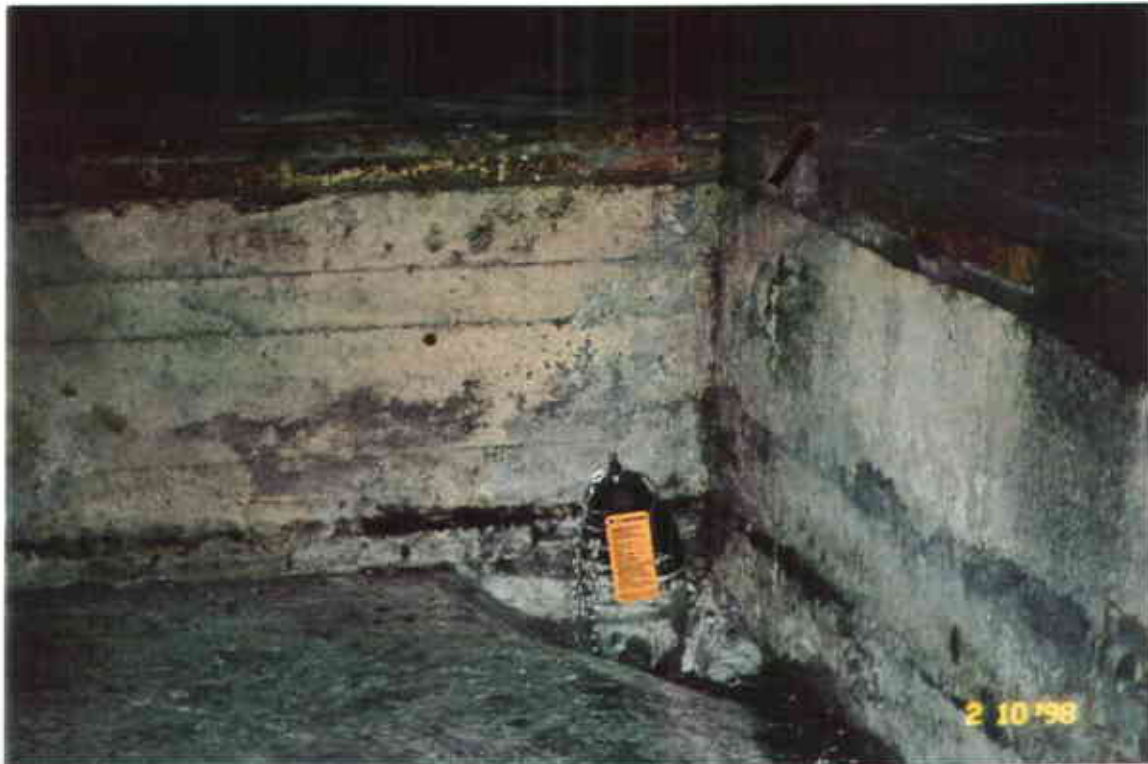
- The concrete bottom and sides of this pit appeared to be free of any evident or visible integrity failures such as cracks. This pit had a metal liner that was removed during decommissioning.
- Two (2) 4-inch diameter pipes were found exiting the pit. These exit pipes created a potential integrity failure situation that could have impacted the subsurface soil.

- Two electrical conduit boxes are located on the sidewall of the pit in two separate areas. The integrity of the boxes and conduits within them are a potential source of integrity failure.
- A 1/2-inch wide crack was observed at the edge of the pit/floor intersection. This crack is located adjacent to the location of one of the exit pipes within the pit which is apparently piped to the local sanitary sewer (see Photograph #4).
- Zinc Stearate was used exclusively in this area during the extrusion of the rubber product to inhibit the product from adhering to itself as it was stacked onto pallets. A copy of the MSDS for Zinc Stearate is included in Appendix B.

**Photograph 4 - Camelback Conveyor Pit
Plug inserted in exit pipe; arrow pointing to crack in floor.**

Based on ASE's inspection of the pit and the location of the proposed sampling locations, this pit was backfilled and resurfaced on February 12, 1998. ASE recommended that the subsurface soil be investigated by drilling soil borings and collecting soil samples on the outside of the pit in the areas of potential integrity concerns detailed above. Details of these samples are discussed in a later section of this report.

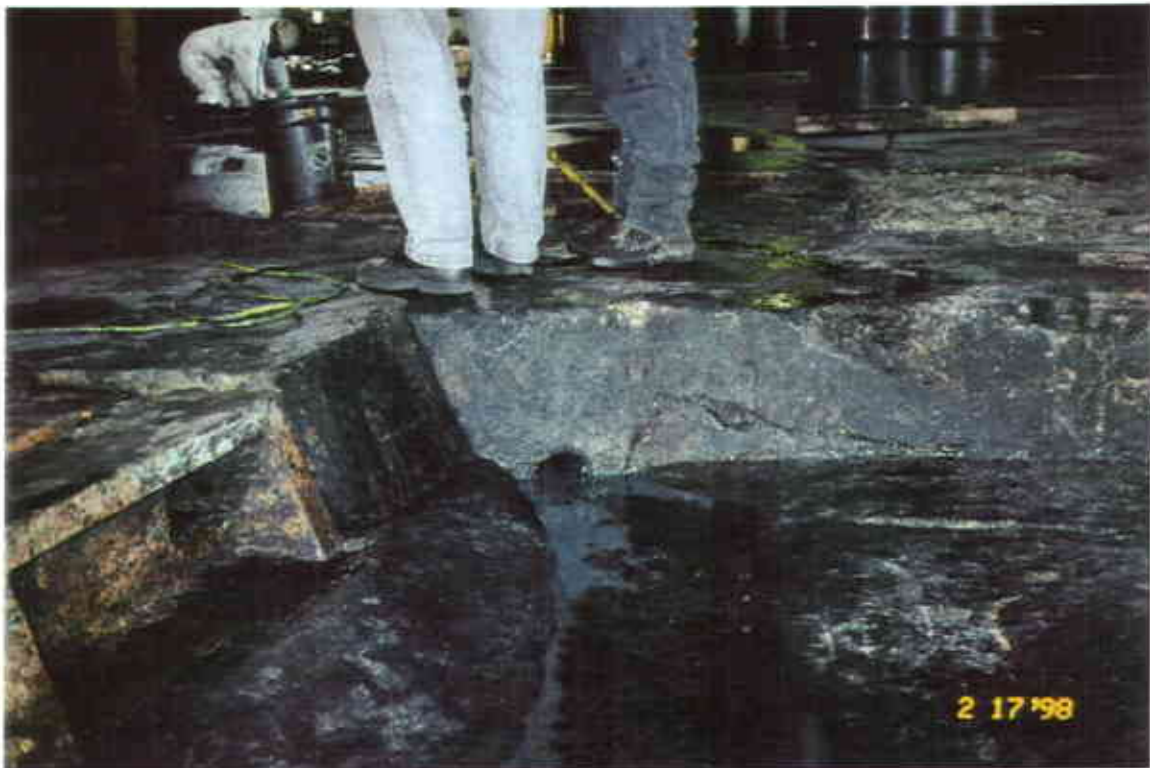
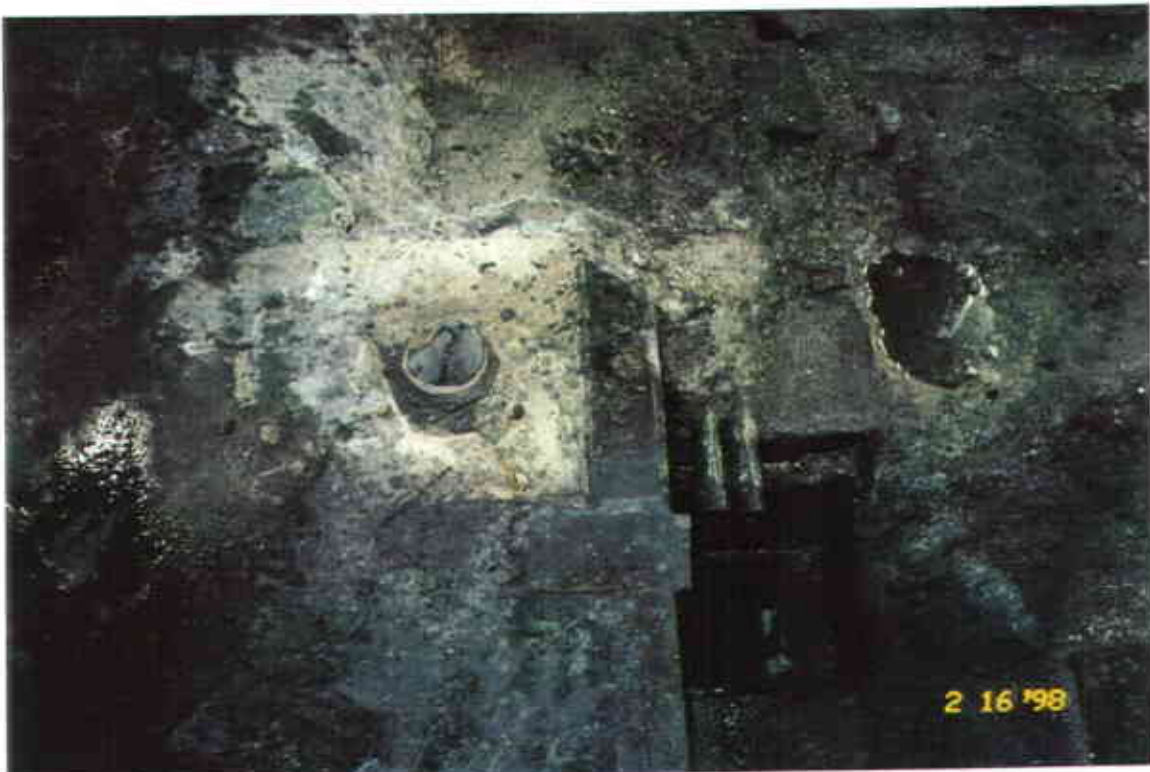
- The concrete bottom and sides of these pits appeared to be free of any evident or visible integrity failures such as cracks.
- Multiple pipes were found exiting these pits; the termination point of some of these pipes has not been determined. These exit pipes create a potential integrity failure situation that could have impacted the subsurface soil (see Photographs #5 and #6).

Photograph 5 - Milling Machine Pit Exit Pipes

Photograph 6 - Milling Machine Pit Exit Pipes

Based on ASE's inspection of these pits, the thickness of the concrete beneath the pits and the location of the proposed sampling locations, these pits were backfilled and resurfaced during the week of February 23, 1998. ASE recommended that the subsurface soil associated with these pits be investigated by drilling soil borings and collecting soil samples on the outside of these pits in the areas of potential integrity concerns detailed above. Details of these samples are discussed in a later section of this report.

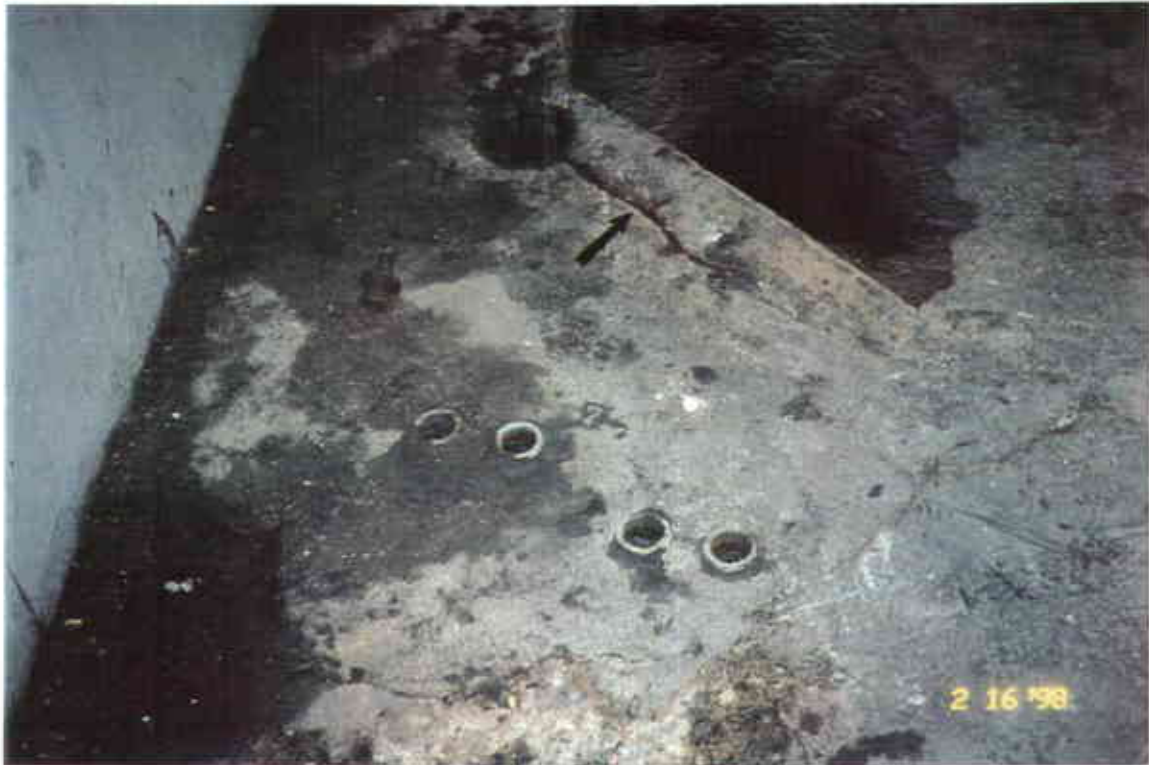
- Cracks found around the top surface of several of these pits were noted. The cracks are a potential sign of integrity failure (see Photograph #7).
- The concrete pits which housed these various milling machines are noted to be as much as 3-feet thick, but not less than 2-feet thick, with extreme amounts of structural steel rebar for reinforcement.

Photograph 7 - Milling Machine Pit Crack

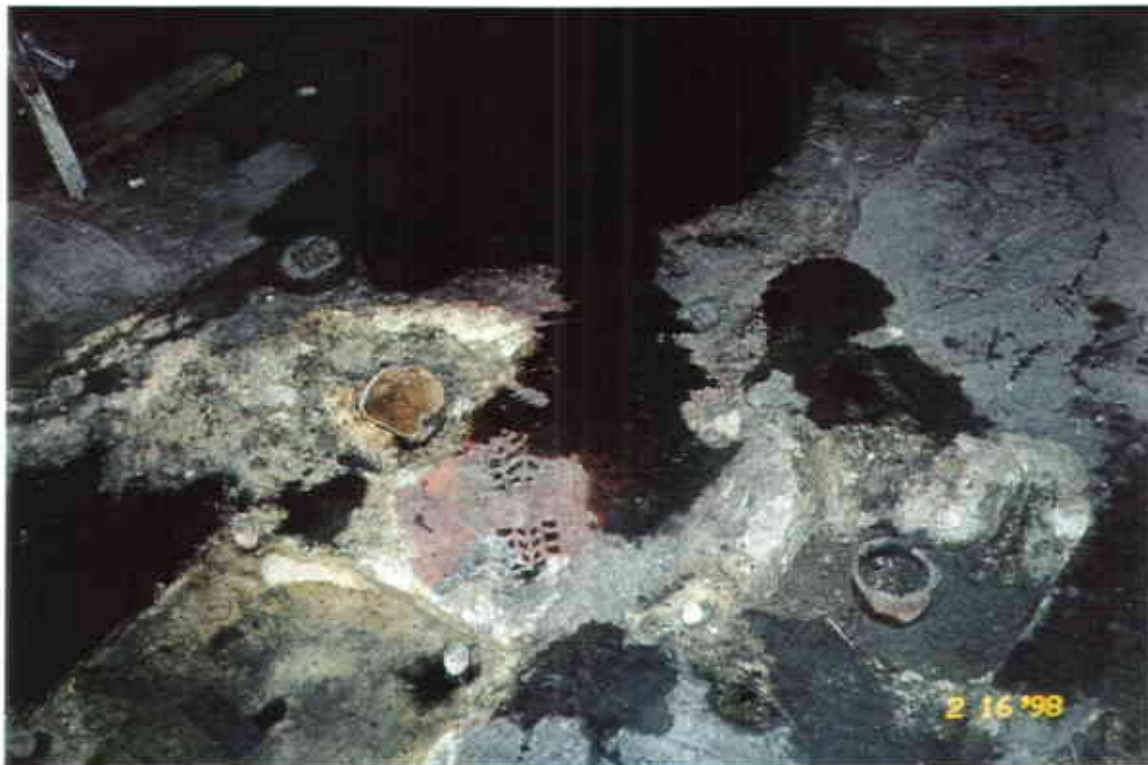
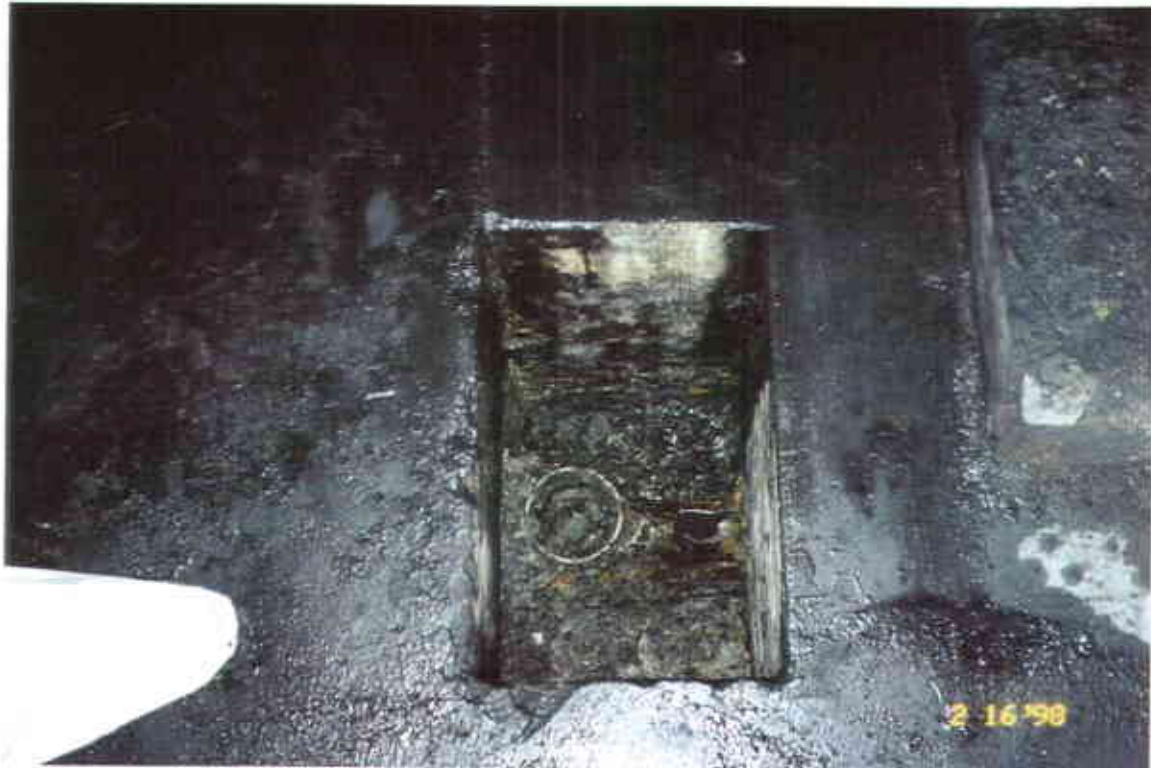
- The concrete bottom and sides of several small pits were inspected and found to have dirt bottoms, rather than concrete bottoms, creating a potential pathway for contaminants into subsurface soil (see Photograph #8 and #9).
- Multiple entry pipes existing related to the round pit associated with the 84-inch mill. Due to the unknown use of this pit, there exists a potential concern for subsurface contamination due to the pipes described above.

Photograph 8 - Pit with exposed soil bottom.

Photograph 9 - Pit with exposed soil bottom.

ASE recommended that the subsurface soil associated with these pits be investigated by drilling soil borings and collecting soil samples adjacent to these pits. Based on the sampling results, which are discussed in a later section of this report, ASE has recommended to ORCo that these pits be backfilled and resurfaced.

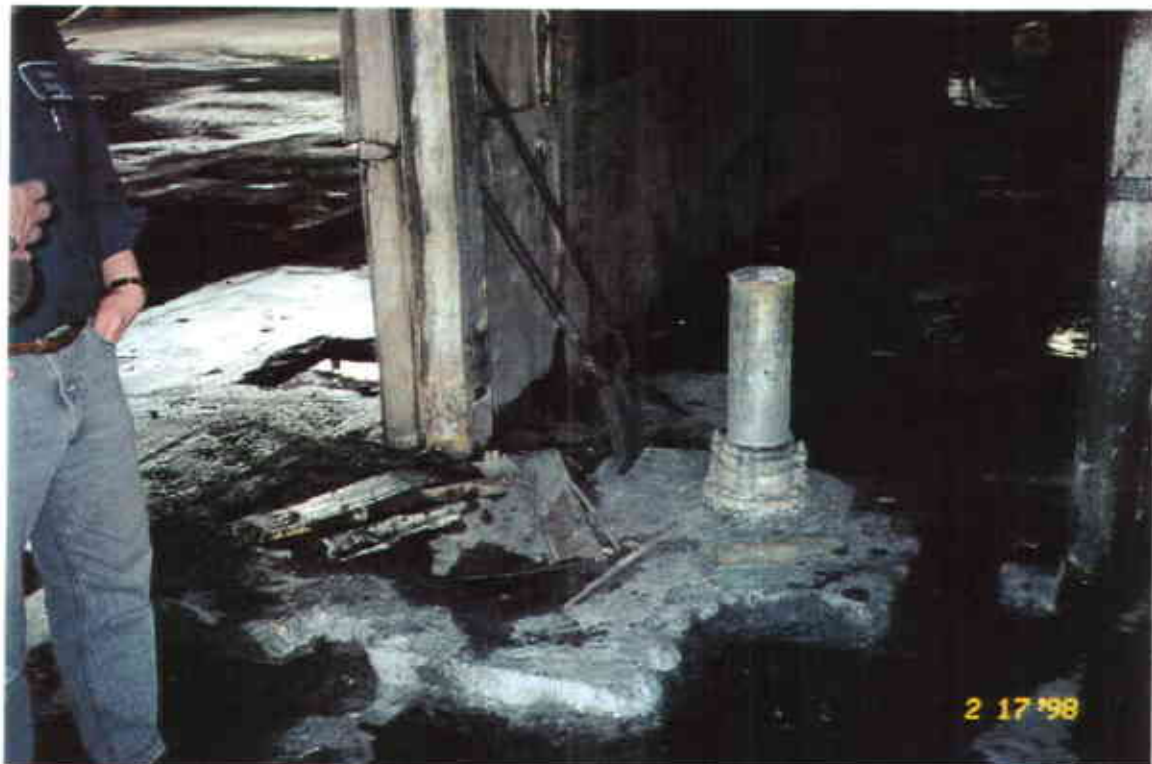
A pallet elevator was used at the site as depicted on Figure 2 and Photograph #10. The shaft of the elevator ended at a depth of 25-feet below ground surface. The shaft appeared to be in relatively fair shape upon its removal; however, the use of a soluble oil as the hydraulic fluid led to the possibility of subsurface soil contamination. Although hydraulic fluids are typically exempt as environmental concerns, ASE recommended a soil sample in this area to determine if the hydraulic ram/shaft had impacted the subsurface soil. Based on the sampling results, which are discussed in a later section of this report, ASE has recommended to ORCo that these pits be backfilled and resurfaced.

Photograph 10 - Pallet Elevator Shaft

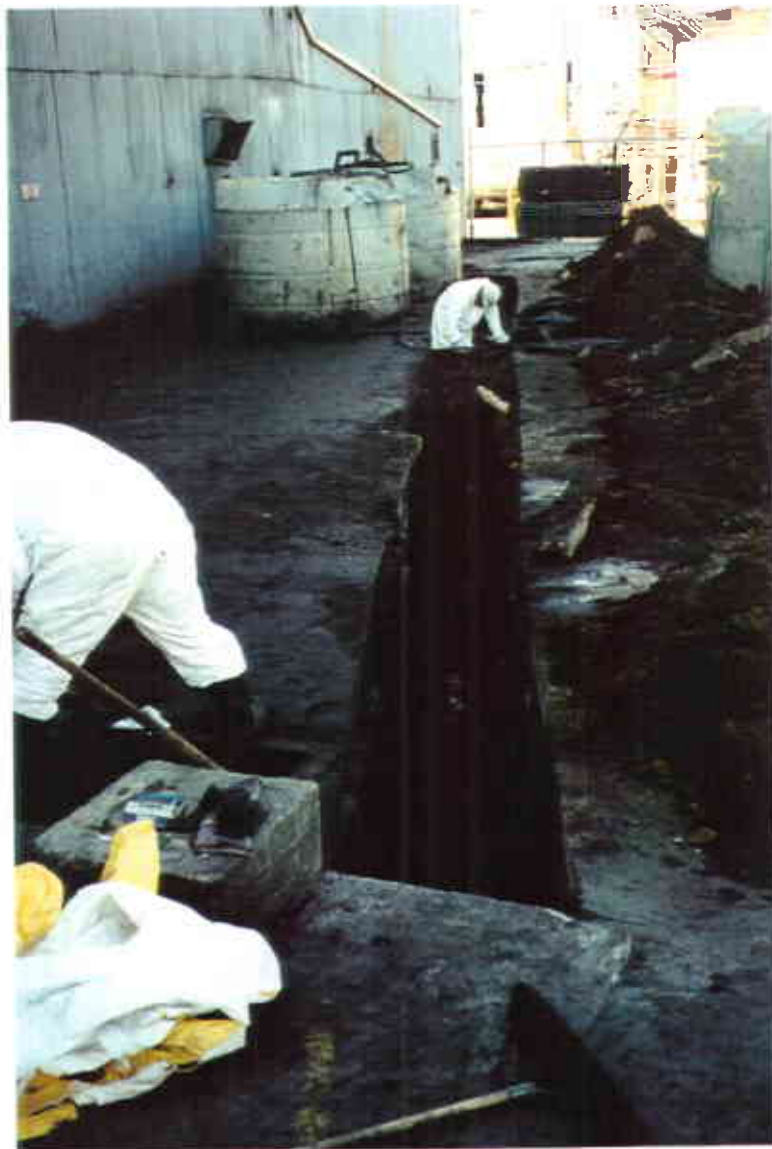
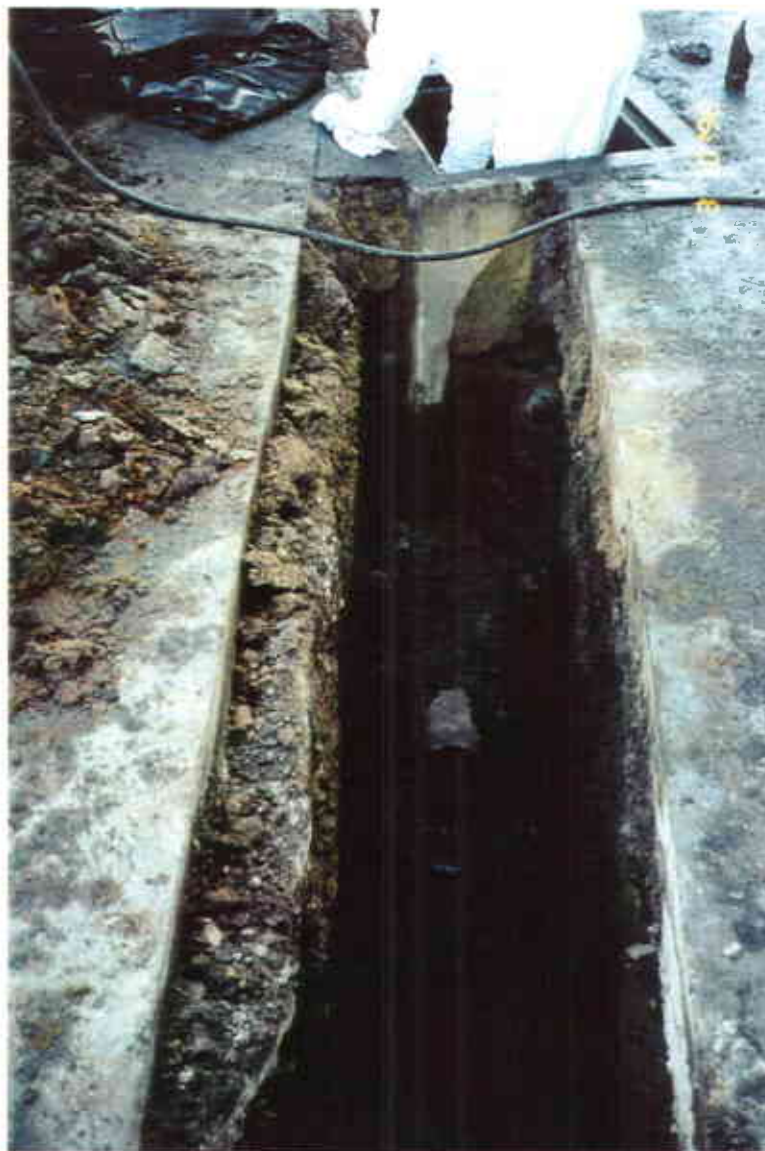
The offloading of the RAFFEX from tank trucks was performed at the RAFFEX offloading manifold as depicted on Figure 2. An underground steel pipe, contained in a secondary steel pipe, was used to transport the RAFFEX from the offloading area to the vaulted tanks. Since the subsurface beneath this pipe could not be inspected, ASE recommended soil samples to be collected upon the removal of this underground piping system. Details of these samples are discussed in a later section of this report.

Photograph 11 - RAFFEX Underground Pipeline Removal

Photograph 12 - RAFFEX Underground Pipeline Removal
