ALAMEDA COUNTY  
HEALTH CARE SERVICES

Subject: SLIC Case Closure; Stone Boat Yard, 2517 Blanding Avenue, Alameda; Case No. [REDACTED]

**CASE CLOSURE SUMMARY  
SPILLS, LEAKS, INVESTIGATION, AND CLEANUP PROGRAM**

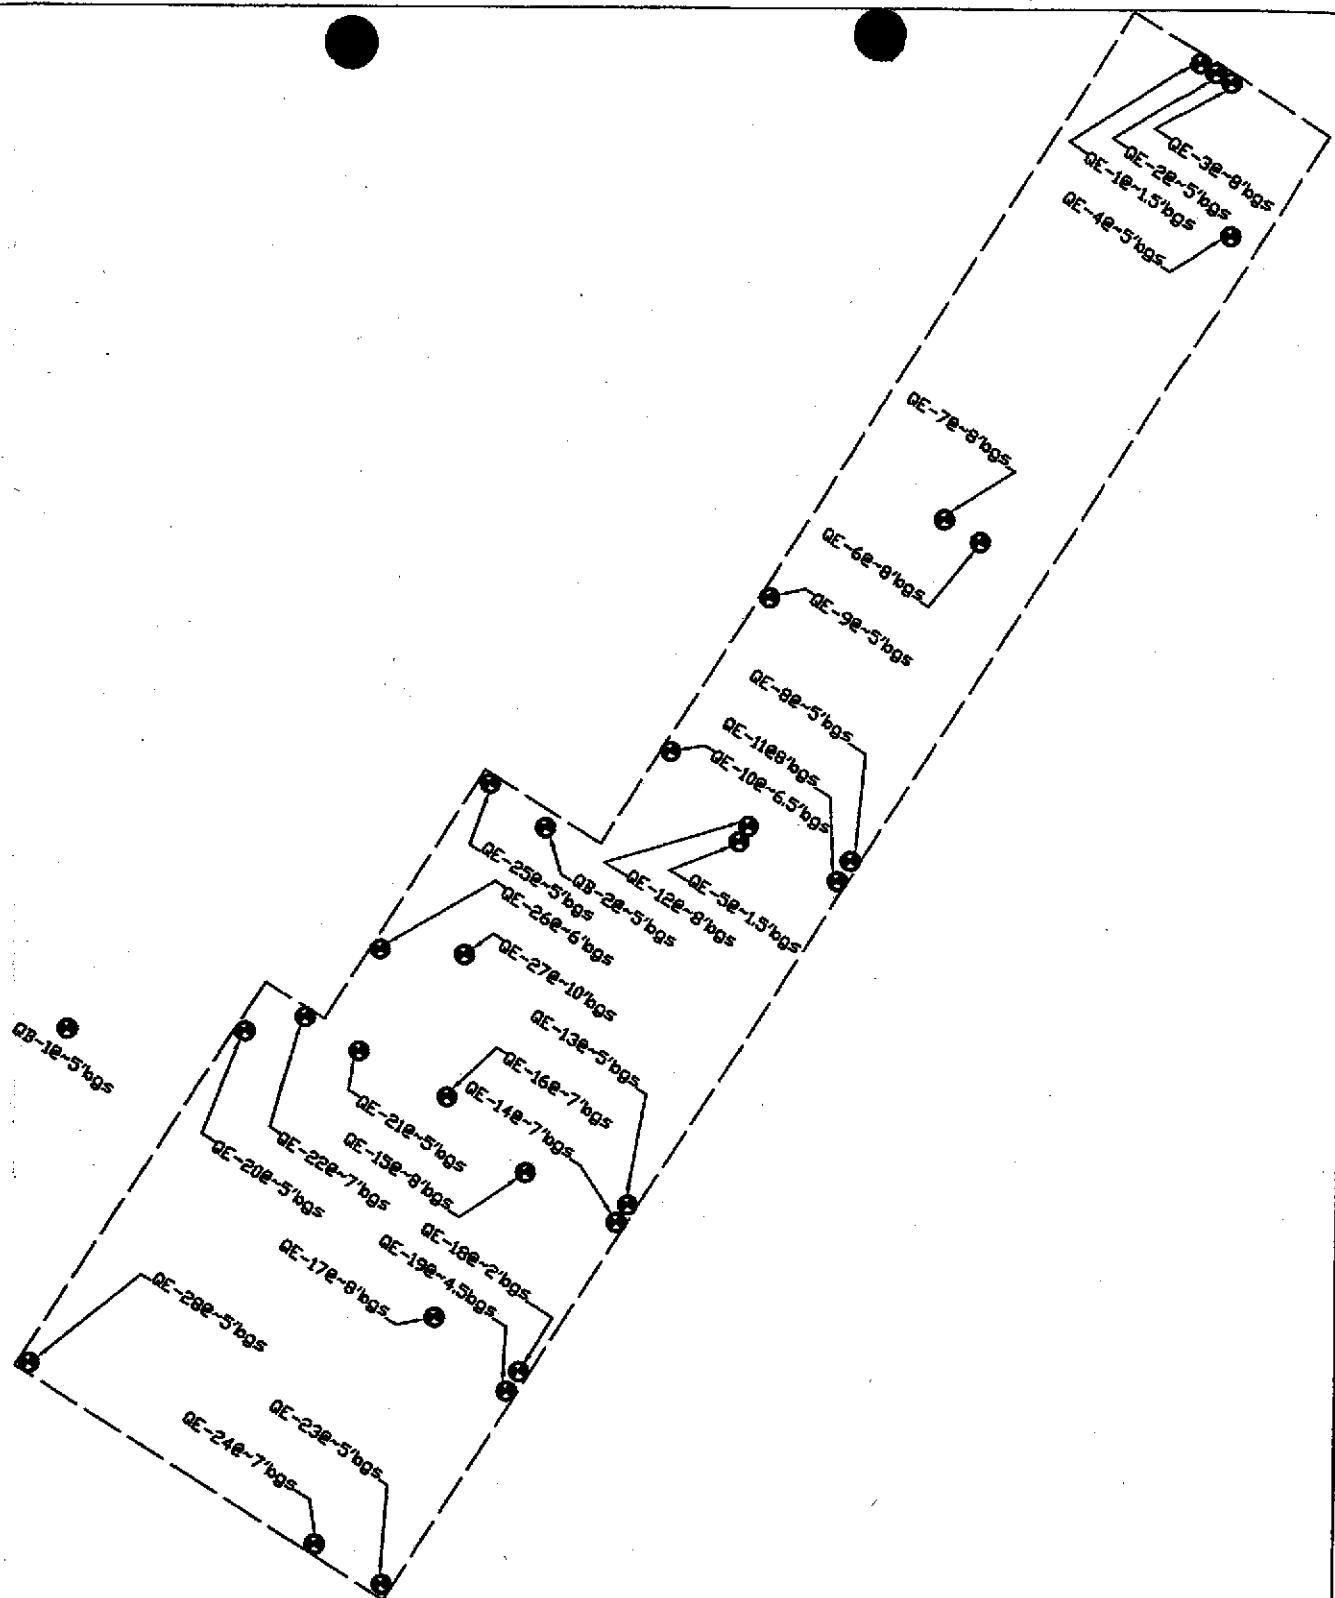
**Stone Boat Yard  
 Excavation B  
 Sampling Plan  
 Alameda, California**

● QE  
Sample Location

Table 3. Results of Analytical Testing for Excavation Soil Samples- Excavation B

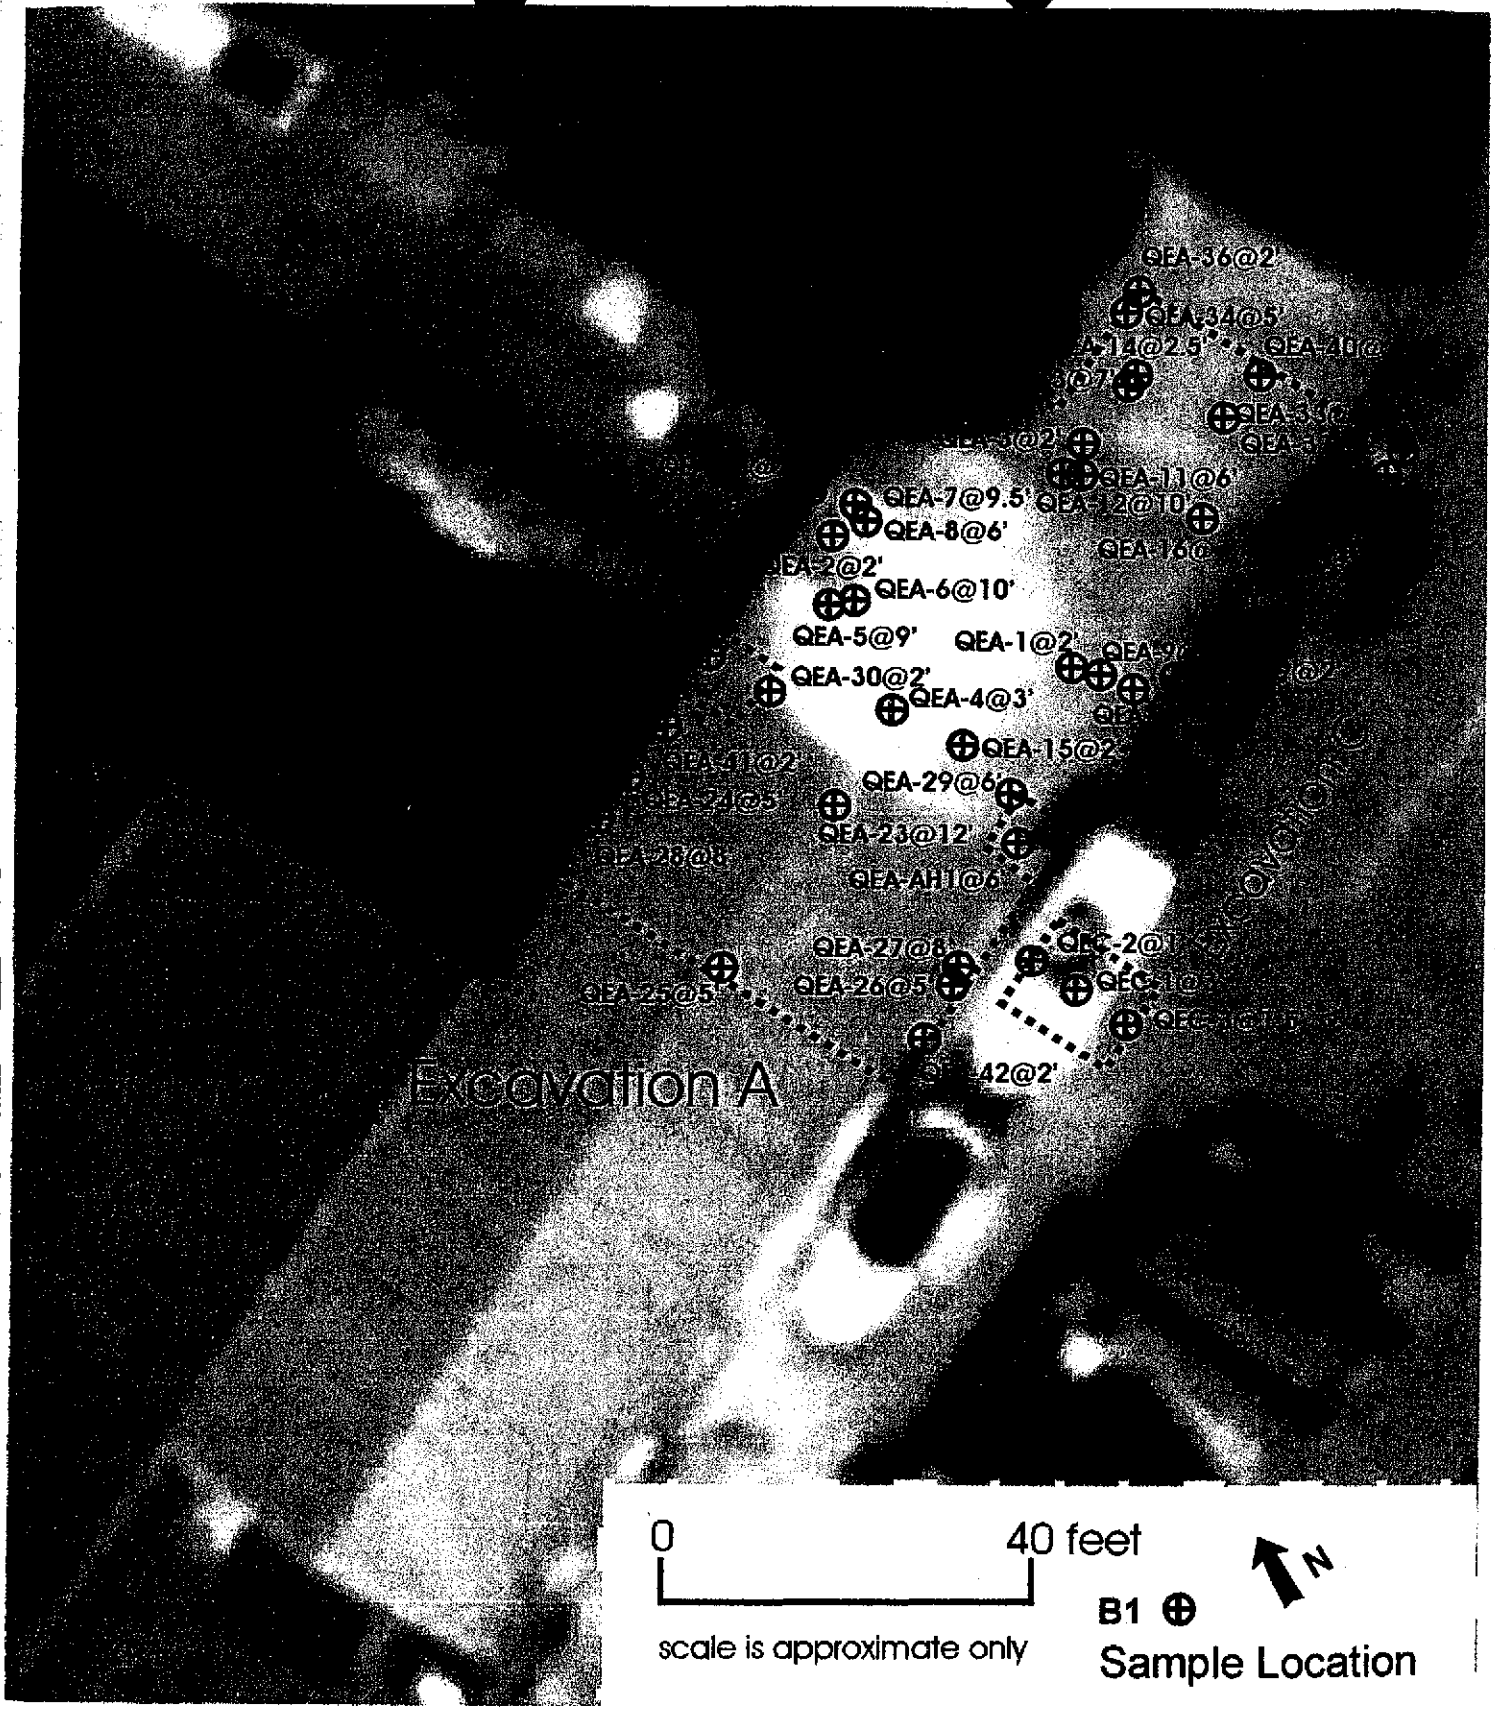
Stone Boat Yard  
 Excavation A and C  
 Sampling Plan  
 Alameda, California

Excavation A

Sample Location

Table 2. Results of Analytical Testing for Excavation Soil Samples- Excavation A
