*Phase 1 Update*

*Environmental  
Investigation*

*Stone Boat Yard  
Alameda, California*

*Project #240165*

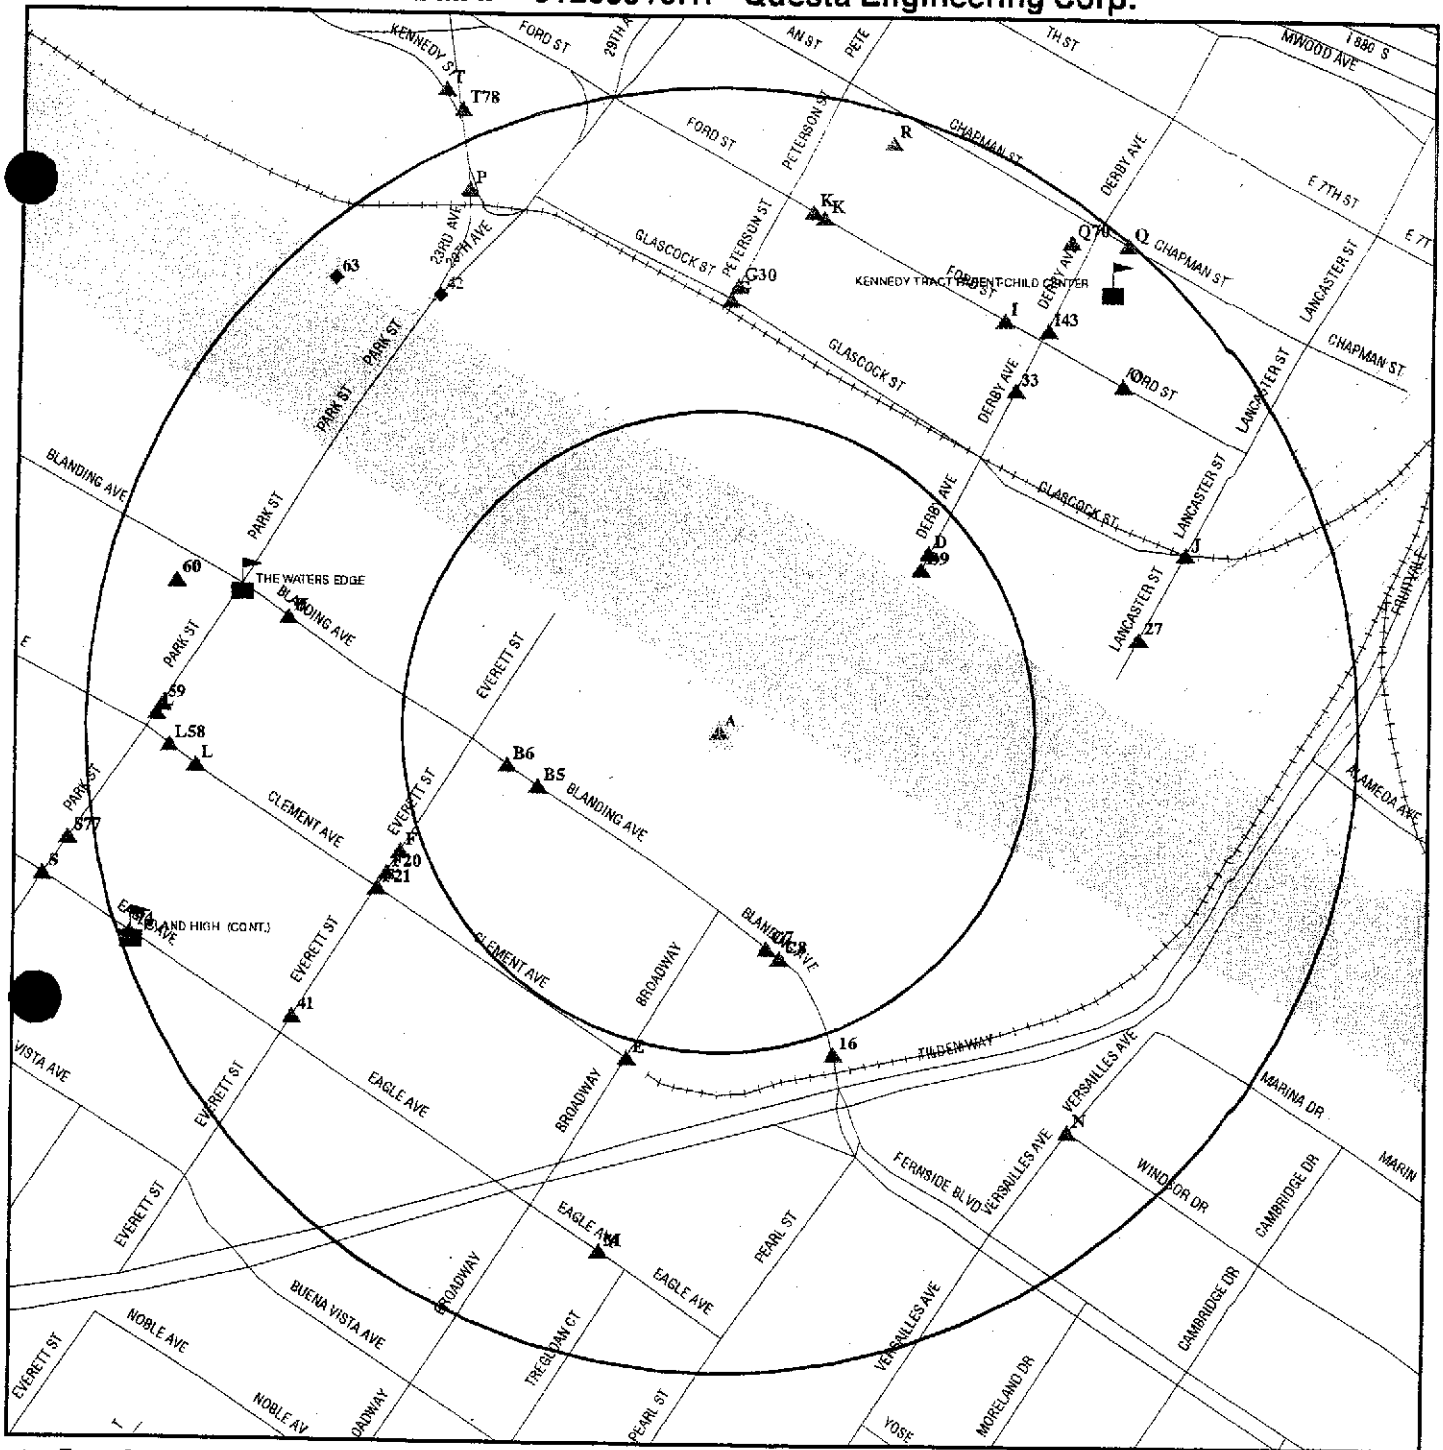
# DETAIL MAP - 01269910.1r - Questa Engineering Corp.

**TARGET PROPERTY:** Stone Boat Yard  
**ADDRESS:** 2517 Blanding Avenue  
**CITY/STATE/ZIP:** Alameda CA 94501  
**LAT/LONG:** 37.7698 / 122.2340
