**Subject: Transmittal of Underground Storage Tank Removal Report
700 Independent Road, Oakland, California**

**SUBJECT: Underground Storage Tank Removal Report
700 Independent Road, Oakland, California**

700 INDEPENDENT ROAD
 OAKLAND, CALIFORNIA
 PROJECT NO. 54504-EAA

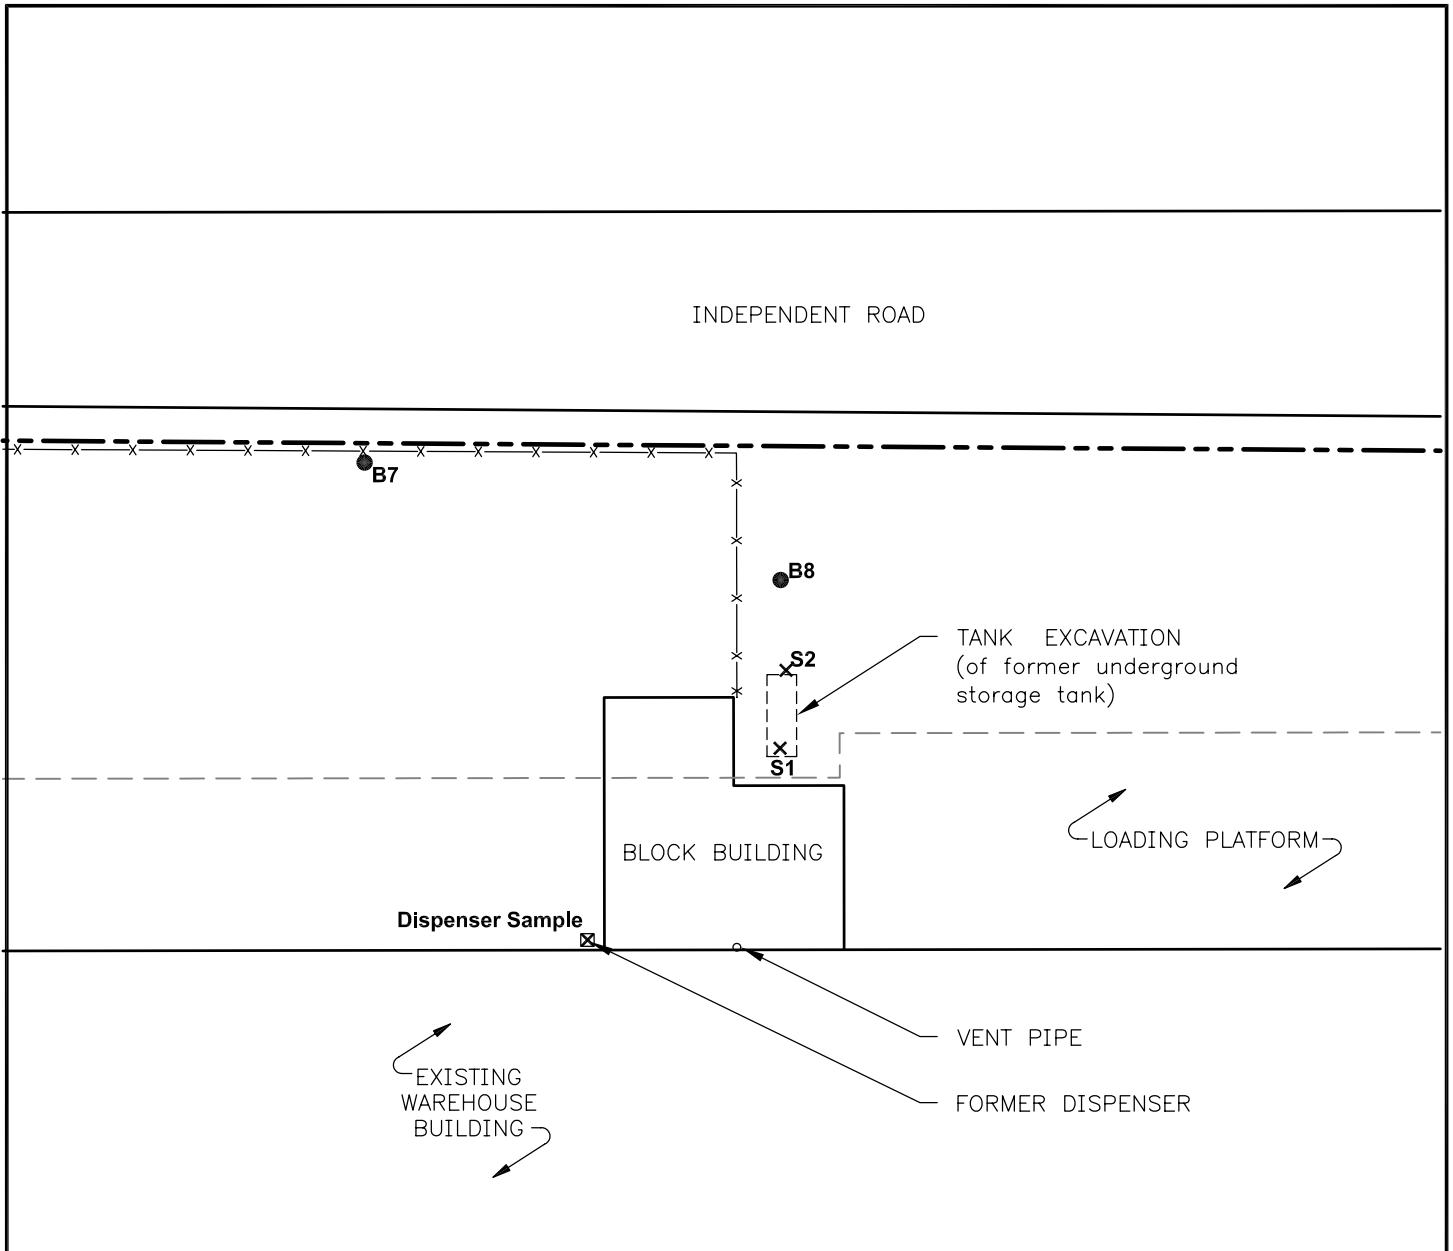
SITE PLAN: DETAIL

At Mr. Gomez's direction, Kleinfelder collected four soil samples following the UST removal, locations of which are shown on Plate 3. Sample S1 was collected from the south end of the former tank location, and sample S2 was collected from the north end of the former tank location. Samples from the UST excavation were collected from approximate depths of 8 ft bgs. From ground surface to an approximate depth of four feet bgs, soils in the excavation consisted of sandy materials. Below four feet bgs, clays were observed surrounding the tank.

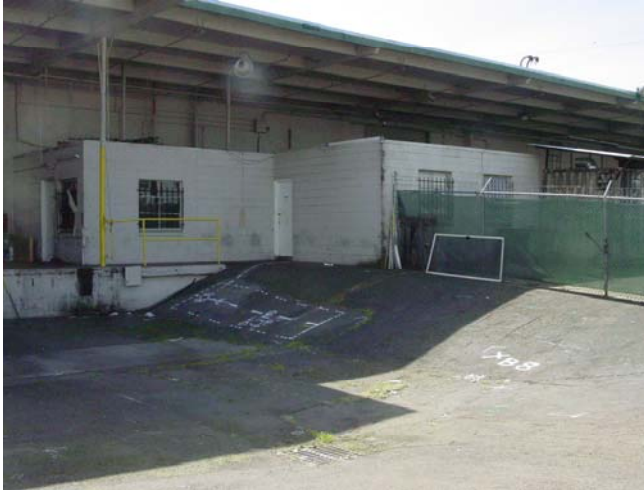
PHOTO 1. March 16, 2005, Geophysical survey estimation of spray paint UST location and boring location B8 (by Golder Associates, August 2004)

On March 16, 2005, Kleinfelder and a utility subcontractor, Norcal Geophysical (Norcal), visited the site and performed a geophysical survey of the site, particularly in the region of the suspected fill-port observed by Golder, and the impacted soil samples they collected and analyzed.

Using a combination of field observations, hand-held metal-detection, ground penetrating radar, and electromagnetic line locating methods, Norcal concluded that a UST existed below the observed fill-port. The depth of the bottom of the UST was determined to be approximately 7.5 feet below the lip of the fill-port, and the top of the UST was estimated to be at a 3.5-foot depth from the fill-port lip. The UST's size was estimated to be approximately four feet wide, 14 feet long, and 1,300-gallons in capacity. The UST was believed to contain approximately 400 gallons of product suspected to be gasoline.

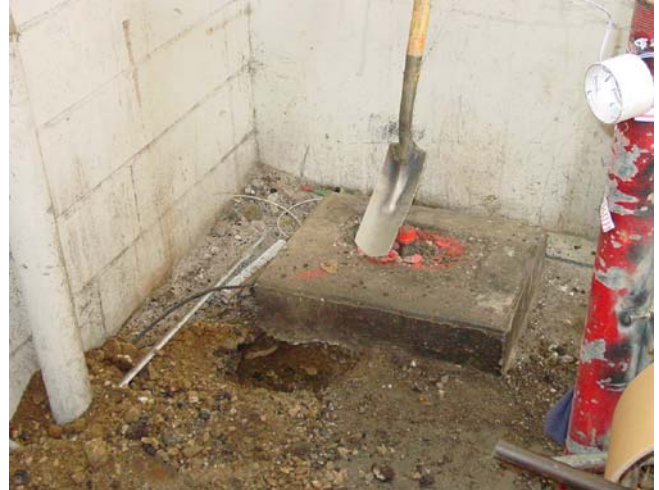
PHOTO 2. Concrete dispenser foundation located west of the block building. The sample identified as "Dispenser" was collected adjacent to the foundation.

An additional sample was collected from the fuel dispenser (photo 2, Plate 4) and was identified as "Dispenser." This sample was collected from an area immediately adjacent to the foundation of the former dispenser, at an approximate depth of eight inches bgs.

The sample collected from the former dispenser location was found to contain 246 mg/kg TPH-d and 0.185 mg/kg TPH-g. Aromatic hydrocarbons were not detected in the Dispenser sample. LUFT metals detected included chromium (23 mg/kg), lead (15 mg/kg), nickel (28 mg/kg), and zinc (67 mg/kg). ESLs were not exceeded for any chemicals in this sample.

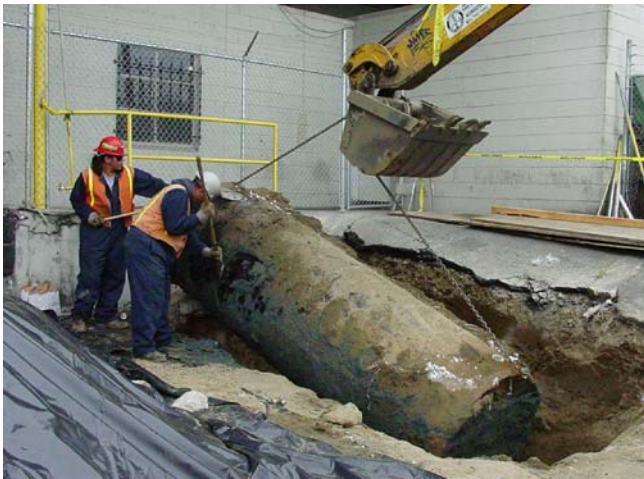
PHOTO 3. Tank is shown as it is being lifted out of pit by excavator.

GGTR lifted the tank out of the excavation by wrapping a chain around its perimeter and attaching it to the excavator (Photo 3). GGTR then placed the tank on a flatbed truck licensed for transporting hazardous waste (Photo 4), and the tank was subsequently transported to Ecology Control Industries in Richmond, California for disposal.

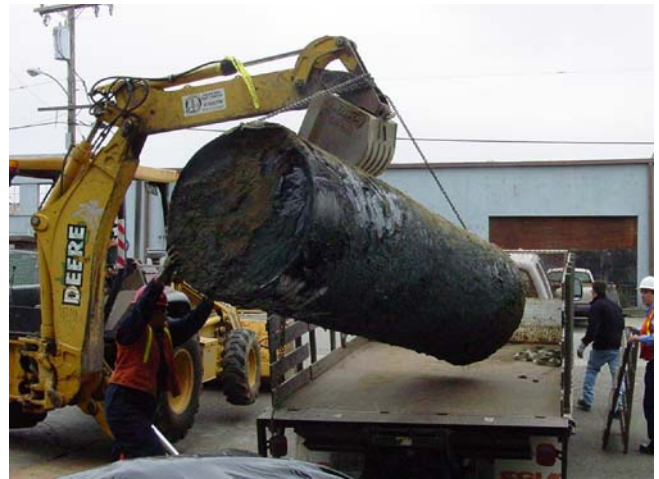
PHOTO 4. Tank is shown being loaded onto the truck bed.

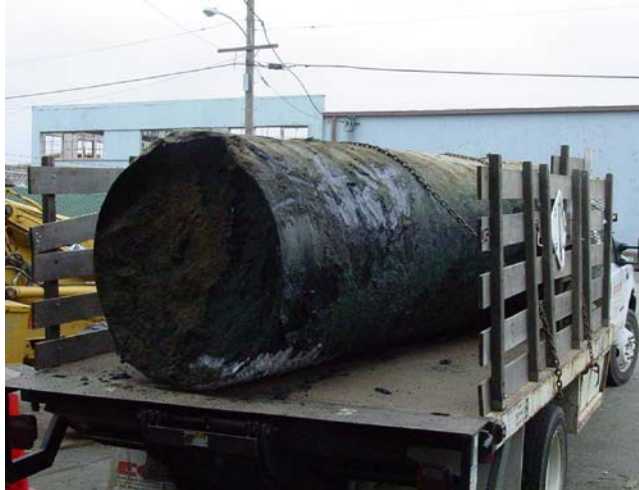
PHOTO 5. Tank is secured onto truck bed prior to its transport to Ecology Control Industries in Richmond, California.

The 1,100-gallon UST, along with associated piping and debris, were hauled off-site by GGTR on August 17, 2005 and transported to Ecology Control Industries in Richmond, California for disposal. Waste manifests are included in Appendix C.

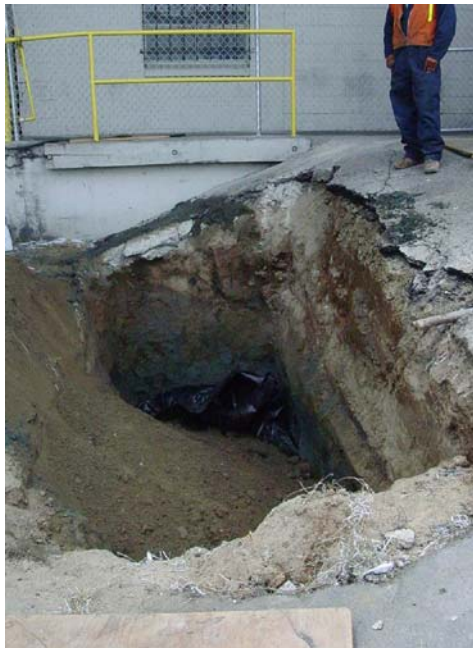
PHOTO 6. On August 17, 2005, the UST excavation was temporarily filled with clean backfill soil, which was separated from potentially impacted soil using Visqueen plastic sheeting. The excavation was backfilled and compacted on September 15 and 16, 2005.

Following sampling, the 24 cubic yards of excavated soil was placed on visqueen plastic back into the excavation to support the sidewalls of the excavation pending analytical results. For security, the top of the excavation was covered with 1-1/8-inch boards of plywood, and the work area was enclosed with construction hazard tape.

On September 15 and 16, 2005, Kleinfelder and GGTR returned to the site to backfill and compact the excavation. All soils which had been temporarily placed inside the excavation pending analytical results were removed, along with the plywood and visqueen plastic sheeting. The imported soil was then placed into the bottom of the excavation up to an approximate depth of 5 ft bgs, and compacted by GGTR. Original soil taken from the excavation was then backfilled from 5 ft bgs to the surface in 8 to 10-inch lifts. On September 16, 2005, GGTR resurfaced the sidewalk with asphalt.

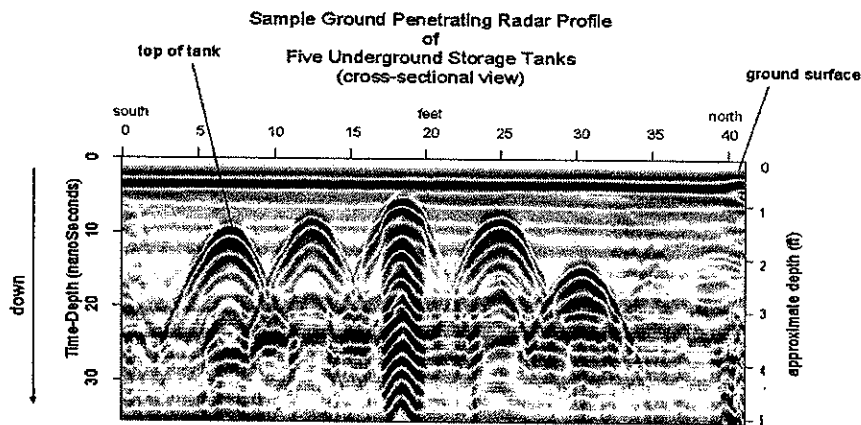
subsurface objects producing reflections, the horizontal banding is disrupted. Discrete objects typically produce reflections having the appearance of inverted “U”s, forming what are known as “hyperbolic reflections”. Metallic objects often produce markedly strong reflections, in many cases forming multiple reflections appearing as a series of inverted U’s cascading down the record. Non-metallic objects can produce similar reflections, but the multiples are typically much weaker.

A sample profile from a different site with five adjacent steel USTs is presented below:
