UNDERGROUND FUEL STORAGE TANK-RELATED CORRECTIVE ACTION REPORT

**2836 UNION STREET
OAKLAND, CALIFORNIA**

**THE ESTATE OF LAWRENCE WADLER
2525 MANDELA PARKWAY
OAKLAND, CA 94607**

**STELLAR ENVIRONMENTAL SOLUTIONS, INC.
2198 SIXTH STREET, SUITE 201
BERKELEY, CALIFORNIA 94710**

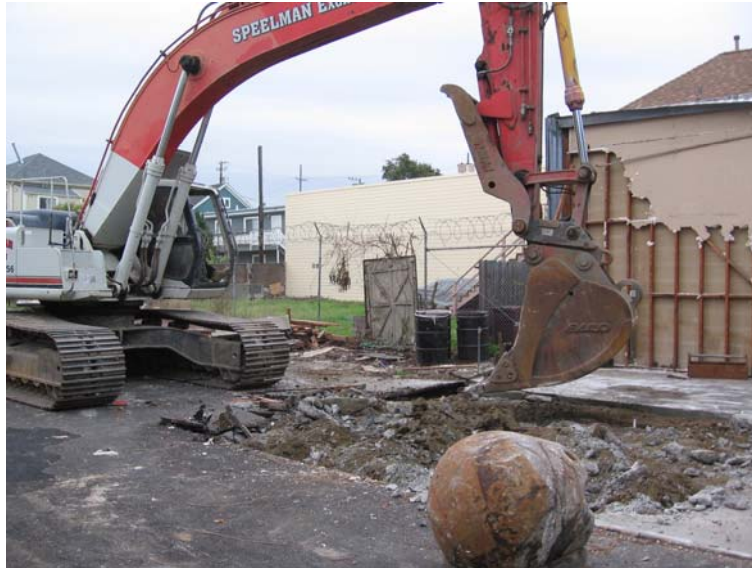
Photo No.: 01

Subject: Beginning of the excavation; breaking the concrete.

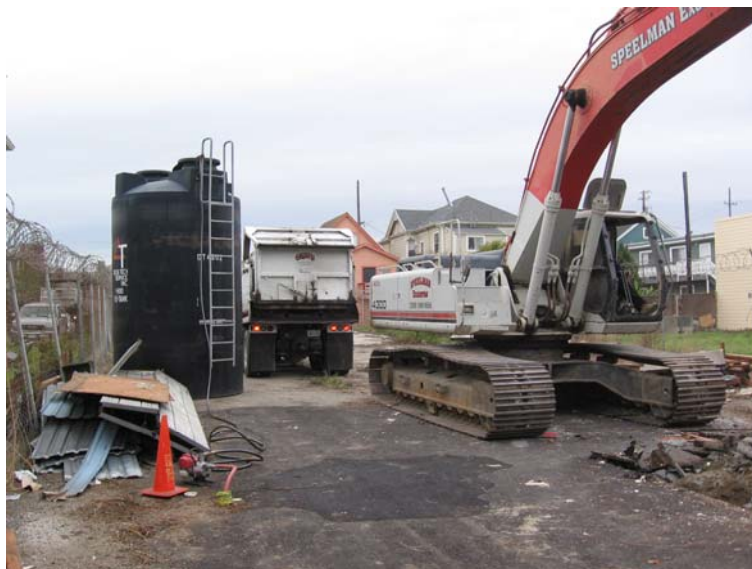
Photo No.: 02

Subject: View of the dewatering.

Groundwater in the immediate area ranges from 6 to 8 feet bgs; therefore, to prevent groundwater infiltration during excavation activities, the area was dewatered via a temporary dewatering point located about 8 feet south of the current excavation in the backfill of the October 2006 excavation. As a result of dewatering, no significant quantities of groundwater infiltrated from the walls or upward from the excavation floor during the excavation activity.

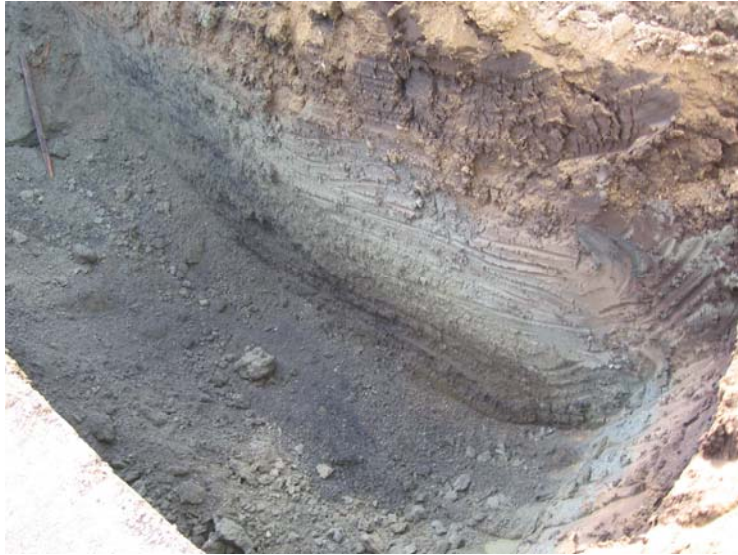
Photo No.: 03

Subject: View of the excavation pit.

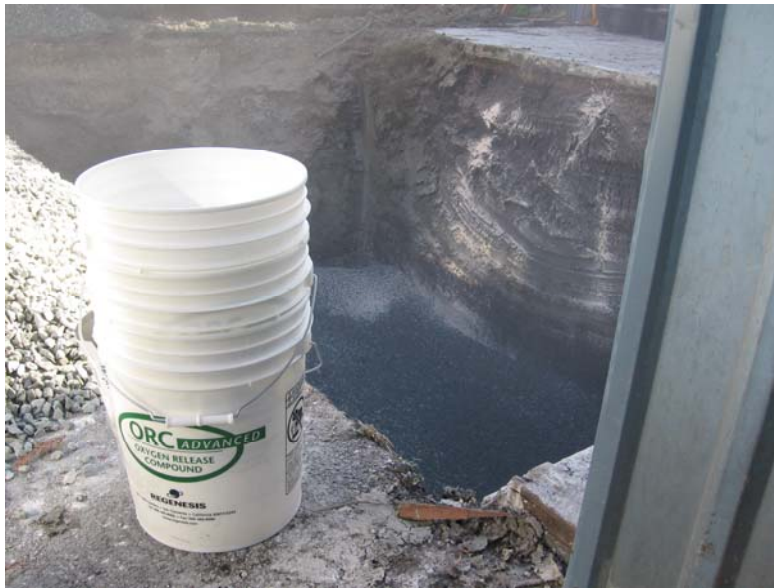
Photo No.: 04

Subject: Introduction of ORC.

On November 27, 2007, ORC Advanced™ was applied to the open excavation. A total of 375 pounds of product was applied to the excavation in three separate lifts—each containing 125 pounds of ORC Advanced™ mixed with 35 gallons of water. (ORC Advanced™ develops a toothpaste-like consistency when mixed with water.) The first application was placed on the bottom of the excavation and mixed using the excavator bucket. Drainrock was emplaced in the base of the excavation to a height of approximately 9 feet below grade (sufficient to bridge any infiltrating groundwater and water added with ORC Advanced™, and to also allow for sufficient compaction). This was followed by the second application of ORC Advanced™, followed with drainrock to 8 feet bgs, and then the final ORC Advanced™ application.

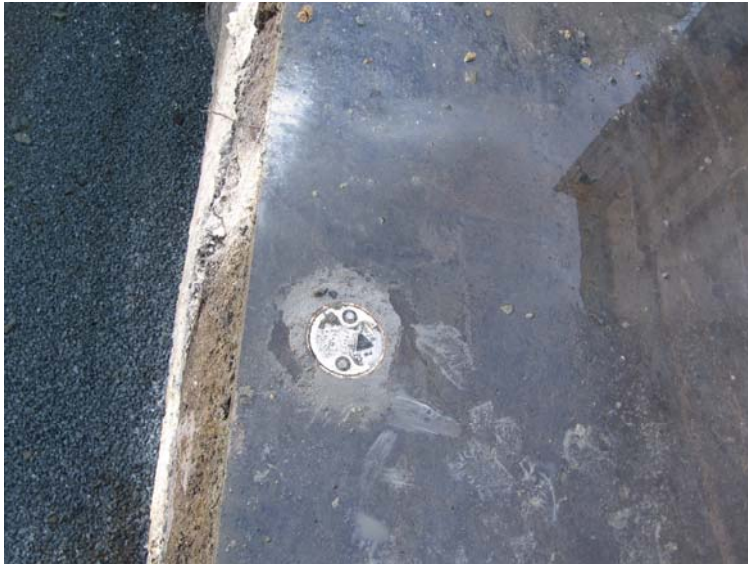
Photo No.: 05

Subject: View of monitoring well MW-5B, not destroyed during the excavation.

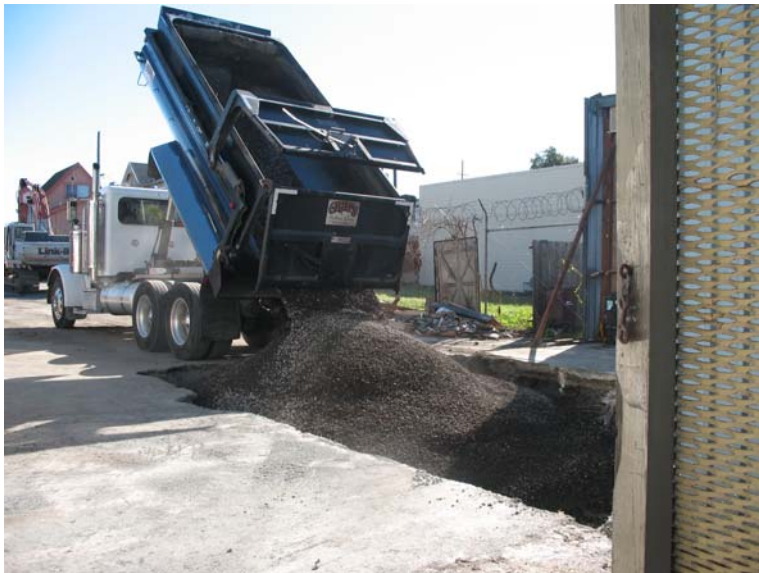
Photo No.: 06

Subject: Backfilling the excavation.

Backfilling was conducted on November 29, 2007. ORC Advanced™ product was applied during backfilling to a depth of 8 feet bgs (discussed in Section 4.0). Drain rock (59.93 tons) was placed in the base of the excavation to a height approximately 5 to 6 feet below grade (to bridge infiltrating groundwater). The remainder of the excavation was backfilled with 146.11 tons of Class 2A/B clean imported fill having a predominant silt/clay-size and relatively low permeability to a depth of 3 inches bgs. The excavation was backfilled in approximately 1-foot lifts, and each lift was compacted with a whacker-type compacter mounted on the excavator. The excavation was resurfaced to existing grade with asphalt by J.W. Riley & Son, Inc. on December 7, 2007.

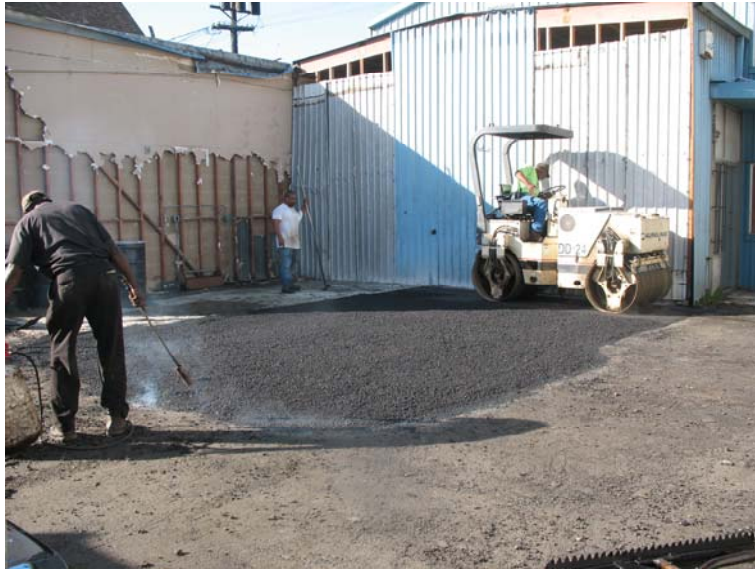
Photo No.: 07

Subject: Repaving the excavation

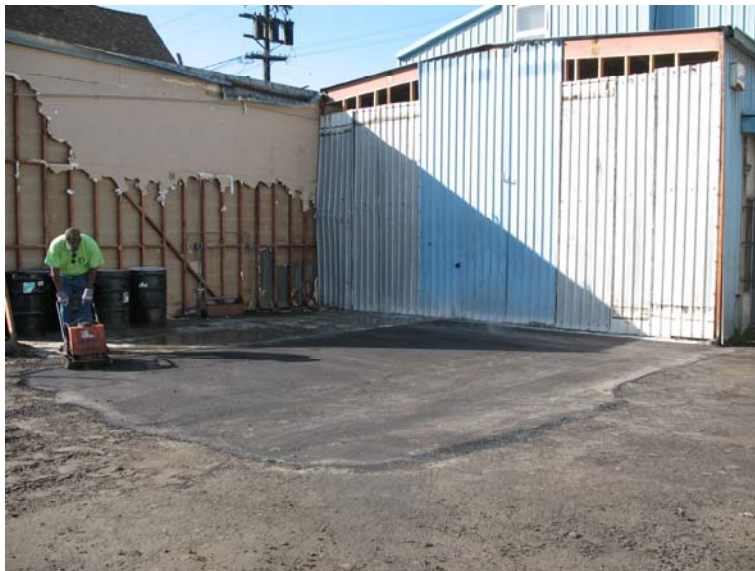
Subject: View of the completed repave.

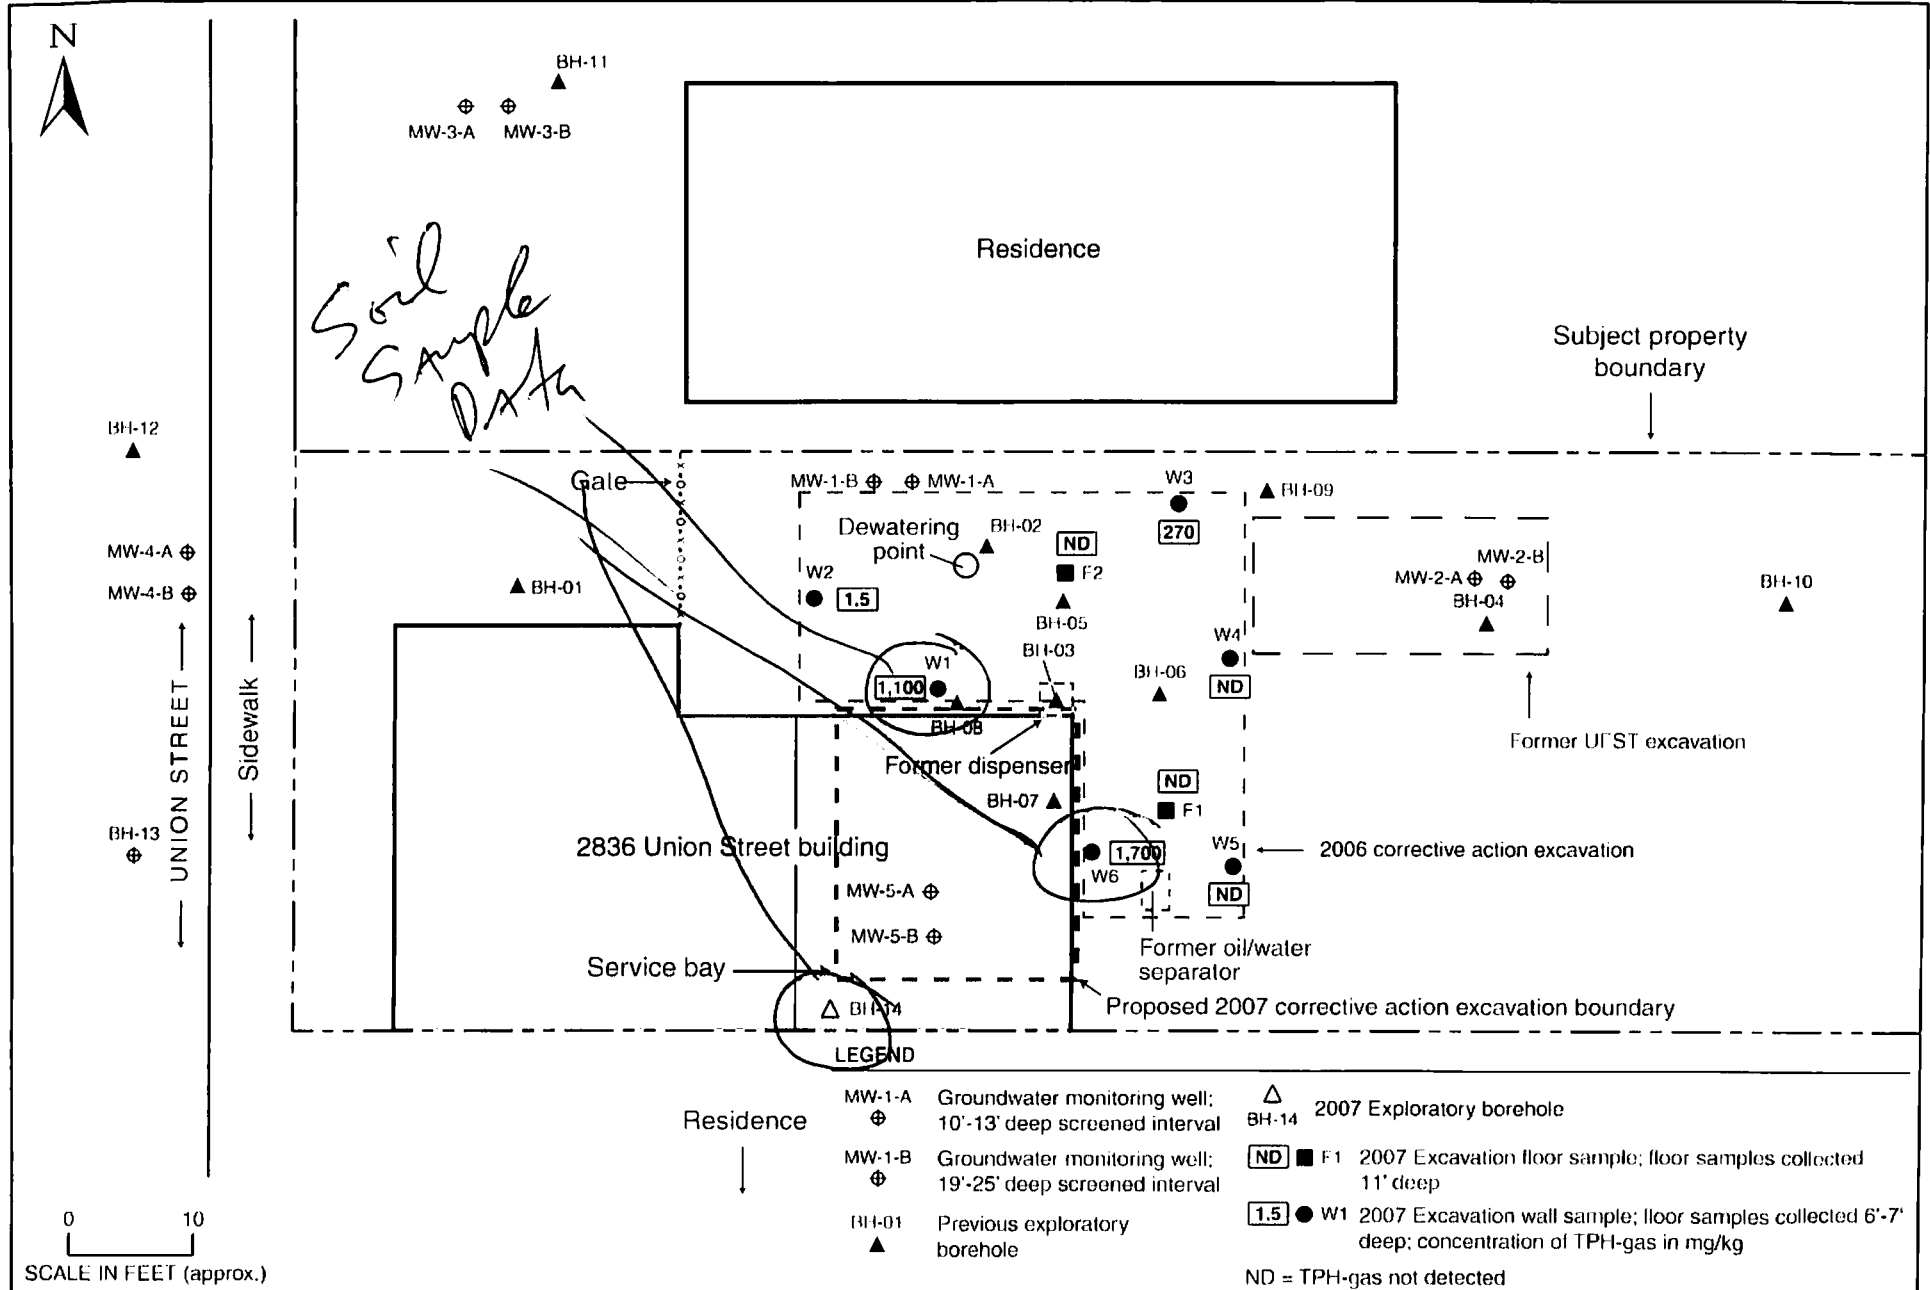
Figure 1

PROPOSED 2007 CORRECTIVE ACTION EXCAVATION
2836 Union Street, Oakland, CA
