UST-RELATED SUBSURFACE SITE INVESTIGATION

**1001 77TH AVENUE
OAKLAND, CALIFORNIA**

Subject: Report of Findings for UST-Related Subsurface Site Investigation
1001 77th Avenue, Oakland, California

Project No. 2005-51

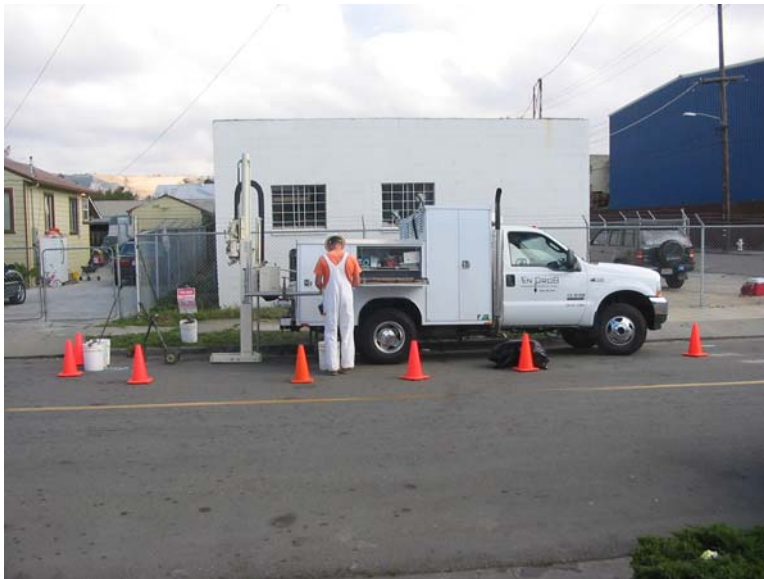
Photo No.: 02

Subject: View south, across Spencer Street, of drill rig set up at drilling location BH-07.

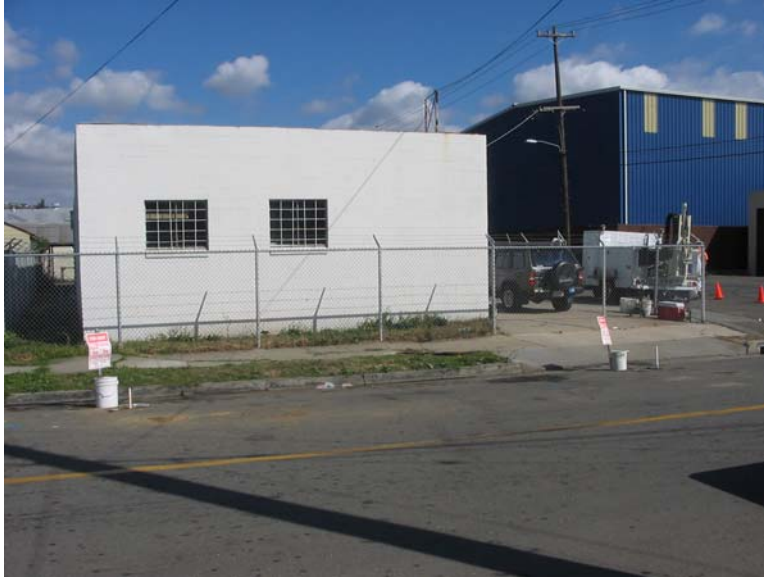
Photo No.: 03

Subject: View south, across Spencer Street, showing borehole locations BH-07 (at left) and BH-06 (at right).

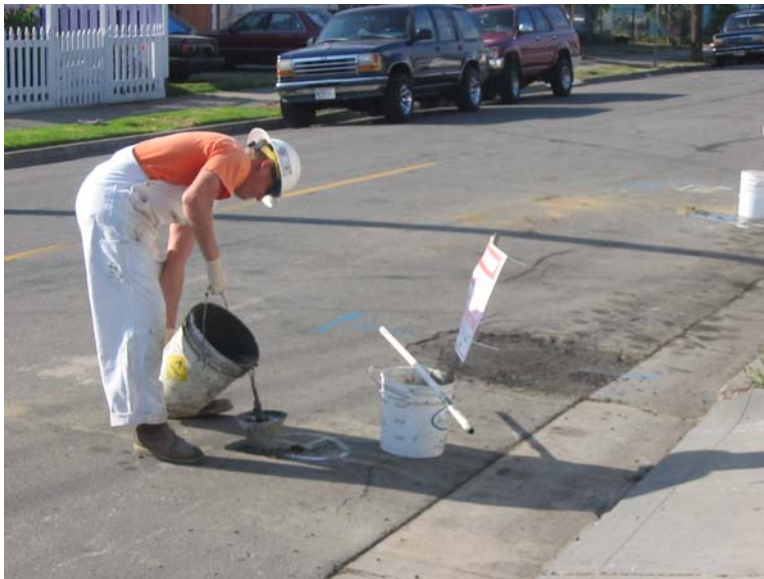
Subject: Grouting borehole BH-06 in Spencer Street.

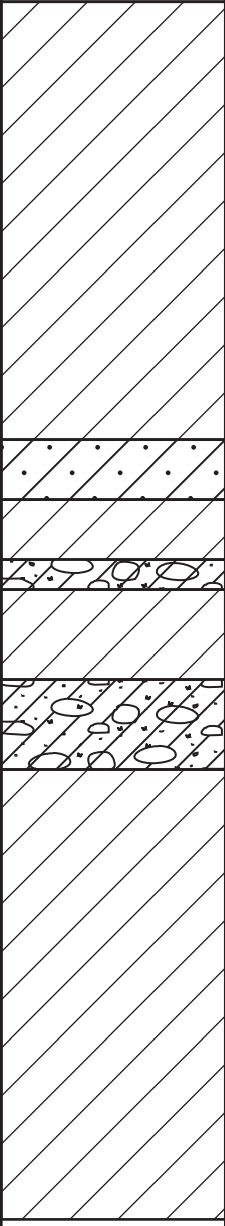
Concrete	
2					Black clay (CL), med. stiff, med. cohesive, sl. moist	
4						
6					5" Becomes stiff with minor gravels	
8					6' Color change to brown with green mottling

6.5' Brown sandy clay (CL), cohesive, moist	▼ 7.25' bgs
					7' Bluegray clayey sand (SC), friable, moist	9.5' bgs - petroleum odor
10			BH-03-9.5		8' Bluegray sandy clay (CL), minor subangular gravels, sl. moist, cohesive	11' bgs - odor absent
			BH-03-11.5		8.5' Becomes stiff silty clay (CL)	
12					9' Clayey gravel (GC), poorly sorted, sub-rounded, very stiff	▽ 12' bgs

9.5 Green silty clay (CL), stiff, sl. moist, cohesive	
14					11' Clayey gravel (GC), poorly sorted, moist, sl. cohesive, friable, sub-rounded gravels	
16					12' Saturated color change to orange	
18					12.5' Brown silty clay (CL), stiff, saturated, minor gravels	
20					20' Bottom of borehole

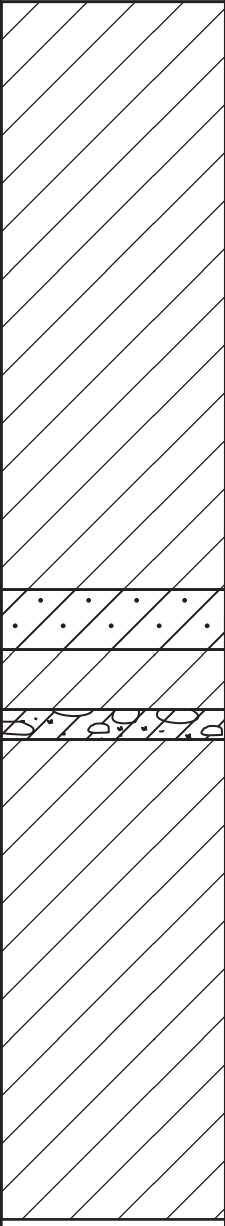
Concrete	
2					Black clay(CL), med. stiff, mod. cohesive, sl. moist	
4					4' Color change to brown with green mottling, minor small gravels, stiff, sl. cohesive	
6					5' Gravel absent	▼ 6.8' bgs
8					8.5' Gravelly clay, gravels are small and subrounded ~30-40%, sl. moist	▽ 9.5' bgs
10			BH-04-8.5'		9.5' Brown clayey sand (SC), poorly sorted, occ. small gravel, sl. cohesive, wet	
12			BH-04-10'		10.5' Brown sandy clay (CL), occ. small gravel, sl. moist, sl. cohesive, stiff	
14					11.5 Grades to clayey gravel (GC), poorly sorted, small gravel, stiff, sl. friable, sl. moist	
16					12' Brown silty clay(CL), med. soft, cohesive, moist	
18					15' Becomes stiff	
20					16.5' Becomes dark brown in color	
					17' Dark brown sandy clay (CL), stiff, cohesive, sl. moist	
					20' Bottom of borehole

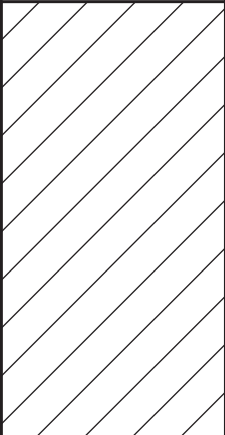
Concrete	
2					Gray gravelly clay (CL), angular gravels, soft, cohesive, sl. moist	
4					4'-6' No recovery	
6					6' Gray gravelly clay (CL), angular gravels, soft, cohesive, sl. moist	
8					7' Gray clayey gravel (GC), poorly sorted, sl. cohesive, moist	
8.5					8' Color change to brown, saturated	
10

8.5' Brown sandy clay (CL), stiff, cohesive, moist, minor subangular gravels	
12

10' Brown clayey gravel (GC), Wet, subrounded	▼ 5.3' bgs ▽ 8' bgs
14					10.5' Brown sandy clay (CL), minor gravels, subangular, cohesive, moist	
15					11' Gravels absent	
16					15' Bottom of borehole	
18						
20

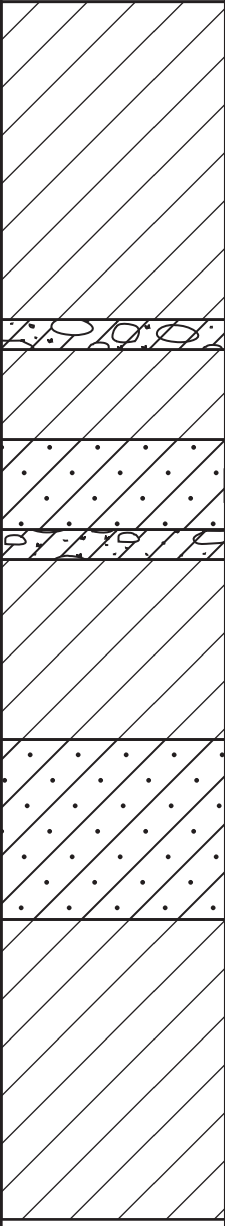
Asphalt	
2					Brown sandy clay (CL), minor subangular gravels, cohesive, sl. friable, med. stiff	
4					4' Gravels absent, becomes stiff

5.4					5' Brown clayey gravel (GC), sl. moist	▼ 5.4' bgs
5.5					5.5' Brown sandy clay (CL), well sorted sand, stiff	
6.5					6.5' Becomes poorly sorted sand, increasing moisture	▽ 8' bgs
7					7' Brown clayey sand (SC), moist, sl. cohesive, poorly sorted	
8					8' Saturated, subangular gravels present

8.5					8.5' Brown clayey gravel (GC), poorly sorted, saturated, cohesive, subangular gravels	
9					9' Brown silty clay (CL), stiff, cohesive, sl. moist

10.5					10.5' Minor gravels present	
12					12' Brown clayey sand (SC), poorly sorted, saturated, loose, green mottling	
15					15' Brown silty clay (CL), stiff, cohesive, sl. moist	
20					20' Bottom of borehole

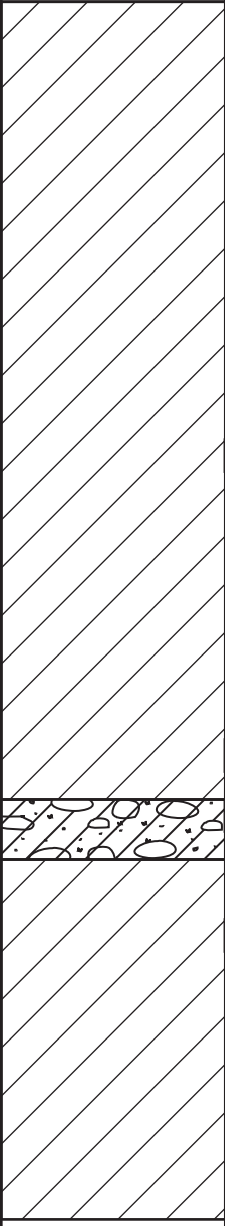
Asphalt	
2					Black clay (CL), med. stiff, med. cohesive, sl. moist	
4						
6					5.5' Blue gray gravelly clay (CL), poorly sorted angular gravels, friable, sl. cohesive	▼ 6.45' bgs
8			BH-05-7		7' Blue gray sandy clay (CL), moist, cohesive, med. stiff	7" Strong petroleum odor

7.5' Gravel present, subangular	
					8' Blue gray silty clay (CL), med. stiff, cohesive, moist	
10					10' Blue gray sandy clay (CL), med. stiff, cohesive, moist	
12			BH-05-12'		11' Minor gravels present	
					12' Blue gray silty clay (CL), soft, moist, very cohesive	▽ 13' bgs
14			BH-05-13'		13' Blue gray clayey gravel (GC), saturated, loose, sl. cohesive	13.75' Odor absent
					14' Brown silty clay (CL), stiff, sl. moist, cohesive	
16			BH-05-15'			
18						
20					20' Bottom of borehole
