**GROUNDWATER REMEDIATION
RELATED TO A FORMER HEATING OIL
UFST**

**387 ORANGE STREET
OAKLAND, CALIFORNIA**

**STELLAR ENVIRONMENTAL SOLUTIONS, INC.
2198 SIXTH STREET, SUITE 201
BERKELEY, CALIFORNIA 94710**

December 11, 2008

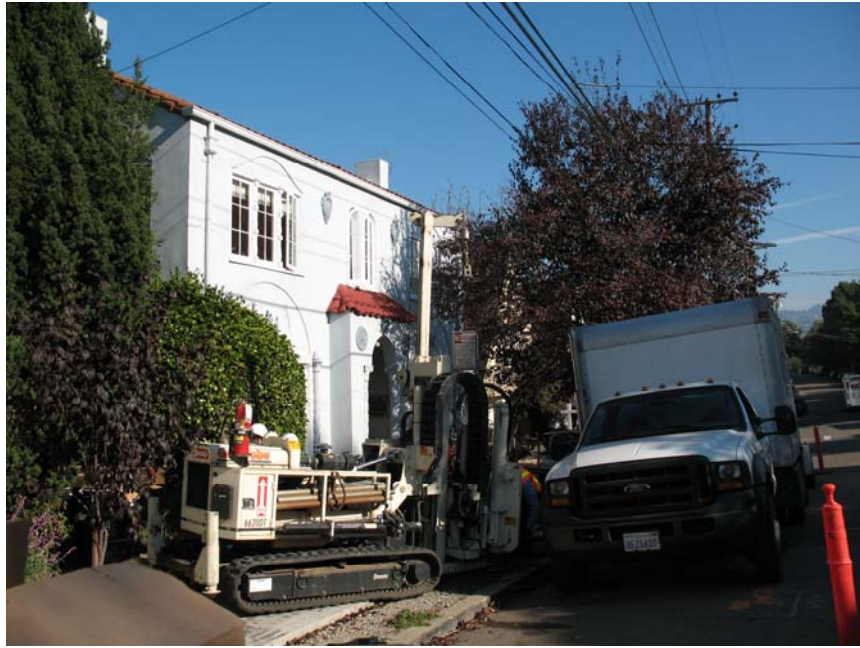
Photo No.: 01

Subject: Limited Access drill rig set up onsite

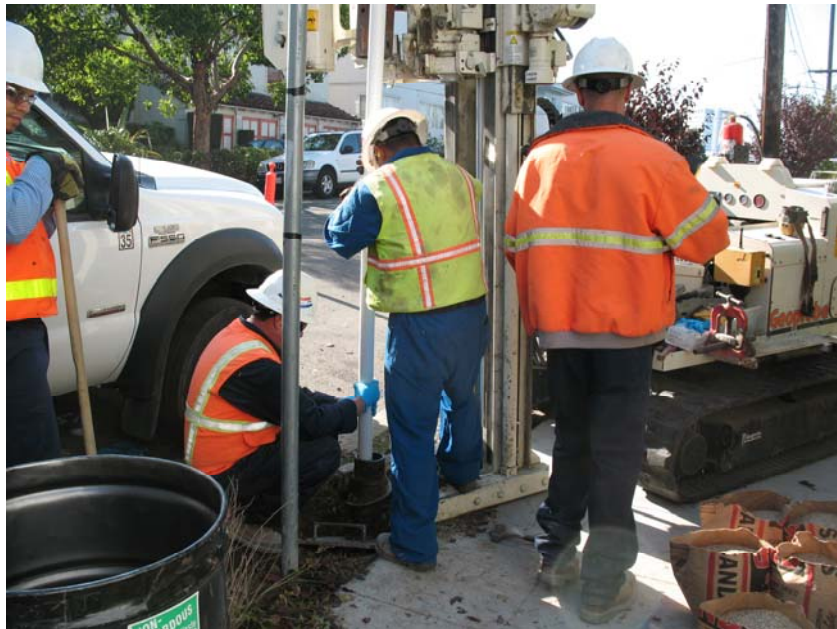
Photo No.: 02

Subject: Building monitoring well MW-1

The newly installed monitoring well (MW-1), had to be located in the planter strip adjacent to the sidewalk, three feet south of bore B1. This was based on the City of Oakland Department of Public Works’ regulation which does not allow for a “permanent” fixture to be placed in the sidewalk without an application for a special variance. The significant decrease in the concentration of hydrocarbons (from 2,400 mg/L at B1 in 2007 to 7.5 mg/L in well MW-1 in 2008) just 3 feet south of the bore B1 corroborates previous data that the “pocket” of hydrocarbons appears very limited, and not mobile. It is also possible that the sample collected at B1 was not really representative of what was in the environment, being biased as a grab-groundwater sample that had some spike from soil or colloidal particles that was misrepresented in the analyses.

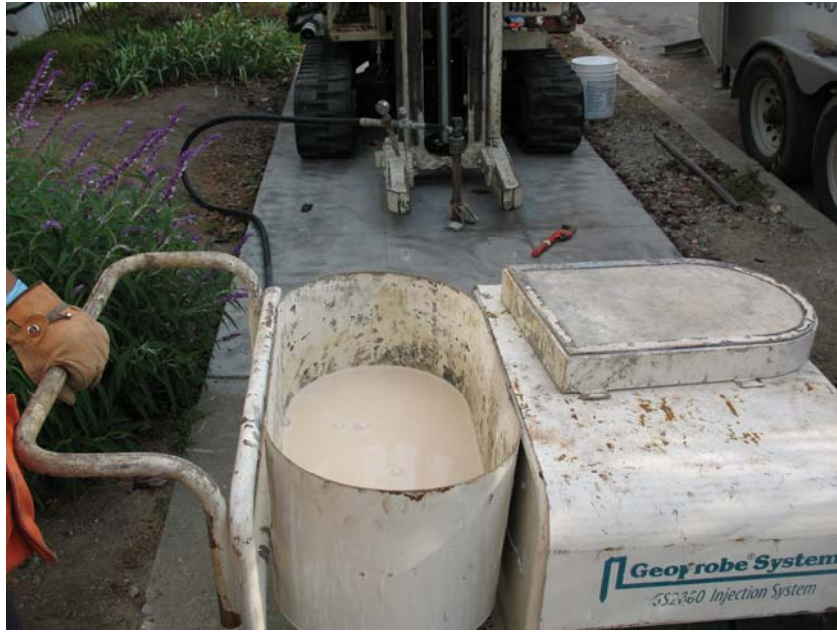
Photo No.: 03

Subject: Injecting ORC product into injection point I-2

Following the product recovery (discussed in the previous section), ORC[®] was injected to inoculate the groundwater where the highest historical “hot spot” of contamination was found.

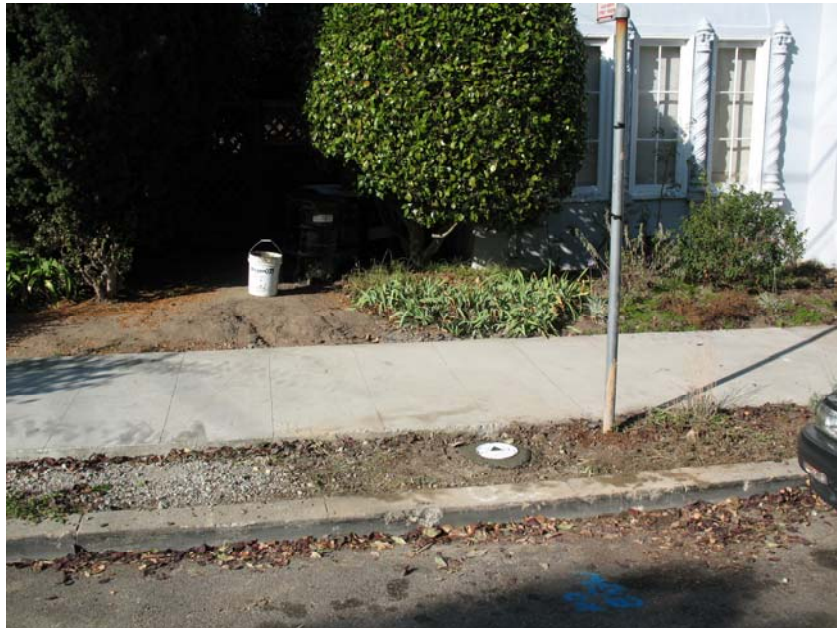
Photo No.: 04

Subject: Surface completion of monitoring well in planter strip

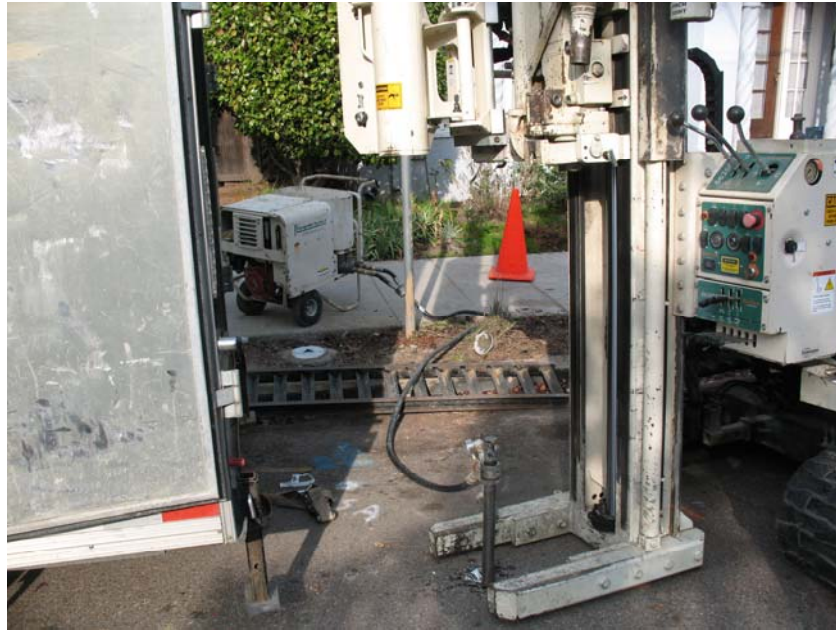
Photo No.: 05

Subject: Injecting ORC product into injection point I-1

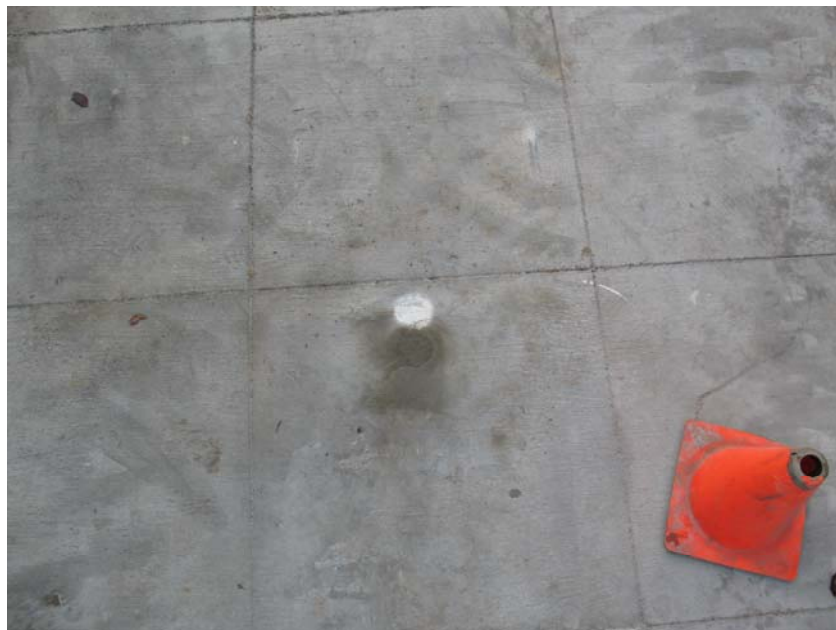
Subject: Injection point grouted in sidewalk
