Subject: **Closure Plan for Area of Concern #2 and 3, Former Hanson Aggregates Radum Facility, 3000 Busch Road, Pleasanton, California (ACEH Case RO0002952 and Geotracker Global ID SL0600101555)**

Closure Plan for the Area of Concern #2 and Area of Concern #3 at the Former Hanson Aggregates Radum Facility, 3000 Busch Road, Pleasanton, California (ACEH Case #RO0002941 and Geotracker Global ID #SLT19719376)

FORMER HANSON AGGREGATES, RADUM FACILITY, 3000 BUSCH ROAD, PLEASANTON, CALIFORNIA	
SITE LOCATION MAP

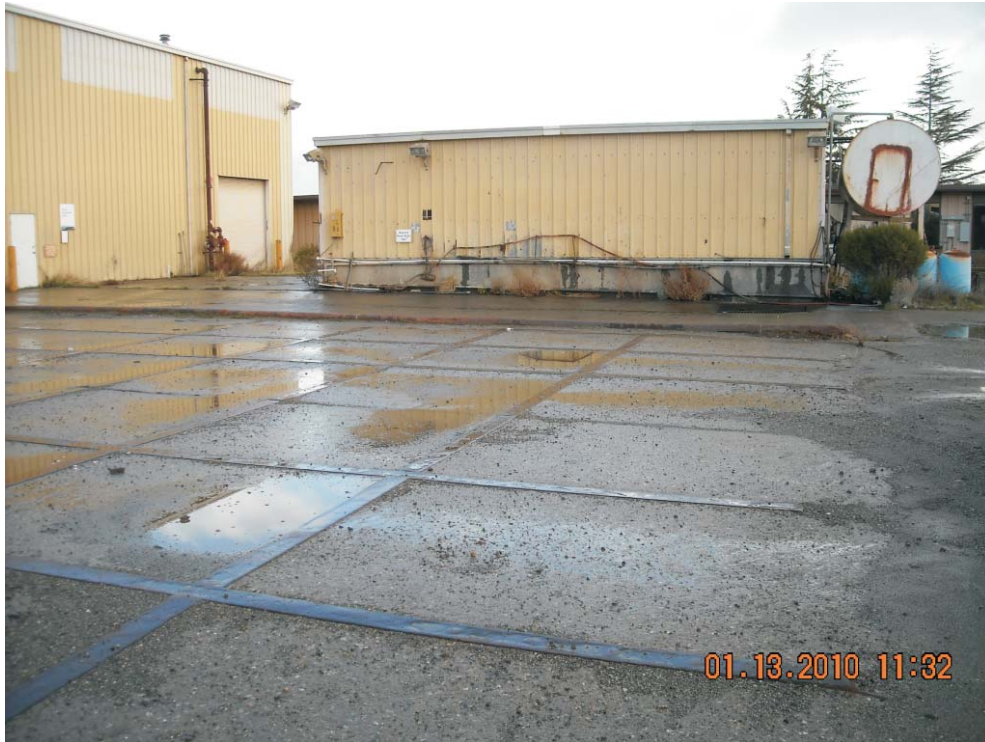
FORMER LUBE SHED LOOKING EAST

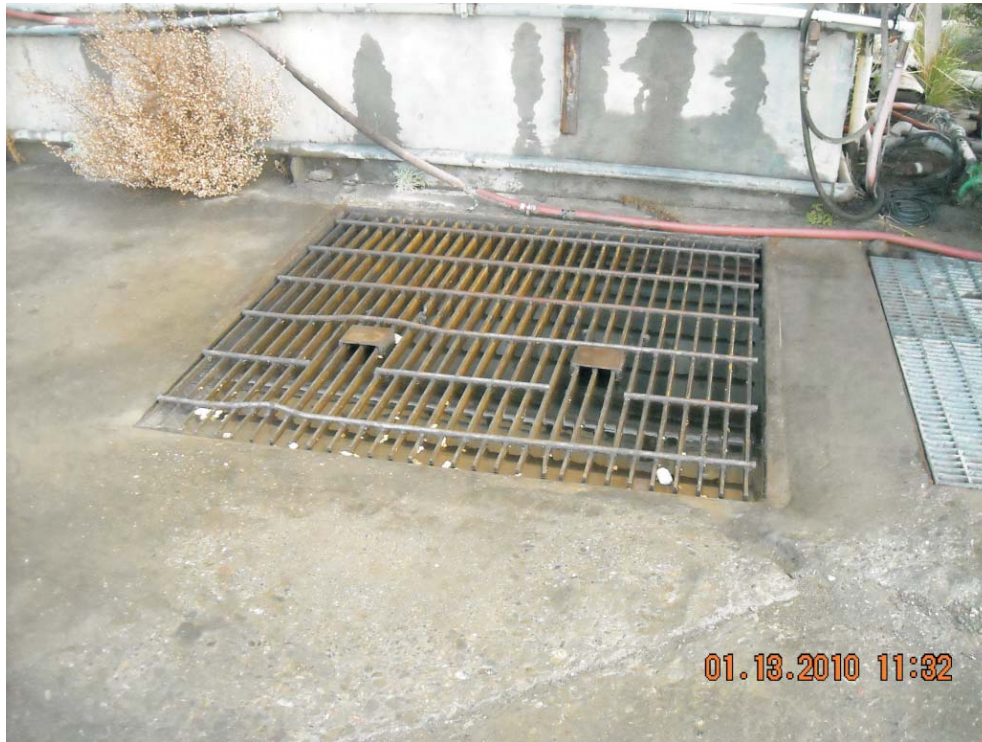
GREASE TRAP

Removal and disposal of oils water and sediment from the grease trap and double weir was discussed in the January 2010 Closure Plan. Prior to removal of the subsurface feature, any remaining liquid will be removed from the grease trap and double weir for off-site disposal or removal. It is anticipated that a service such as Evergreen Oil will be retained to profile, remove, and recycle the material to their treatment, storage, and disposal facility (TSDF) located in Newark, California. Following the removal of the liquid, the Contractor will remove the concrete walled grease trap and double weir using appropriate earthmoving equipment. It is anticipated that the concrete will be stained with oil. As such, the concrete will be segregated and disposed of as a Class II or III nonhazardous solid waste at an appropriate disposal facility, in accordance with the facility's waste soil disposal criteria. If necessary samples of the concrete will be collected and submitted to a

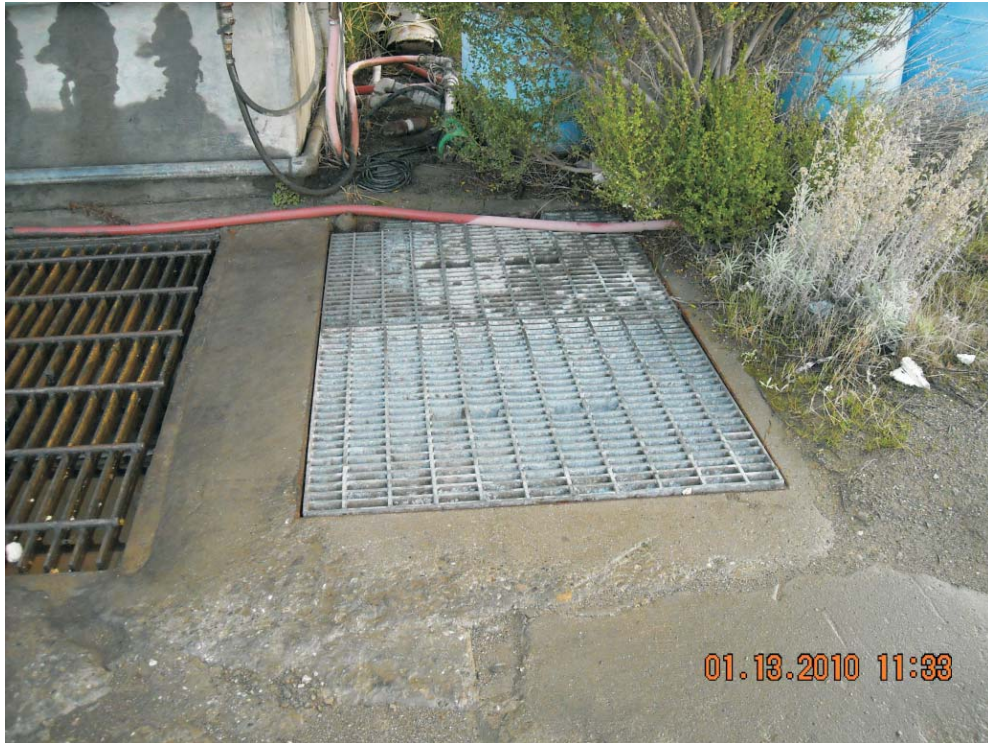
DOUBLE WEIR

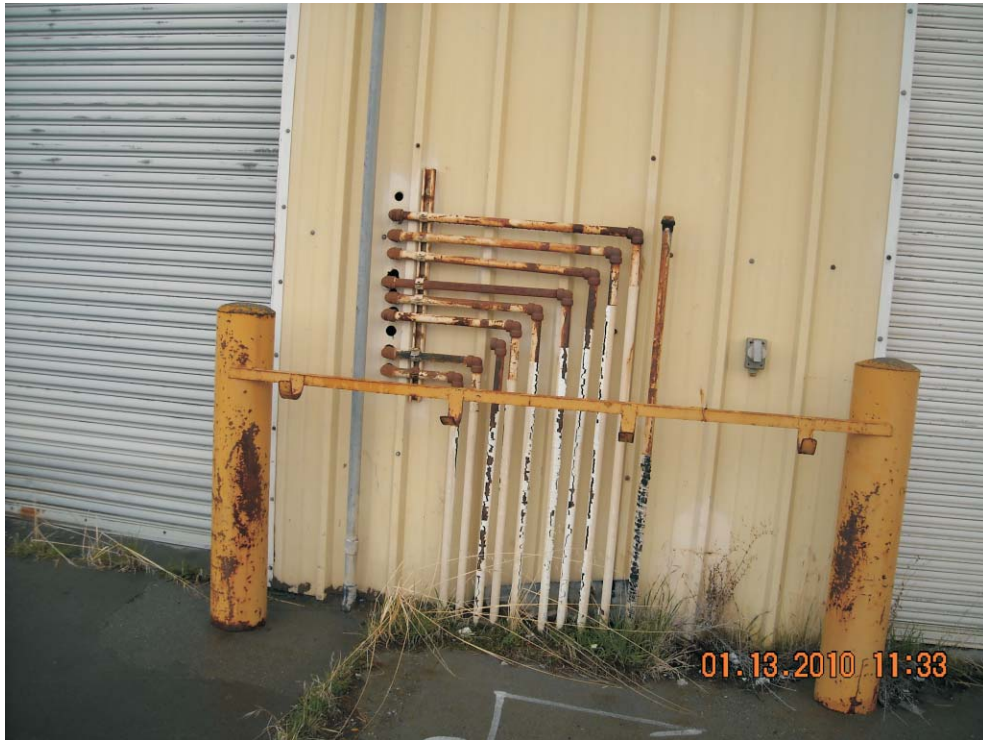
10 - 1-INCH DIAMETER PIPES AT THE FORMER HEAVY MAINTENANCE SHOP

Currently, 10 one-inch diameter pipes are present in the area between the former lube shed and the maintenance shop (see Figure 5). It is anticipated that each pipe has been purged of liquid. In order to verify this, compressed air at 10 to 20 pounds per square inch will be injected into each pipe. A container consisting of a 5-gallon bucket or the like will be set on the opposite end of each pipe to contain any liquid that is in the subsurface pipe. The pipes will be monitored for flammable vapors prior to removal.

Once each pipe is purged with compressed air, the concrete overlaying the pipes will be saw cut, removed, and segregated for recycling or disposal. The soil overlying the pipes and the pipes will be removed and recycled or disposed of as a Class II or III nonhazardous solid waste at an appropriate disposal facility, in accordance with the facility's waste soil disposal criteria.

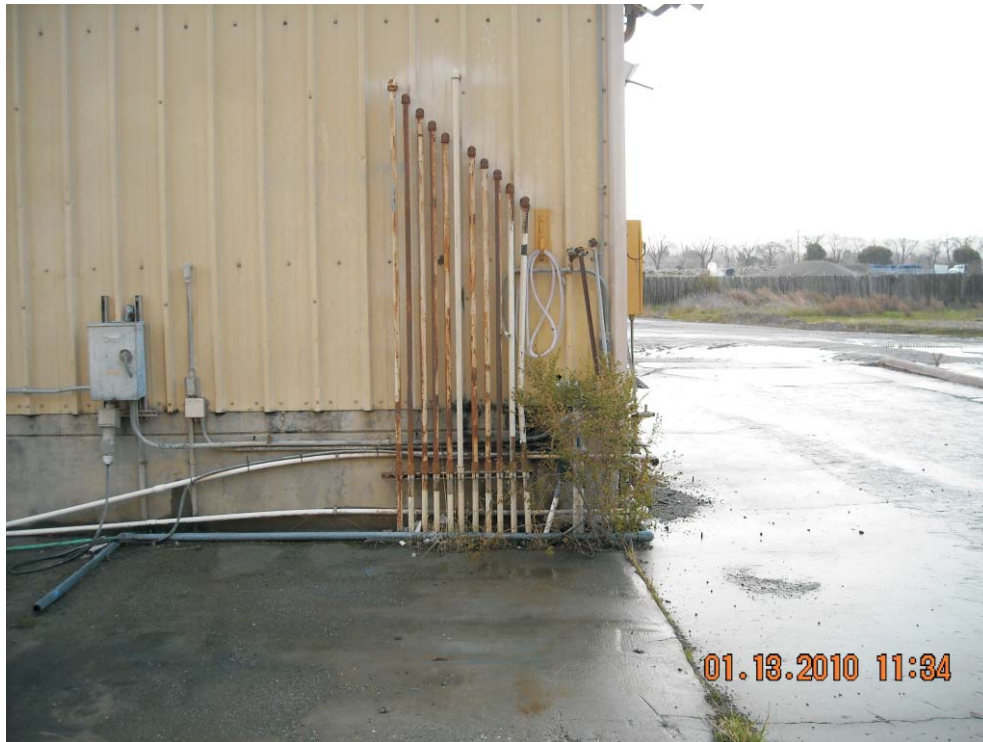
10 - 1-INCH DIAMETER PIPES AT THE LUBE SHOP

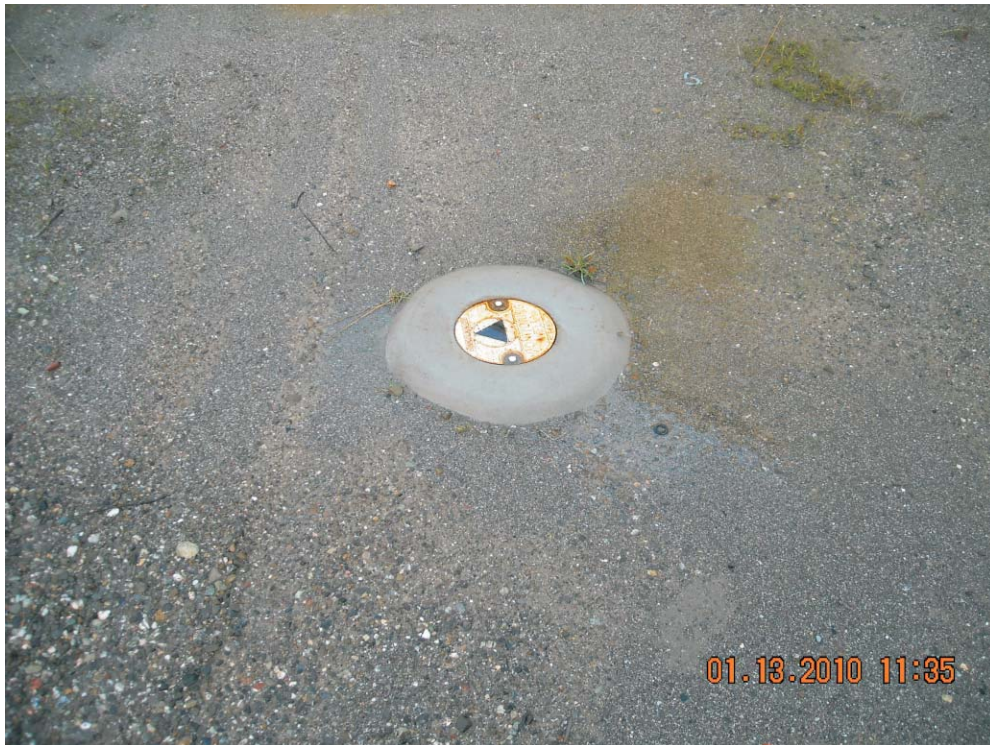
GROUNDWATER MONITORING WELL MW-1

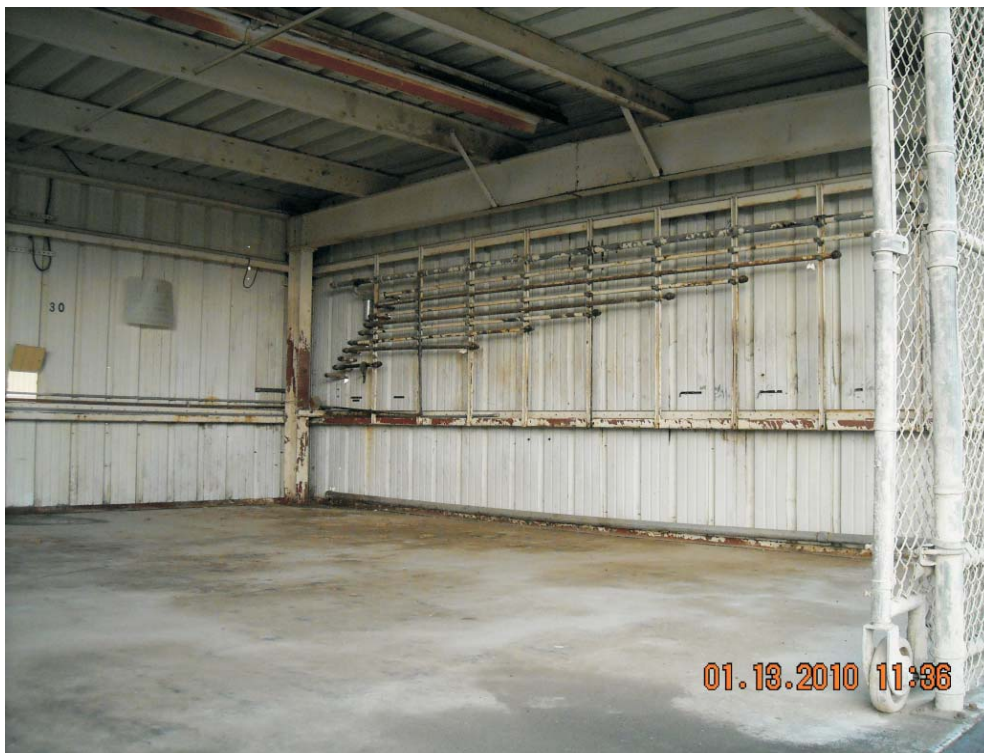
INSIDE THE FORMER LUBE SHED
