**Letter Report to Alameda County  
Department of Environmental Health  
(ACDEH)**

**Assessor's Parcel Number (APN)  
045-6302-010-05  
555 98<sup>th</sup> Avenue  
Oakland, California**

October 11, 2007

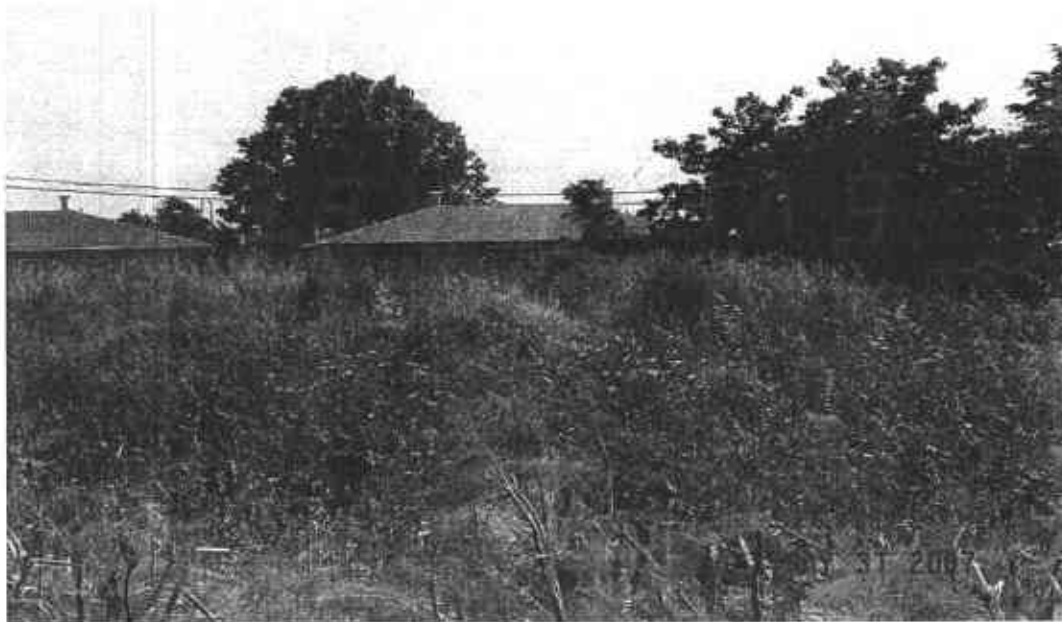
**Photo 3. Top view of debris pile.**

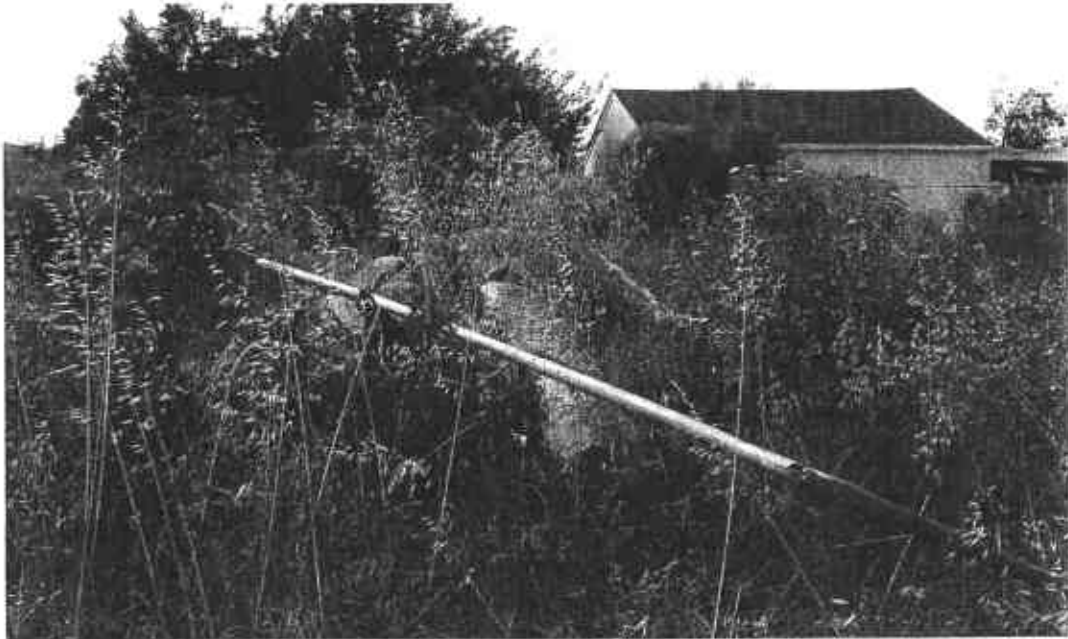
**Photo 5. Miscellaneous debris.**

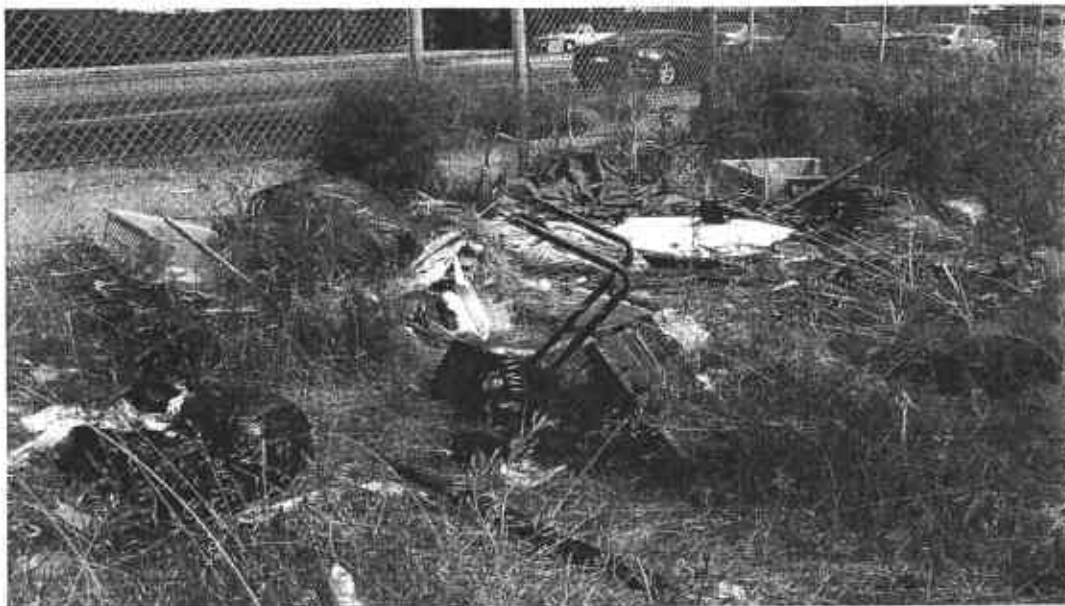
**Photo 6. Miscellaneous debris.**
