**SUBJECT      Response to Request for Work Plan and Remedial Progress Report**

Former Exxon Service Station 79374  
990 San Pablo Avenue, Albany, California

Alameda County Department of Environmental Health RO 0002974

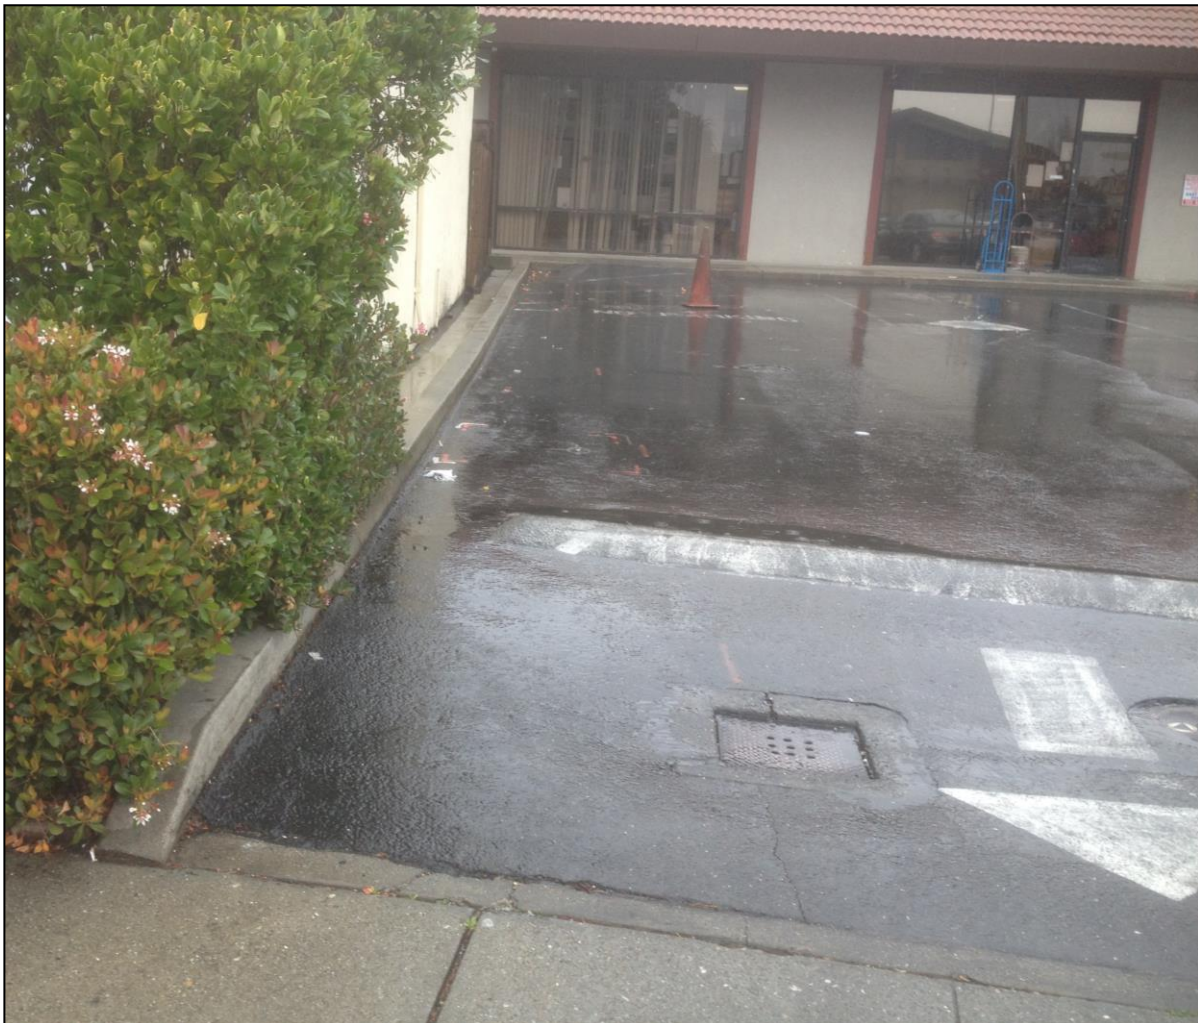
*Photo Showing the Western Property Boundary*

Cardno agrees that the neighboring residential property appears on Google Earth to sit at a lower elevation than the subject site due to what appears to be a retaining wall installed between the site and the residential property. In reality, what appears to be a retaining wall is actually just a curb and the neighboring property is at close to the same elevation as the site, as shown in the photo below.

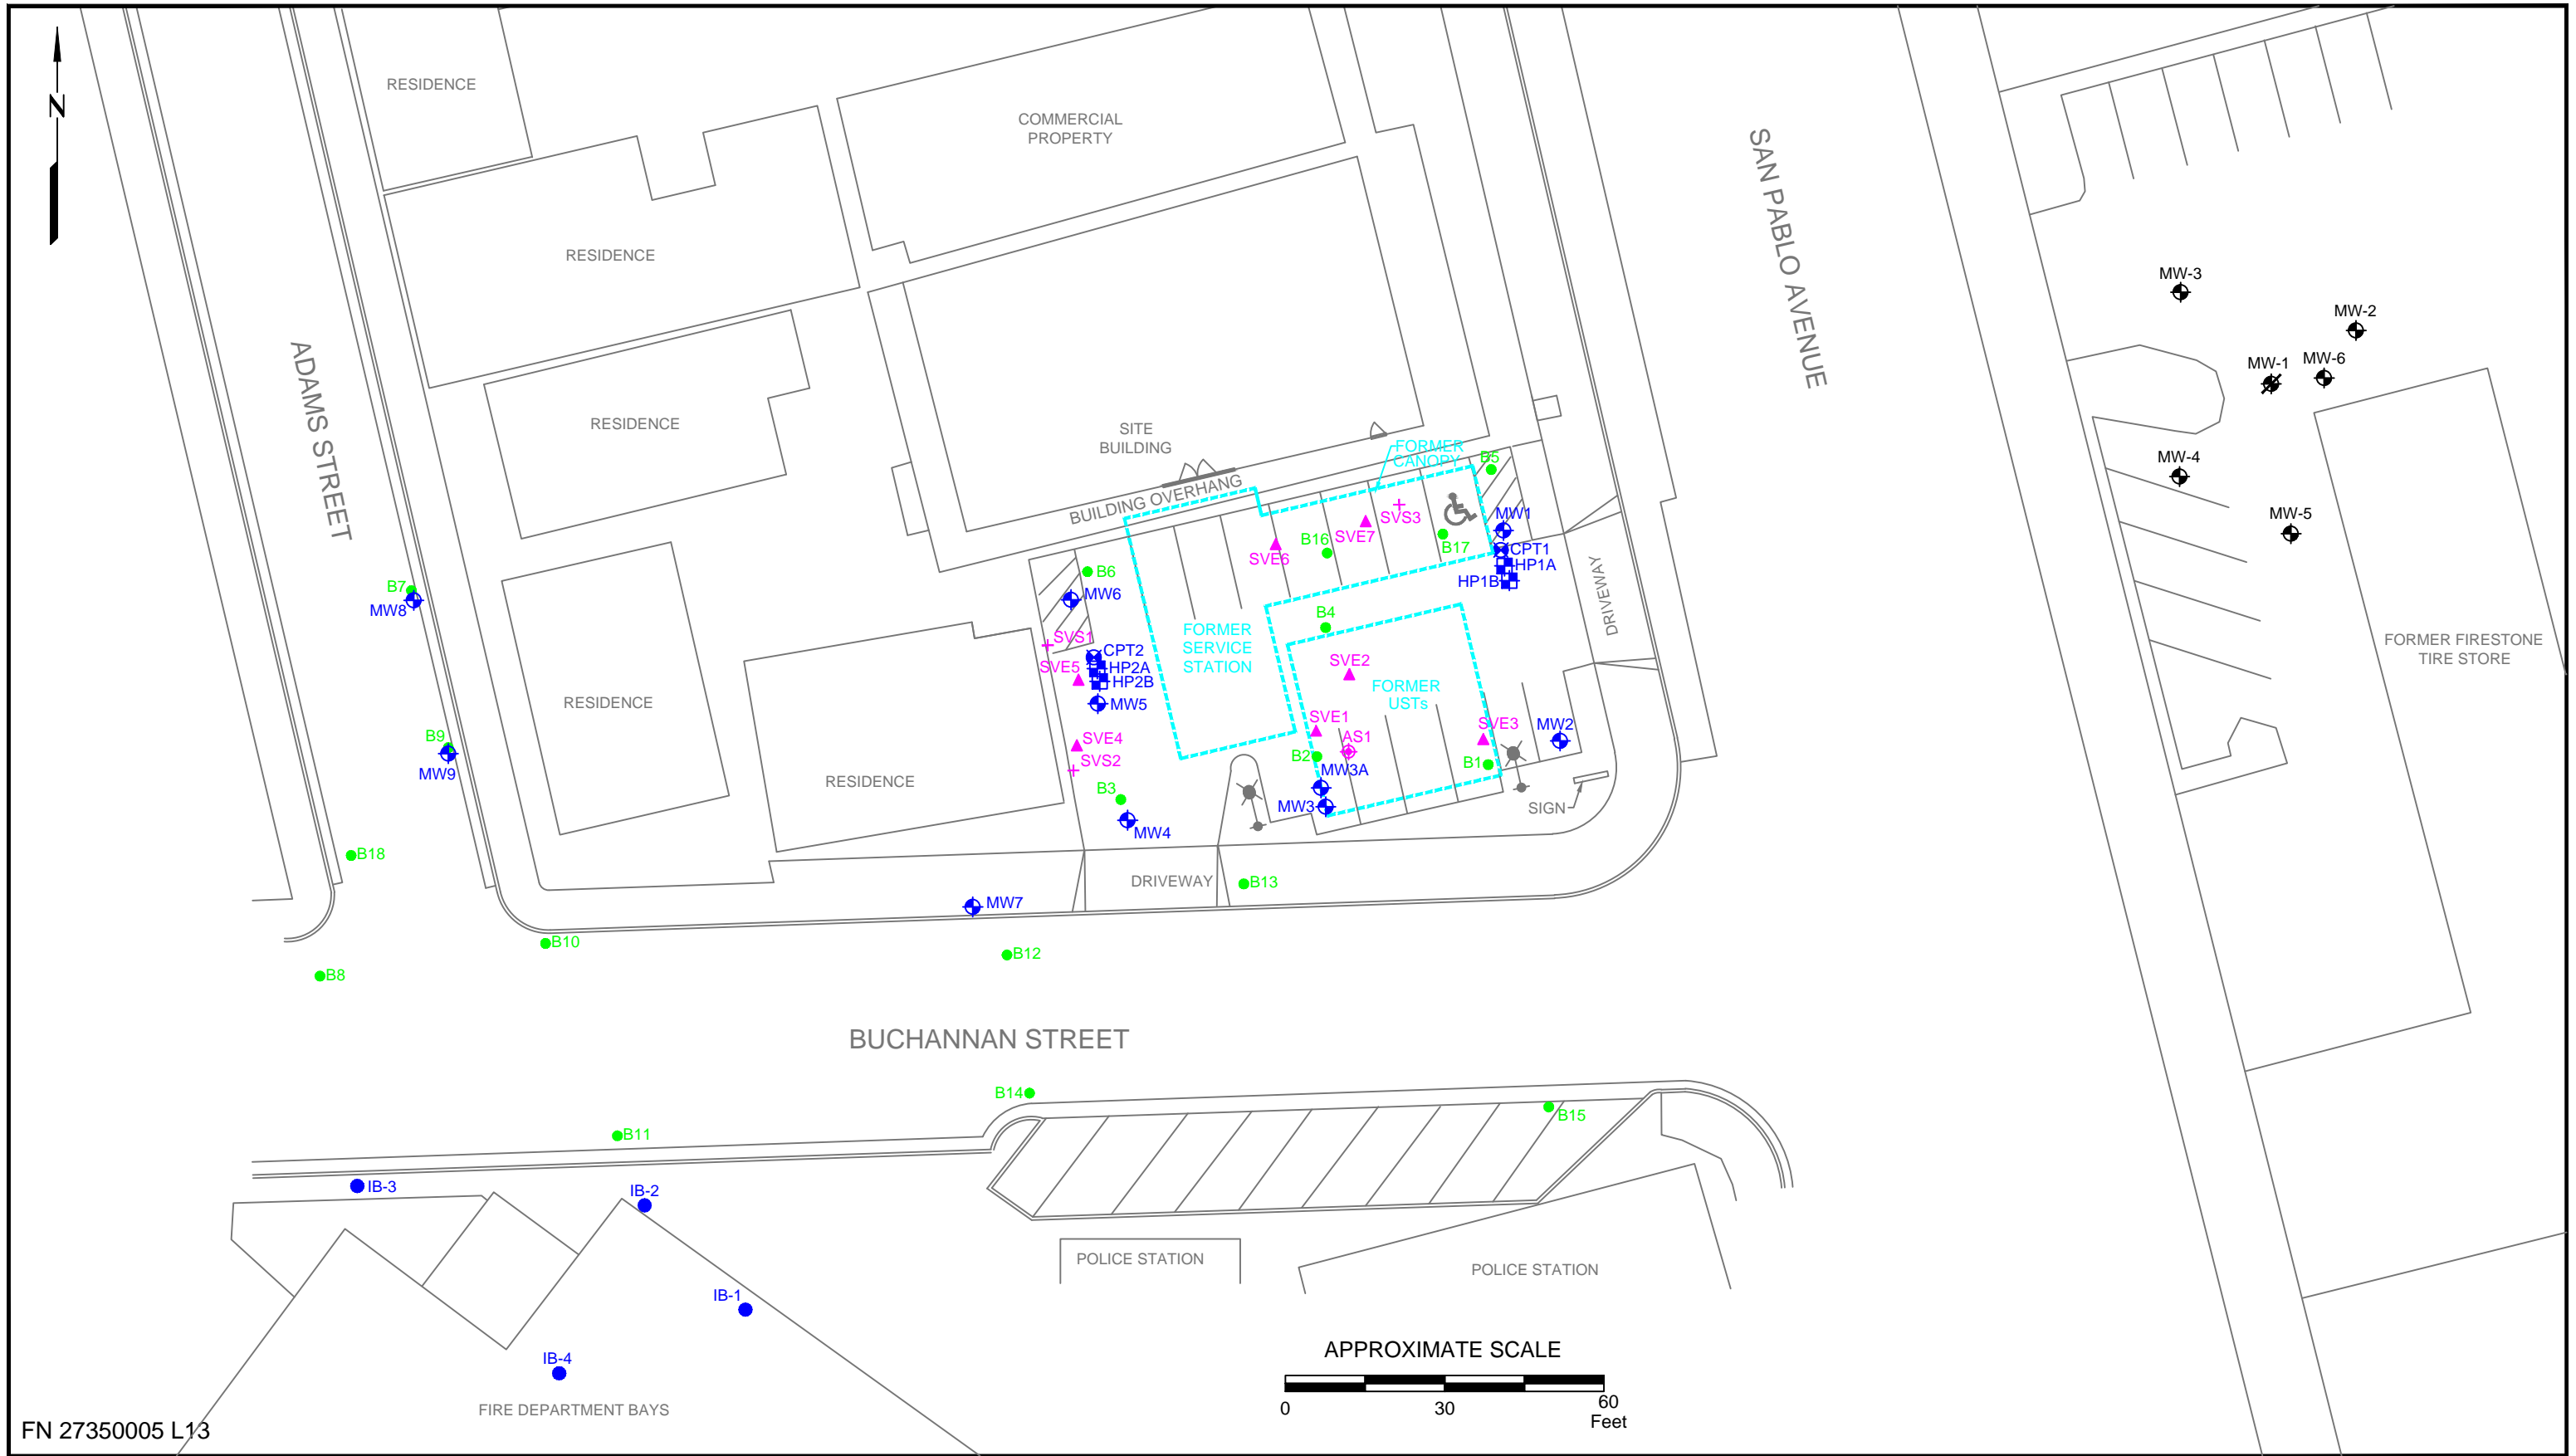
### EXTENDED SITE PLAN

- MW9 Groundwater Monitoring Well
- MW-6 Groundwater Monitoring Well for Firestone
- MW-1 Destroyed Groundwater Monitoring Well for Firestone
- HP2B Hydropunch Boring
- CPT2 Cone Penetration Test Boring
- IB-4 Soil Boring by Other Consultant for City of Albany
- B18 Soil Boring
- AS1 Air Sparge Well
- SVE7 Soil Vapor Extraction Well
- SVS3 Soil Vapor Sampling Well
