**PHASE I  
ENVIRONMENTAL SITE ASSESSMENT REPORT**

FORMER GASOLINE STATION  
PLUCKY'S LIQUORS  
6415 INTERNATIONAL BOULEVARD  
OAKLAND, CALIFORNIA 94621

**SUBJECT: Report of Phase I Environmental Site Assessment  
Former Gasoline Station  
Plucky's Liquors  
6415 International Boulevard  
Oakland, California 94621**

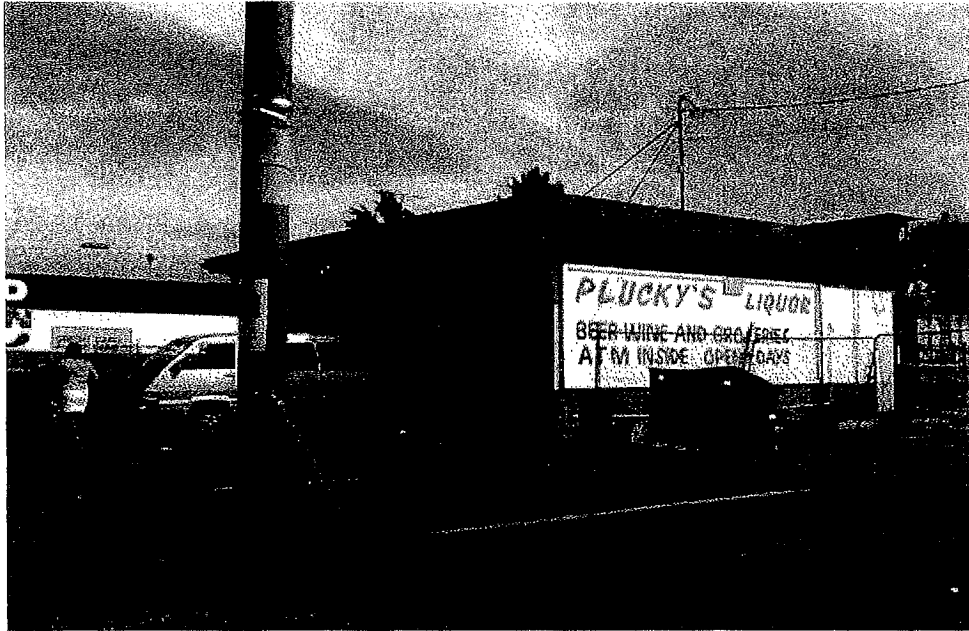
Photo 1 - View looking south at the subject property.

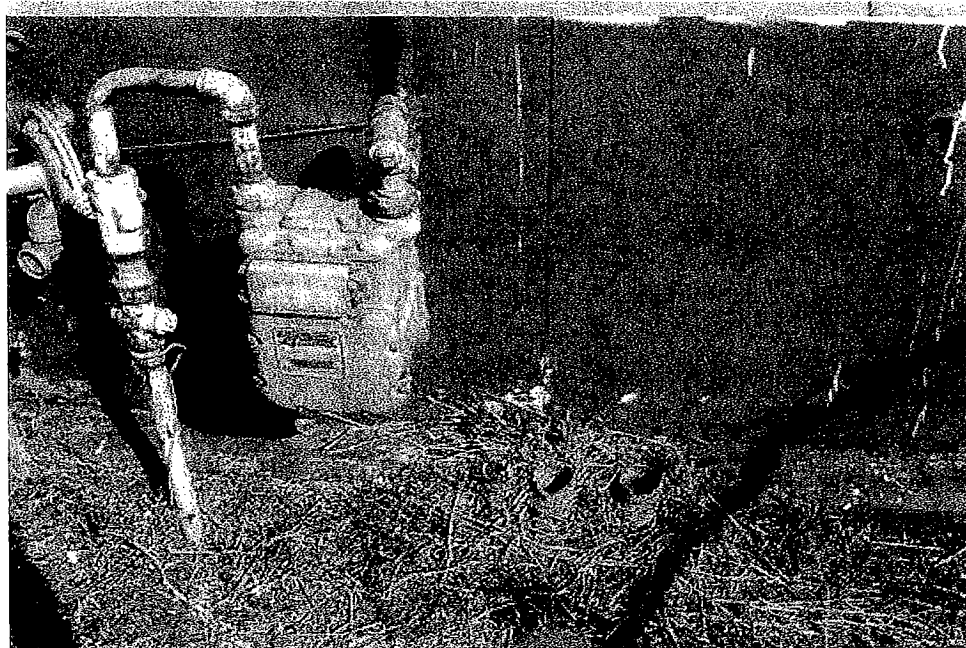
Photo 6 - View looking at the suspect vent pipes to the west of the main subject property building

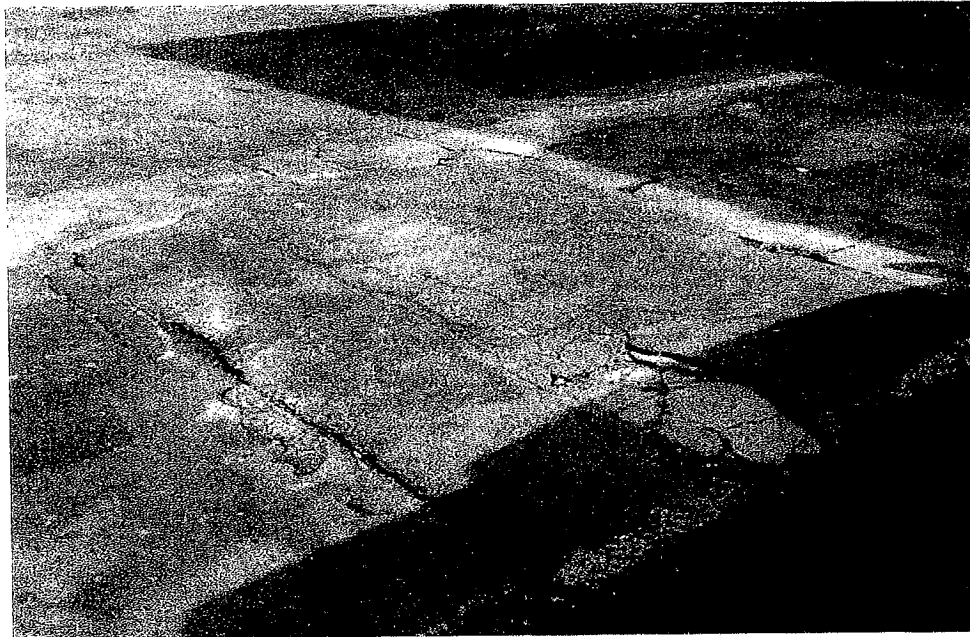
According to Mr. Fabian Labat, a representative of the former subject property owner, one or two USTs were previously located on the northeastern portion of the subject property, adjacent to the pump island. Mr. Labat stated that the USTs were removed prior to 1976. During AAI's investigation, no soil sampling data or removal/closure records were found in relation to the former USTs. The USTs were likely located on the subject property between 1935 and 1976, during the timeframe that the gasoline station was in operation. Based on the lack of records regarding the former UST/s, these were considered to be a REC for the subject property.

Photo 8 - View looking at the approximate location of the former canopy and suspect former underground storage tank (UST) locations on the northeastern portion of the subject property.

Based on these findings, AAI recommends that a Limited Phase II Environmental Site Assessment be conducted at the subject property. The Limited Phase II Environmental Site Assessment should include a geophysical survey to assess the potential presence of USTs and associated structures at the subject property. In addition, based on the results of the geophysical survey, soil and groundwater samples should be collected and analyzed for the constituents of concern.

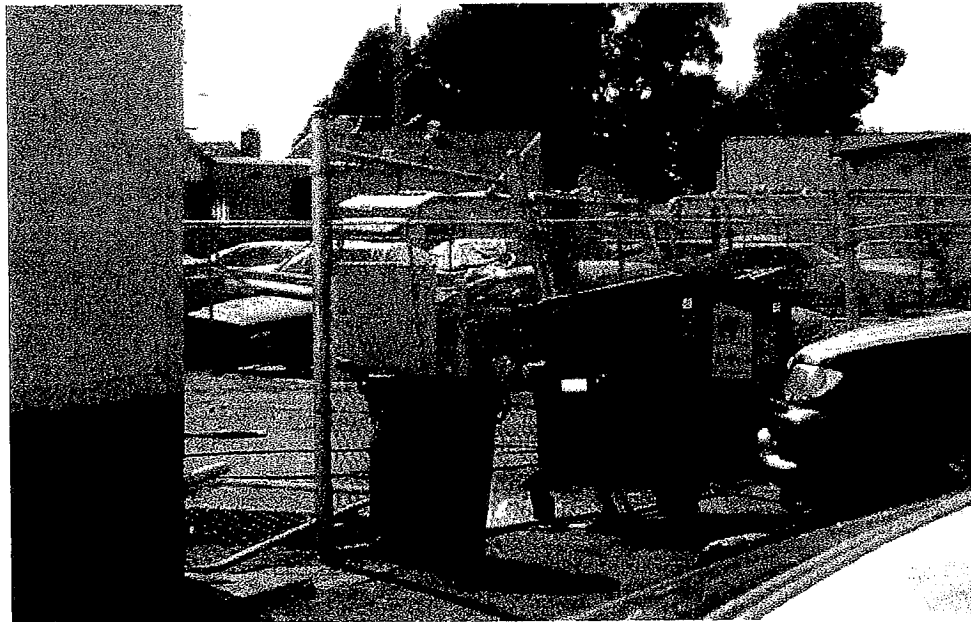
Photo 16 - View looking at the dumpster located on the northern portion of the subject property.
