PHASE II ENVIRONMENTAL SITE ASSESSMENT

**SHELL OIL PRODUCTS US, SAP #165112
4895 HACIENDA DRIVE
DUBLIN, CALIFORNIA**

DELTA PROJECT NO. CASHL-BADW-A-165112

October 28, 2008

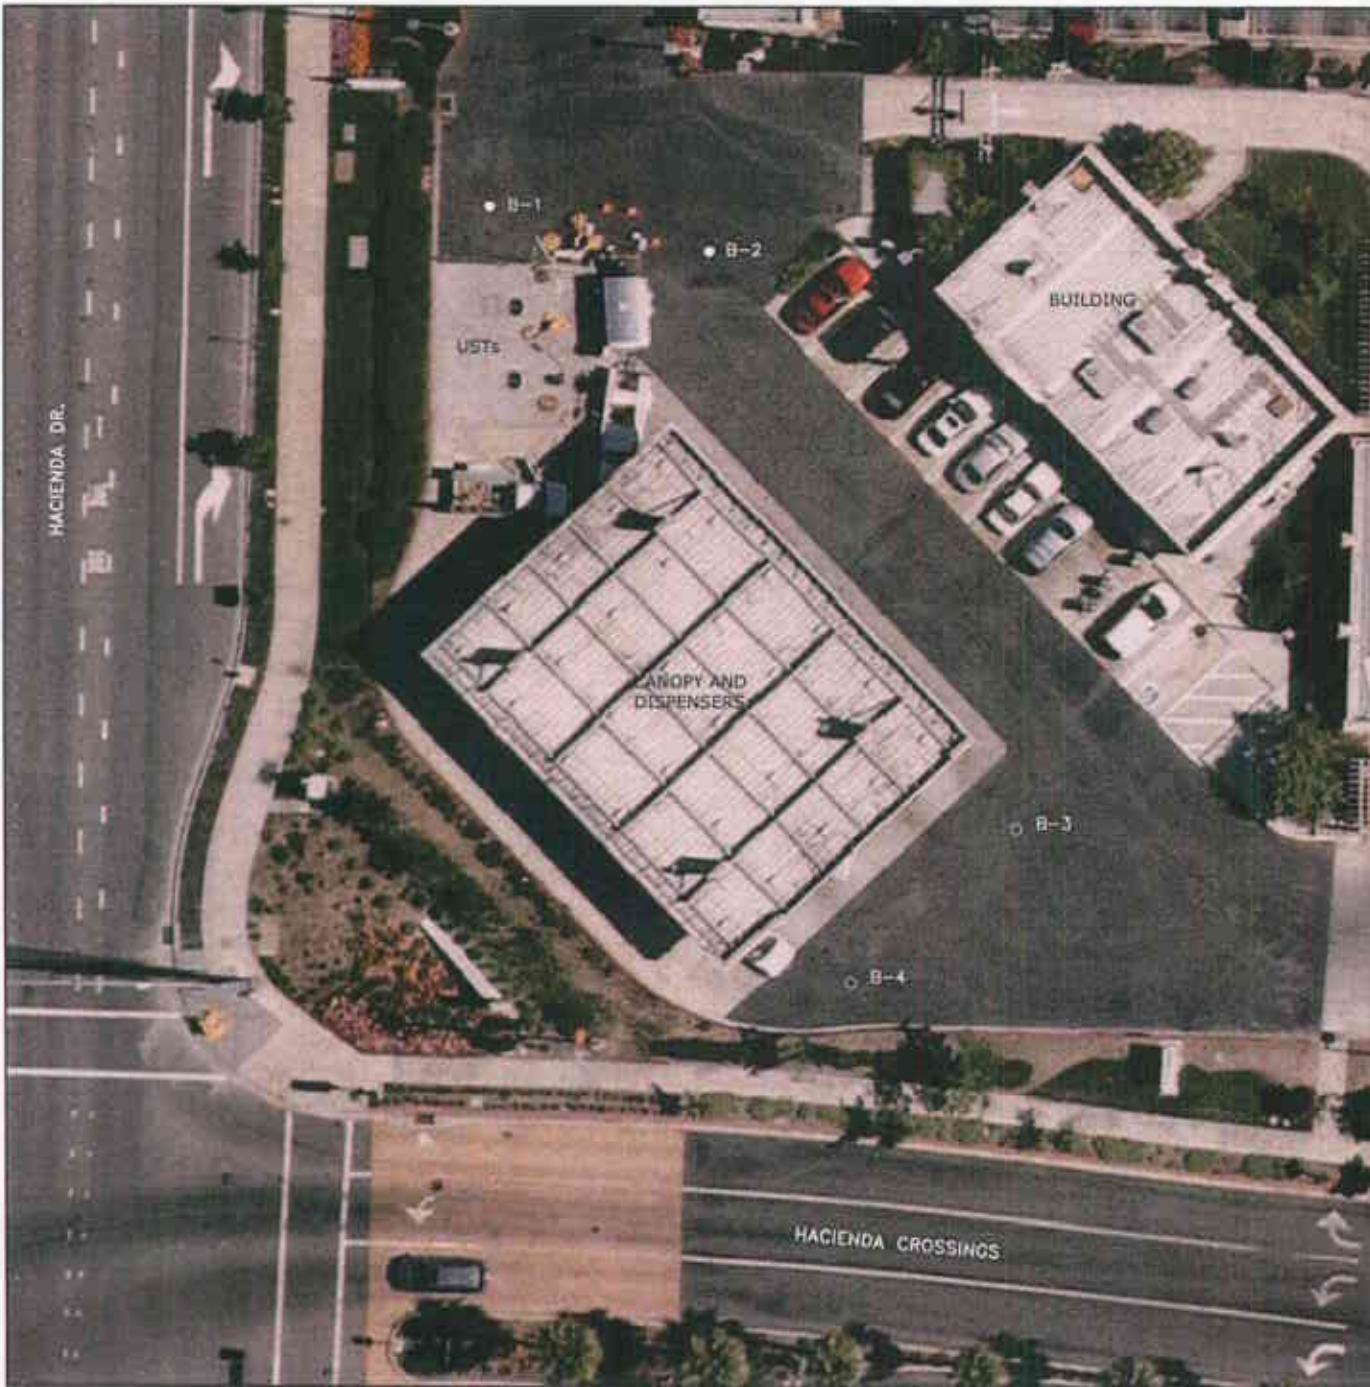
Figure 2
SITE PLAN
Shell SAP 165112
4895 Hacienda Drive
Dublin, California

• BORING LOCATIONS ARE APPROXIMATE

- UNDERGROUND STORAGE TANK (UST) AREA SOIL BORING
- DISPENSER AREA SOIL BORING

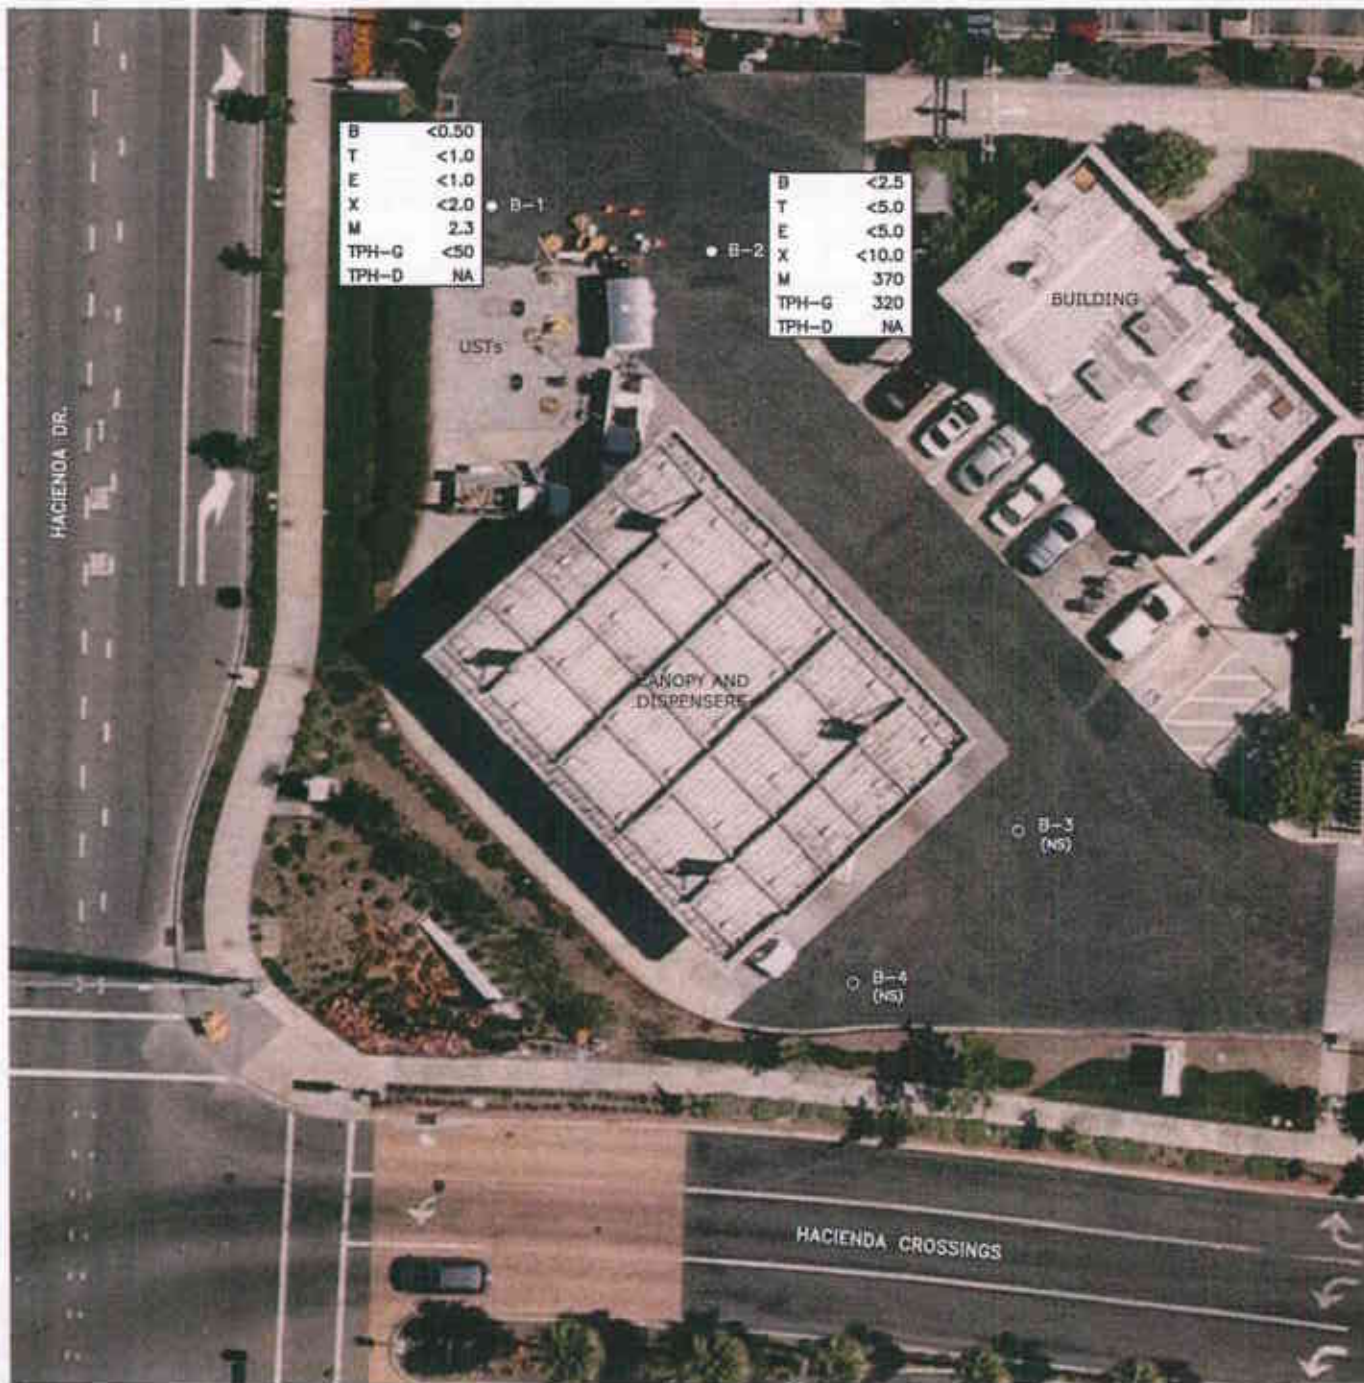
Figure 4
GROUNDWATER CONCENTRATION MAP
 AUGUST 20, 2008
 Shell SAP 185112
 4895 Hacienda Drive
 Dublin, California

- None of the groundwater samples collected and submitted for laboratory analysis during this investigation contained concentrations of any constituent in excess of the ESLs with one exception. The groundwater sample collected from boring B-2 contained concentrations of TPH-G (320 ug/L) and MTBE (370 ug/L) in excess of the ESLs (100 ug/L and 5 ug/L, respectively).

B	<0.50
T	<1.0
E	<1.0
X	<2.0
M	2.3
TPH-G	<50
TPH-D	NA

B	<2.5
T	<5.0
E	<5.0
X	<10.0
M	370
TPH-G	320
TPH-D	NA

Based on Delta's review of the analytical results, Delta notified the Alameda County Water District that concentrations of TPH-G and MTBE had been detected in groundwater and/or soil samples collected at the Site. Delta also submitted an *Underground Storage Tank Unauthorized Release (Leak)/Contamination Site Report*. A copy of the release report is included in **Appendix E**.

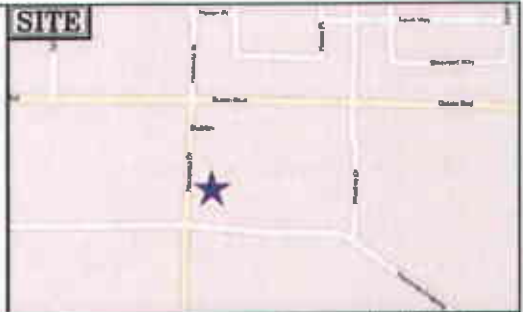
Drilling Started: 08/20/2008
 Drilling Completed: 08/20/2008
 Drilling Method and Diameter: Direct Push - 2" Dia.
 Drilling Company: Cascade Drilling
 Drilled By:
 Logged By: Steve Harquail
 Boring: B-1

Depth (feet)	Samples	Recovery (%)	PID (ppm)	LITHOLOGIC DESCRIPTION	USCS	Graphic Log	Depth (feet)
0				No Recovery - Air Knifed to 5 feet below ground surface (bgs).			0
2							2
4							4
5.00'				Clayey Silt: Dark brown.	ML		5.00'
6				Clayey Silt: Brown, with 5% fined grained sand.			6
8							8
10	100	0.0		Clayey Silt: Tan, brown.			10
12							12
13.00'				Silty Clay: Tan, soft, high plasticity.	CH		13.00'
14							14
15.00'	100	0.0		Clayey Silt: Light brown, with 5% sand	ML		15.00'
16							16
18							18
20	85	0.0		Silty Sand: Brown, wet.	SM		20
21.50'				Clayey Silt: Tan, hard, white to black marbling.	ML		21.50'
22							22
24							24
25	100	0.0		Boring terminated at 25 feet bgs.			25

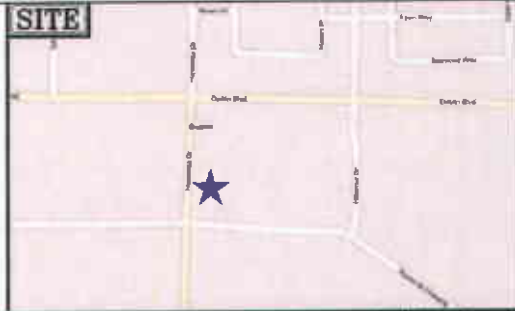
CASHL-BADW-A	SHELL FACILITY No. 165112	Soil Boring Log	FIGURE	
	09-26-2008 09-26-2008	4895 Hacienda Drive			B-2
	CALIFORNIA O.P. J.E.	Dublin, California			
	SH5112-B2

Drilling Started: 08/20/2008
 Drilling Completed: 08/20/2008
 Drilling Method and Diameter: Direct Push - 2" Dia.
 Drilling Company: Cascade Drilling
 Drilled By:
 Logged By: Steve Harquail
 Boring: B-2

Depth (feet)	Samples	Recovery (%)	PID (ppm)	LITHOLOGIC DESCRIPTION	USCS	Graphic Log	Depth (feet)
2				No Recovery - Air Knifed to 5 feet below ground surface (bgs).			2
4							4
6				Sandy Silt: Dark brown, hard, dry.	ML		6
8				Sandy Silt: Brown, with 5% fined grained sand, hard, dry.			8
10	100	0.0		Similar to above.			10
12				Clayey Silt: Tan, dry, firm, with 5% sand.	ML		12
14				Silty Clay: Tan, soft.	CL		14
16				Clayey Silt: Brown, hard, dry.	ML		16
18							18
20	100	0.0		Clayey Silt: Brown/tan Sand: Brown, wet.	SP		20
22				Clayey Sand: Tan.	SC		22
24				Clay: Tan, soft, dry.	CL		24
25	100	0.0		Boring terminated at 25 feet bgs.			25

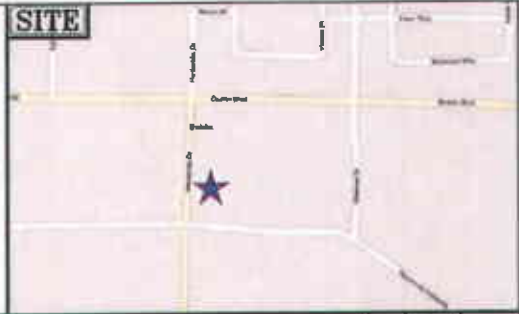
Drilling Started: 08/20/2008
 Drilling Completed: 08/20/2008
 Drilling Method and Diameter: Direct Push - 2" Dia.
 Drilling Company: Cascade Drilling
 Drilled By:
 Logged By: Steve Harquail
 Boring: B-3

Depth (feet)	Samples	Recovery (%)	PID (ppm)	LITHOLOGIC DESCRIPTION	USCS	Graphic Log	Depth (feet)
0 - 5				No Recovery - Air Knifed to 5 feet below ground surface (bgs).			0 - 5
5 - 10				Clayey Silt: Dark brownish-black. Clayey Silt with trace sand: Brown, hard, dry, low to medium plasticity.	ML		5 - 10
10 - 15	90	0.0		Clayey Silt with trace sand: Brown, firm, dry.			10 - 15
15 - 20	90	0.0		Similar to above, hard, dry, medium plasticity.			15 - 20
20	100	0.0		Boring terminated at 20 feet bgs.			20

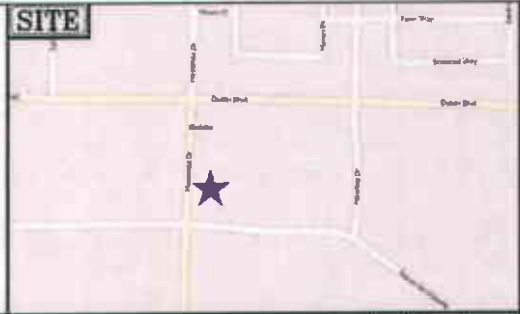
Drilling Started: 08/20/2008
 Drilling Completed: 08/20/2008
 Drilling Method and Diameter: Direct Push - 2" Dia.
 Drilling Company: Cascade Drilling
 Drilled By:
 Logged By: Steve Harquail
 Boring: B-4

Depth (feet)	Samples	Recovery (%)	PID (ppm)	LITHOLOGIC DESCRIPTION	USCS	Graphic Log	Depth (feet)
0 - 5				No Recovery - Air Knifed to 5 feet below ground surface (bgs).			0 - 5
5 - 10				Clayey Silt with Sand: Dark brown, dry, hard, medium plasticity. Similar to above, brown.	ML	[Vertical lines]	5 - 10
10 - 14		80	0.0	Clayey Silt: Dark brown, dry, hard.			10 - 14
14 - 20		90	0.0	Clayey Silt: Brown, hard, dry, with 5% fine grained sand.			14 - 20
20		90	0.0	Boring terminated at 20 feet bgs.			20
