LIMITED ENVIRONMENTAL ASSESSMENT  
AT

SUNOL COMMUNICATIONS CENTER  
3700 PALOMARES ROAD, SUNOL, CA

JUNE 9, 1990

RE: Limited Environmental Assessment at the Sunol Communications Site, Palomares Road, Sunol, CA

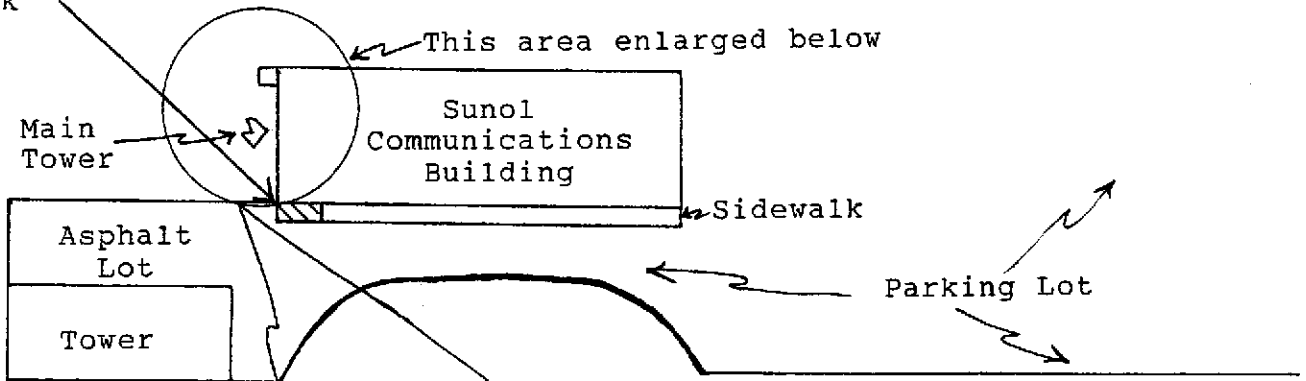
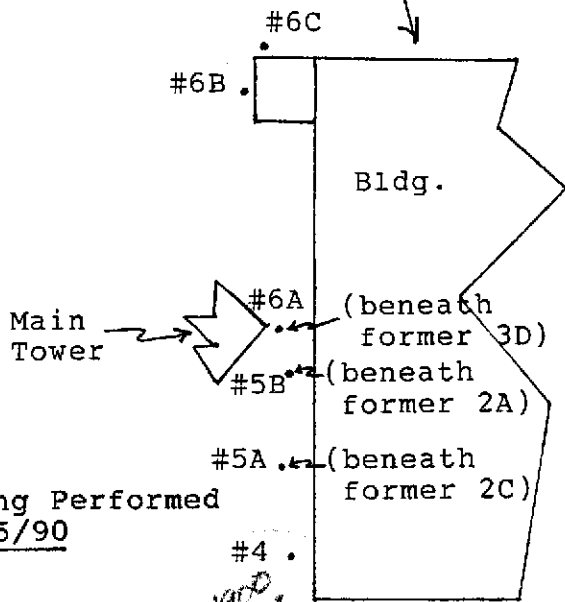
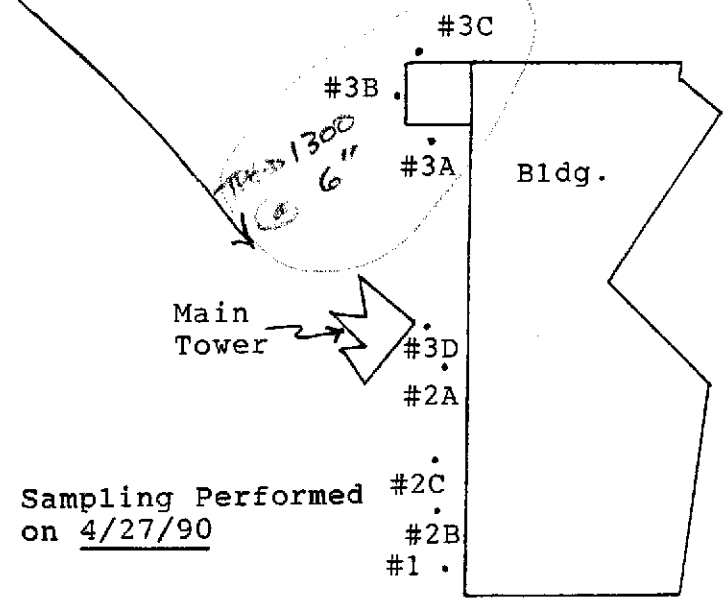
Site Map

Scale for enlargement  
 below:  
 1" = 12.5'

Location of 1- 2,000 gallon  
 underground diesel storage tank  
 and 1- 7 gallon above ground  
 day tank
