Re: Sub-Slab Venting Installation and Floor Sealing Work Plan
Terradev Jefferson Property – 645 4th Street, Oakland CA
Fuel Leak Case RO0003001

**Subject: Sub-Slab Venting Installation and Floor Sealing Work Plan
Terradev Jefferson LLC Property, 645 4th Street, Oakland, California**

HISTORICAL SOIL VAPOR AND SUB-SLAB VAPOR CONCENTRATIONS AND PROPOSED SSVS

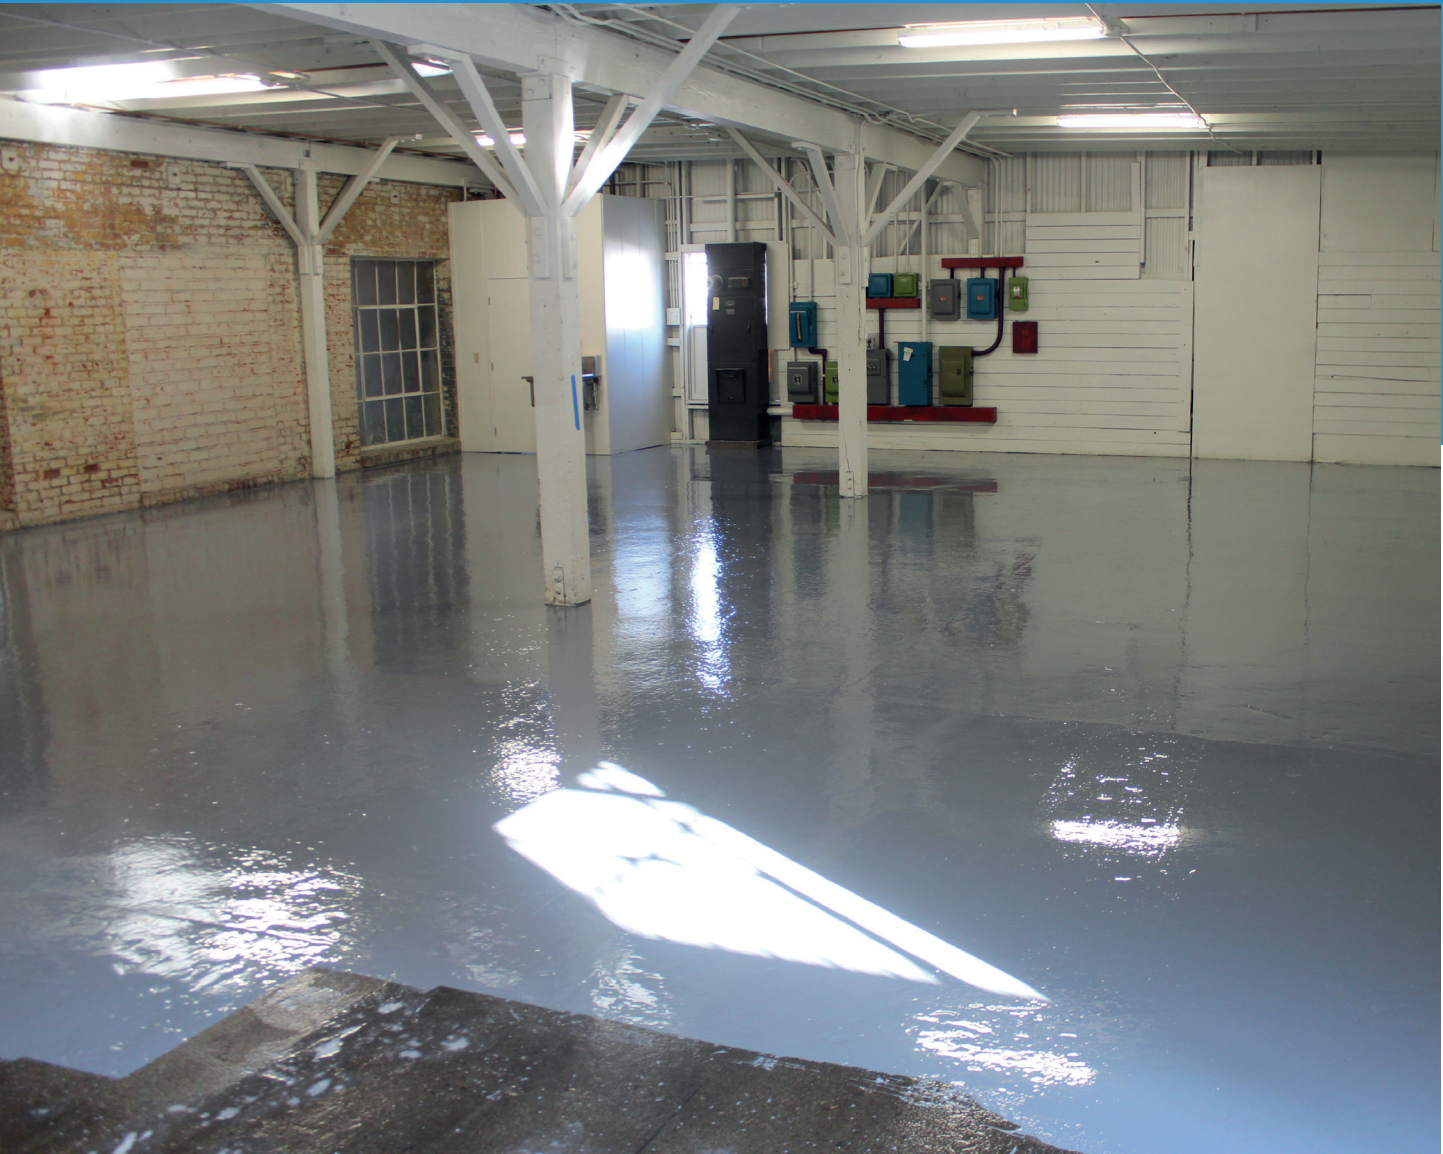
Vapor Intrusion Coating System for Existing Structures

The Retro-Coat™ Vapor Intrusion Coating System is a complete product line that consists of chemically resistant materials to properly protect existing structures from the threat of contaminant vapor intrusion without the need for additional concrete protection. Developed by the R&D team of Land Science®, the Retro-Coat system has been subjected to rigorous testing procedures to prove its ability to combat the most aggressive chemical vapors. The main component of the Retro-Coat system is the Retro-Coat coating which is a two part, odorless, no VOC, 100% solids coating.

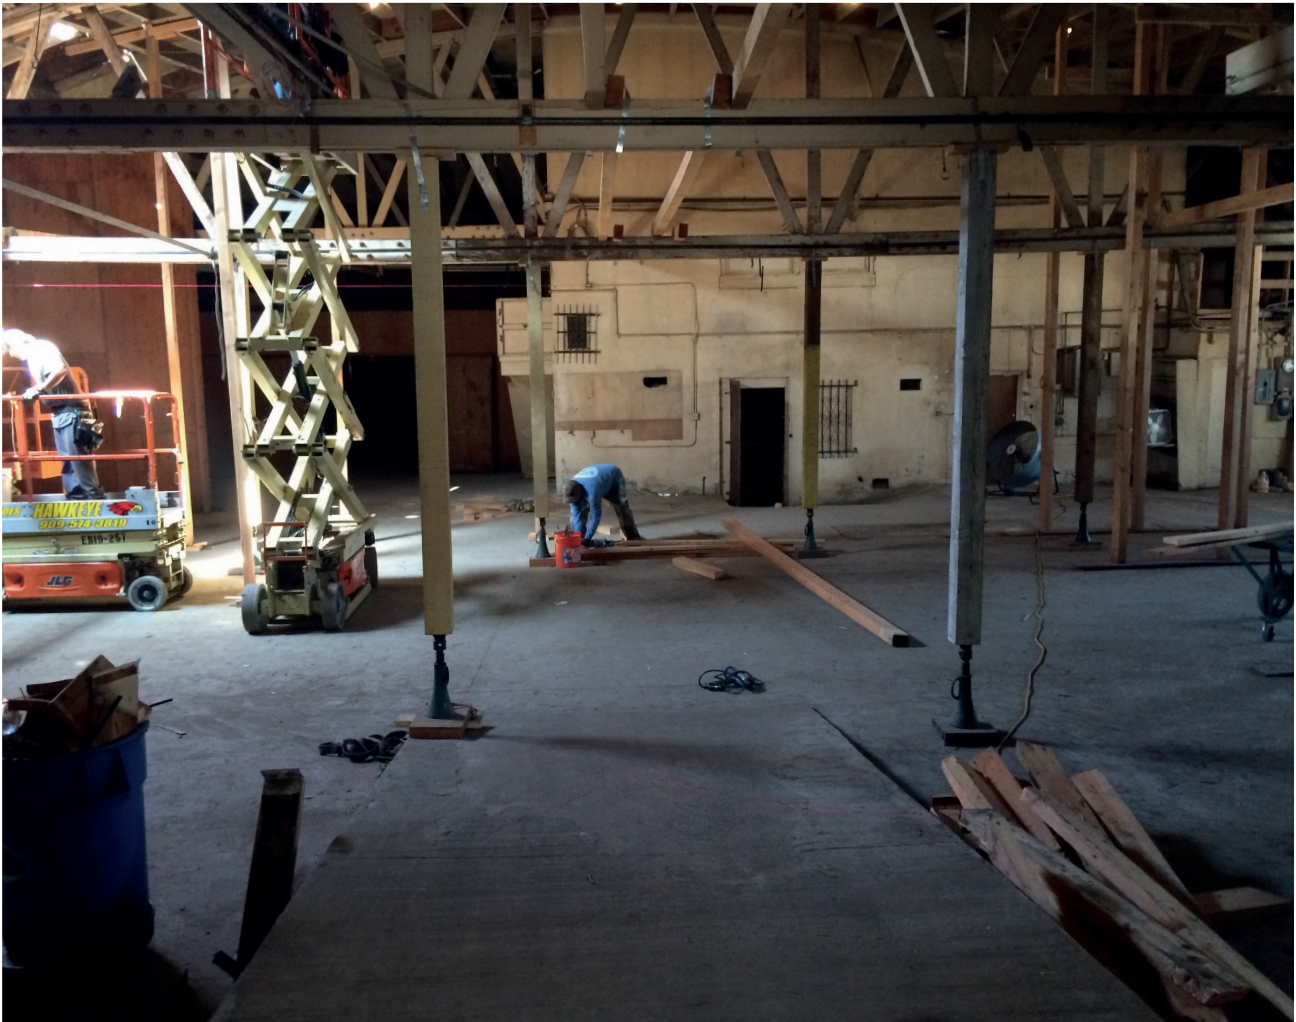
Typical Application

Retro-Coat is suitable as a barrier to block contaminated vapors from entering existing structures. Particular uses include coating the horizontal surfaces of existing structures where contamination under, or adjacent to, a structure can potentially migrate inside the structure and create a vapor encroachment condition. This condition is most commonly found when the existing structure was operated as a dry cleaner, gas station, manufacturing facility or located in close proximity to any structure where carcinogenic chemicals were utilized.

A typical application consists of a minimum 20 mil thick system; consisting of two 10 mil coats of Retro-Coat at 160 SF/gallon per coat and is recommended along with a 6 mil coat of Retro-Coat PRIMER. The typical 20 mil application can withstand forklift traffic, other machinery and even act as secondary containment. However, if Retro-Coat is exposed to harsh conditions over a longer period of time and/or used for a unique application, please consult with a LST representative to discuss options and a recommended approach.
