**Third Quarter 2013  
Groundwater Monitoring Report**

**6501 Shattuck Avenue  
Oakland, California**

**September 26, 2013**

**Project 5031**

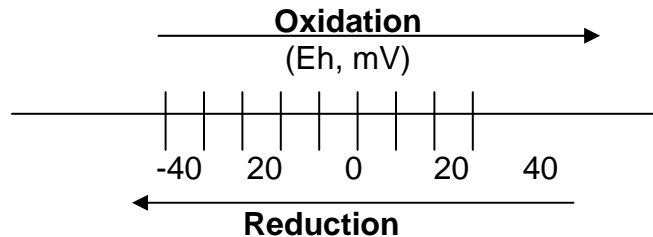
and others (Freeze and Cherry, 1979). As these oxidizing agents are consumed, the groundwater environment becomes more and more reduced. If the process advances far enough, the environment may become so strongly reduced that the petroleum hydrocarbons undergo anaerobic degradation, resulting in the production of methane and carbon dioxide. The concept of oxidation and reduction in terms of changes in oxidation states is illustrated below.
