Soil and Groundwater Investigation Report

6501 Shattuck Avenue, Oakland, California

Project 5032

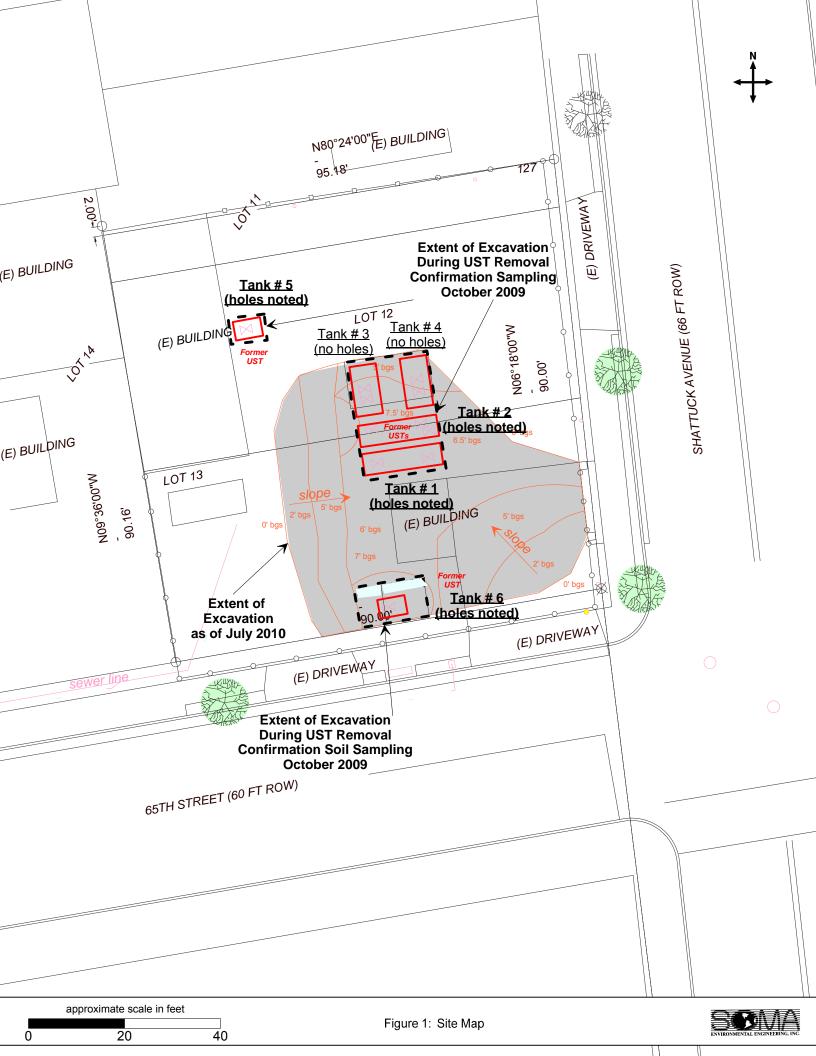
Figure 1	1:	Site map
----------	----	----------

SOMA Environmental Engineering, Inc. (SOMA) conducted an additional soil and groundwater assessment and prepared this report at the request of Bruder LLC manager Mr. Athan Magganas, for the property located 6501 Shattuck Avenue, Oakland, California. This report was prepared in response to Alameda County Health Care Services (ACHCS) approval correspondence dated February 10, 2011 and May 12, 2011. This correspondence pertains to SOMA's workplan addendum entitled "Addendum to Interim Remedial Excavation and Proposed Soil and Groundwater Investigation" dated December 13, 2010 and correspondence dated March 14, 2011, entitled "Revised Site Figure". The site map is shown in Figure 1.

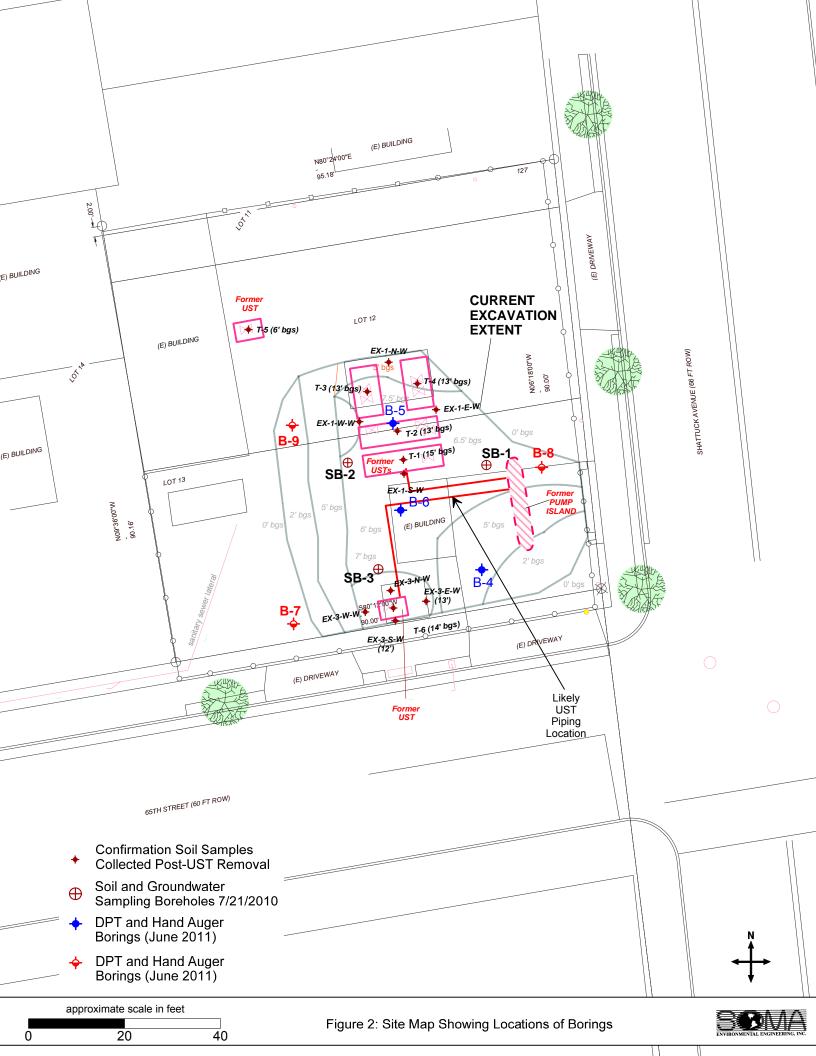
Figure 2: Site map showing location of borings

Based on ACHCS directives dated February 10, 2011 and May 12, 2011, SOMA advanced six additional soil boreholes (B-4 through B-9) in order to determine the extent of soil and groundwater contamination at the site.

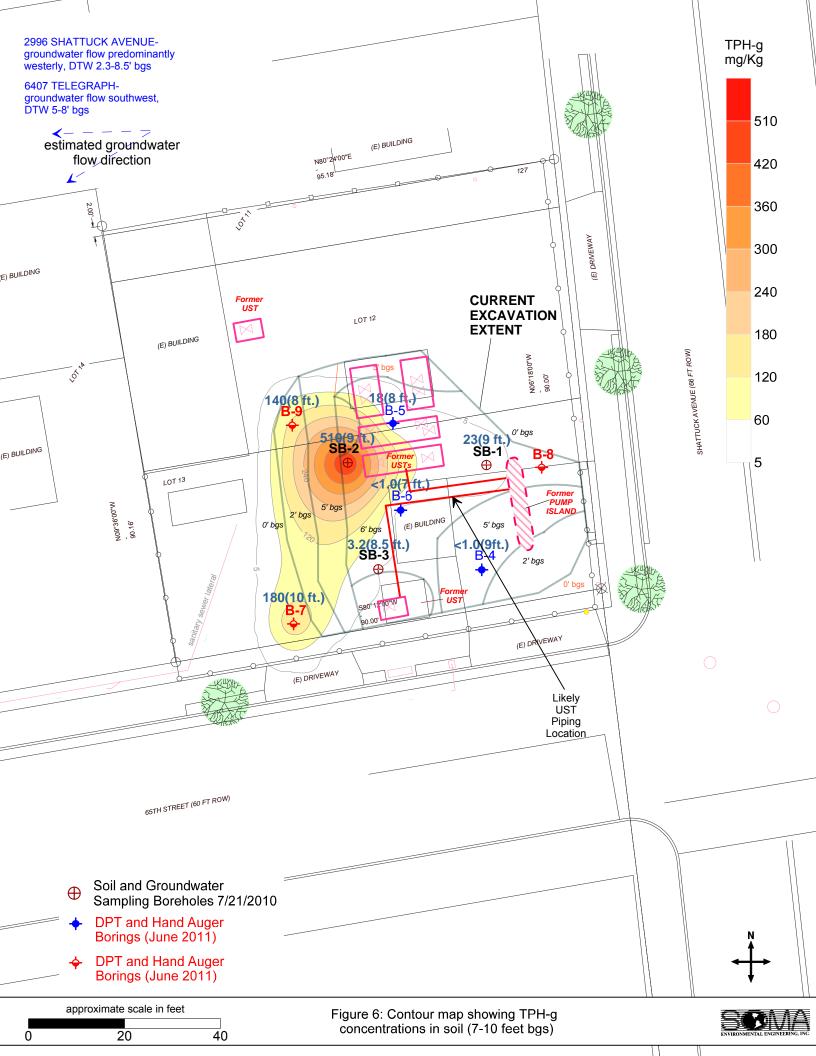
Figure 6: Contour map showing TPH-g concentrations in soil (7-10 feet bgs)

During this investigation, all analytes were detected below laboratory-reporting limits or ESLs in analyzed soil samples except for TPH-g, which was detected in borings B-7 and B-9 above ESLs. In B-7, TPH-g was detected at 10 feet bgs at 180 mg/kg. In B-9, TPH-g was detected at 8 feet bgs at 140 mg/kg. The laboratory noted that the some of the samples exhibited a chromatographic pattern which did not resemble standard. A contour map showing TPH-g concentrations in soil between 7 and 12 feet bgs during the current and previous soil sampling is shown in Figure 6. Maximum TPH-g concentration was detected during previous site investigation in boring SB-2 at 510 mg/kg at 9 feet below ground surface. Table 4 summarizes current and historical soil analytical results; the current analytical report is contained in Appendix C.

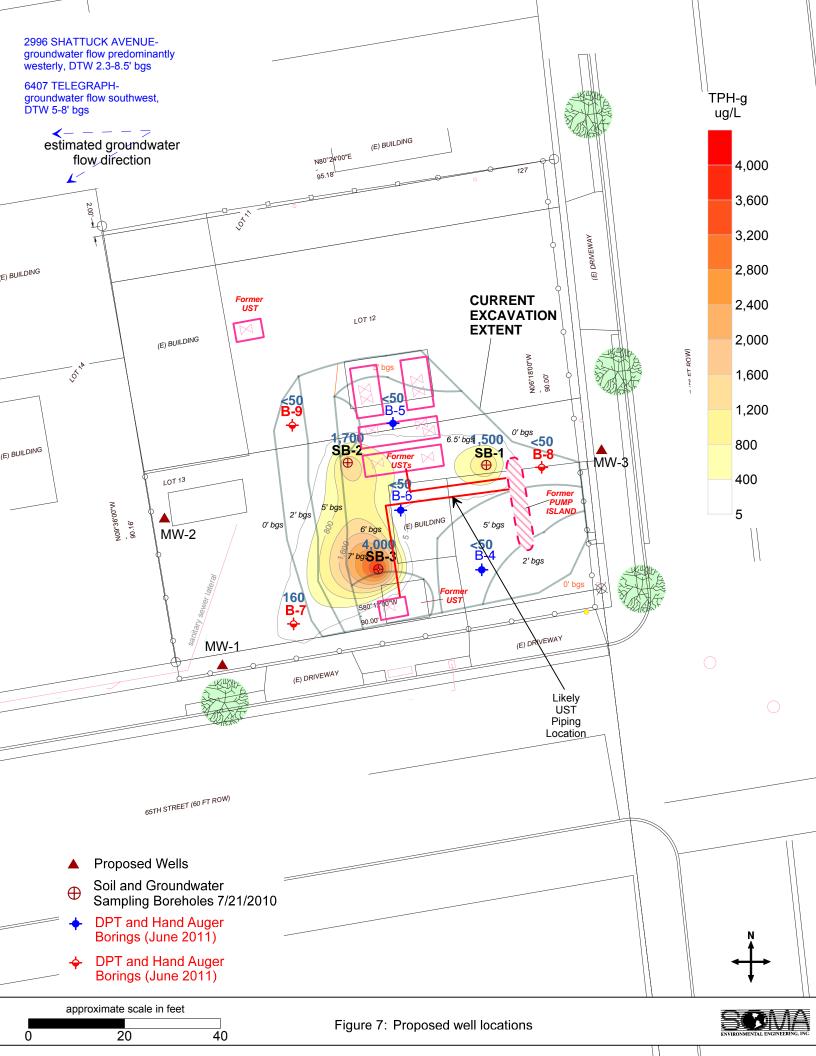
Figure 7: Proposed well locations

impact at the site. monitoring wells.	Figure	7	shows	proposed	locations	of	groundwater

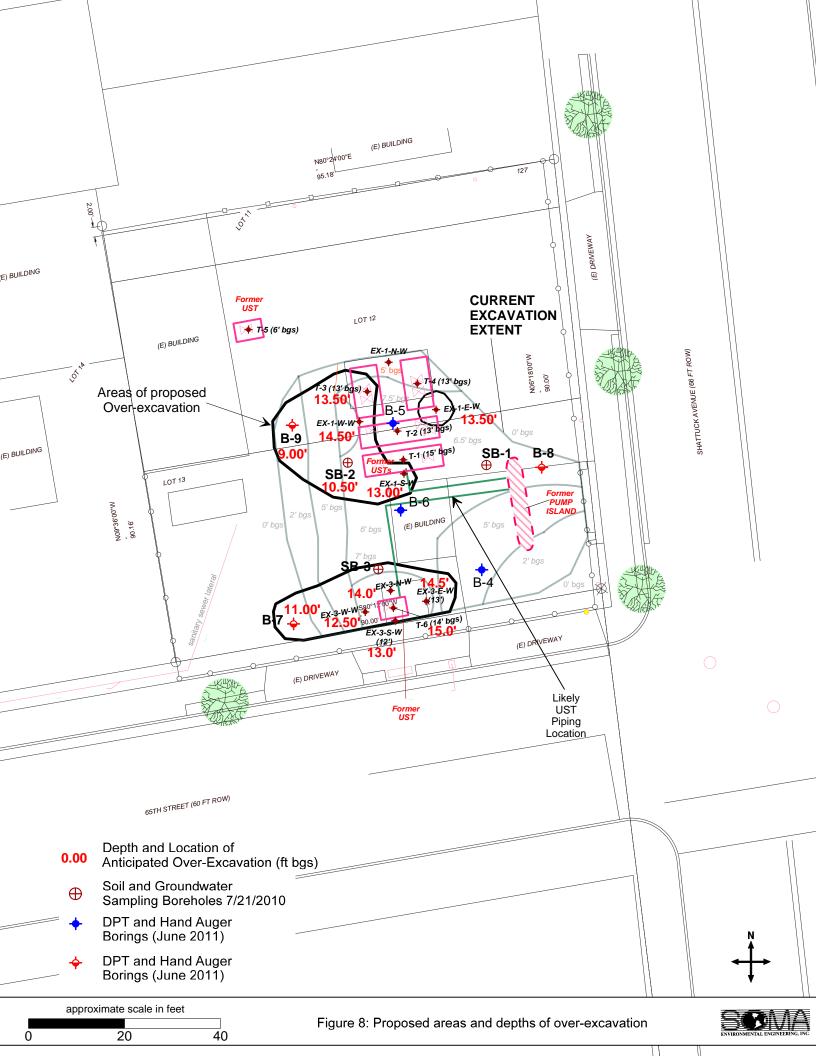
Figure 8: Proposed areas and depths of over-excavation

- Based on current soil sampling, and as proposed in earlier SOMA correspondence, further soil over-excavation is necessary to remove residual soil contamination. During the proposed over-excavation, areas around confirmation soil samples (EX-3-W-W through WX-3-E-W) as well as soil borings SB-2, B-7 and B-9 should be over-excavated. Tables 2 and 4 illustrate the recommended depth of over-excavation at each sampling location (Figure 8). Since it is SOMA's understanding that some earthmoving activities have taken place since the majority of these samples were collected, SOMA proposes conducting a land survey which at minimum will aid in determining which locations have already been over-excavated and which have not. Historical contour figures, illustrating contaminant levels in confirmation samples collected after removal of USTs, are included in Appendix D.

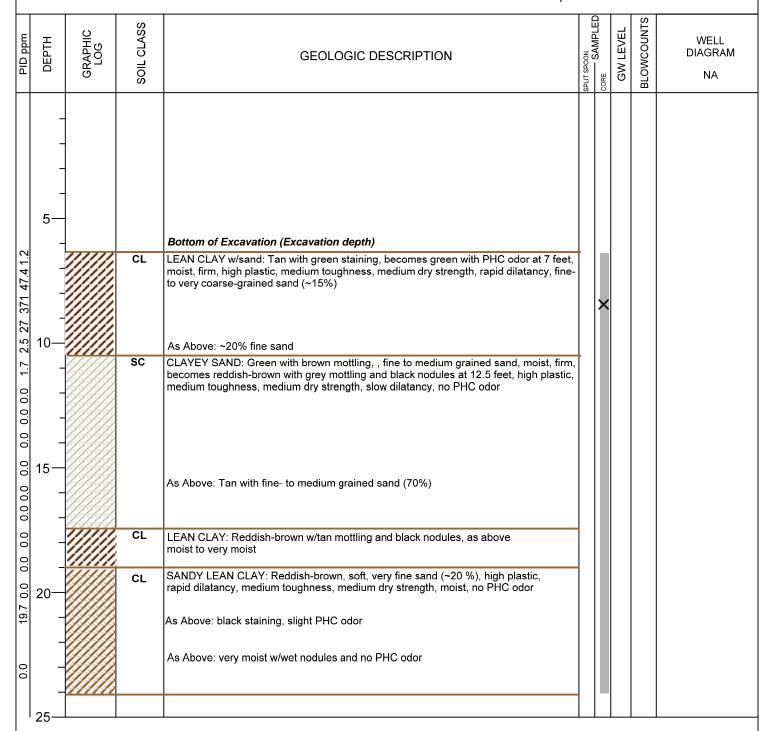
COMMENTS: Total depth 24 ft bgs. Stabilized GW not encountered, GW sample collected as soon as water in casing.

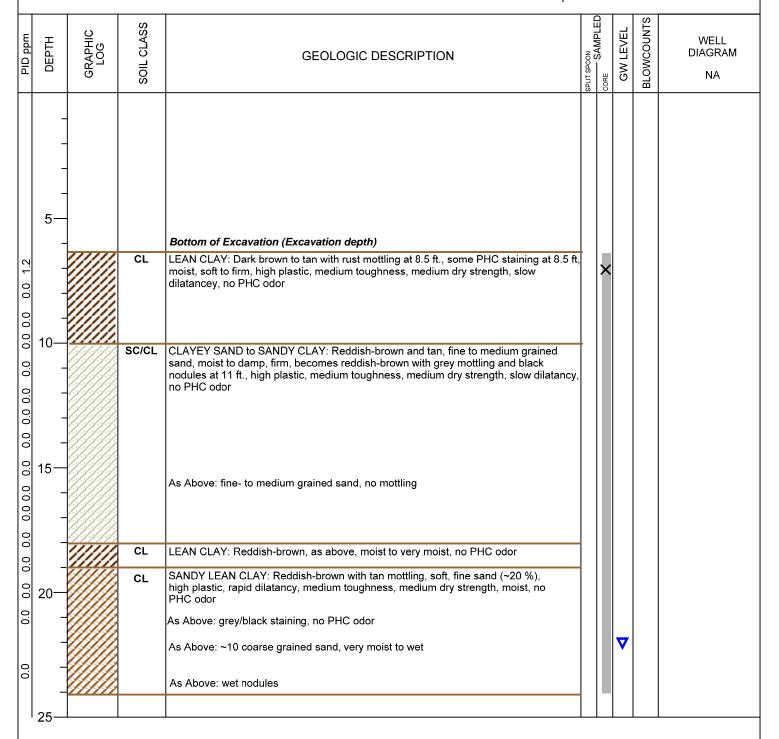
COMMENTS: Total depth 24 ft bgs. Stabilized GW not encountered, GW sample collected as soon as water in casing.

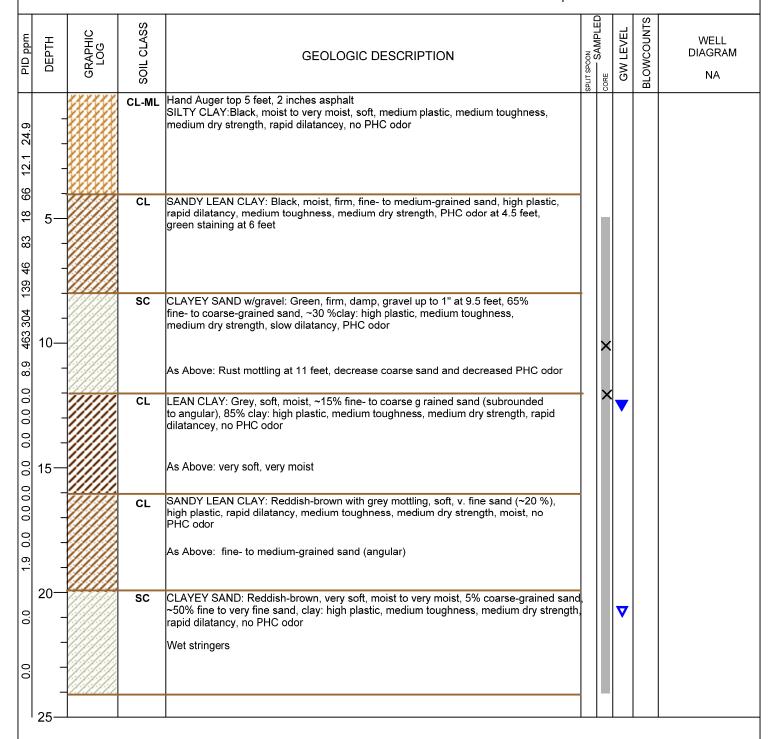
COMMENTS: Total depth 24 ft bgs. Stabilized GW at 12.45 feet bgs

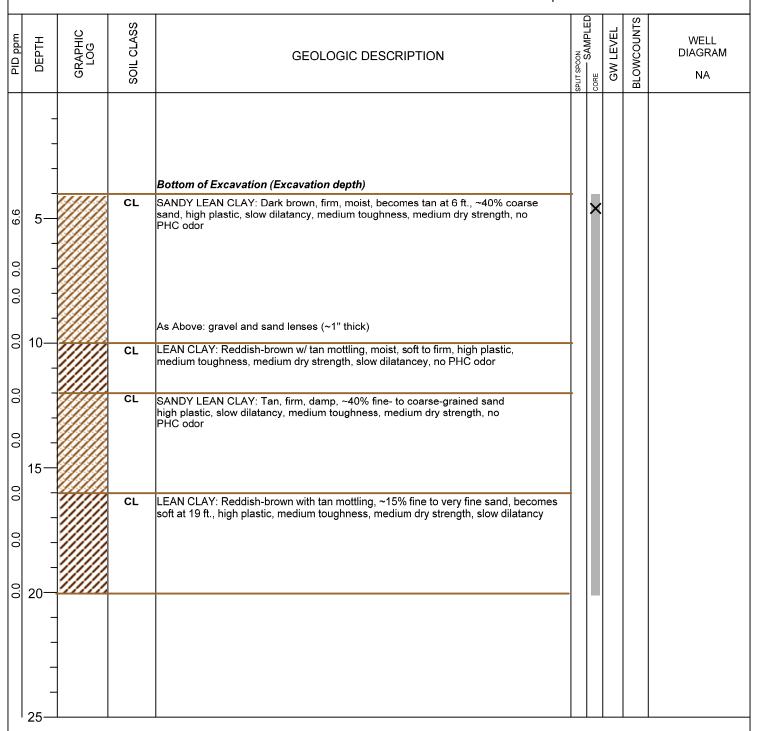
COMMENTS: Total depth 20 ft bgs. Stabilized GW not encountered, GW sample collected as soon as water in casing.
