**PHASE I
ENVIRONMENTAL SITE ASSESSMENT
3645 SAN PABLO AVENUE
EMERYVILLE, CALIFORNIA**

February 6, 2002
Project No. 400596001

Subject: Phase I Environmental Site Assessment
3645 San Pablo Avenue
Emeryville, California

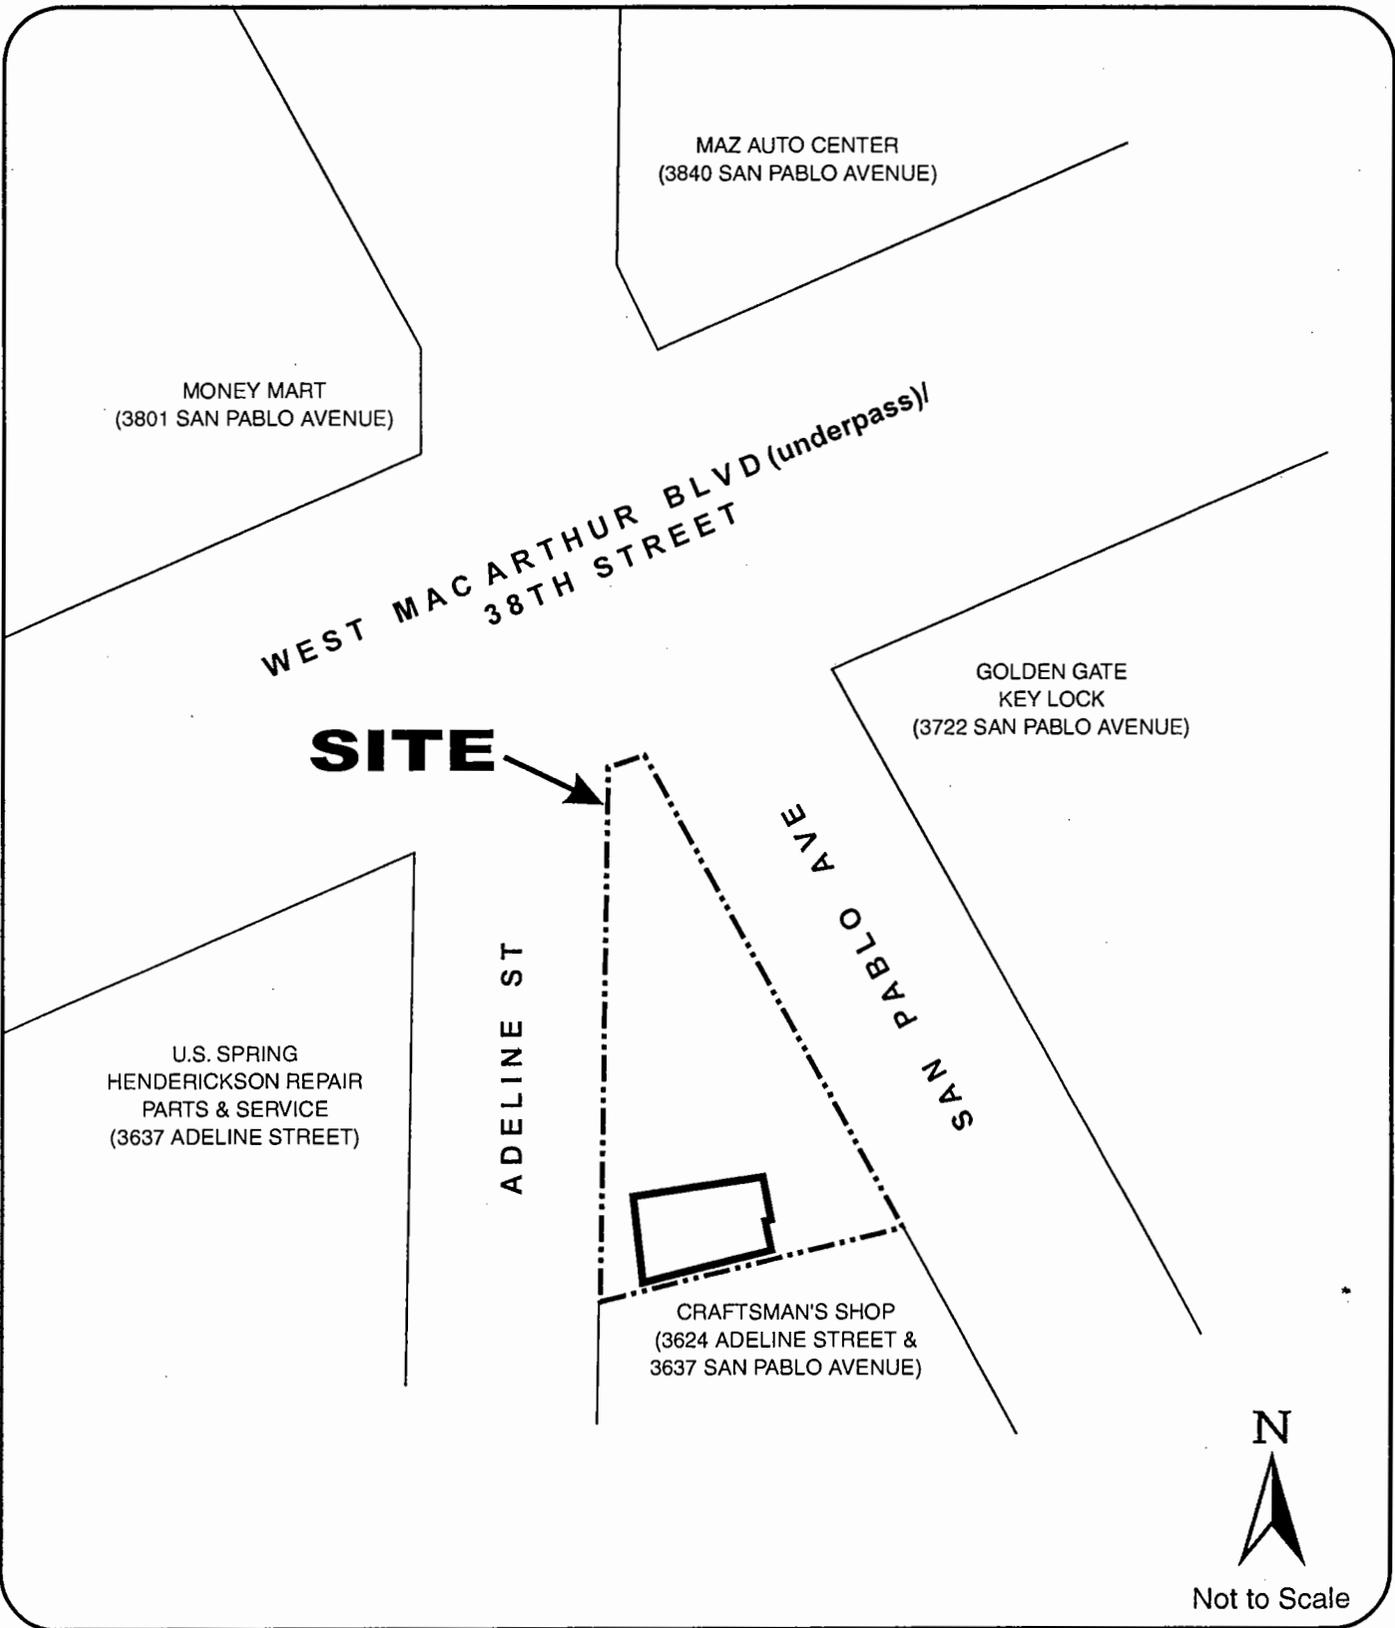
SITE AND VICINITY MAP

south of the site is a large structure that is utilized for a craftsman's shop. In general, the site vicinity consists of a mix of commercial businesses, shops and residences (Figure 2).
