RE: Data Gap Investigation Report

SITE: Mulholland Residence
132 Guilford Road, Piedmont, California
ACHCSA Fuel Leak Case No. RO0003070
Global ID #T10000002521

DATA GAP INVESTIGATION REPORT

Mulholland Residence

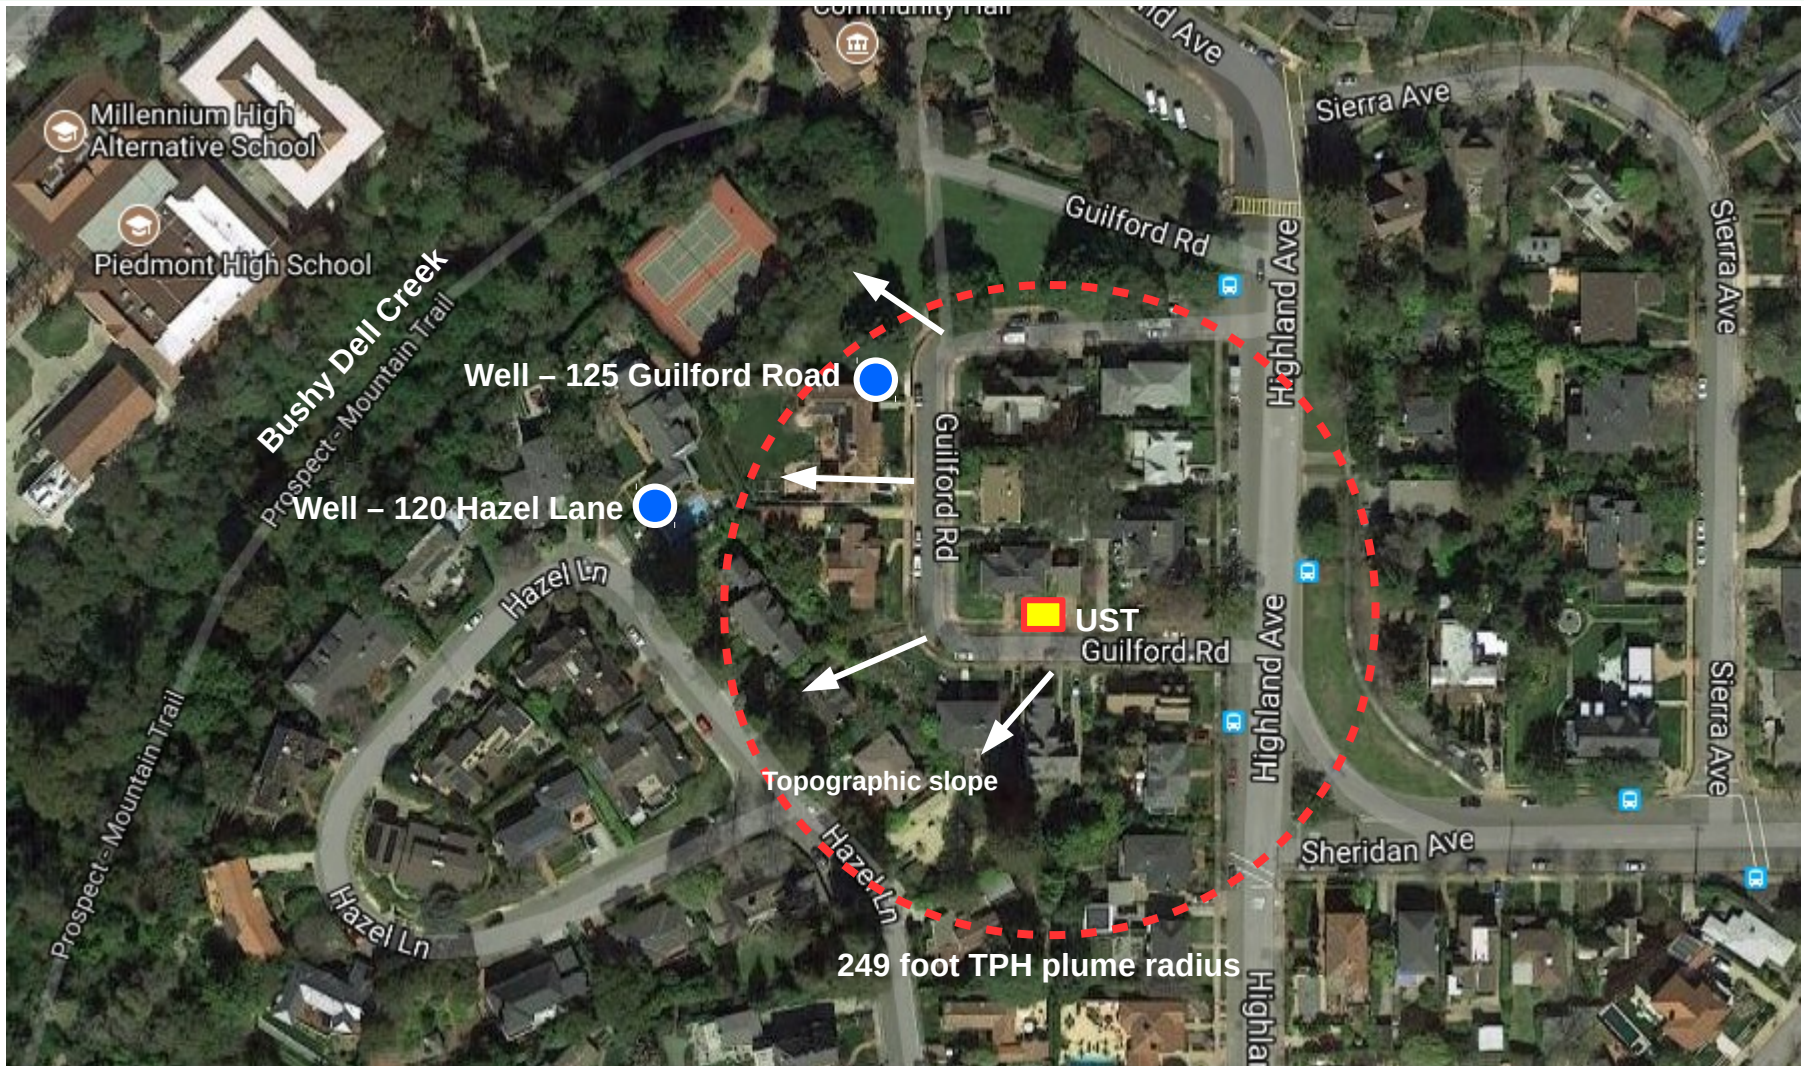
Potential TPH plume from heating oil UST at 132 Guilford Road based on 249 foot diameter potential plume diameter. The nearest well at 125 Guilford Road is within the plume radius. Other well at 120 Hazel Lane is just outside the potential plume estimate. Direction of topographic slope shown by white arrows. Base map from Google Maps 2017 with annotations by Wheeler Group Environmental, LLC.

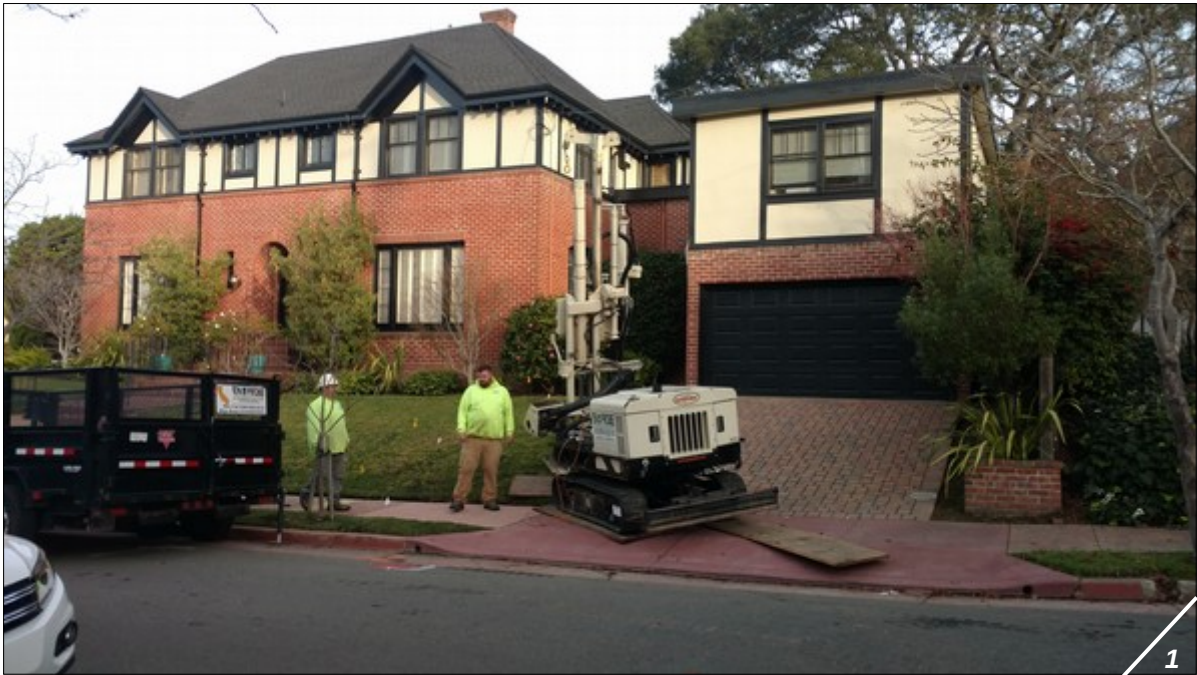
Photograph No. 1 – Northwest view of front yard and garage driveway of residence, showing EnProbe Drilling personnel during initial setup of GeoProbe 7822DT Combo Track Rig at Field Point B1, along north side of former 200-gallon heating oil UST excavation; additional proposed field point boring locations shown as white flagging, placed during WGE's site markout activities on January 10, 2018; (WGE, 1/17/18).

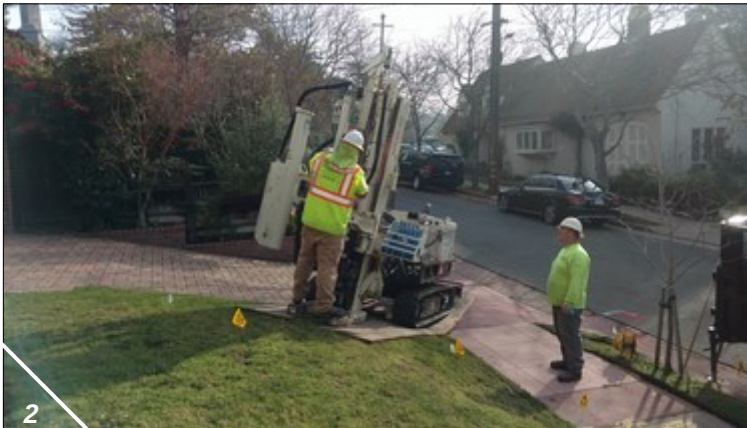
Photograph No. 2 – East view of front yard and sidewalk of subject residence along Guilford Road showing EnProbe personnel during drilling/sampling at at Field Point B1; yellow flagging signifies location of subsurface natural gas service lateral pipe (WGE, 1/17/18).

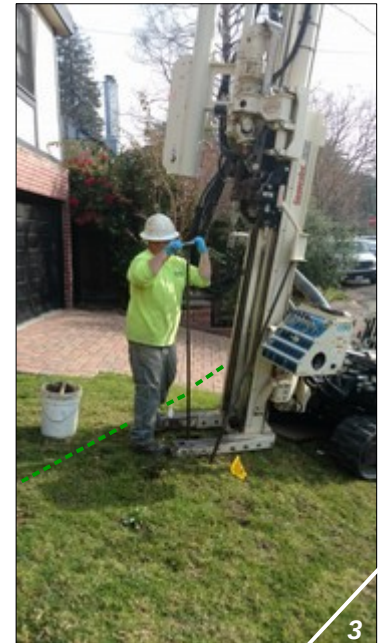
Photograph No. 3 – East view of residence front yard showing EnProbe personnel at Field Point B5, clearing borehole to 4 fbg to clear for unmarked subsurface utilities prior to using GeoProbe drilling equipment; approximate location of existing sanitary sewer service lateral shown as green dashed line (WGE, 1/17/18).

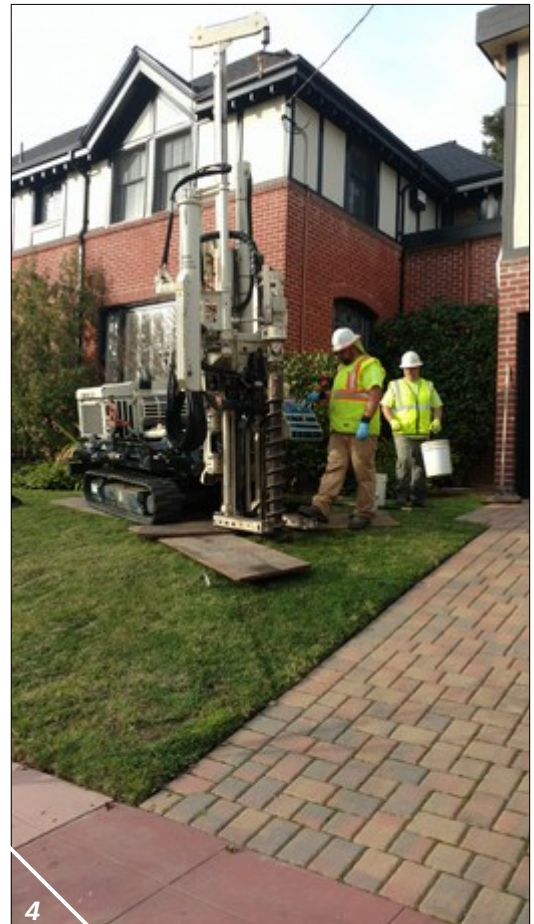
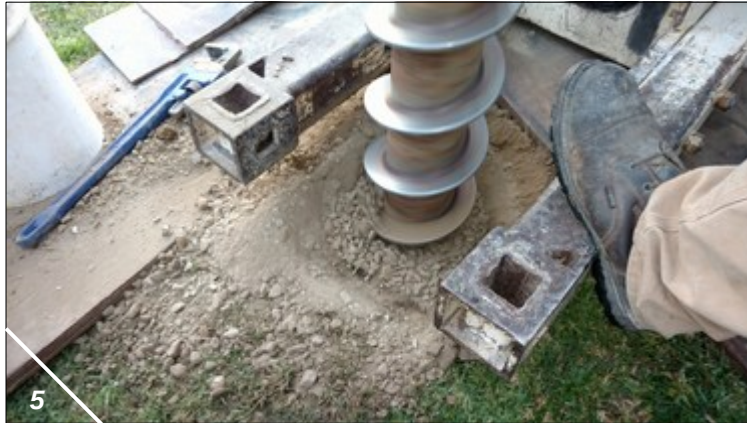
Photograph No. 4 – Northwest view of front yard and garage driveway of residence, showing EnProbe Drilling personnel during rotary hollow stem auger drilling at Field Point B5, located approximately 6 feet north-northwest of former UST excavation; 8.25"-diameter hollow stem augers used following drilling refusal of GeoProbe equipment at 8.5 fbg; borehole drilled to total depth of 13 fbg (WGE, 1/17/18).

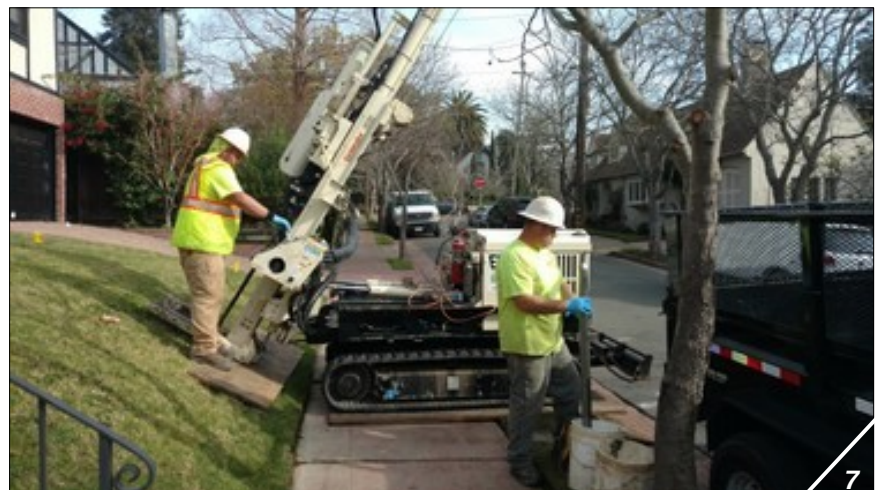
Photograph No. 5 – View of soil cuttings generated during rotary auger drilling at Field Point B5 from weathered bedrock zone encountered between 4.5 and 13 feet below grade; grayish orange to light olive gray, fine silt & siltstone fragments (pulverized weathered bedrock) observed (WGE, 1/17/18).

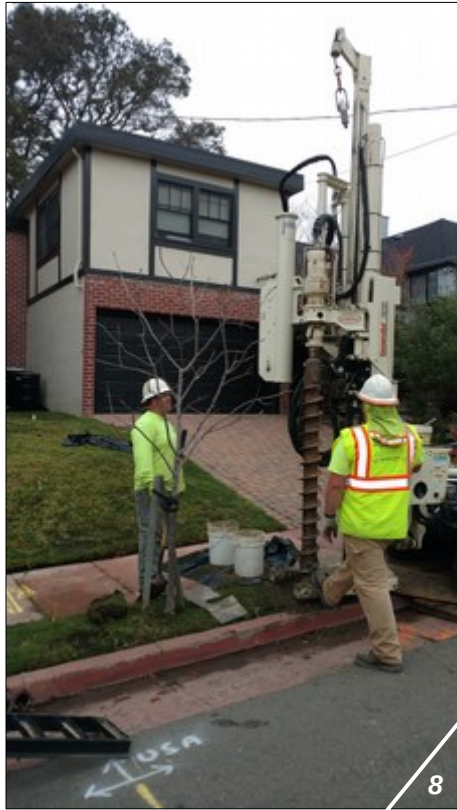
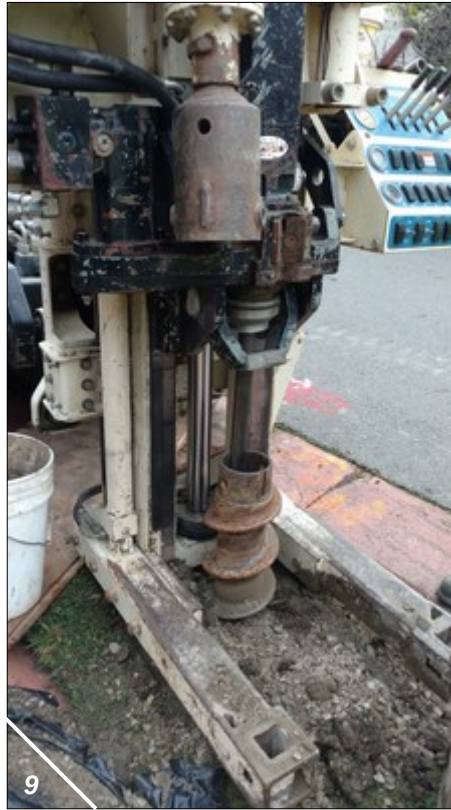
Photograph Nos. 6 & 7 – Respective south and east views of front yard and sidewalk of subject residence along Guilford Road showing EnProbe personnel during drilling/sampling at Field Point B7, located approximately 12 feet west of the former UST excavation; borehole drilled at 30 degree angle form vertical plane (WGE, 1/17/18).

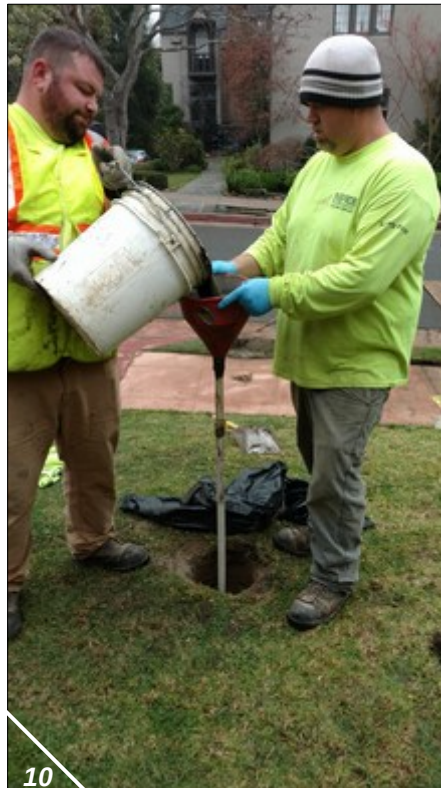
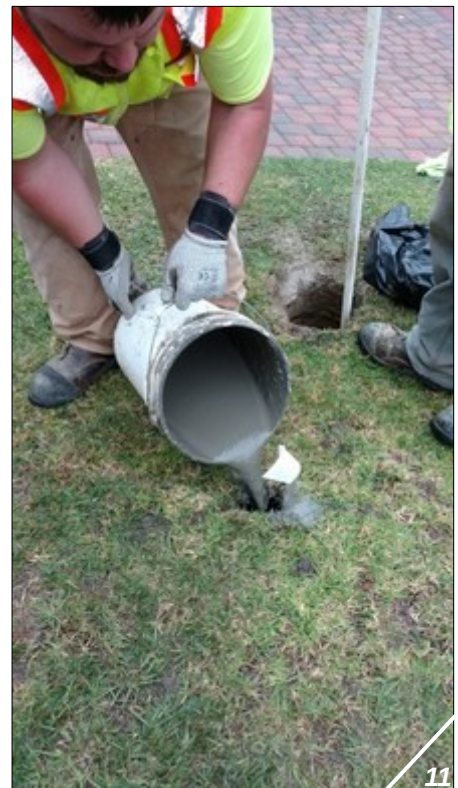
Photograph Nos. 8 & 9 – Respective northeast and southeast views of front yard and sidewalk of subject residence, showing EnProbe Drilling personnel during rotary hollow stem auger drilling at Field Point B3, located approximately 7 feet south of former UST excavation, and in direct vicinity of former UST remote fill pipe; Photograph No. 9 shows GeoProbe sampler advanced through center of hollow stem augers during collection of discrete soil samples in bedrock zone at 10 and 14 fbg; borehole drilled to total depth of 14 fbg (WGE, 1/18/18).

Photograph Nos. 10 & 11 – Views of EnProbe personnel during borehole backfilling activities; backfilling by tremie grout was requested by Alameda County Public Works Agency inspector at Field Point B5 due to small volume of drainage water observed in borehole on January 18, 2018 (WGE, 1/18/18).

Following completion of soil sampling activities, EnProbe periodically measured for the presence of groundwater in each borehole using an electronic water level meter and/or oil/water interface meter, and subsequently backfilled each borehole with neat Portland cement up to approximately 1 fbg. Drainage water was observed in the borehole at Field Point B5 and the well was sealed by tremie grouting, as required by Alameda County Public Works Agency (ACPWA) Inspector, Mr. Eneyew Amberber. The balance of each borehole was backfilled with appropriate cover material to restore original Site conditions. All backfilling activities were overseen by ACPWA Inspector Amberber. Photographs of the borehole sealing activities are presented in photograph numbers 10-11 on Photograph Page 3 of Appendix A

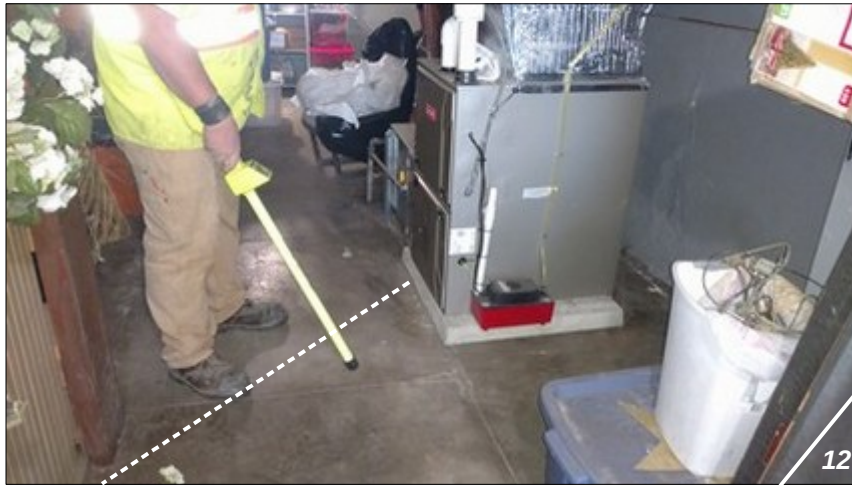
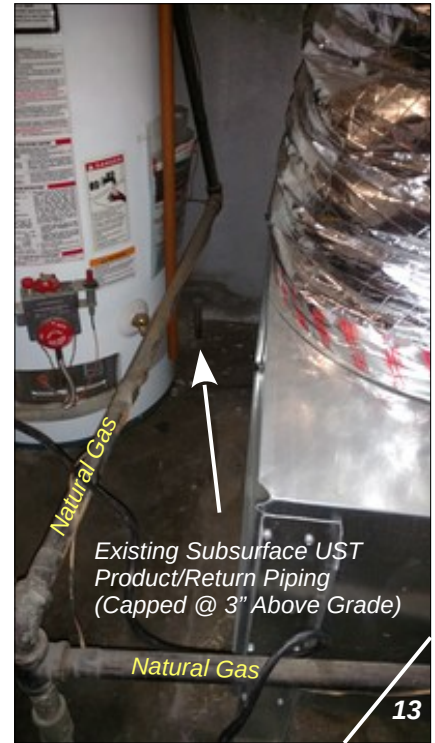
Photograph Nos. 12 & 13 – Interior views of basement of subject residence, showing EnProbe Drilling personnel utilizing handheld magnetometer to locate subsurface product/return line piping (dashed white line) prior to sub-slab vapor point installation; Photograph No. 12 shows location of product/return pipes along north partition wall between existing water heater and central furnace unit; pipes are 0.5"-diameter, steel, capped @ 3" above basement floor surface (WGE, 1/17/18).

On January 18, 2018, WGE and EnProbe located the underground product line beneath the basement concrete floor utilizing a handheld magnetometer. WGE was unable to locate the product line in the front yard of the residence using the metal detector. Boring B6 was located along the assumed alignment of the product line from the oil burner to the former UST location. WGE in collaboration with EnProbe attempted product line confirmation soil sampling at location B6, as shown in Figure 3 – Site Plan as a Dashed Line. At soil boring Field Point B6, EnProbe hand augured a 2.25-inch-diameter borehole to approximate 1.5 fbg while simultaneously transferring the auger soil cuttings to a 5-gallon plastic bucket. Drilling refusal was encountered at a depth of 1.5 fbg on dense rock. Because the refusal depth was above the assumed product line depth and no evidence of petroleum contamination was observed, no soil sample was recovered at Field Point B6.

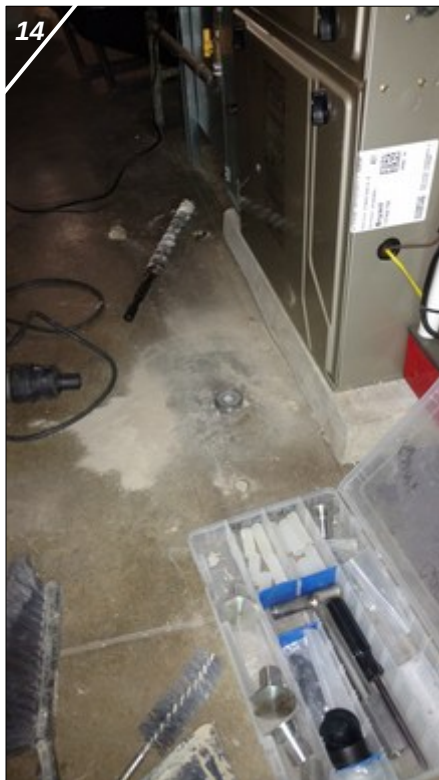
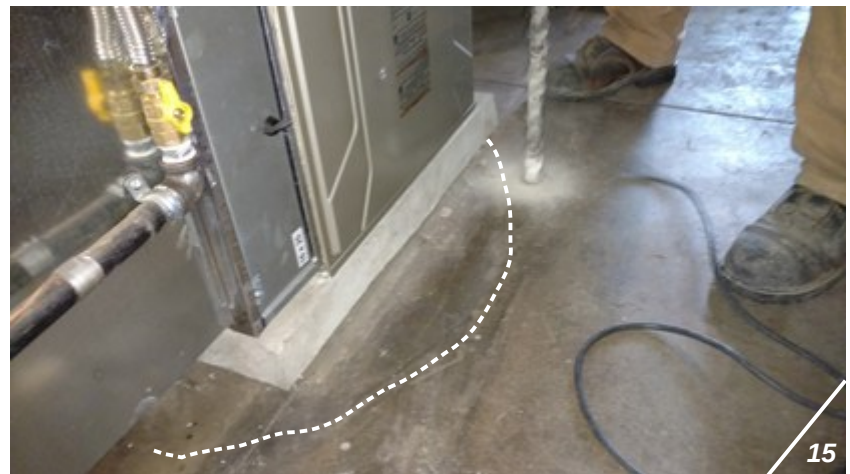
Photograph Nos. 14 & 15 – Interior views of basement of subject residence, showing EnProbe Drilling personnel during installation of Sub-Slab Vapor Field Point SSI; Photograph No. 15 shows approximate footprint of former oil burner associated with former UST system (WGE, 1/17/18).

On January 18, 2018, following completion of exterior drilling activities, EnProbe installed one sub-slab vapor sampling point within the concrete floor of the basement furnace room. Pictures of the vapor pin installation are shown in photographs number 12-15 on Photograph Page 4 of Appendix A. Two ½ inch diameter heating oil supply line are capped at the basement wall as shown in photograph 13. EnProbe located the underground product line beneath the basement concrete floor utilizing a handheld magnetometer. The vapor pin was installed in close proximity to the former oil burner furnace and above the alignment of the buried supply line as shown in the photographs.

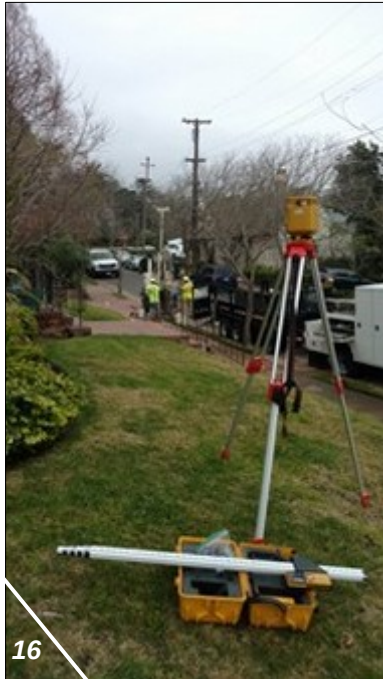
Photograph No. 16 – Southeast view of front yard at southwest corner of residence showing survey equipment during grade elevation survey performed by WGE; survey also used to acquire approximate grade elevation of private water supply well located at 125 Guilford Road (WGE, 1/18/18).

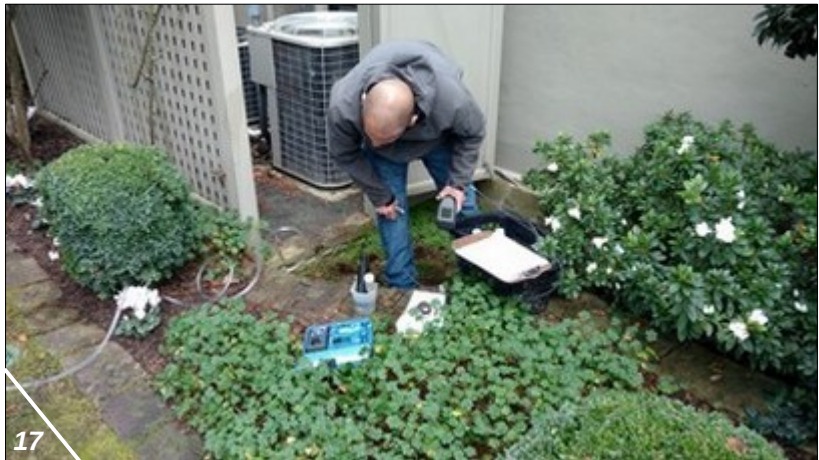
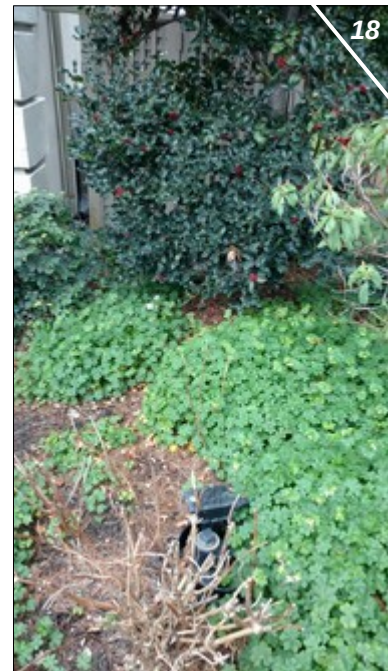
Photograph Nos. 17 & 18 – Respective southeast and west views of residence at 125 Guilford Road showing Dysert Environmental field technician during purging/monitoring/sampling of private water supply well; sample collected directly from effluent spigot located approximately 13 feet west of wellhead shown in Photograph No. 18; private water supply well installed in February 2016 by Martell Water Systems, Inc. to depth of 200 feet (WGE, 1/18/18).

In the 125 Guilford Road irrigation well, the driller reported topsoil from 0 to 2 fbg, dark brown and black rock from 2 to 38 fbg, grey rock with some white and green rock from 38 to 160 fbg, and grey rock with black silty layers from 160 to 200 fbg. WGE interprets this description to indicate the well encountered weathered Franciscan sandstone and shale from 2 to 38 fbg, Franciscan melange—sandstone with greenstone and/or serpentinite from 38 to 160 fbg, and Franciscan sandstone and shale from 160 to 200 fbg. Water is believed to be present in fracture systems within the hard crystalline Franciscan bedrock.

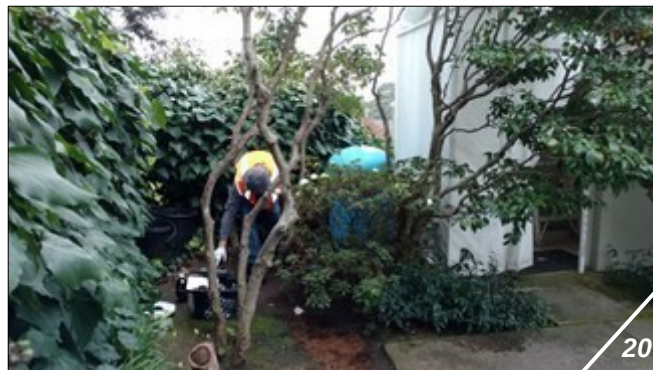
Photograph Nos. 19-21 – Exterior views of residence at 120 Hazel Lane showing Dysert Environmental field technician during purging/monitoring/sampling of private water supply well; sample collected directly from effluent spigot located approximately 20 feet east of wellhead located in driveway, as shown shown in Photograph No. 21; private water supply well installed in October 1992 to depth of 275 feet (WGE, 11/15/17 & 1/18/18).

The 120 Hazel Lane well was completed from 0 to 55 fbg with 4.5 inch internal diameter cemented casing. Casing with a 4.5 inch internal diameter and 0.040 inch slot size with "Aqua. Sand" was installed from 55 to 275 fbg. The well as tested produced 35 gallons per minute at 80 fbg. The standing water level was measured at 51 fbg. The geologic log recorded: 0-60 Yellow brown shale & clay w/ streaks of brown sandstone, 60-125 Fractured grey sandstone & shale w/streaks of grey clay, 125-137 Shaley clay w/fractured grey sandstone, 137-145 Grey clay w/streaks of grey sandstone, 145-300 Grey & blue sandstone w/streaks of white & grey clay. WGE interprets this description to indicate the well encountered weathered Franciscan sandstone and shale from 0 to 60 fbg, fractured Franciscan sandstone and shale from 160 to 145 fbg, and Franciscan melange—sandstone with greenstone and/or serpentinite from 135 to 300 fbg, and. Water is believed to be present in fracture systems within the hard crystalline Franciscan bedrock.

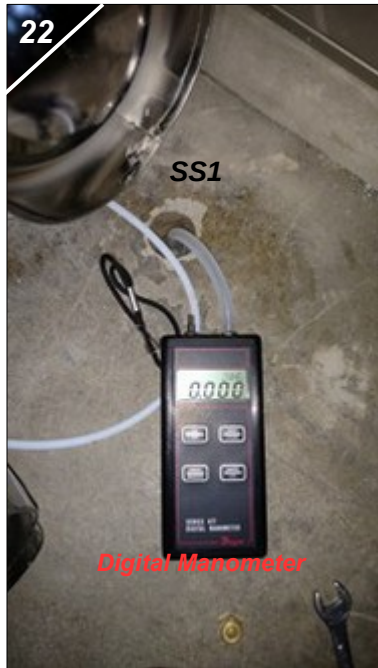
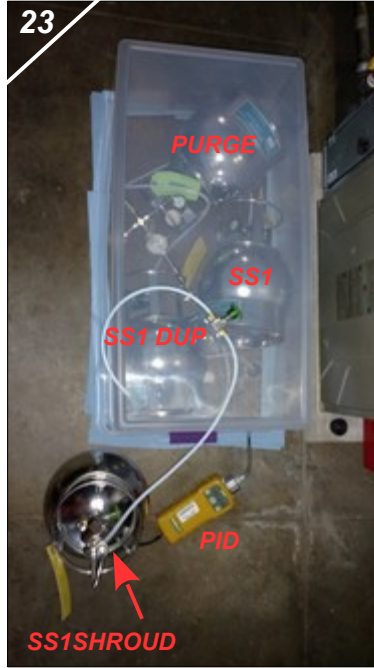
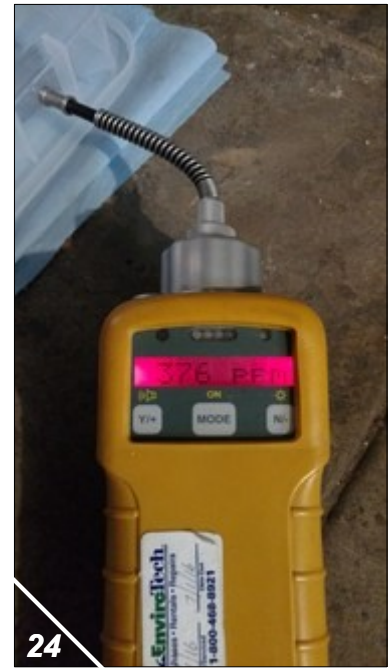
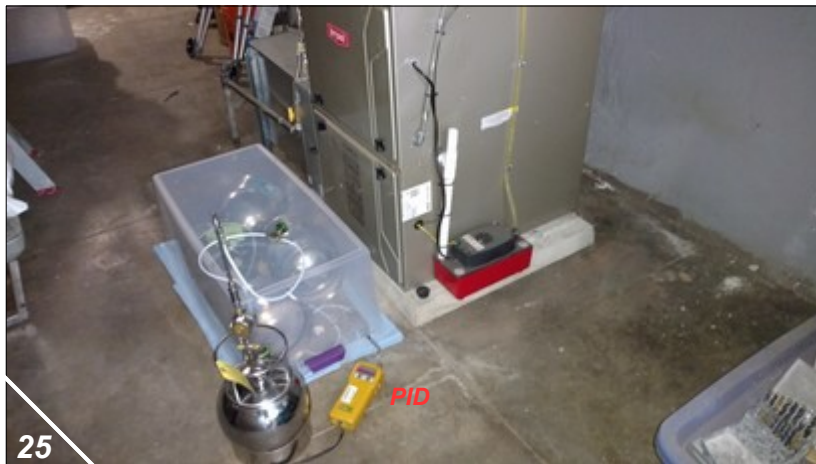
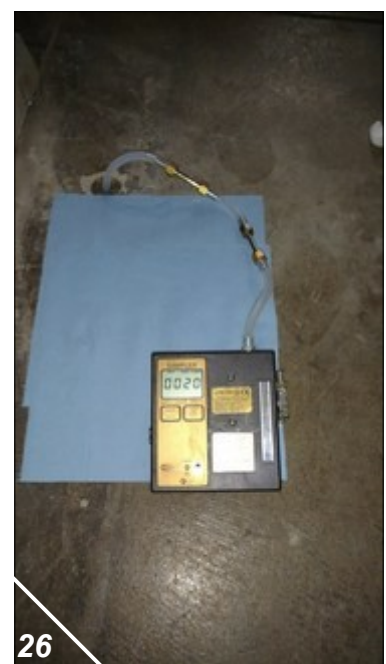
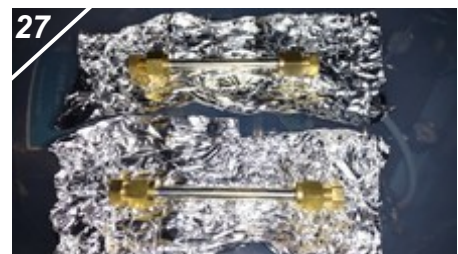
Photograph Nos. 22-27 - Views of sub-slab vapor sampling activities at Field Sampling Point SS1 located within existing furnace room in basement; Field Point SS1 installed next to former oil burner and product lines associated with UST; Photograph Nos. 22 & 24 shows initial sub-slab vacuum (0.000"Hg) and interior shroud VOC measurement (376 ppm) during sampling with Summa canisters; Photograph Nos. 23 & 25 show sub-slab vapor sampling in progress, with typical manifold assembly, shroud enclosure, and measurement of shroud tracer gas (2-Propanol) using calibrated PID; Photograph Nos. 26 & 27 show subsequent sub-slab sampling for TPH-Diesel & Naphthalene (TO-17) using Thermal Desorption Tubes (In series) and sampling pump (WGE, 2/1/18).

On February 1, 2018, Wheeler Group personnel returned to the Site to perform sub-slab vapor sampling at Field Sampling Point SS1—in accordance with the procedures presented in Wheeler Group’s August 25, 2017 Data Gap Investigation Work Plan, per the associated conditions in the ACDEH’s October 25, 2017 Conditional Work Plan Approval Letter, and per California EPA DTSC and SF Bay Regional Water Quality Control Board’s July 2015 Advisory for Active Soil Gas Investigation document. No significant rain event occurred within 5 days of the sub-slab sampling. Pictures of the vapor sampling are shown in photographs number 22-27 on Photograph Page 6 of Appendix A.

One sub-slab vapor sample and one duplicate sub-slab vapor sample (FPN SS1) were collected in 6-liter Summa canisters and analyzed for VOCs by EPA Method TO-15 and for Fixed Gases (Oxygen, Carbon Dioxide, Methane) by ASTM Method D1946. A sub-slab sample was also collected from SS1 using Thermal Desorption Tubes and analyzed for TPH as diesel range organics and Naphthalene by EPA Method TO-17. Using a Summa canister, one additional air sample was collected from the interior of the shroud and analyzed for isopropyl alcohol (2-Propanol; leak check compound) only by EPA Method TO-15. Throughout the duration of the sub-slab sampling event (@ 85 to 92 minutes), Wheeler Group monitored and recorded the interior shroud air concentration every 2 minutes using a photo ionization detector.
