**PHASE I ENVIRONMENTAL
BOTW NO. 09-0510-02
SITE ASSESSMENT
GENO'S COUNTRY STORE, INC.
1000 NORTH VASCO ROAD
LIVERMORE, CALIFORNIA**

Pursuant to ASTM E 1527-05

Project No. 013-09074
April 3, 2009

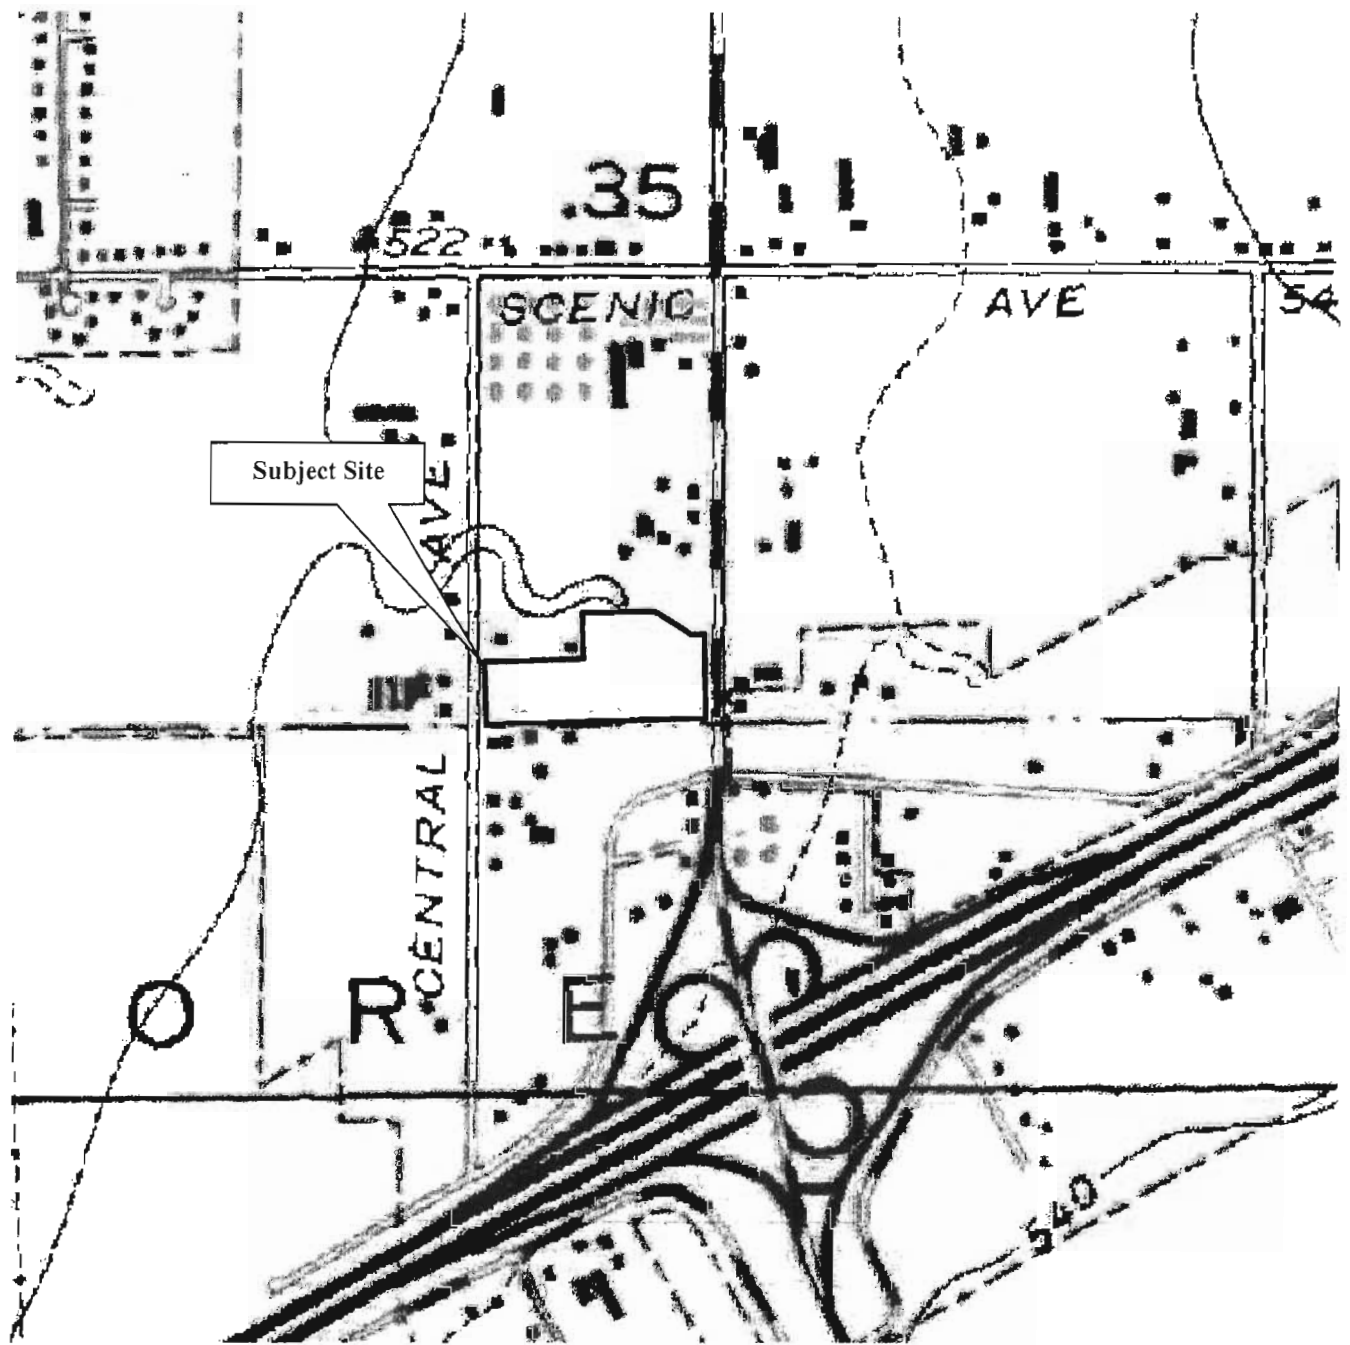
Krazan SITE DEVELOPMENT ENGINEERS <i>Conducting Assessments Nationwide</i>
	Drawn by: PH	Approved by: CWT	
BOTW No. 09-0510-02 Geno's Country Store, Inc. 1000 North Vasco Road Livermore, California 94551	Project No. 013-09074	Figure No. 2

TOPOGRAPHIC MAP - 1981 BOTW No. 09-0510-02 Geno's Country Store, Inc. 1000 North Vasco Road Livermore, California 94551	Scale: NTS	Date: April 2009

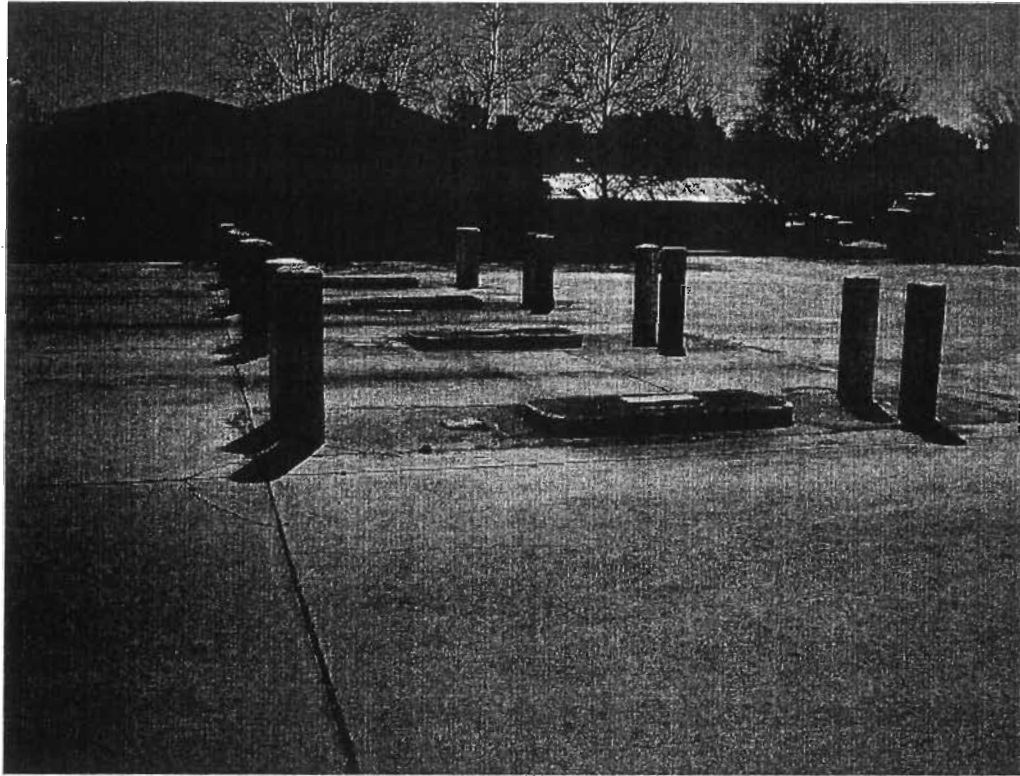
- At the time of Krazan's March 26, 2009 site reconnaissance, five gasoline dispenser islands were observed east of the restaurant building and four diesel dispenser islands were observed north of the restaurant building. Krazan observed evidence of three current USTs at the subject site northeast and north of the restaurant building. According to Mr. Macedo and regulatory records with the Livermore Pleasanton Fire Department (LFPD), the USTs consist of two, 15,000-gallon gasoline USTs and one, 12,000-gallon diesel UST. LFPD is the lead regulatory agency concerning current and historical USTs and hazardous materials storage and handling. The current USTs, dispenser islands, and associated piping were installed in 1994. According to LFPD records, the dispensers were removed, piping sealed, and USTs temporarily abandoned in place in July 2008. LFPD records included numerous non-compliance violations concerning the current USTs dating from 2003 to 2008. Violations ranged from non-submittal of tank/piping monitoring results to non-submittal of hazardous materials business plans. According to Mr. Macedo, the planned use of the subject site will no longer include retail sales of gasoline or diesel fuel.

Photo 3: View of the diesel dispenser islands located north of the on-site restaurant.

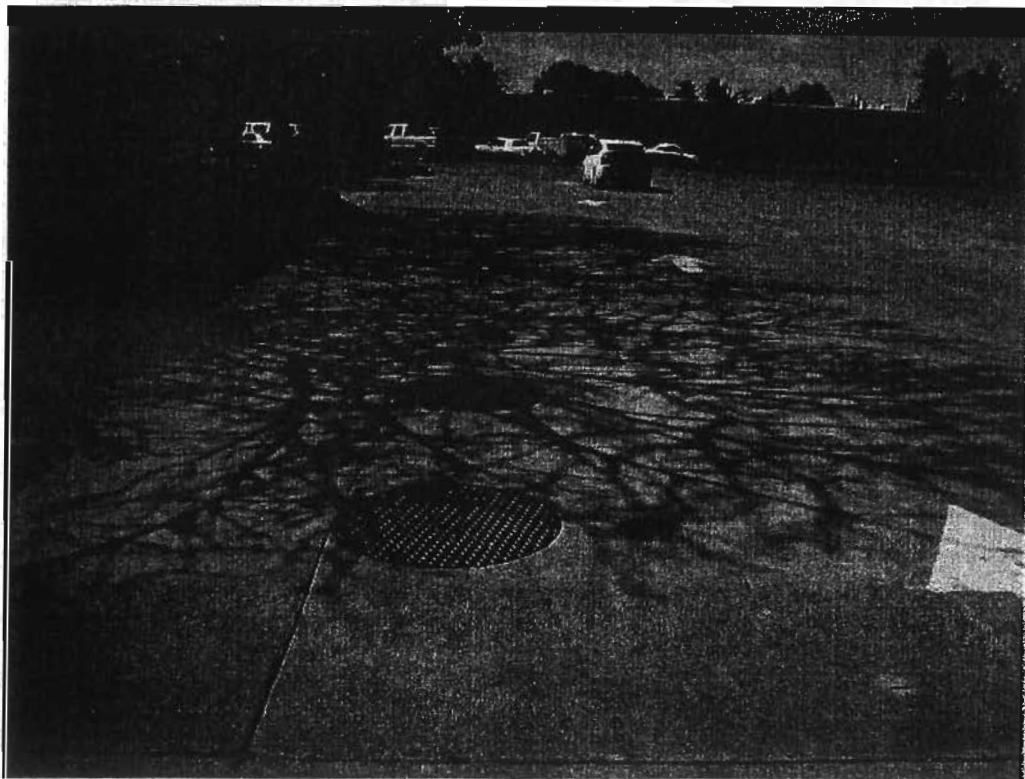
building. According to Mr. Macedo, the owner, and regulatory records on file with the Livermore Pleasanton Fire Department (LPPFD), the USTs consist of two, 15,000-gallon gasoline USTs and one, 12,000-gallon diesel UST. LPPFD is the lead regulatory agency concerning current and historical USTs and hazardous materials storage and handling for the subject site. The current USTs, dispenser islands, and associated piping were installed in 1994. According to LPPFD records, the dispensers were removed, piping sealed, and USTs temporarily abandoned in place in July 2008. LPPFD records included numerous non-compliance violations concerning the current USTs dating from 2003 to 2008. Violations ranged from non-submittal of tank/piping monitoring results to non-submittal of hazardous materials business plans. According to Mr. Macedo, the planned use of the subject site will no longer include retail sales of gasoline or diesel fuel. Based on their planned discontinued use, the USTs should be properly removed under the guidance and direction of the LPPFD and the Alameda County Department of Environmental Health Services. Based on the unknown condition and potential of impacts to soil and groundwater, the USTs, piping, and dispenser islands represent a recognized environmental condition in connection with the subject site.

Photo 4: View of the diesel UST located north of the on-site restaurant.

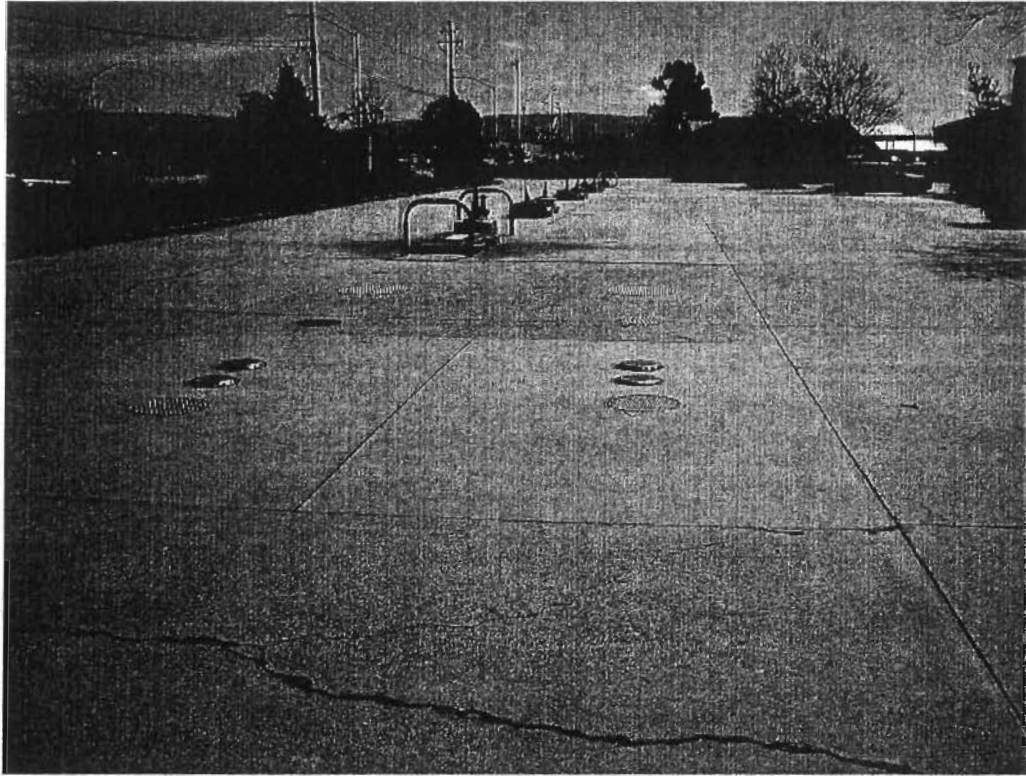
- At the time of Krazan's March 26, 2009 site reconnaissance, five former gasoline dispenser islands were observed east of the restaurant building and four former diesel dispenser islands were observed north of the restaurant building. Krazan observed evidence of three current underground storage tanks (USTs) at the subject site to the northeast and north of the restaurant

Photo 5: View of the gasoline USTs and dispenser islands located east of the on-site restaurant.

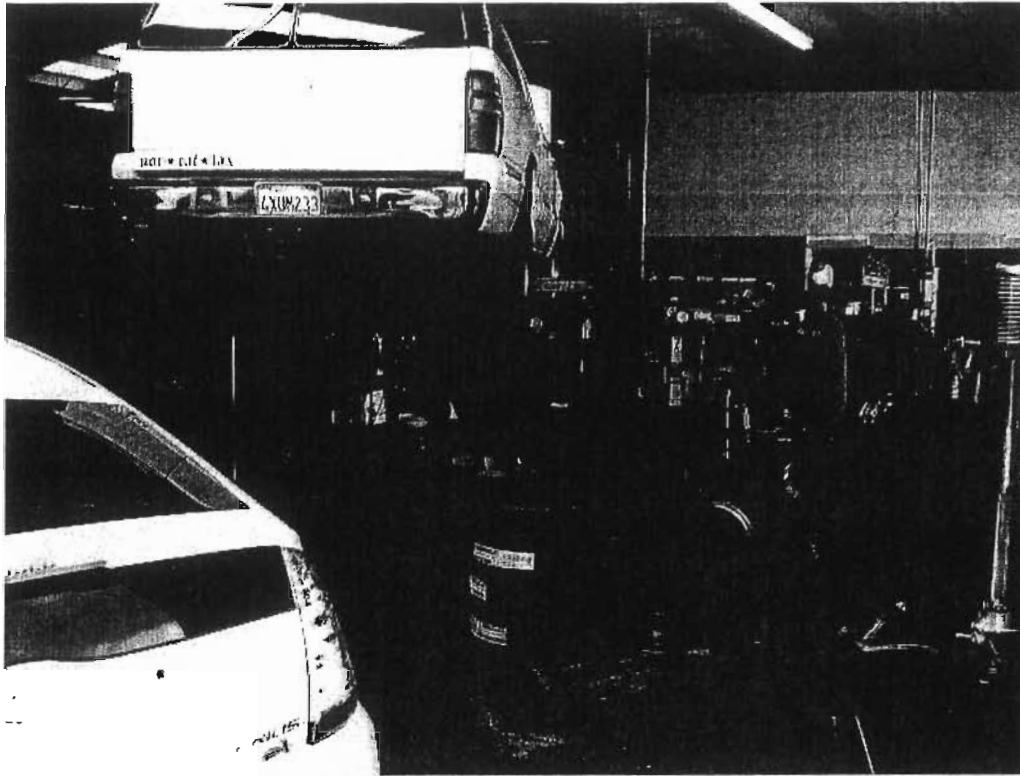
Photo 7: View of interior of Ken's Tire Service shop.

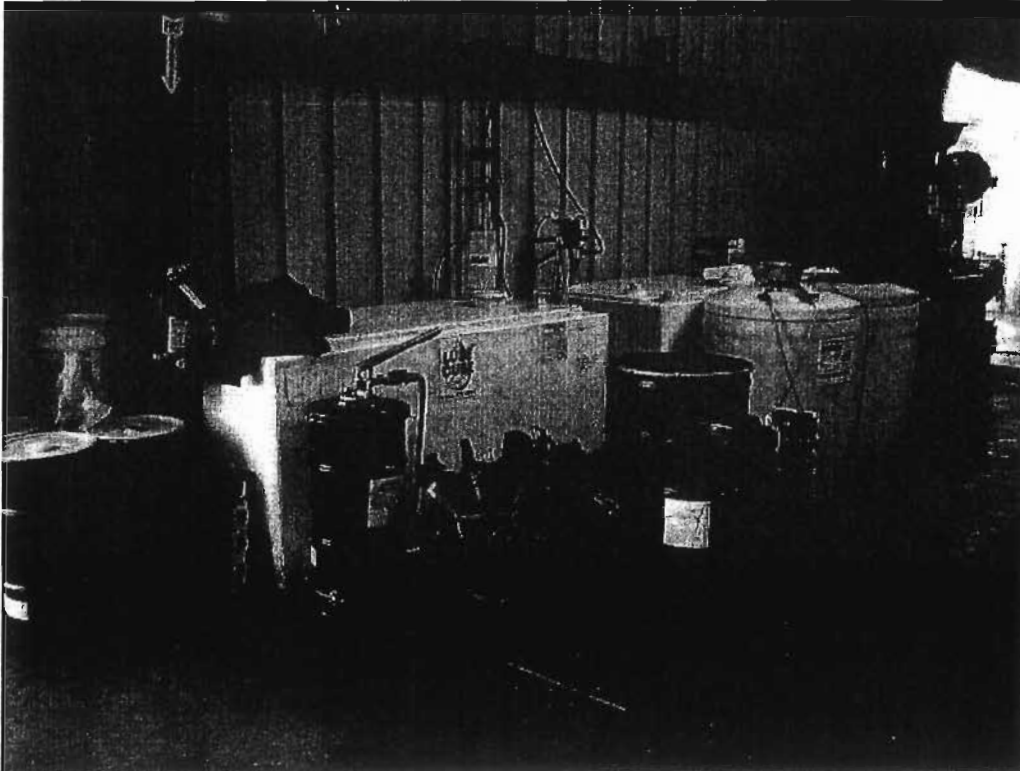
- Hazardous materials observed within the automotive service area included one 55-gallon drum of waste oil from waste oil filters, one 55-gallon drum of oily rags, two 35-gallon drums of grease, two 400-gallon new oil ASTs, one 300-gallon waste oil AST, one 250-gallon plastic AST containing new coolant, and one 250-gallon plastic AST containing waste coolant. The referenced drums and containers were observed to be resting on the AC pavement along the east wall of the building. *De minimis* surface staining was observed on the AC pavement beneath the drums and containers. Mr. Ken Limtiaco, owner of the tire and

automobile service and repair business stated that waste oil, coolant, and waste oil filters are removed for off-site disposal by Evergreen. Only aboveground vehicle lifts were observed in the service area.

Photo 8: View of Ken's Tire Service shop new oil, waste oil, coolant, and grease storage area.

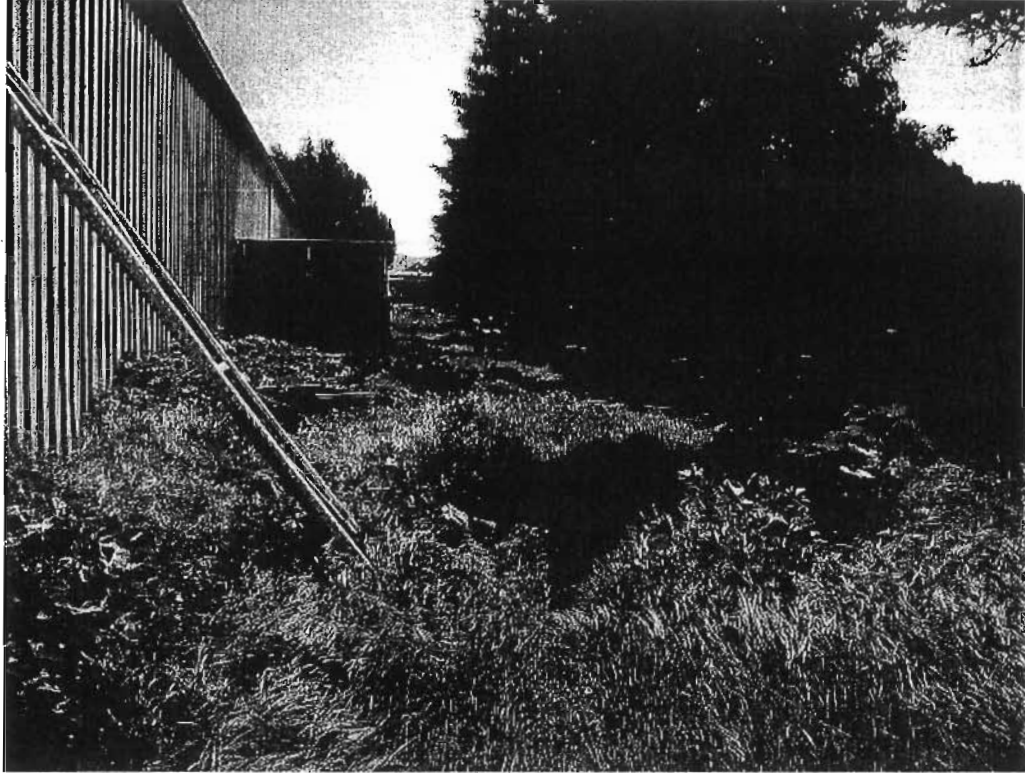
- Approximately 200 waste tires were observed at the west exterior of the tire automobile service and repair shop. The accumulation of tires is not considered an environmental condition, however, is considered a code compliance issue and potential regulatory environmental concern

Photo 9: View of waste tires stored at the west side of Ken's Tire Service shop.

- Approximately 200 waste tires were observed at the west exterior of the tire automobile service and repair shop. The accumulation of tires is not considered an environmental condition, however, is considered a code compliance issue and potential regulatory environmental concern. The tires should be removed for off-site disposal by a licensed waste hauler.

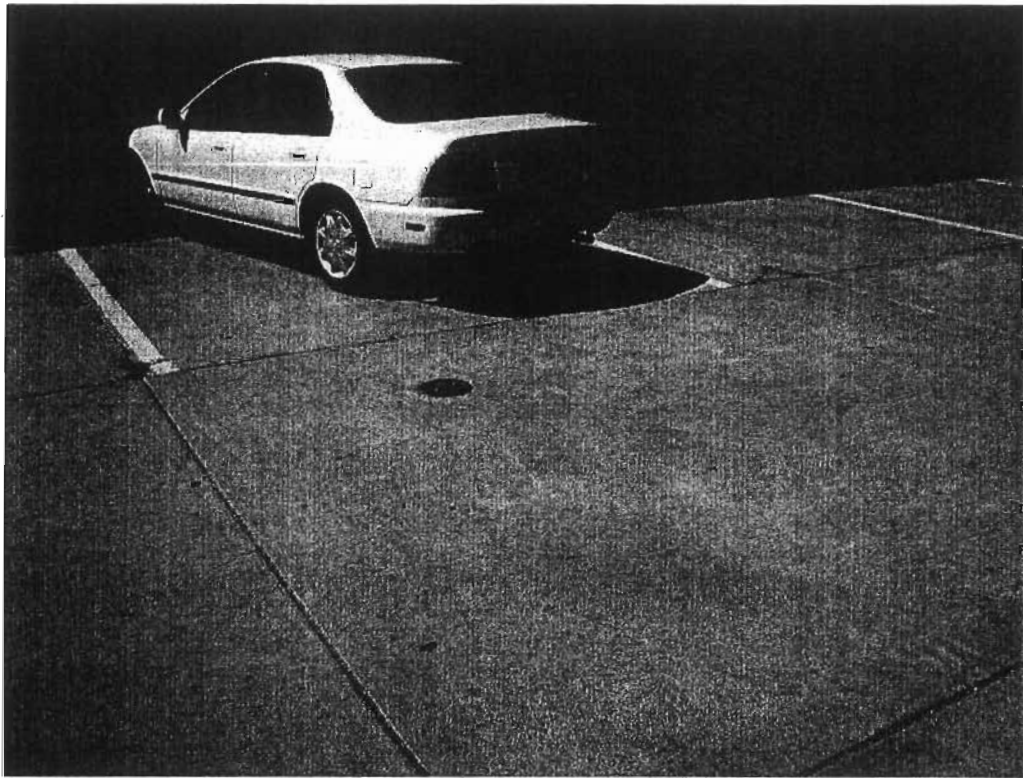
- At the time of Krazan's March 26, 2009 site reconnaissance, three monitoring wells were observed on the east portion of the parcel in the area of the former 1978 to 1994 era USTs. According to local regulatory agency information, the wells were utilized to assess impacts to groundwater by a release associated with the 1978 to 1994 era USTs and are no longer being monitored, with the investigation having been issued a closed status. See Section 6.3 Regulatory Agency Interface for a full discussion of the 1978 to 1994 era USTs and monitoring wells.

Photo 13: View of one of three remaining monitoring wells on the site.

Based on Krazan's current site observations and LPFD closure documentation, the former USTs are considered a HREC and do not require further assessment at this time. However, during Krazan's site reconnaissance, it was noted that the three monitoring wells from the 1996 investigation were still present. It is recommended that the wells be properly abandoned/closed in accordance with State and local guidelines.

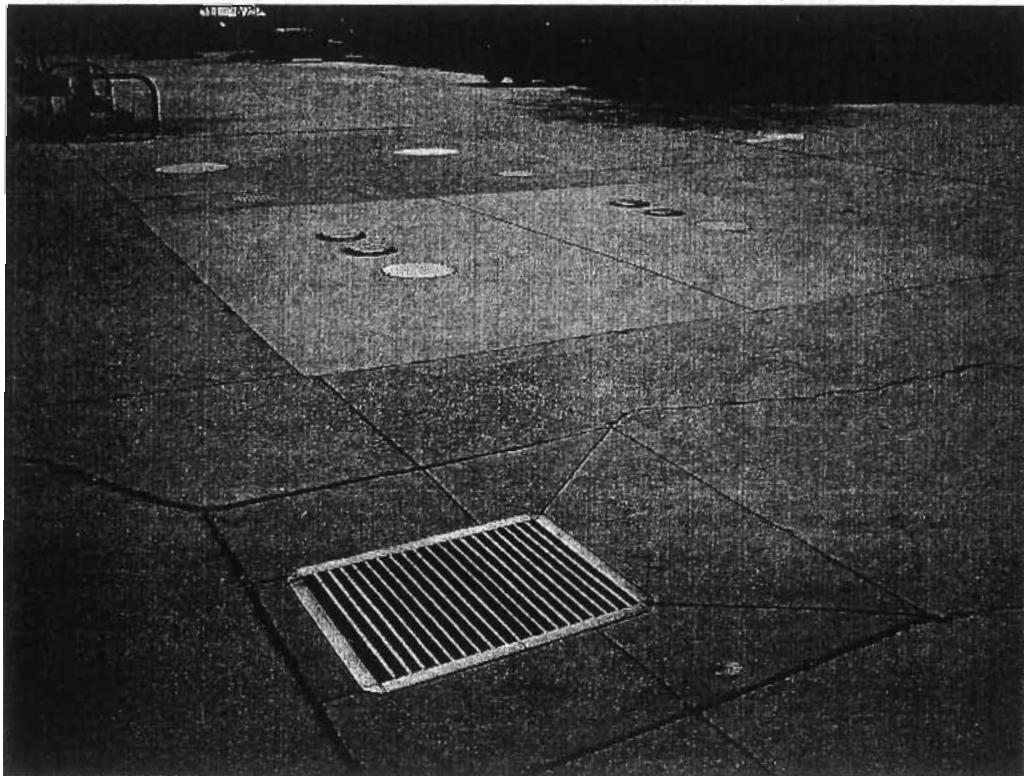
- Four stormwater drains were observed in the parking lot areas of the subject site. According to Mr. Macedo, the drains are located over dry wells and are not connected to the municipal stormwater system. Mr. Macedo indicated the four dry wells were installed in 1994 at the time of paving of the subject site areas surrounding the restaurant and east of the storage warehouse and automotive shop buildings. Mr. Macedo indicated that the dry wells are four to six feet in diameter and approximately 15 feet deep below ground surface.

Photo 14: View of stormwater drain with reported drywell.

- Four storm water drains were observed in the parking lot areas of the subject site. According to Mr. Macedo, the drains are located over dry wells and are not connected to the municipal stormwater system. Mr. Macedo indicated the four dry wells were installed in 1994 at the time of paving of the subject site areas surrounding the restaurant and east of the storage warehouse and automotive shop buildings. Mr. Macedo indicated that the dry wells are four to six feet in diameter and approximately 15 feet deep below ground surface (bgs). Based on the use of a portion of the subject site as an automotive repair shop, the former use of the east portion of the site as a gasoline station, shallow depth of groundwater (estimated at 7 to 10 feet bgs), and their 15 year existence, the dry wells represent a recognized environmental condition in connection with the subject site.

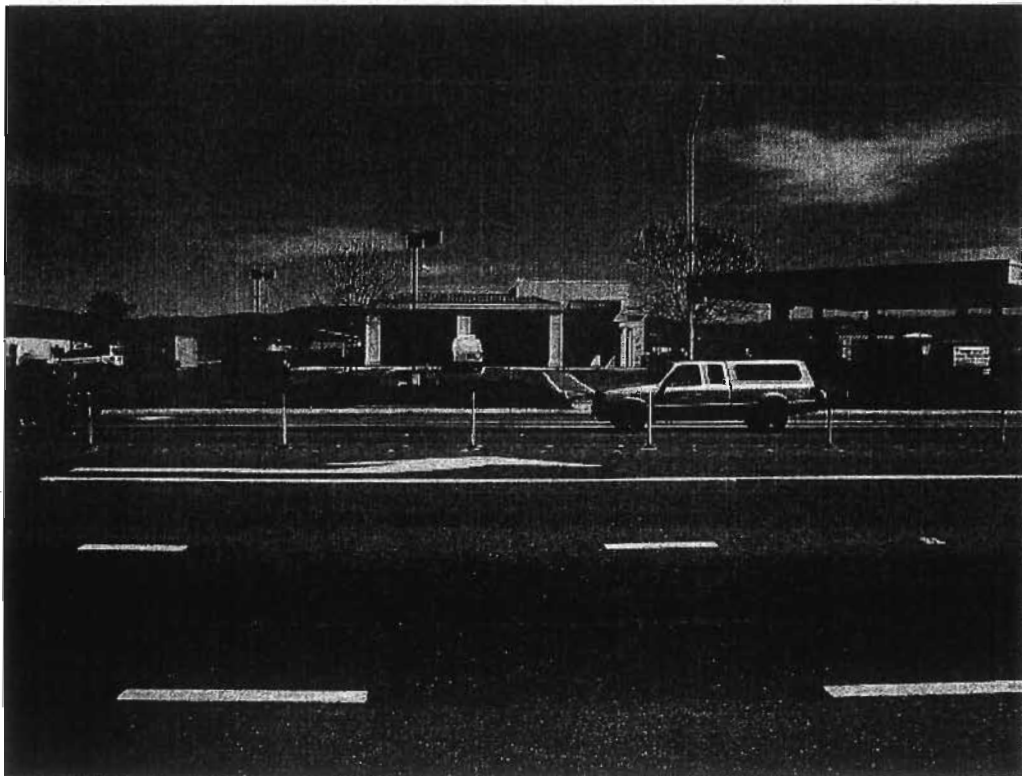
Based on the observed uses of the properties located immediately adjacent to the subject site, it is likely that quantities of hazardous materials are stored at the adjacent properties to the east. Due to proximity to the subject site, the east adjacent Chevron and Quick Stop Gasoline Stations have the potential to present

a recognized environmental condition in connection with the subject site in the event of a significant unauthorized release of fuel from the Chevron and Quick Stop Gasoline Stations underground fuel system. Based on Krazan's review of regulatory records, the Chevron and Quick Stop Gasoline Stations underground fuel system is not currently anticipated to present a recognized environmental condition in connection with the subject site due to absence of documented unauthorized releases of fuel on file with Livermore Pleasanton Fire Department, the lead regulatory agency for underground storage tank facilities in the City of Livermore. In the event of a significant unauthorized release of fuel at the Chevron and Quick Stop Gasoline Stations, potential subsurface assessments or remediation associated with an underground fuel release would be the responsibility of the Chevron and Quick Stop Gasoline Station property owners.

Photo 16: View across N. Vasco Road at the east adjoining Quick Stop gasoline station.

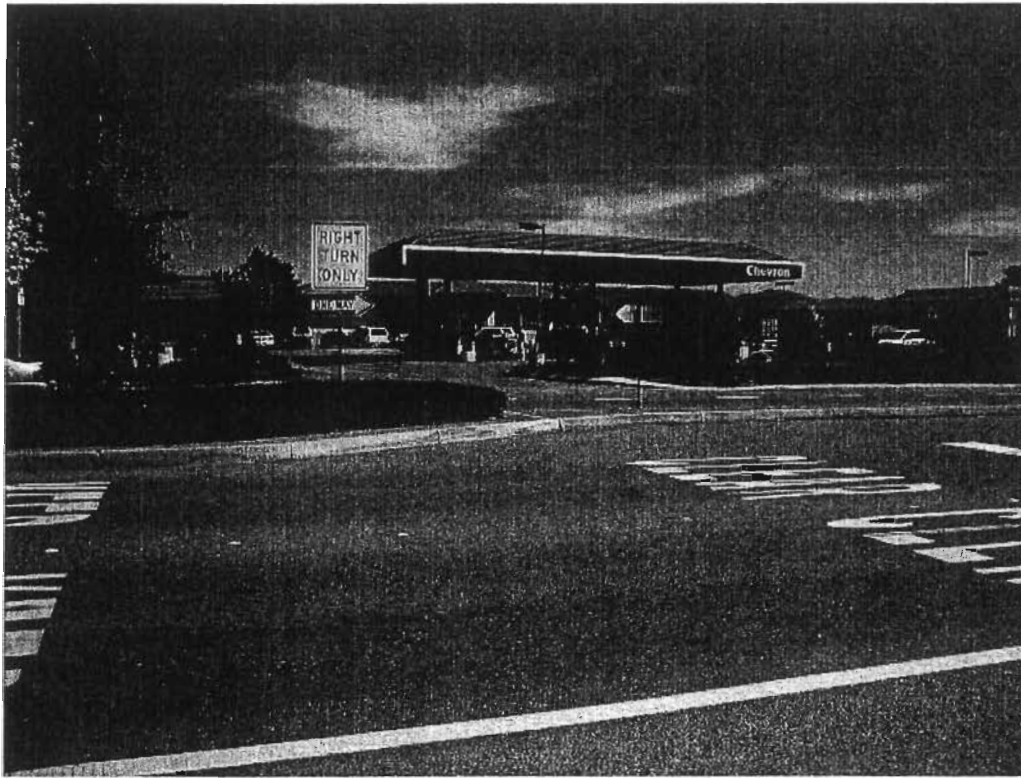
Photo 17: View across N. Vasco Road at the east adjoining Chevron gasoline station.

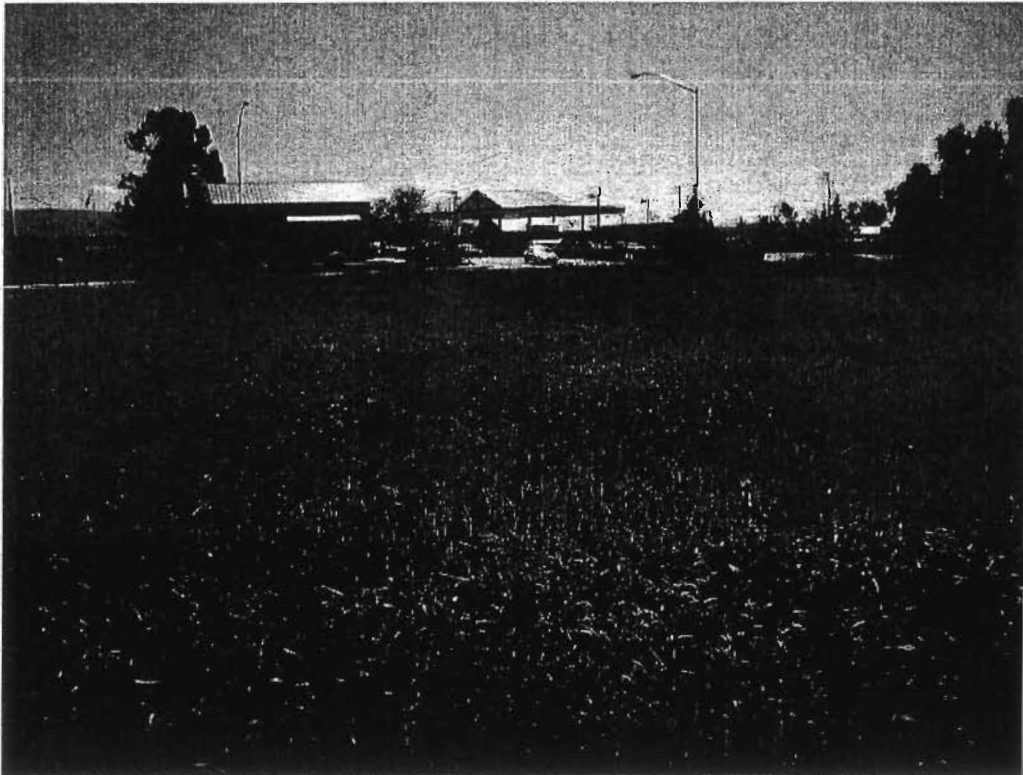
Photo 18: View of the south adjoining vacant land.

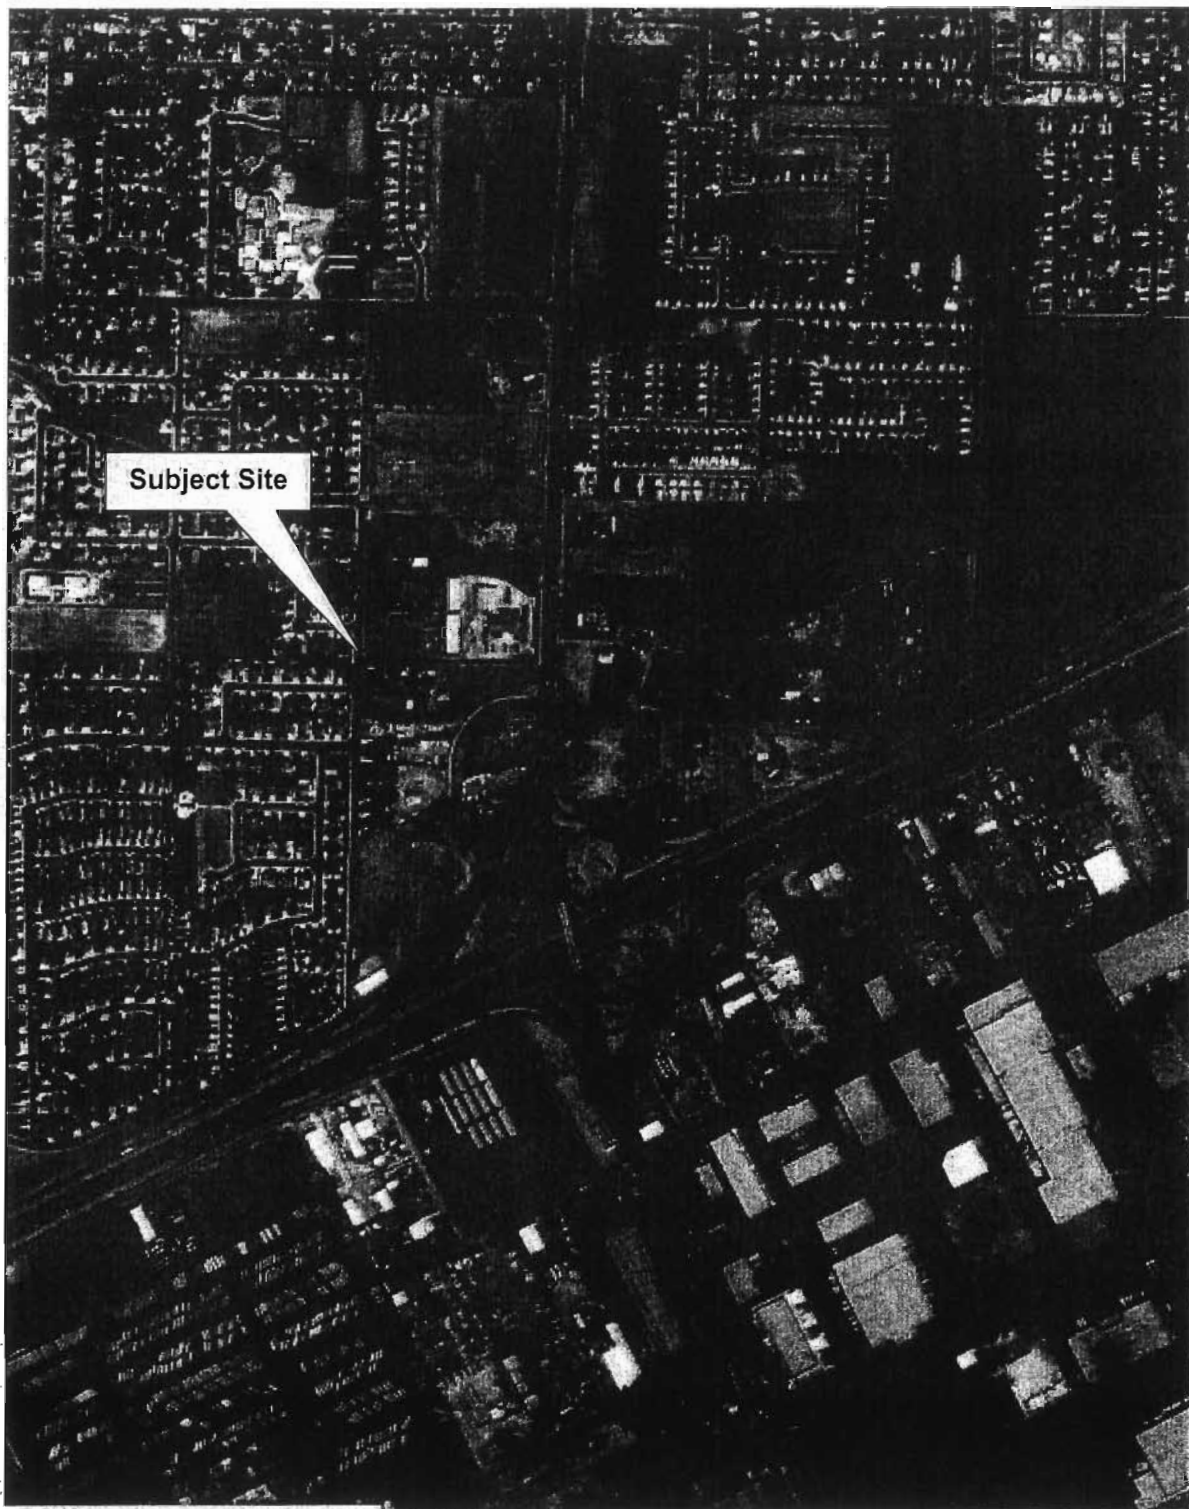
Scale:	1" = 666'
Photo ID	2448230.4

AERIAL PHOTOGRAPH
BOTW No. 09-0510-02
Geno's Country Store, Inc.
1000 North Vasco Road
Livermore, California 94551
Project No. 013-09074

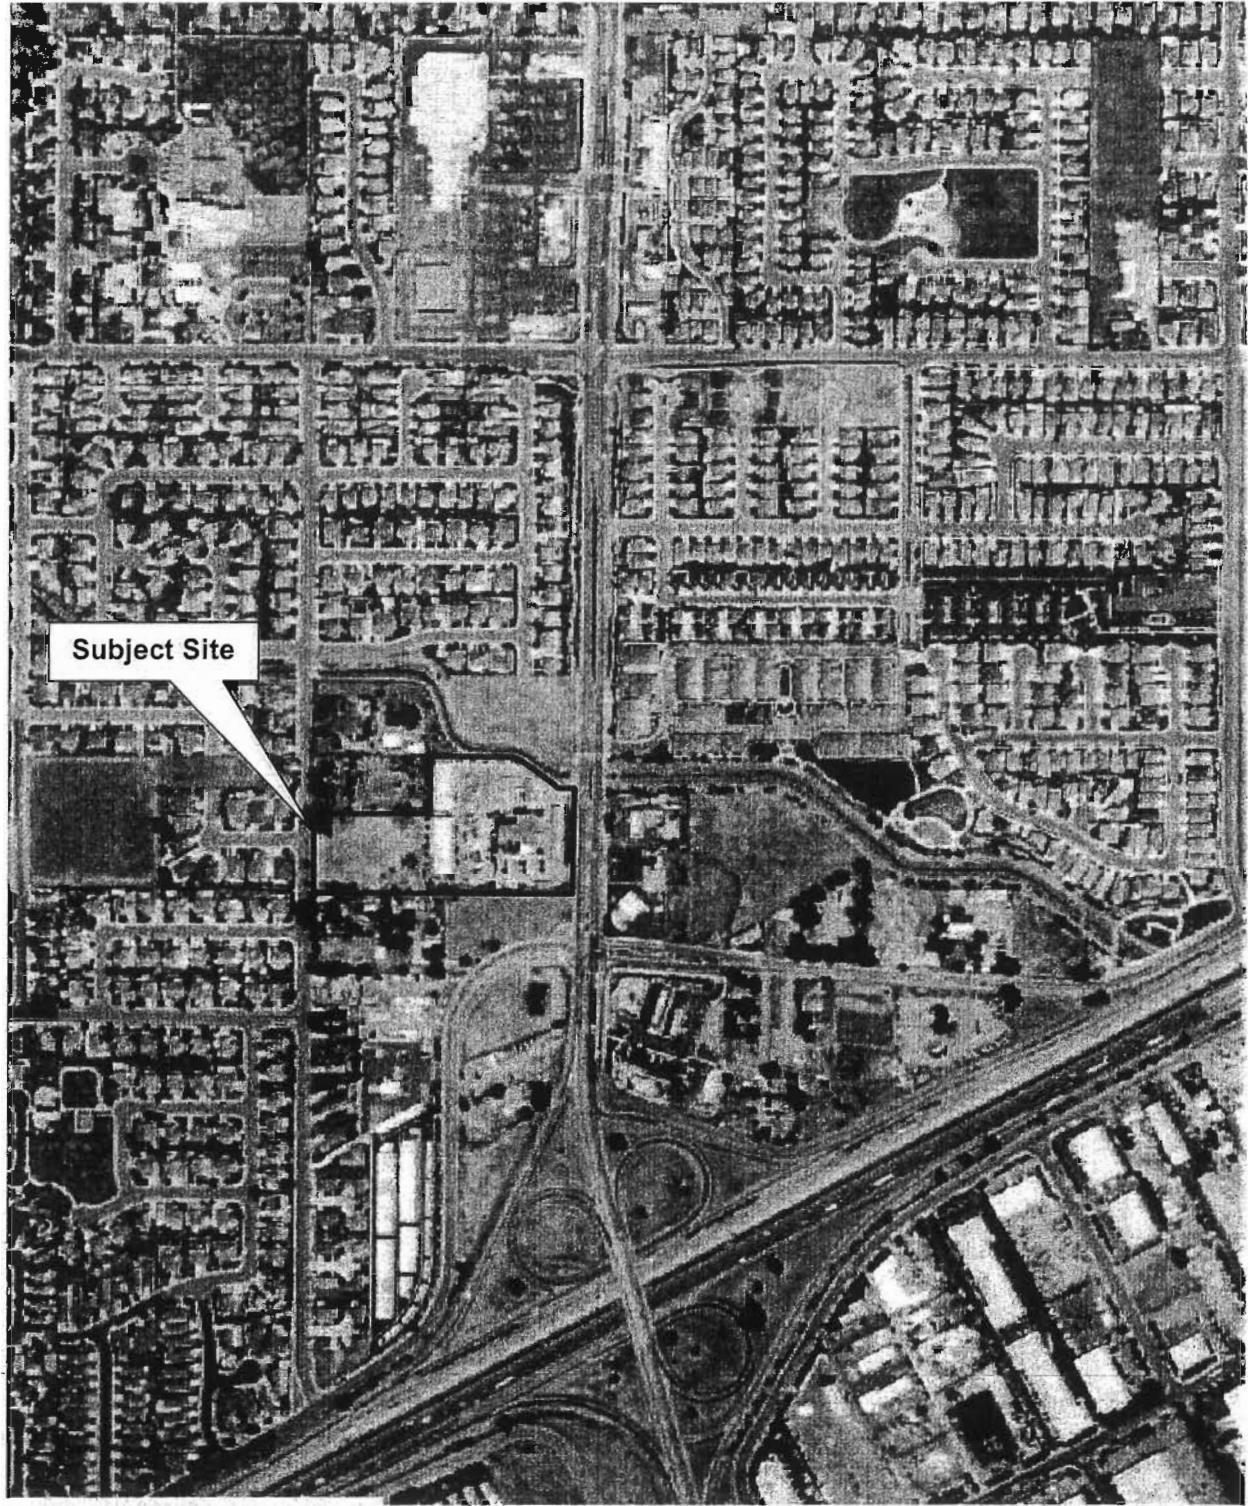
Photo ID 2448230.4

AERIAL PHOTOGRAPH
BOTW No. 09-0510-02
Geno's Country Store, Inc.
1000 North Vasco Road
Livermore, California 94551
Project No. 013-09074
