UNDERGROUND STORAGE TANK REMOVAL REPORT

**CALDECOTT TUNNEL
240 CALDECOTT LANE
OAKLAND, CALIFORNIA**

GEOCON PROJECT NO. E8585-06-19
CALTRANS EA 04-294914

Subject: UST REMOVAL REPORT
240 CALDECOTT LANE
OAKLAND, CALIFORNIA
CONTRACT NO. 43A0199, EA 04-294914

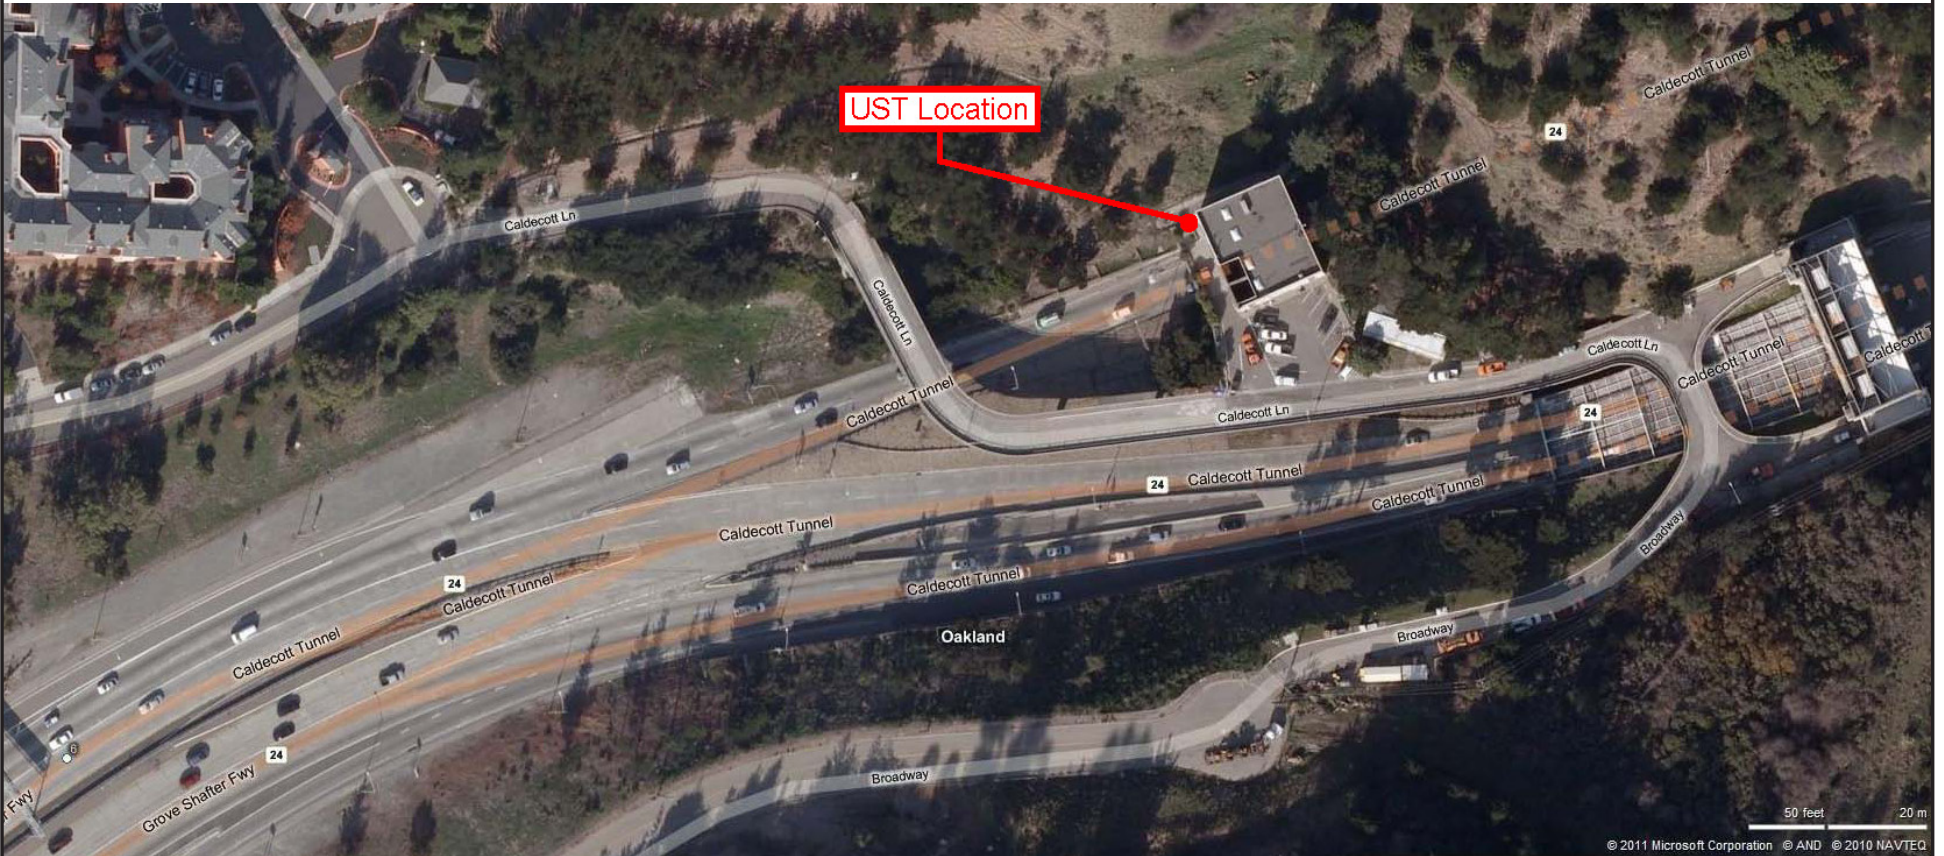
Figure 2

The UST was located immediately above and north of the west end of third bore of the Caldecott Tunnel as shown on Figure 2. The UST was used by Caltrans to store diesel fuel for a backup generator used to operate the tunnel ventilation system in the instance of a power failure.

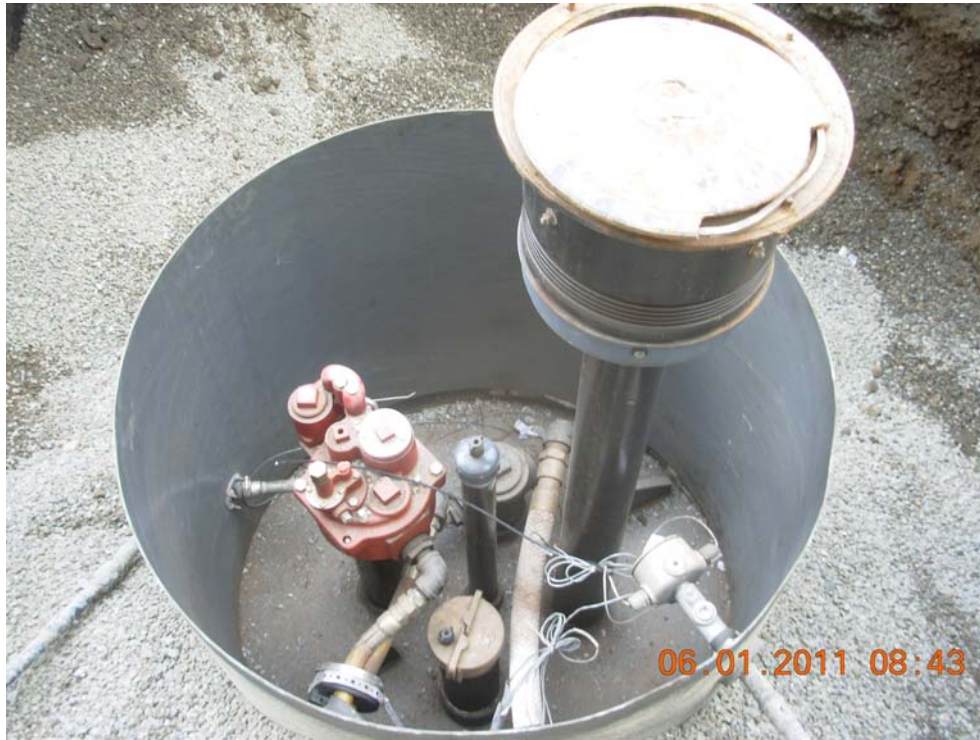
Prior to removing the UST from the ground, we disconnected the fuel and vent line flex hoses from the turbine pump still in-place on top of the UST (see photograph 1), cut the two electrical conduits from away from the secondary containment sump on top of the tank, and then removed the fill port from the UST. After removing several cubic yards of pea gravel from the UST excavation, the UST was removed from the ground and placed on the ECI Truck for transport to their recycling facility in Richmond, California. The turbine pump and associated apparatus was left in-place in the UST when it was removed and hauled to ECI's facility.

Photo 1 – View of appurtenances located on top of UST prior to removal.

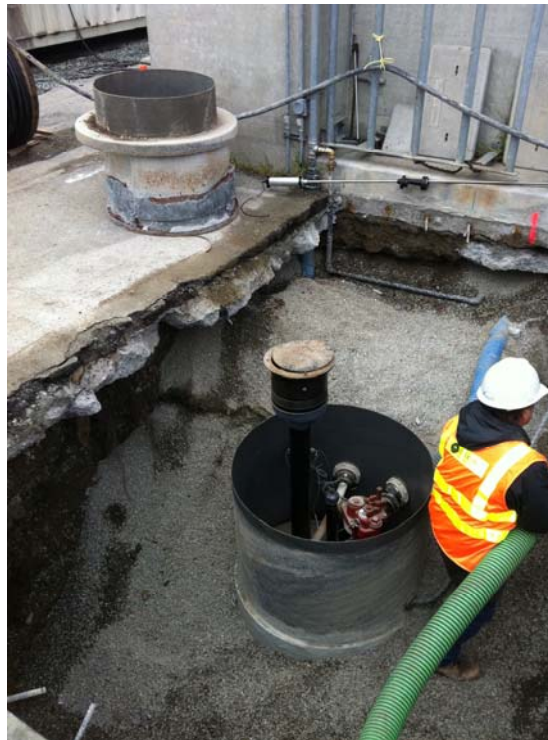
Photo 2 – View of UST excavation during removal of pea gravel using vacuum trailer.

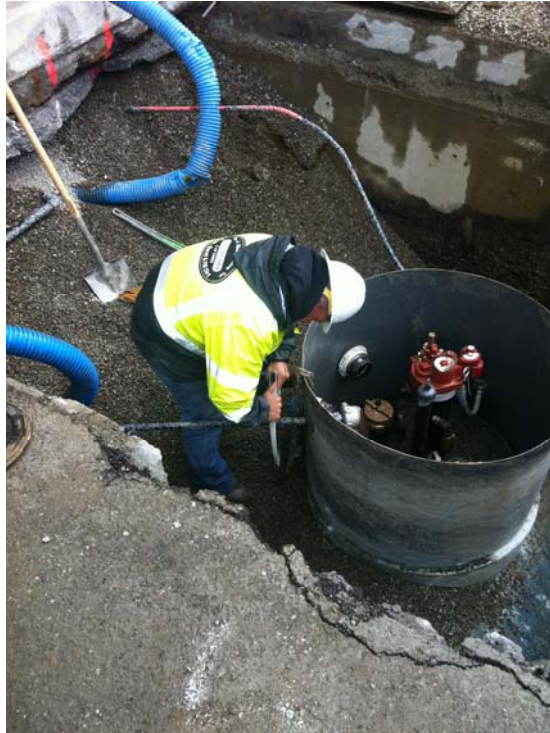
Photo 3 – View of electric and fuel lines being disconnected from UST.

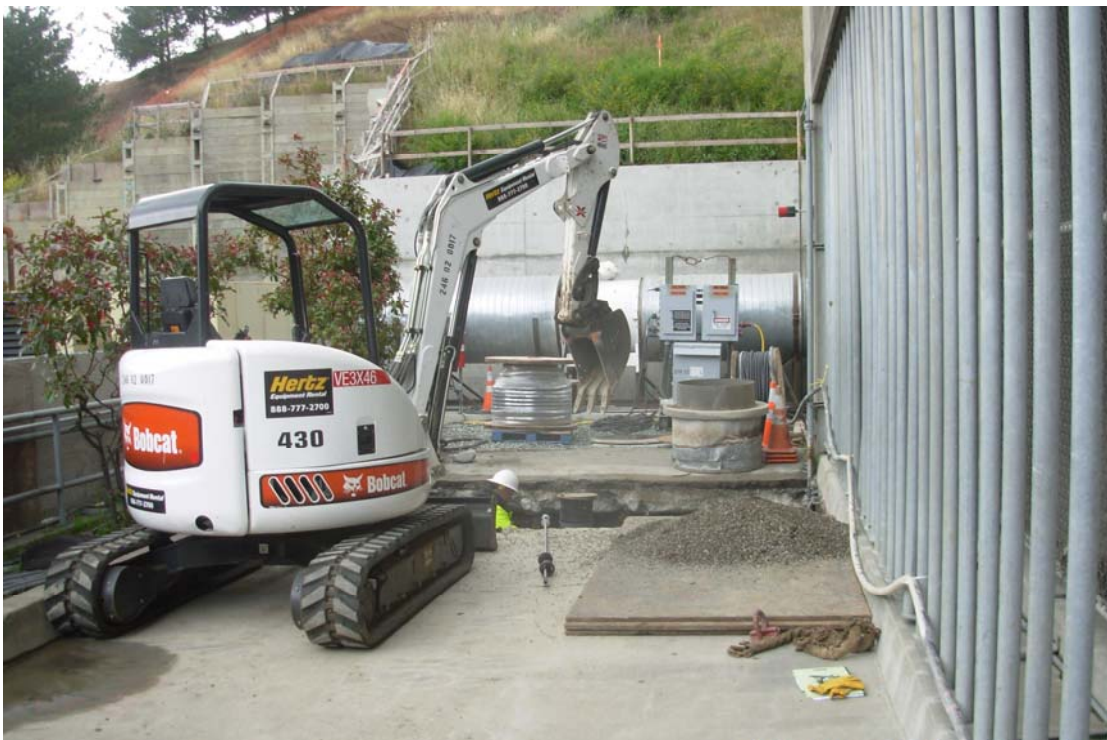
Photo 4 – View of mini excavator used to remove pea gravel from excavation.

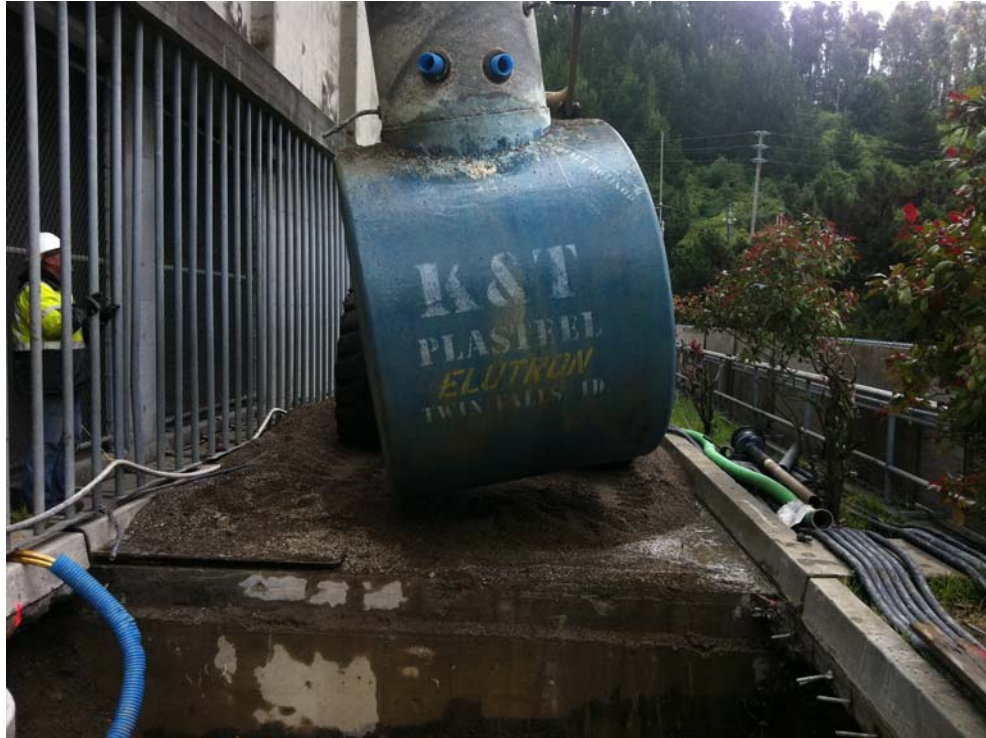
No odors or obvious signs of diesel fuel leakage or spillage were observed during the UST removal process, and the UST appeared to be completely intact. After the UST had been removed from the area, the fuel lines were disconnected at the threaded couplings located inside the building near the wall penetration. Capping the black iron fuel line piping inside the building was not necessary because the fuel lines extended approximately 20 feet down to the floor from that point. The vent line from the UST was disconnected at the base of the building where it connected to the steel riser mounted to the side of the building. The two electrical conduits were cut back to near the base of the building. After the product and electrical lines were removed and cut, the pea gravel removed during the UST removal operation was placed back in the excavation, and the excavation was covered back up with a trench plate. The remainder of the excavation was left to be backfilled by Caltrans' tunnel construction contractor.

Photo 5 – View of UST being hoisted from the excavation by loader.

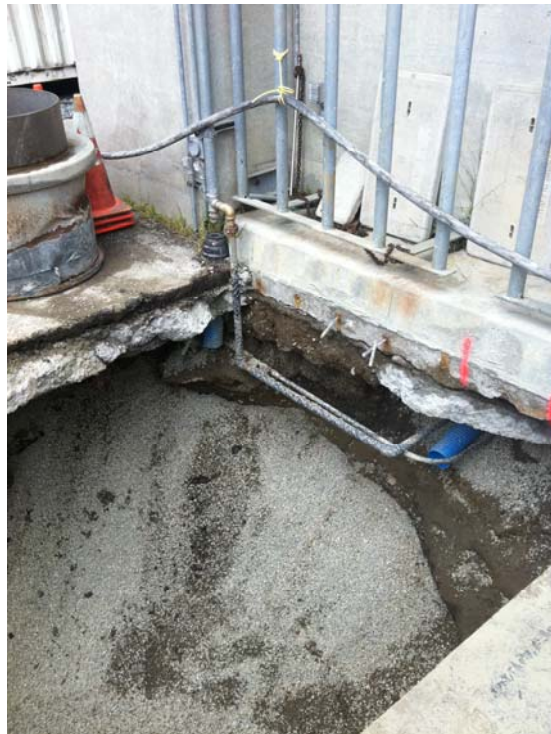
Photo 6 – View of excavation after UST and associated electrical and fuel lines had been removed up to building.
