RE: Environmental Condition of Property Report  
16501 Ashland Avenue, San Lorenzo, California

# ENVIRONMENTAL CONDITION OF PROPERTY REPORT

16501 Ashland Avenue  
San Lorenzo, California

September 2012

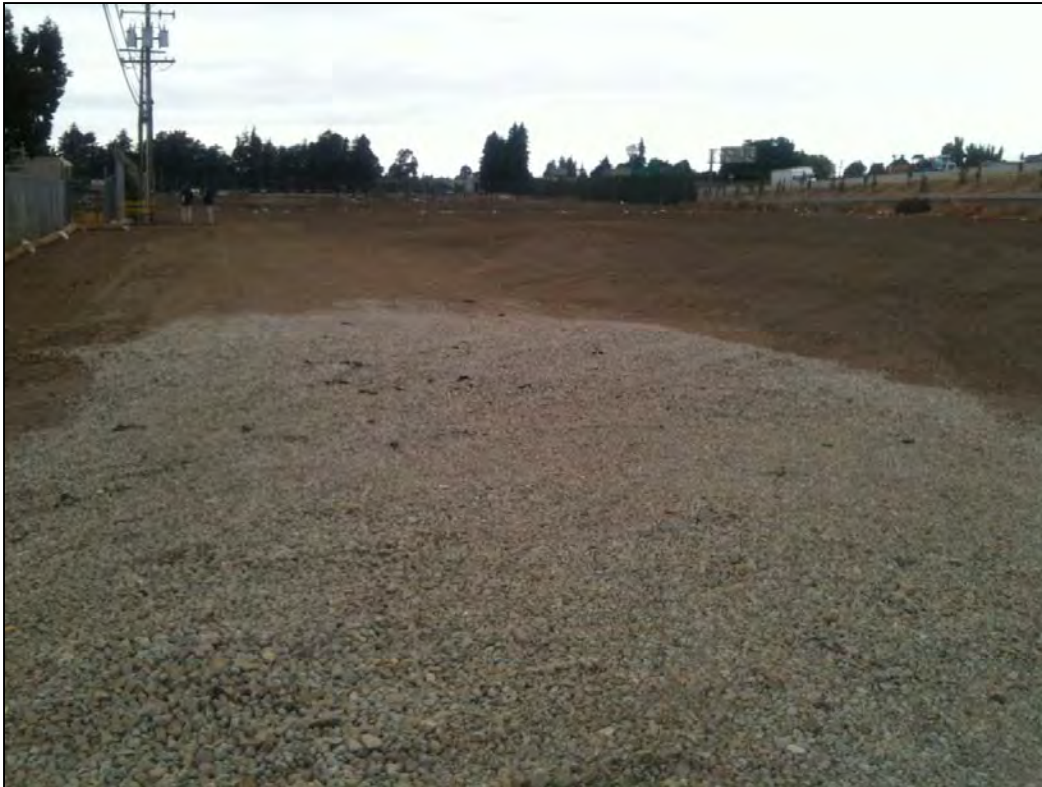
Photo 1: View of the Site

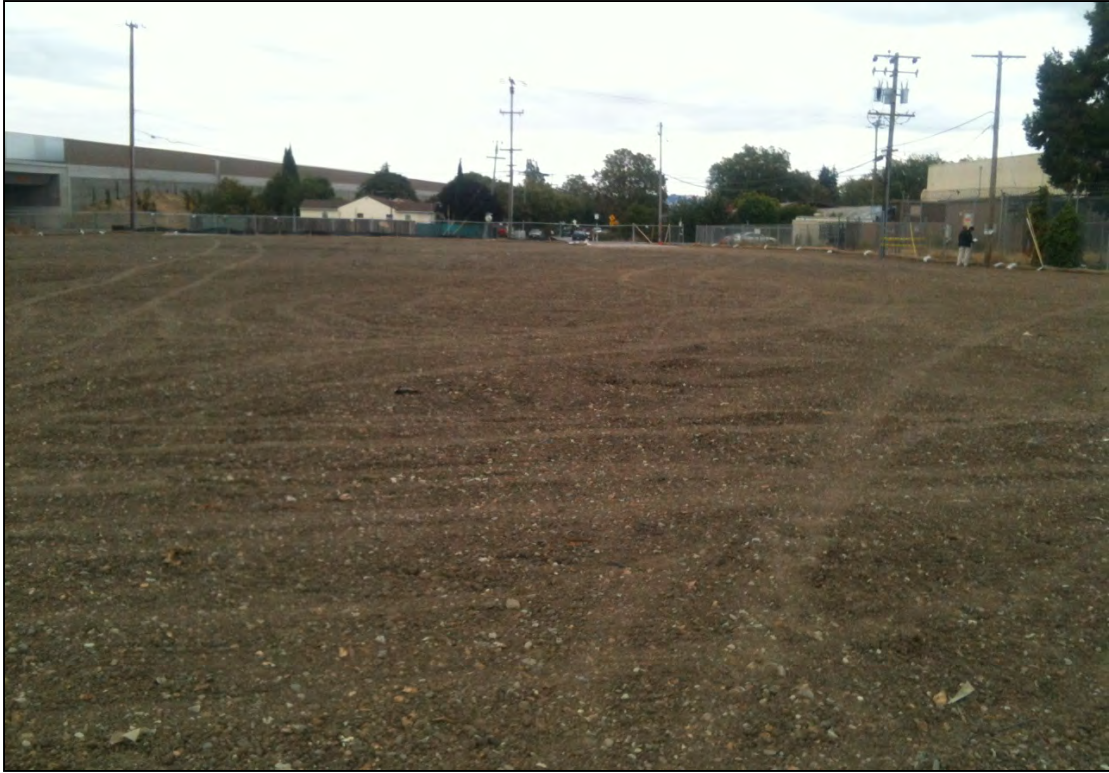
Photo 3: View of Site facing towards Ashland Ave

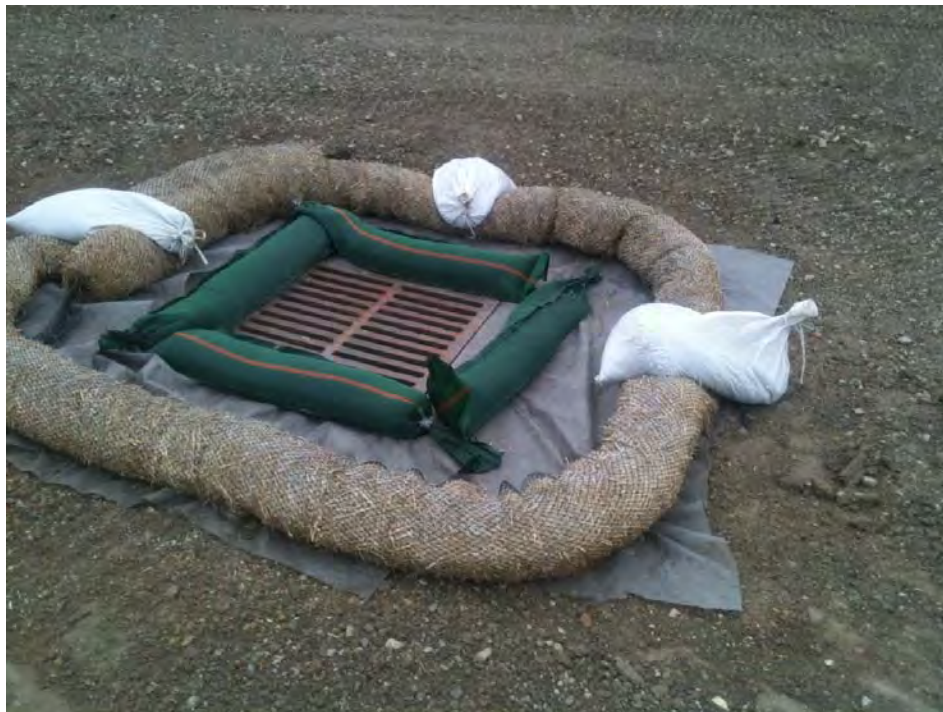
Photo 4: Storm drain on Site

During site reconnaissance, AWR observed a storm drain on the Site. No surface staining was observed in the vicinity of this drain.

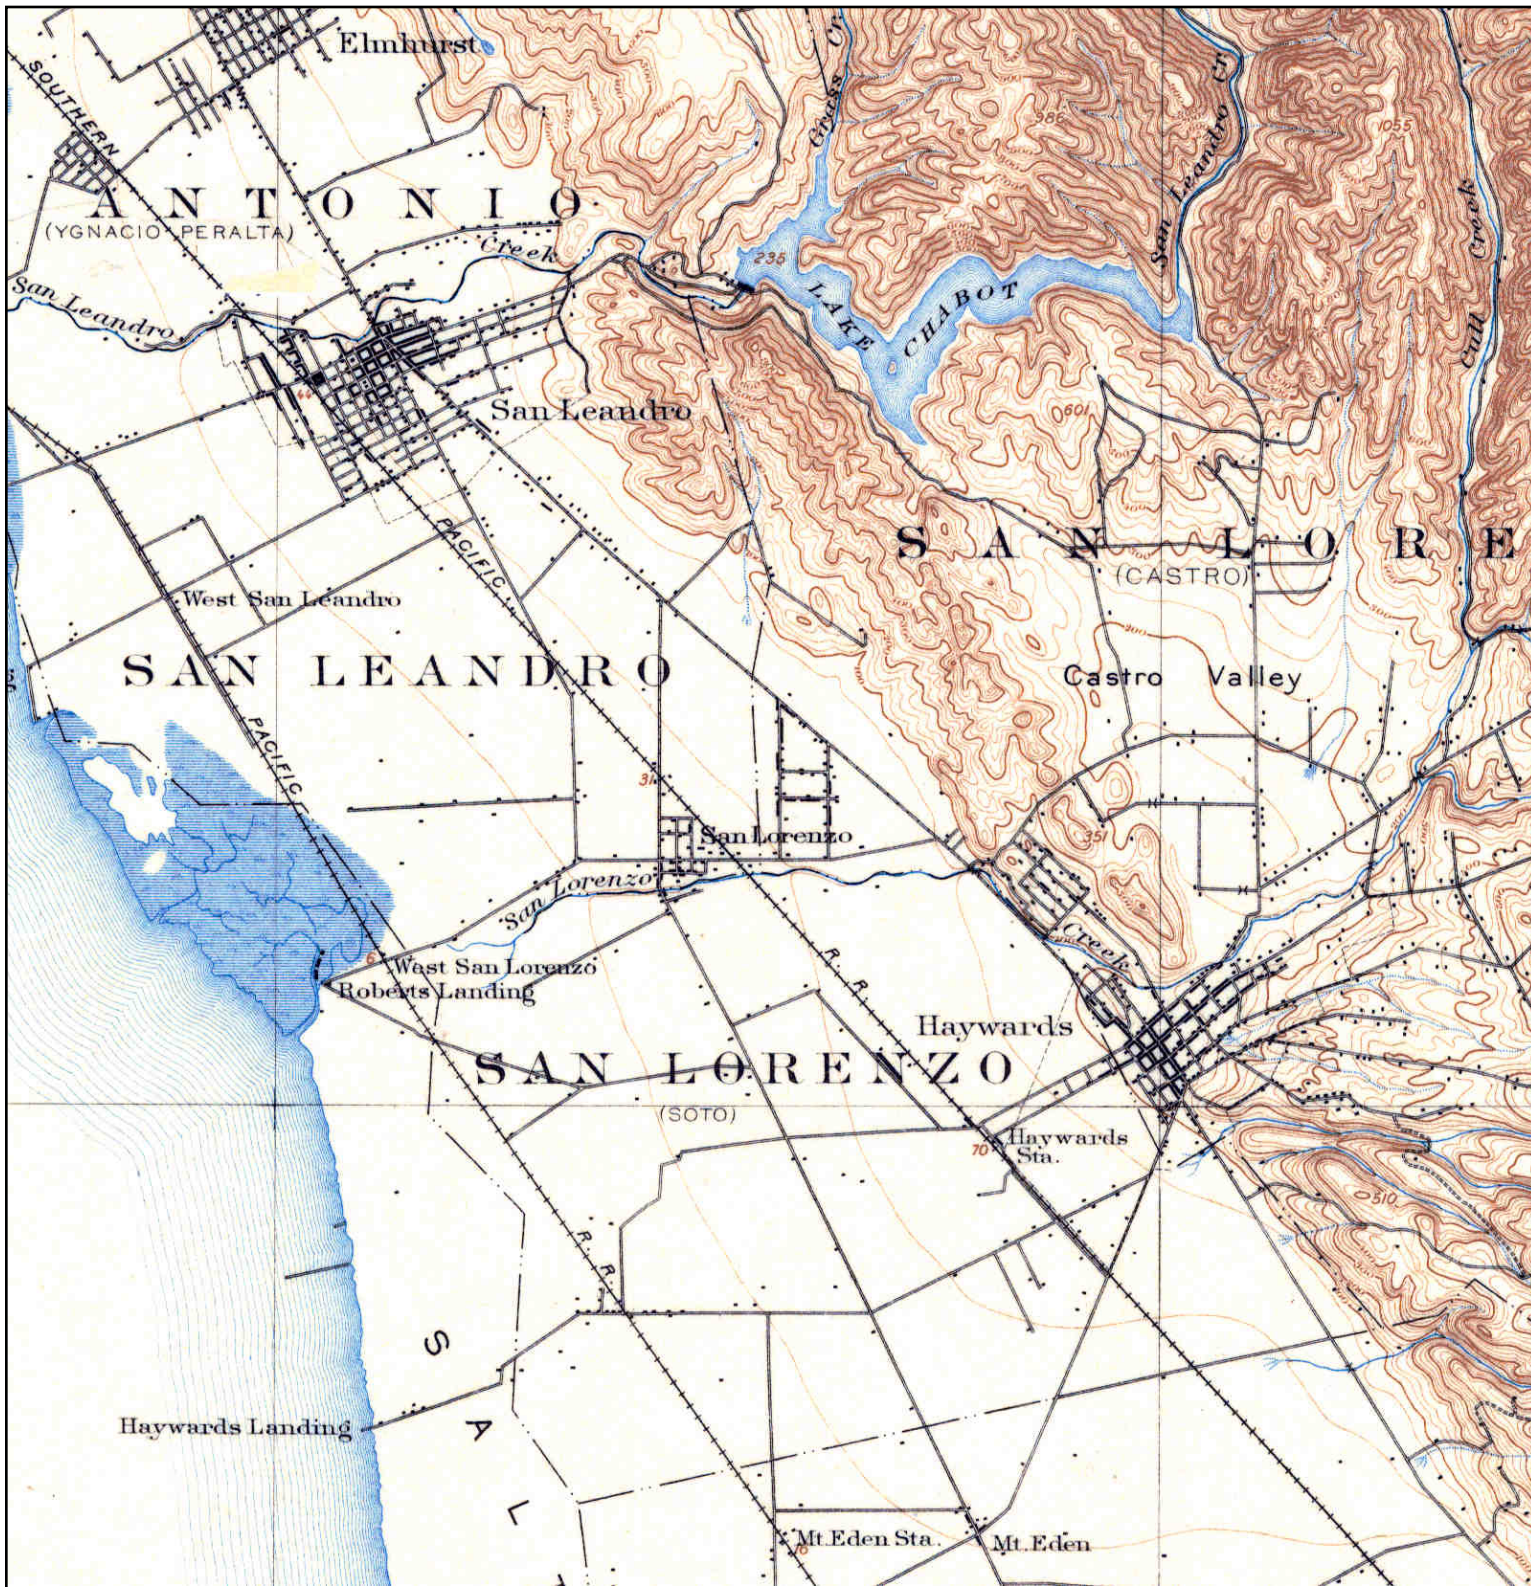
# Historical Topographic Map

<p>N ↑</p>	<p><b>TARGET QUAD</b>                  NAME: HAYWARDS                  MAP YEAR: 1899</p>	<p><b>SITE NAME:</b> 16501 Ashland Ave  <b>ADDRESS:</b> 16501 Ashland Ave                  San Lorenzo, CA 94580  <b>LAT/LONG:</b> 37.6895 / -122.119</p>	<p><b>CLIENT:</b> Environmental Risk Specialties Corp  <b>CONTACT:</b> Yola Bayram  <b>INQUIRY#:</b> 3363074.4  <b>RESEARCH DATE:</b> 07/10/2012</p>
	<p><b>SERIES:</b> 15  <b>SCALE:</b> 1:62500</p>

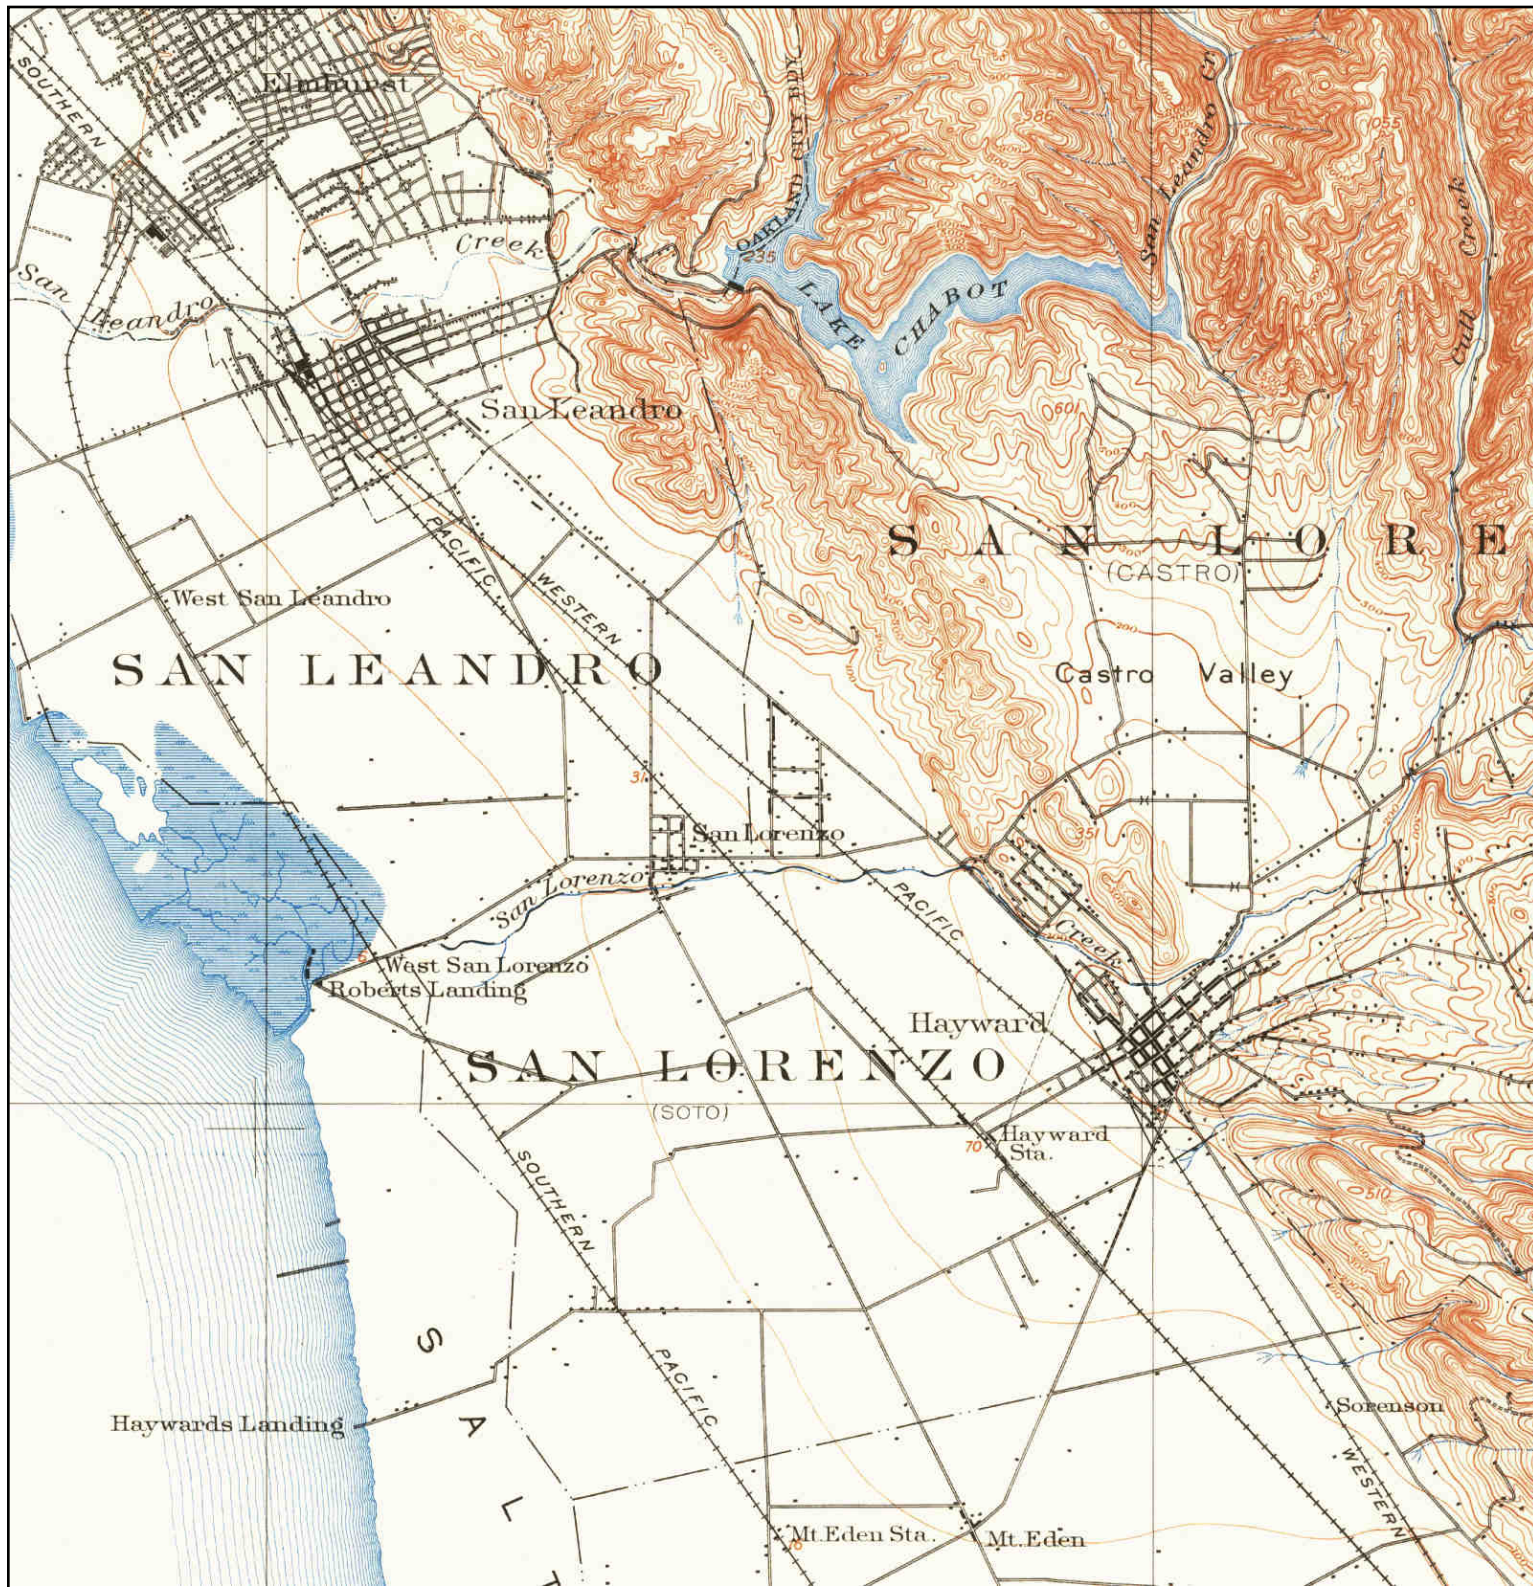
# Historical Topographic Map

<b>TARGET QUAD</b> NAME: HAYWARD MAP YEAR: 1915	SITE NAME: 16501 Ashland Ave ADDRESS: 16501 Ashland Ave San Lorenzo, CA 94580 LAT/LONG: 37.6895 / -122.119	CLIENT: Environmental Risk Specialties Corp CONTACT: Yola Bayram INQUIRY#: 3363074.4 RESEARCH DATE: 07/10/2012
	SERIES: 15 SCALE: 1:62500
