**Subject: 1395 MacArthur Boulevard, San Leandro, California
Remediation Status Report – Third Quarter 2017**

Remediation Status Report – Third Quarter 2017
SWISS VALLEY CLEANERS
1395 MacArthur Boulevard, San Leandro, California

10 October 2017
AGE-Project No. 12-2461

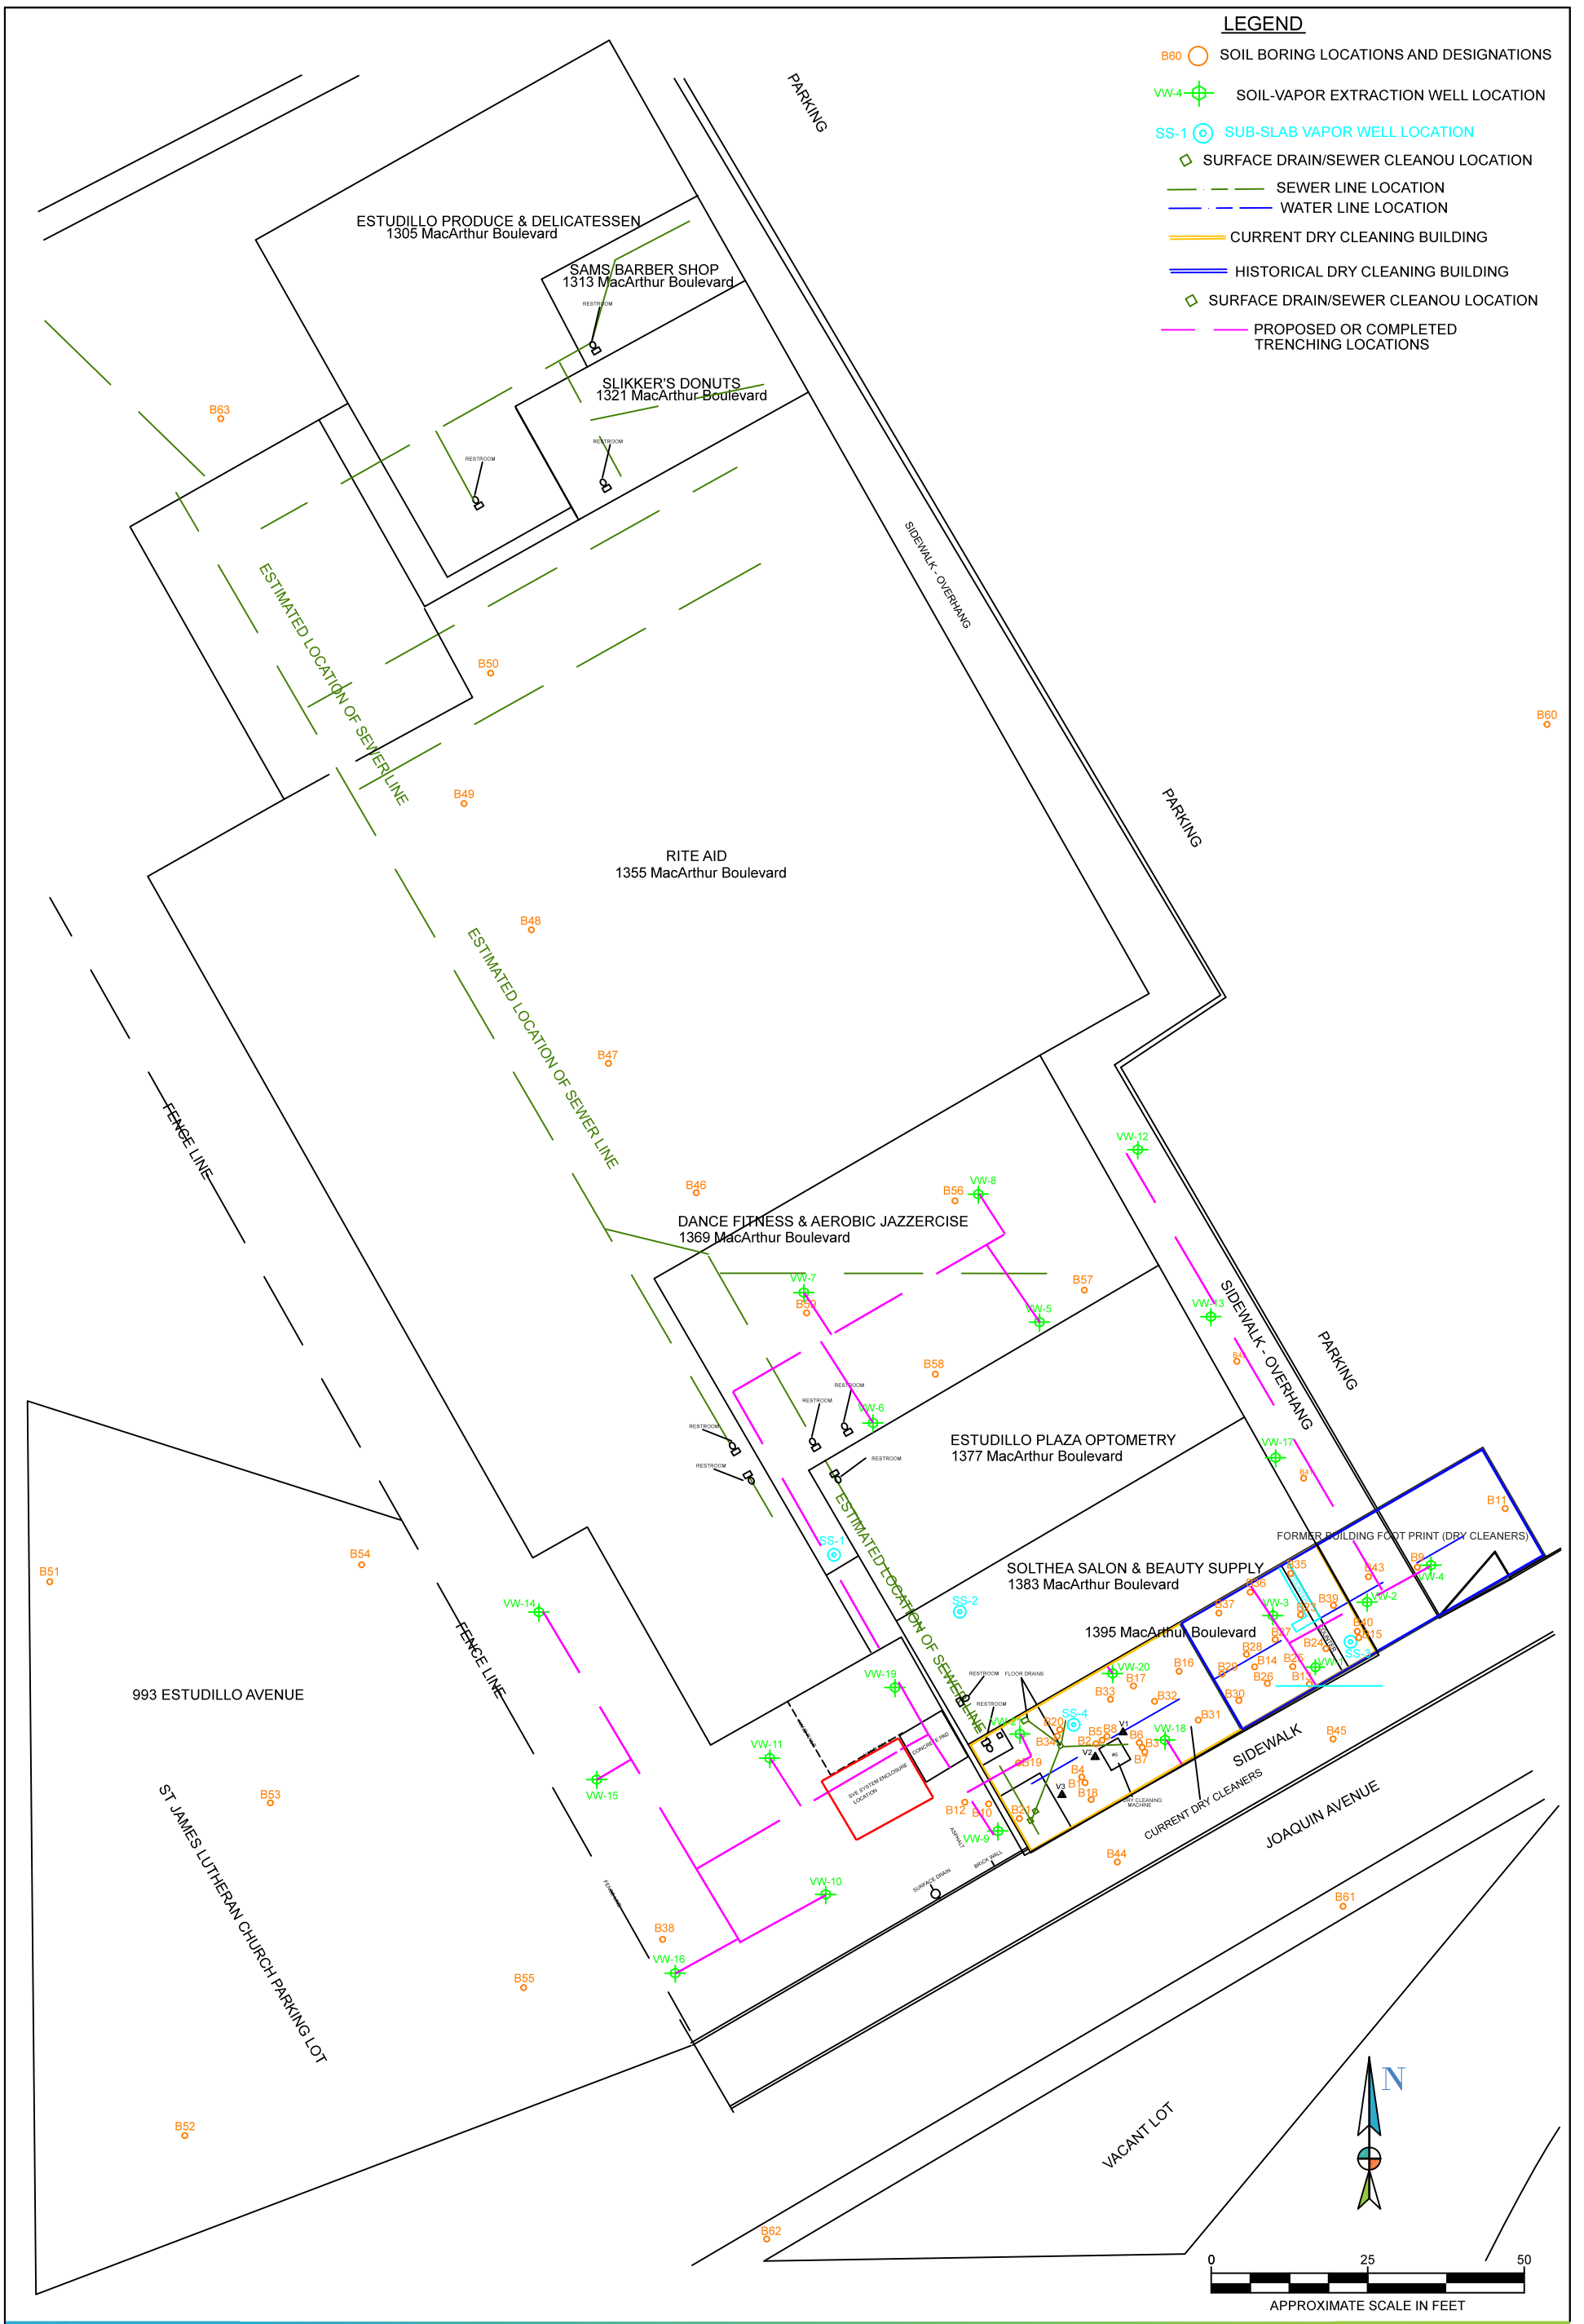
Figure 2 – *Soil-Vapor Well Locations & Trenching Locations*

At the request of Mr. William Mathews Brooks of Ardenbrook, Inc., Advanced GeoEnvironmental, Inc. (AGE) has prepared this, *Remediation Status Report – Third Quarter 2017*, for the Swiss Valley Cleaners site located at 1395 MacArthur Boulevard, San Leandro, California (site). This report documents remedial operation and maintenance of the soil-vapor extraction during the third quarter 2017. The location of the site is illustrated in Figure 1. A plot plan of the site, SVE wells and trenching locations are illustrated in Figure 2. Well construction details are included as Table 1.

Additionally, the SVE well network consists of twenty-one shallow screened SVE wells (VW-1 through VW-21) screened from 2 feet to 7 feet bsg. Each well is fitted with a ball valve to allow individual well adjustments. During this operational period all wells were utilized for SVE remediation (Table 2).

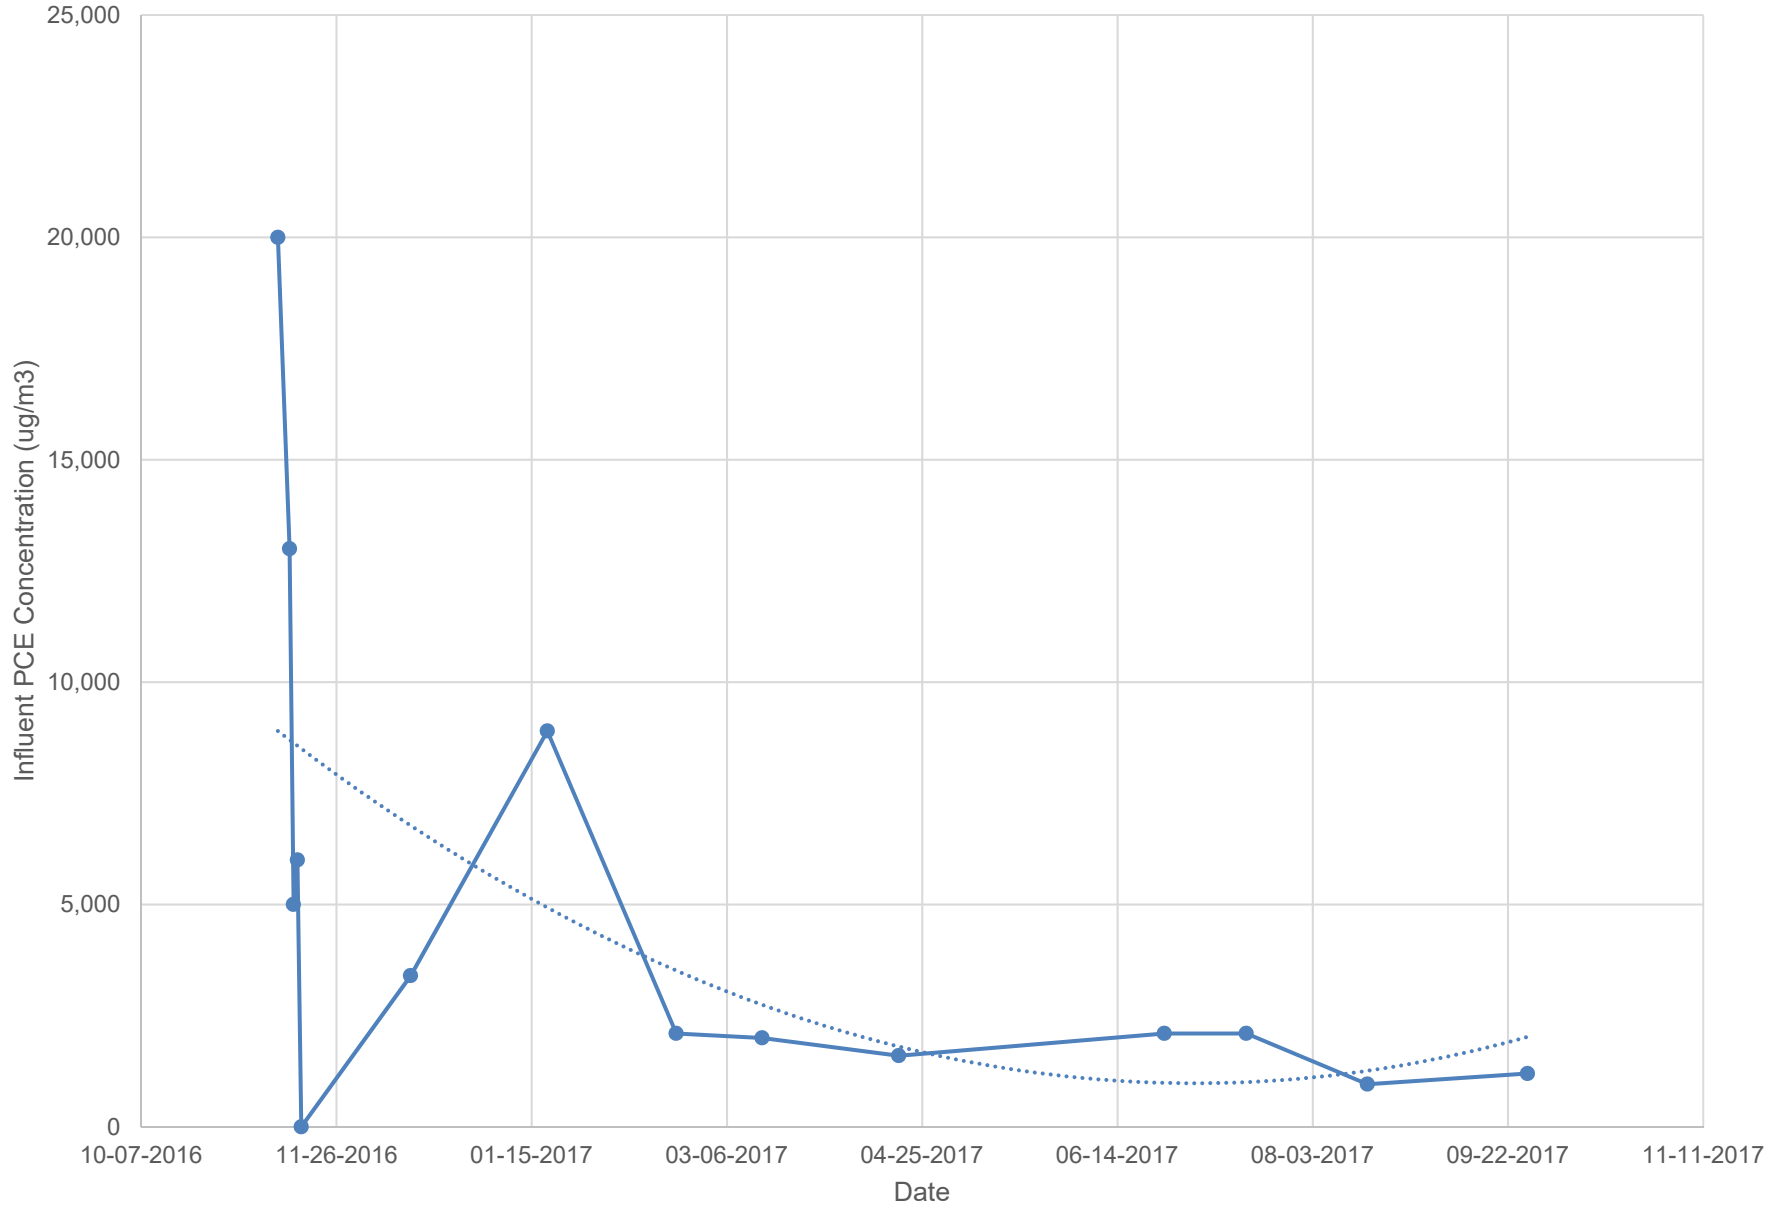
Influent PCE Vs. Time

Influent and effluent vapor samples were collected on 17 July, 17 August and 27 September 2017. Tetrachloroethene (PCE) was detected in all influent samples at concentrations ranging from 960 micrograms per cubic meter ($\mu\text{g}/\text{m}^3$) to 2,100 $\mu\text{g}/\text{m}^3$. Constituents of concern were not reported above laboratory reporting limits in any of the effluent samples collected during the third quarter 2017.

- SVE remediation generally operated without down-time during the third quarter 2017 (Table 2);
- PCE was detected at low concentrations in all influent samples during the third quarter 2017 remediation period. Influent concentrations still appear to be reaching asymptotic levels (see trend graph in Appendix C). However, slight rebound was observed in recently performed indoor air and sub-slab samples and the system should continue to be run until constituents of concern are mitigated.

Based on the findings of the environmental activities performed to date at the site, AGE recommends continued operation of the SVE system with an effort to optimize mass removal from the well network, until indoor air and sub-slab concentrations have been adequately mitigated.
