***Report of Limited Phase II  
Soil, Water and Soil Vapor Investigation  
At:  
13778 DOOLITTLE AVENUE  
SAN LEANDRO, CALIFORNIA***

**PIERS PROJECT NUMBER: 14133**

**RE: *REPORT OF LIMITED PHASE II  
SOIL, WATER AND SOIL VAPOR INVESTIGATION  
13778 DOOLITTLE AVENUE  
SAN LEANDRO, CALIFORNIA***

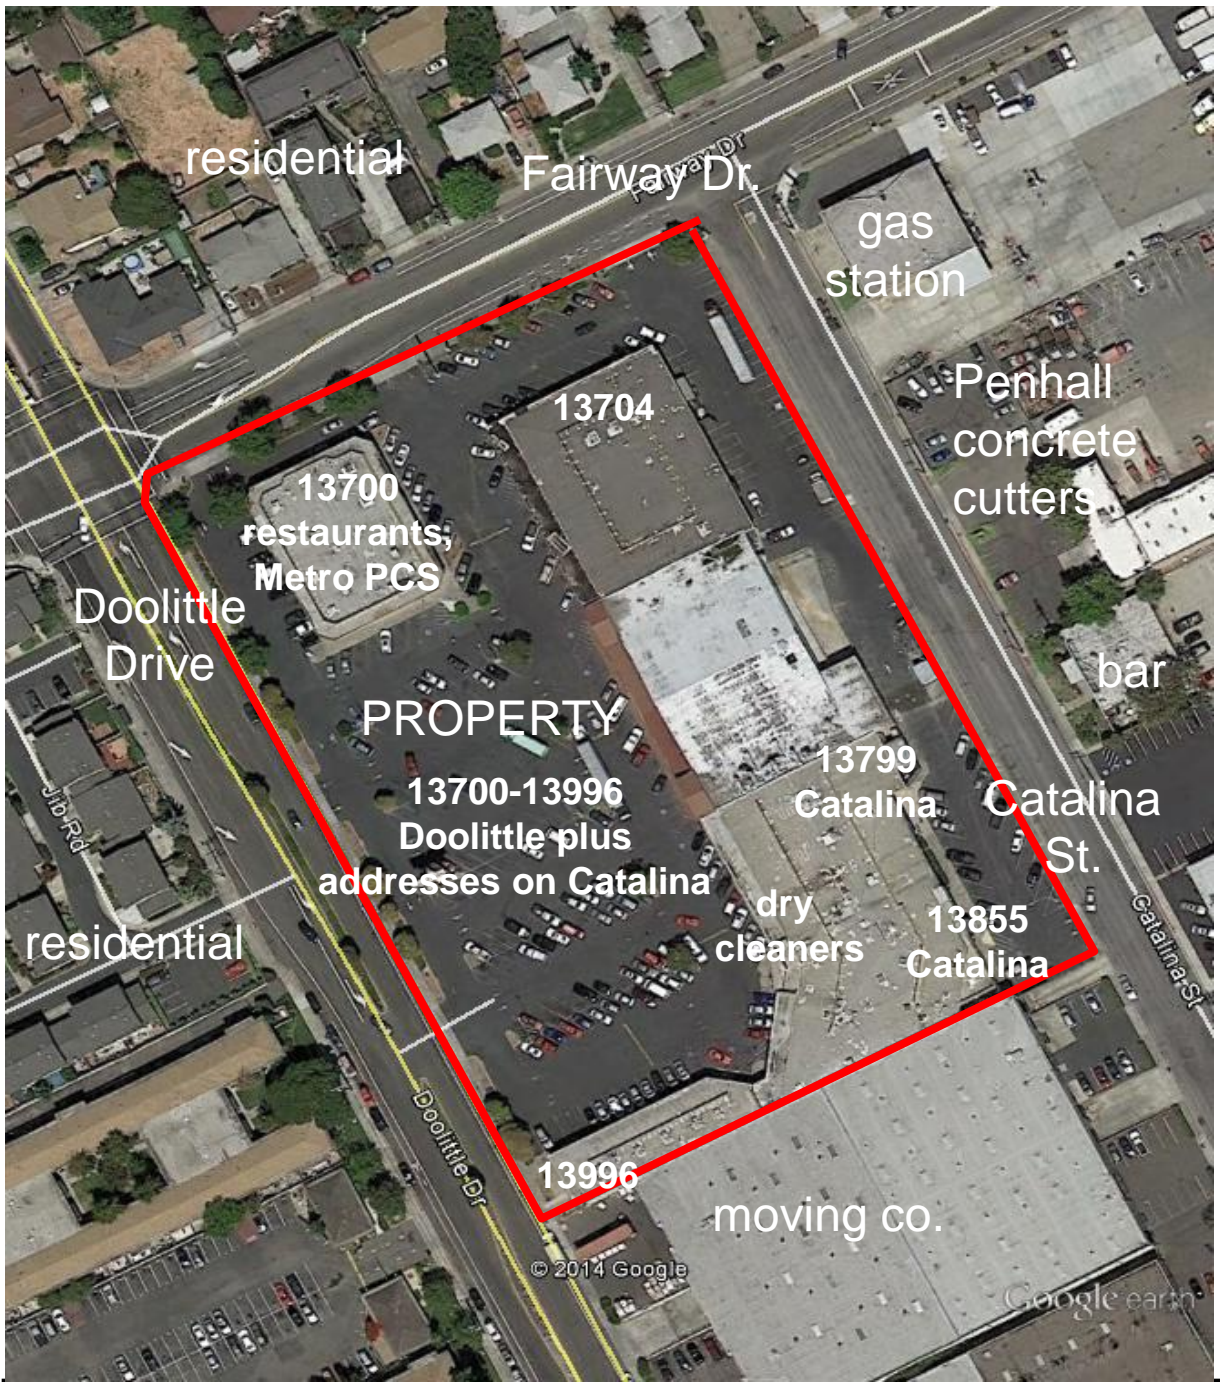
**FIGURE 2**  
**PROPERTY SITE PLAN**

13704-13996 DOOLITTLE DRIVE  
SAN LEANDRO, CALIFORNIA
