**PHASE III ENVIRONMENTAL SITE ASSESSMENT**

**1208 Lincoln Avenue  
Alameda, CA 94501**

**1410097ESAI**

**1/14/2015**

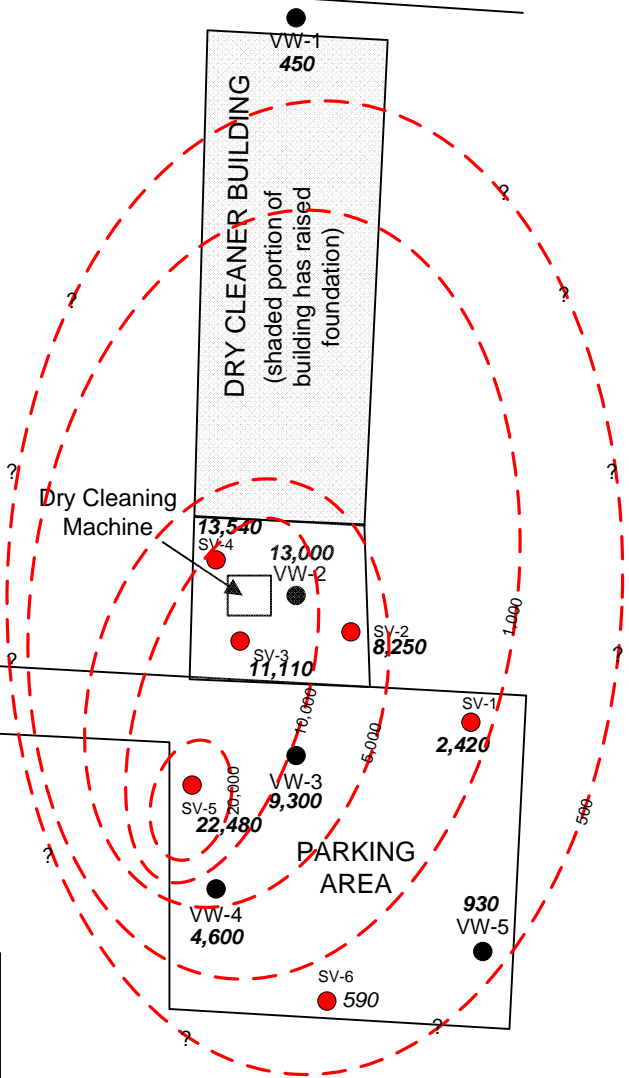
FIGURE 6

DRY CLEANER BUILDING  
(shaded portion of building has raised foundation)

- VW-5 Soil Vapor Well Location, December 2014
- SV-6 Soil Gas Sample Location, August 2014
- 22,480** Tetrachloroethene Concentration, (ug/m3)
- 20,000** Tetrachloroethene Isoconcentration Contour, ug/m3, dashed where approximate, queried where uncertain
- ug/L micrograms cubic meter (ug/m3)

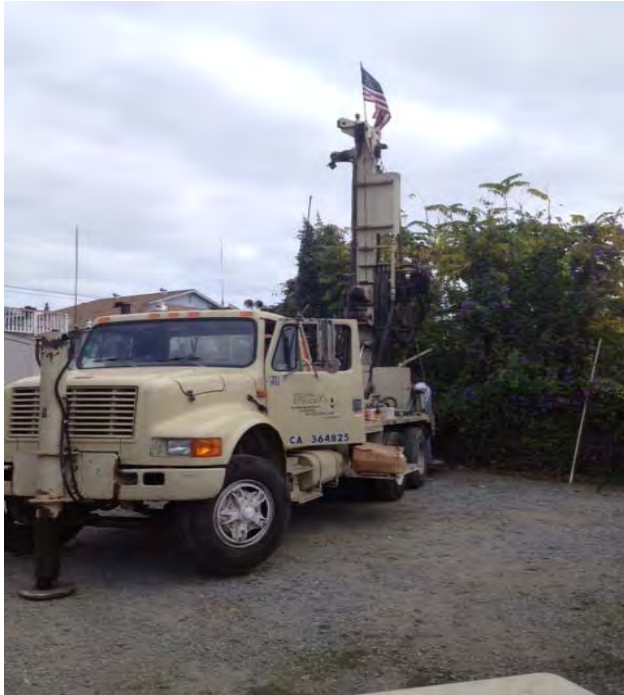
Drill Rig on Site, south of building in gravel lot.

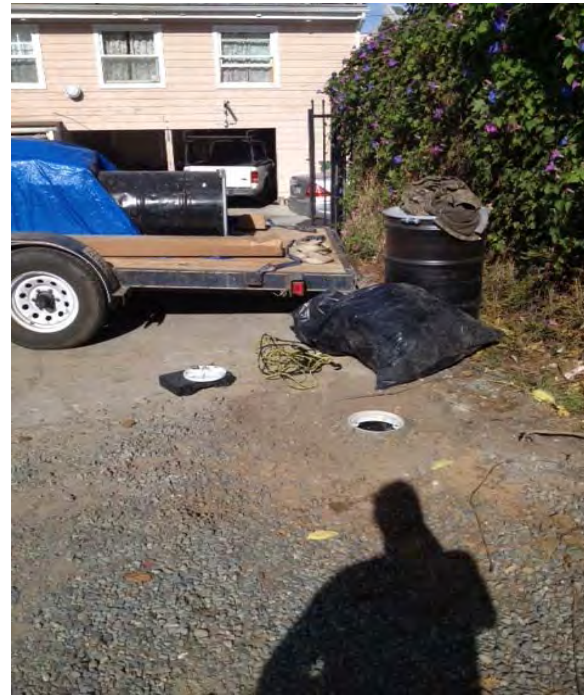
View of MW-3, looking northward

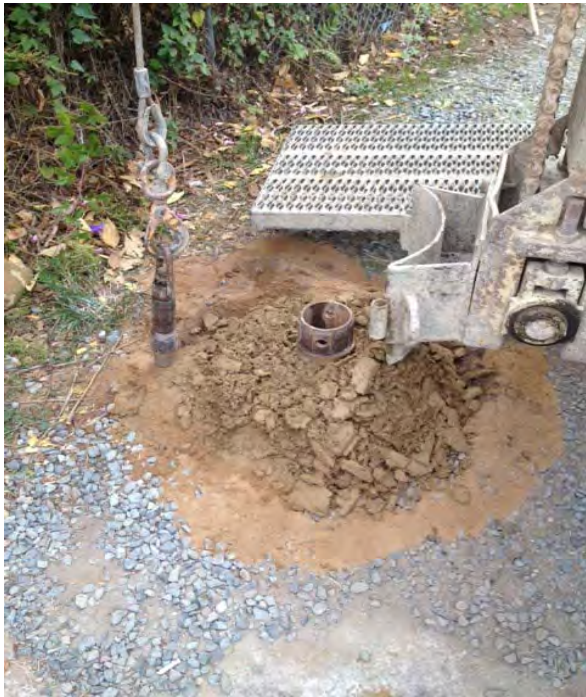
Hollow Stem Auger Drilling for Groundwater Monitoring Well

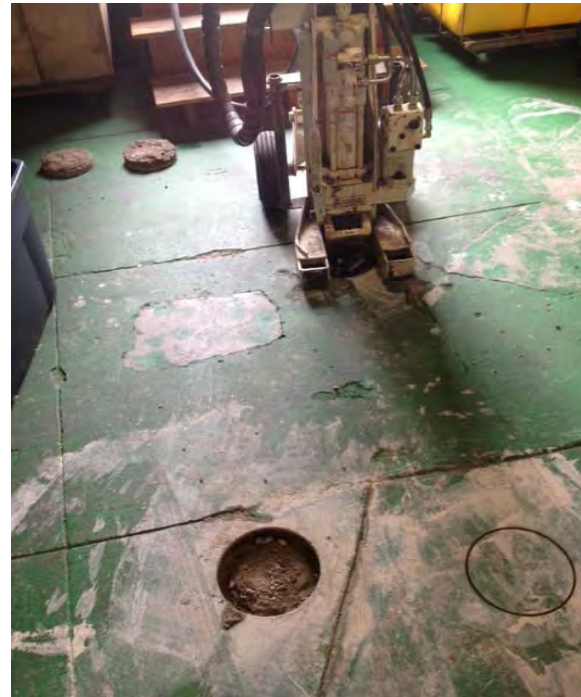
Cored slab, Indoor Limited Access Drilling

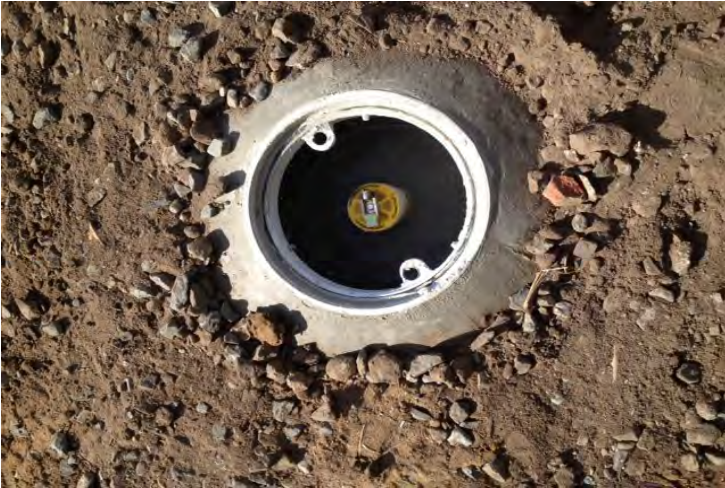
View of Monitoring Well Completion - 2 inch PVC casing.

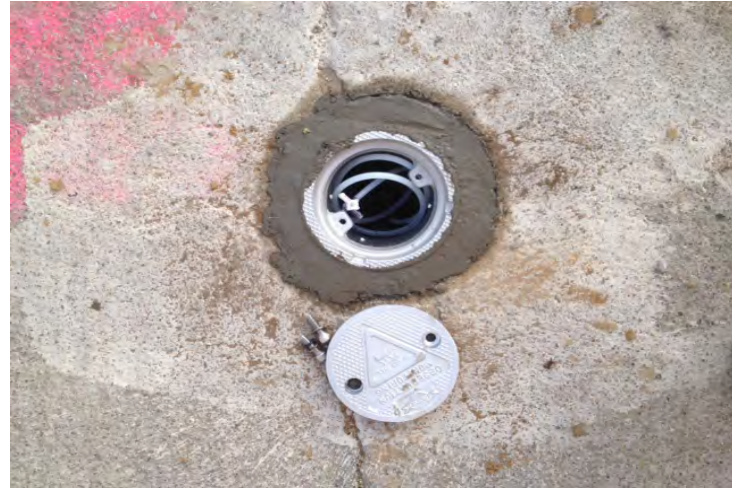
Permanent Soil Vapor Monitoring Well Completion

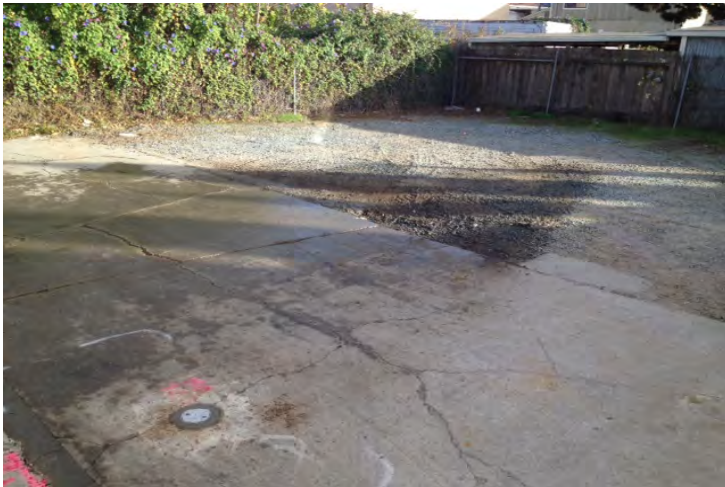
View of southern gravel parking lot and VW-3.

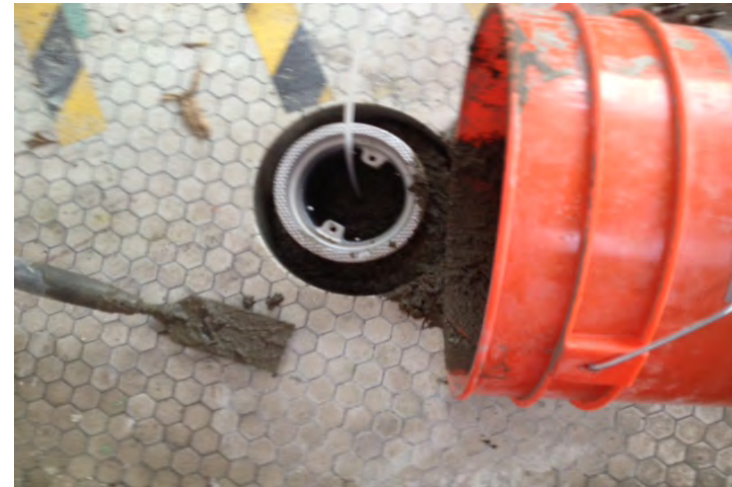
Vapor Monitoring Well Completion, Indoors

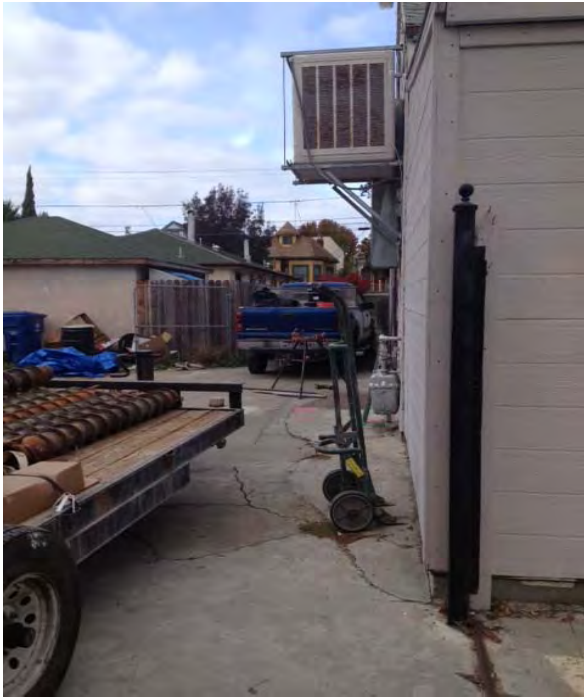
View at rear (south) of building

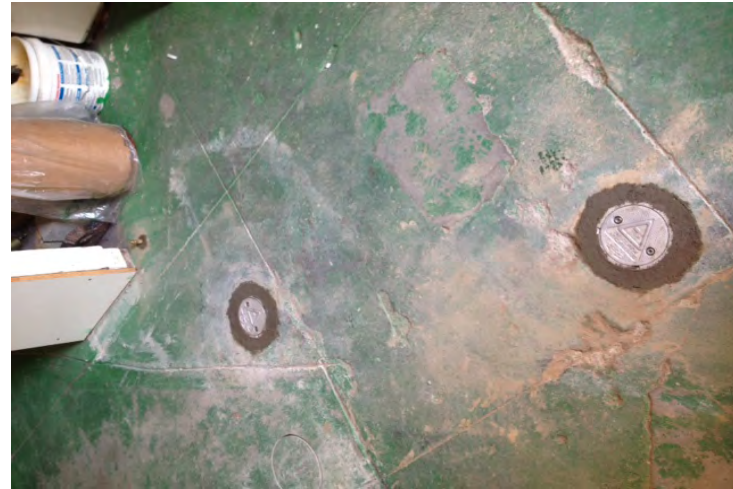
Showing indoor well completions and condition of concrete.

- The condition of the concrete slab was observed to be in poor condition with numerous cracks observed in the slab on grade portion of the foundation near the current dry-cleaning machine.
