**PHASE I
ENVIRONMENTAL SITE ASSESSMENT
RETAIL AND OFFICE BUILDING
1625 & 1635 CHESTNUT STREET
LIVERMORE, CALIFORNIA**

**ENERCON PROJECT NO. WAMU425 ,
WASHINGTON MUTUAL
AUTHORIZATION # 582469**

November 20, 2007

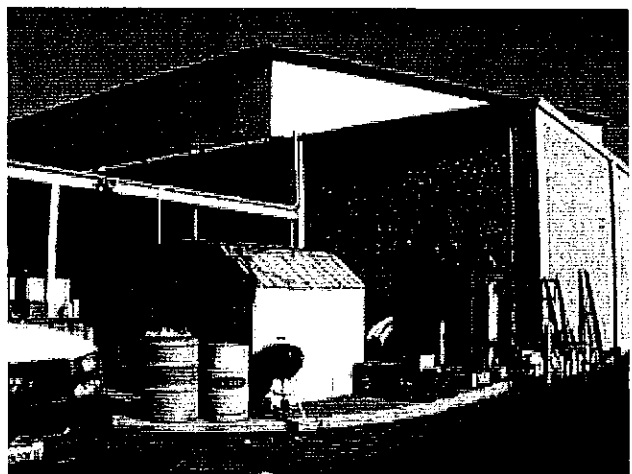
Photo 4: View of the southwest corner of the building on the subject property (note the pad-mounted transformer).

One pad-mounted transformer, owned and maintained by PG&E, was observed on the southwest corner of the subject property. The transformer appeared to be in good condition with no evidence of leaking at the time of the site inspection.

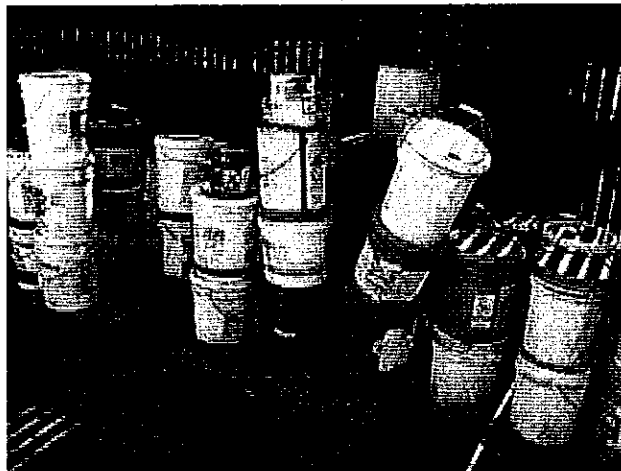
Photo 8: View of the on-site non-hazardous materials.

The subject property had a storage shed along the west side of the building that contained non-hazardous materials such as paint, paint thinner, and mortar. All non hazardous materials observed were stored on secondary containment platforms and there were no observed signs of spills or leaks.
