Re: **Technical Response Letter**
4901, 4915, 4919, 4921, 4939, and 4945 Broadway;
Parcel No. 013-1136-008-04 (no address);
311 and 313 51st Street;
4974, 4970, 4966 and 4964 Desmond Street;
Oakland, California

Re: **Technical Response Letter**
4901 Broadway and 4974, 4970, 4966 and 4964 Desmond Street
Oakland, California
ACDEH Case No. RO0003186
GeoTracker Global ID T0000007664

APPENDIX A

Photographs and Contractor Notes for Southeast Area

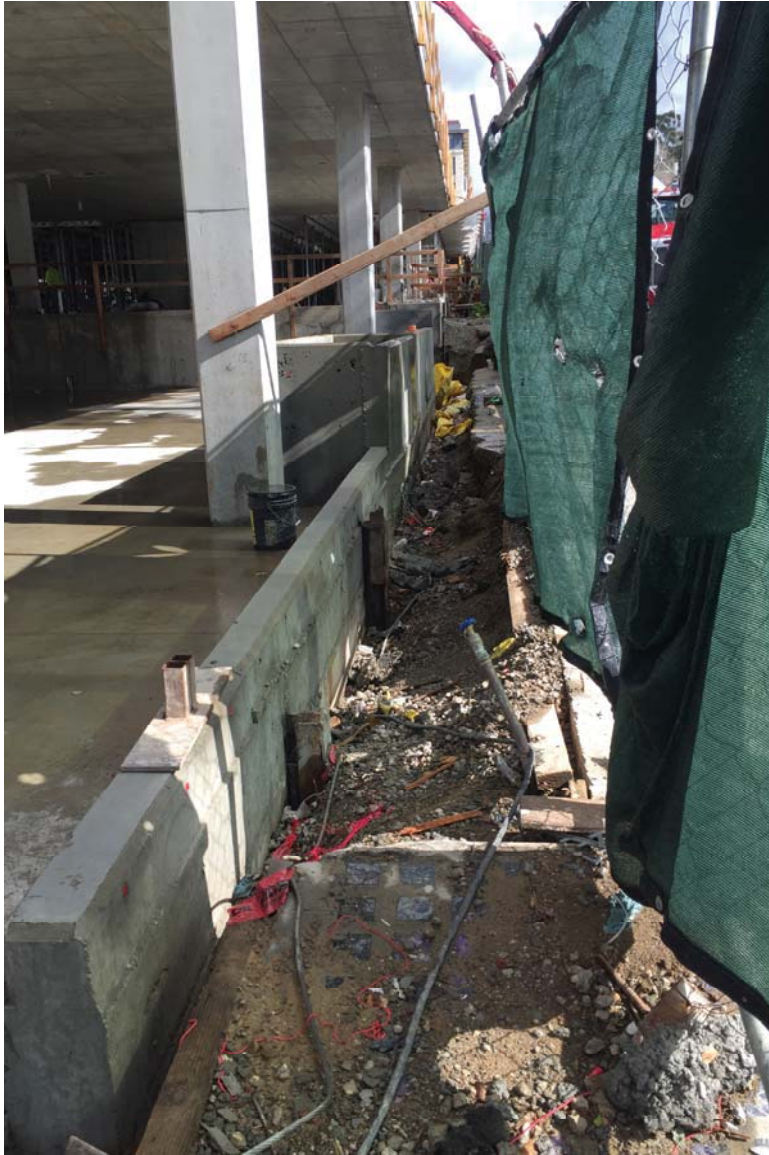
March 2017 Photograph of Southeast Area

The above information documents that lead impact in this area was excavated to approximately 18 ft bgs, replaced with imported gravel for compaction concerns, and covered by a concrete slab and lined planter boxes. Therefore, the lead impact of concern was not only removed, but the concrete slab limits the potential exposure pathway to subgrade soil/gravel in this area.

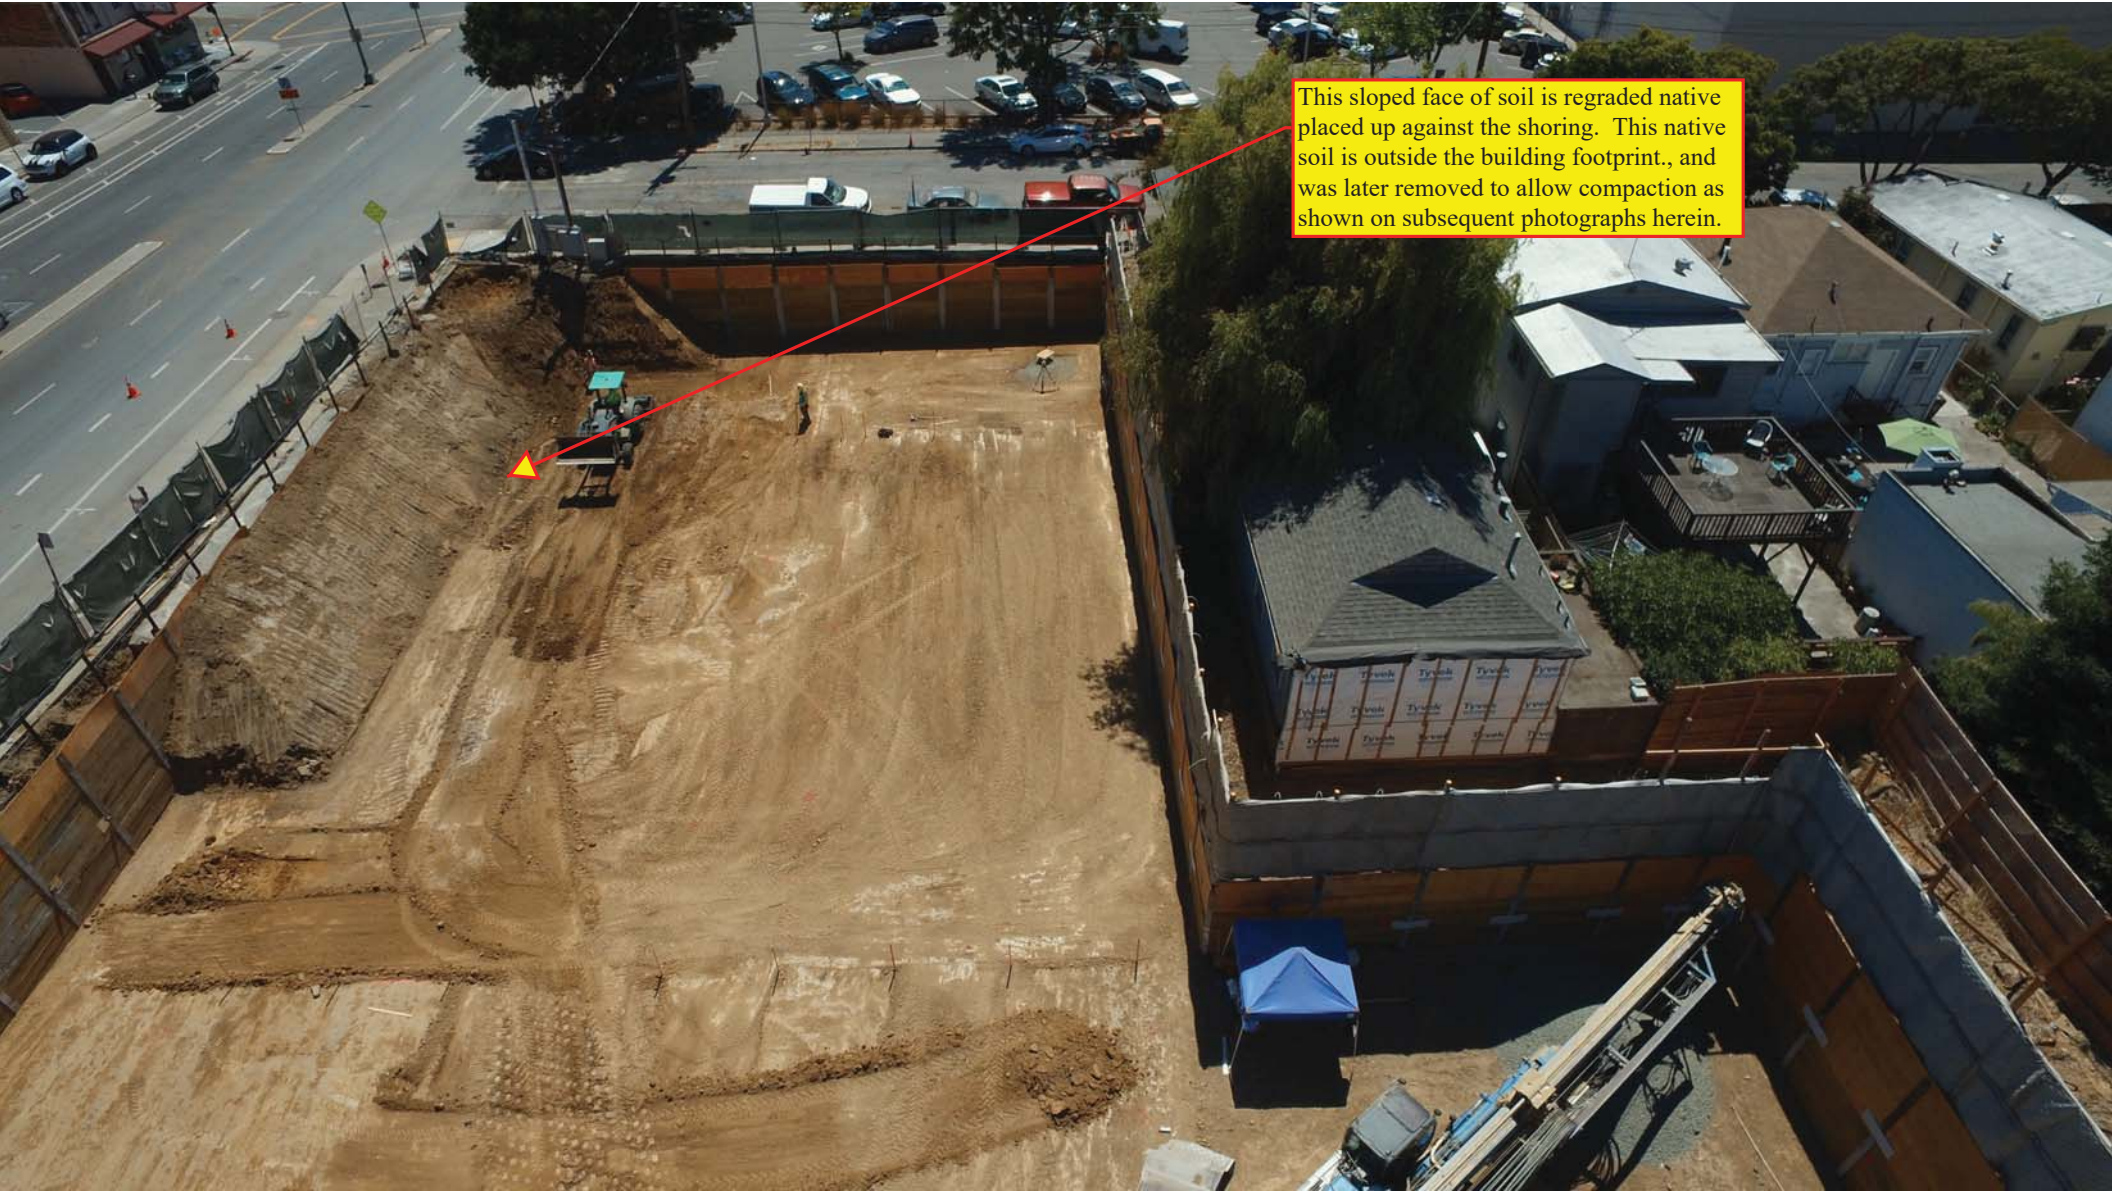
As shown on Figures 7 and 9 of the *Excavation Report*, the shoring activity involved the excavation of soil in the southern corner and sidewall to a minimum of approximately 12 ft bgs. The original shoring plan was expanded to include additional shoring within the southeast area to facilitate the sloping. Shoring was added to allow a greater depth of soil removal well beyond the concrete slab designed needed for excavation to reach the deeper TPH impact in this area. During the shoring installation and TPH removal, the shallow soil along the southeastern wall was excavated to approximately 18 ft at the northern extent and 12 ft at the southern extent. Following the installation of the shoring shown on Figure 9, other site soil was graded and placed up against the shoring within the area beyond the building envelope. This re-graded native soil was later removed to allow compaction of imported gravel as shown on annotated photographs in Appendix A.

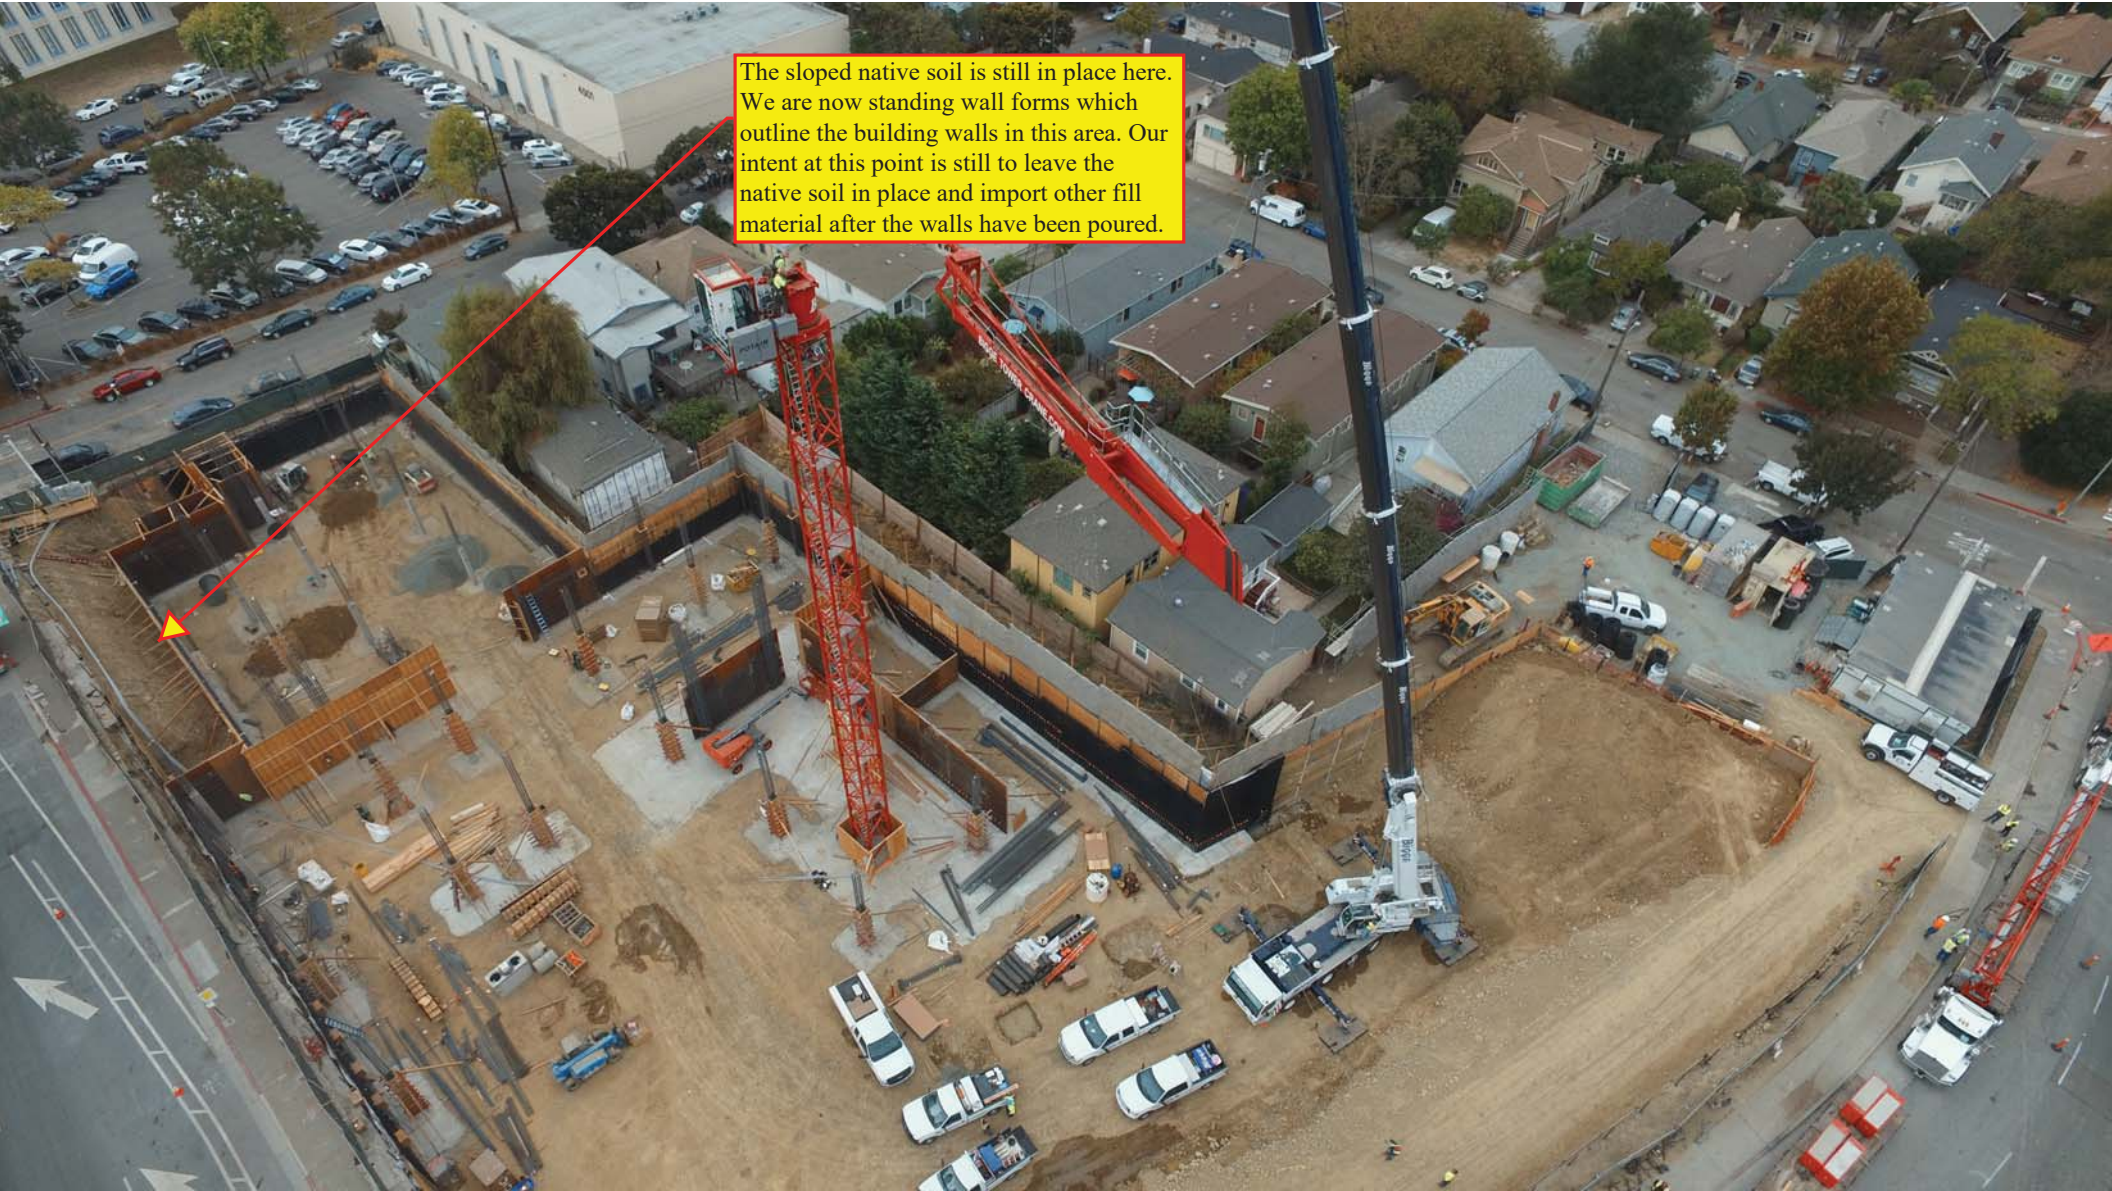
This sloped face of soil is regraded native placed up against the shoring. This native soil is outside the building footprint., and was later removed to allow compaction as shown on subsequent photographs herein.

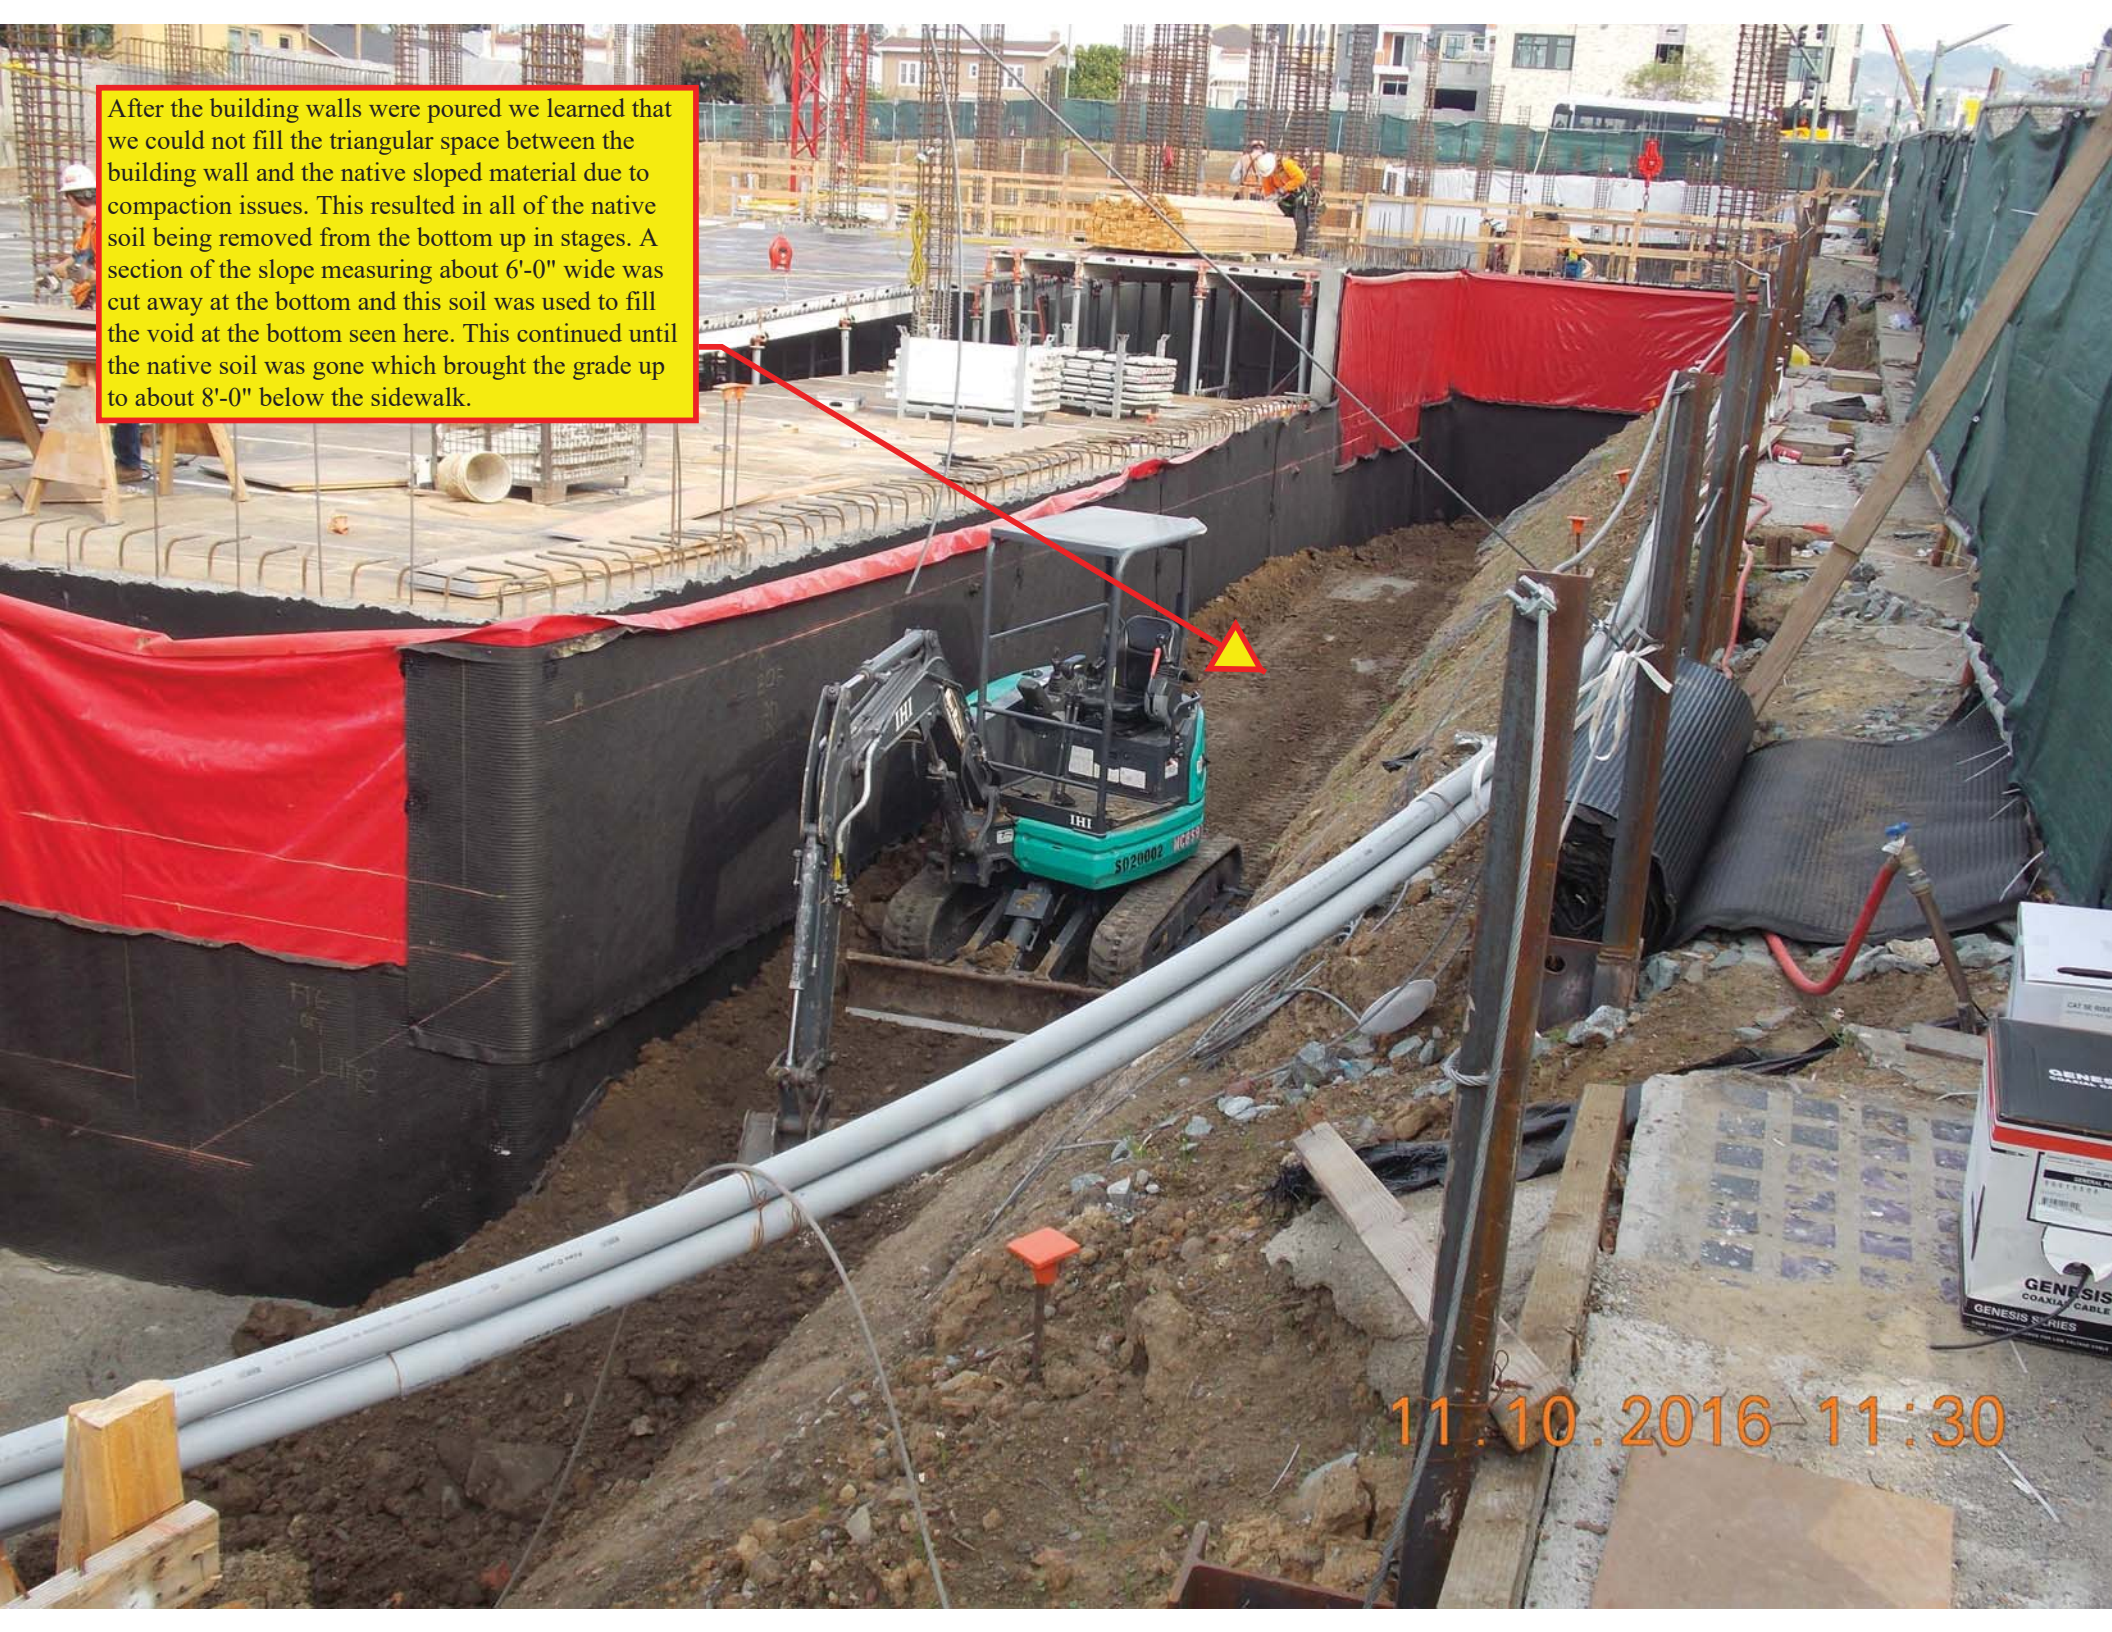
The sloped native soil is still in place here. We are now standing wall forms which outline the building walls in this area. Our intent at this point is still to leave the native soil in place and import other fill material after the walls have been poured.

After the building walls were poured we learned that we could not fill the triangular space between the building wall and the native sloped material due to compaction issues. This resulted in all of the native soil being removed from the bottom up in stages. A section of the slope measuring about 6'-0" wide was cut away at the bottom and this soil was used to fill the void at the bottom seen here. This continued until the native soil was gone which brought the grade up to about 8'-0" below the sidewalk.

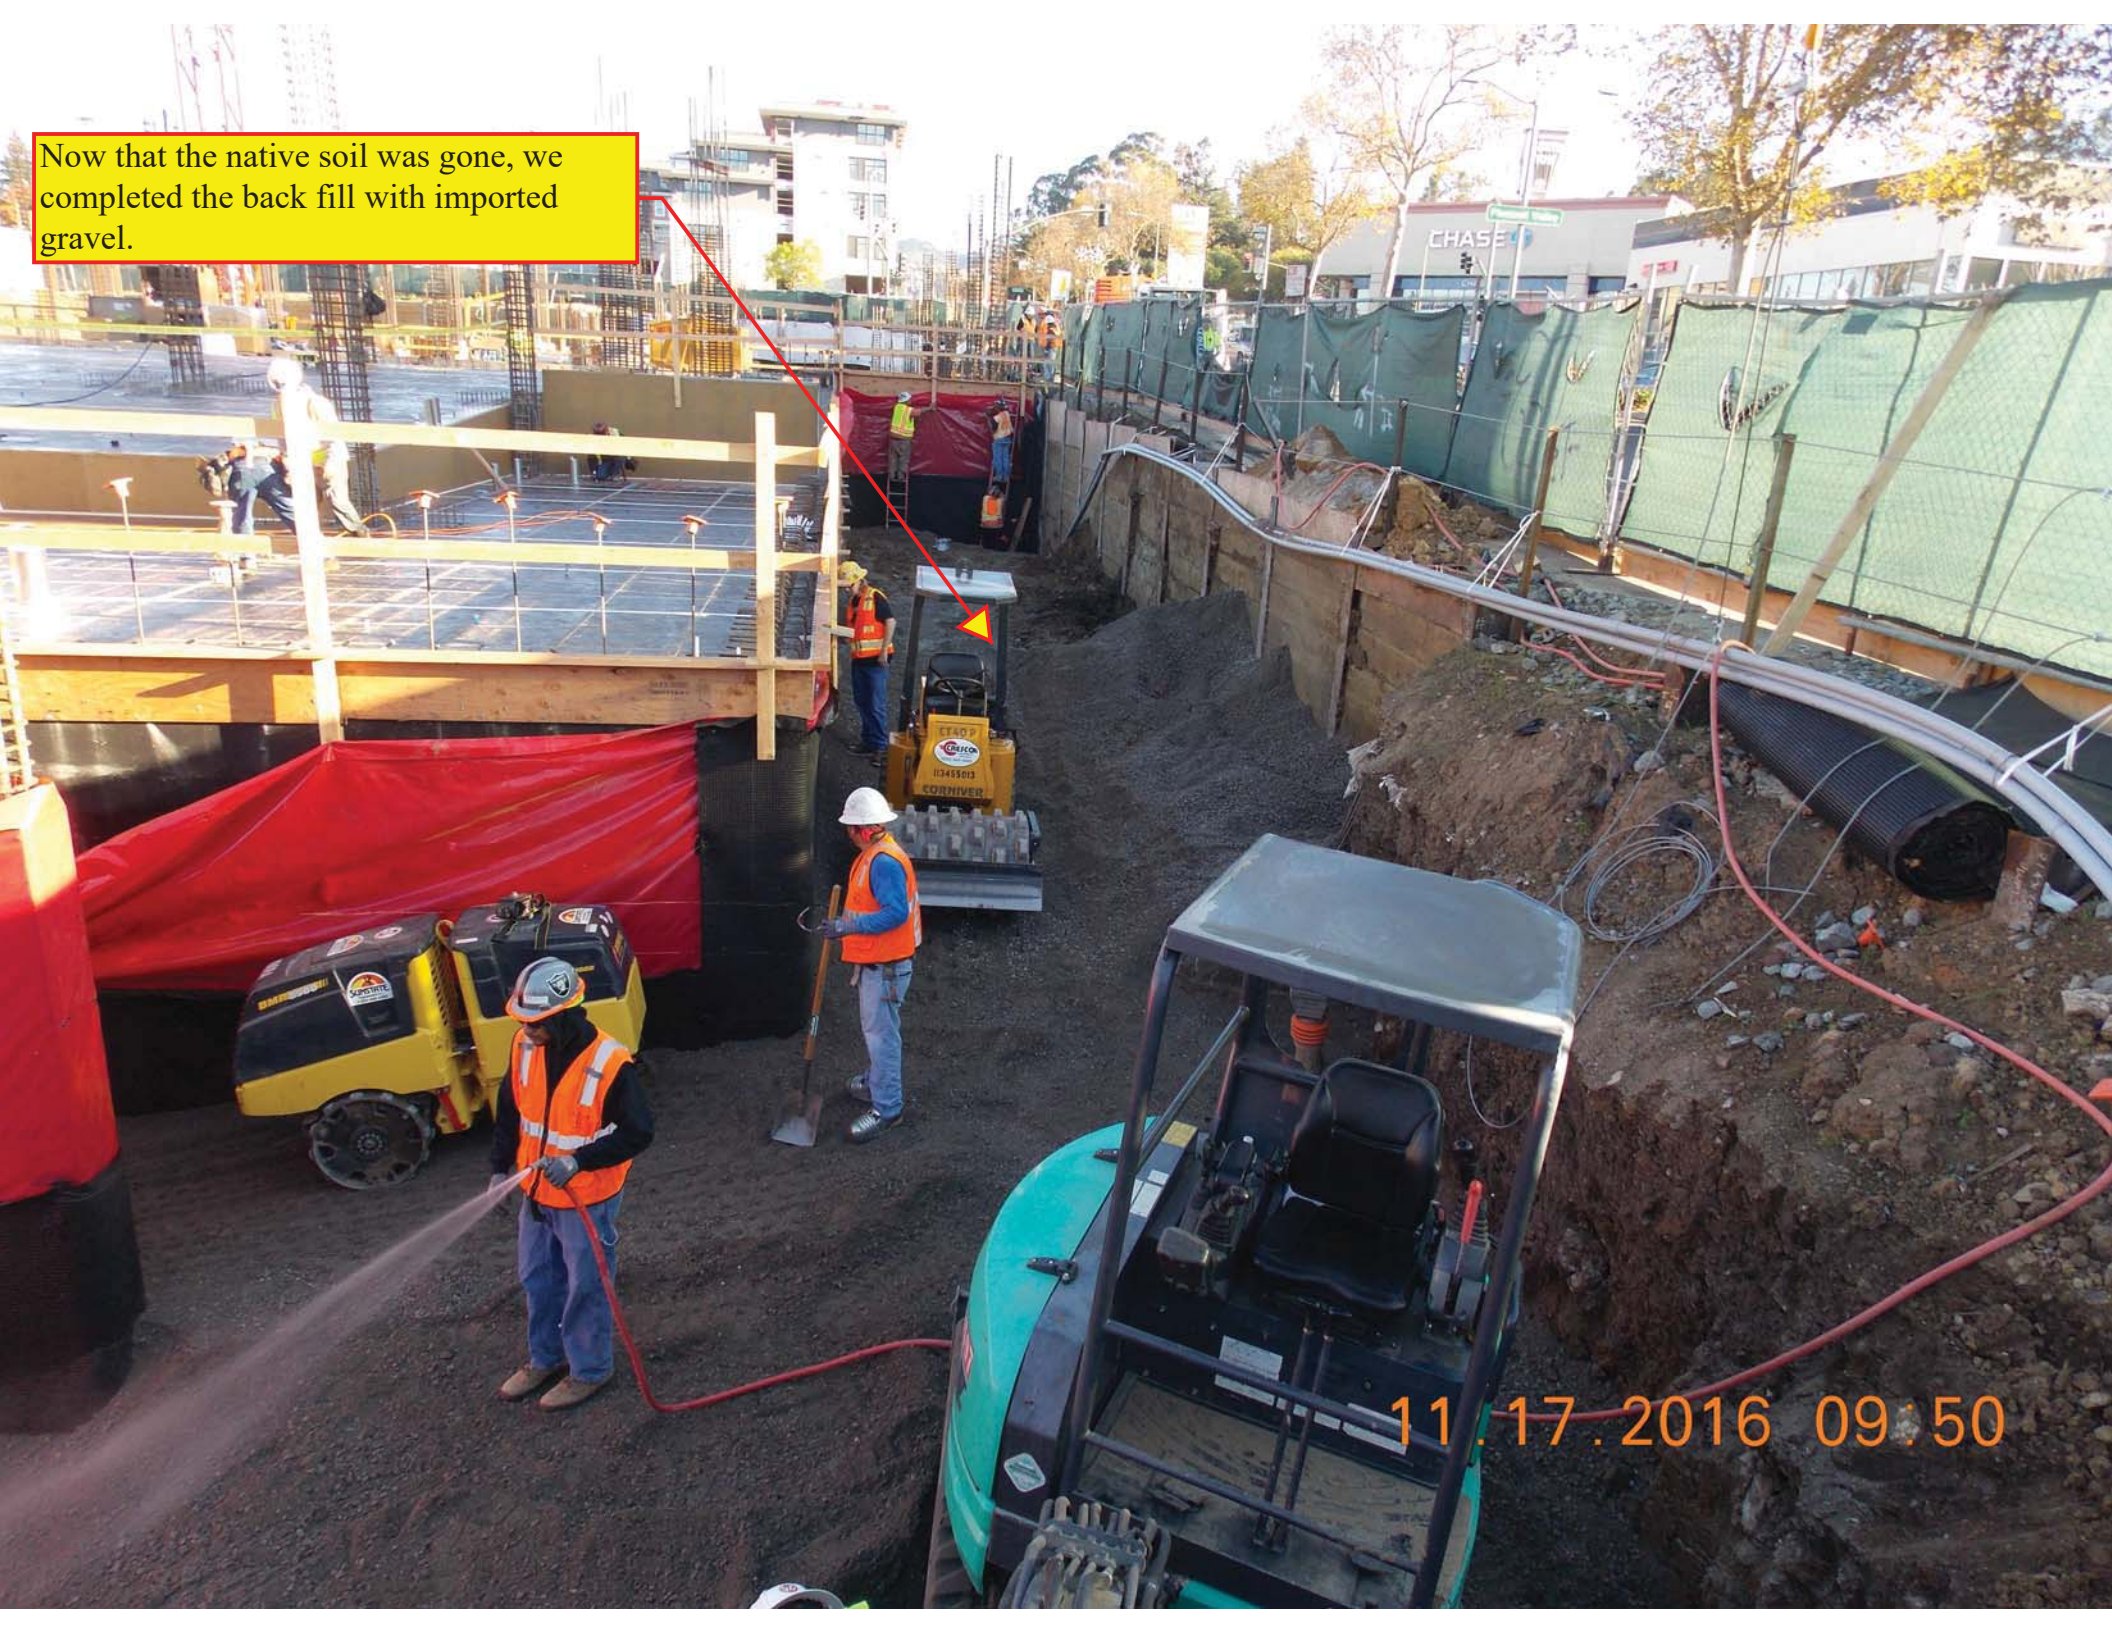
11.10.2016 11:30

Now that the native soil was gone, we completed the back fill with imported gravel.

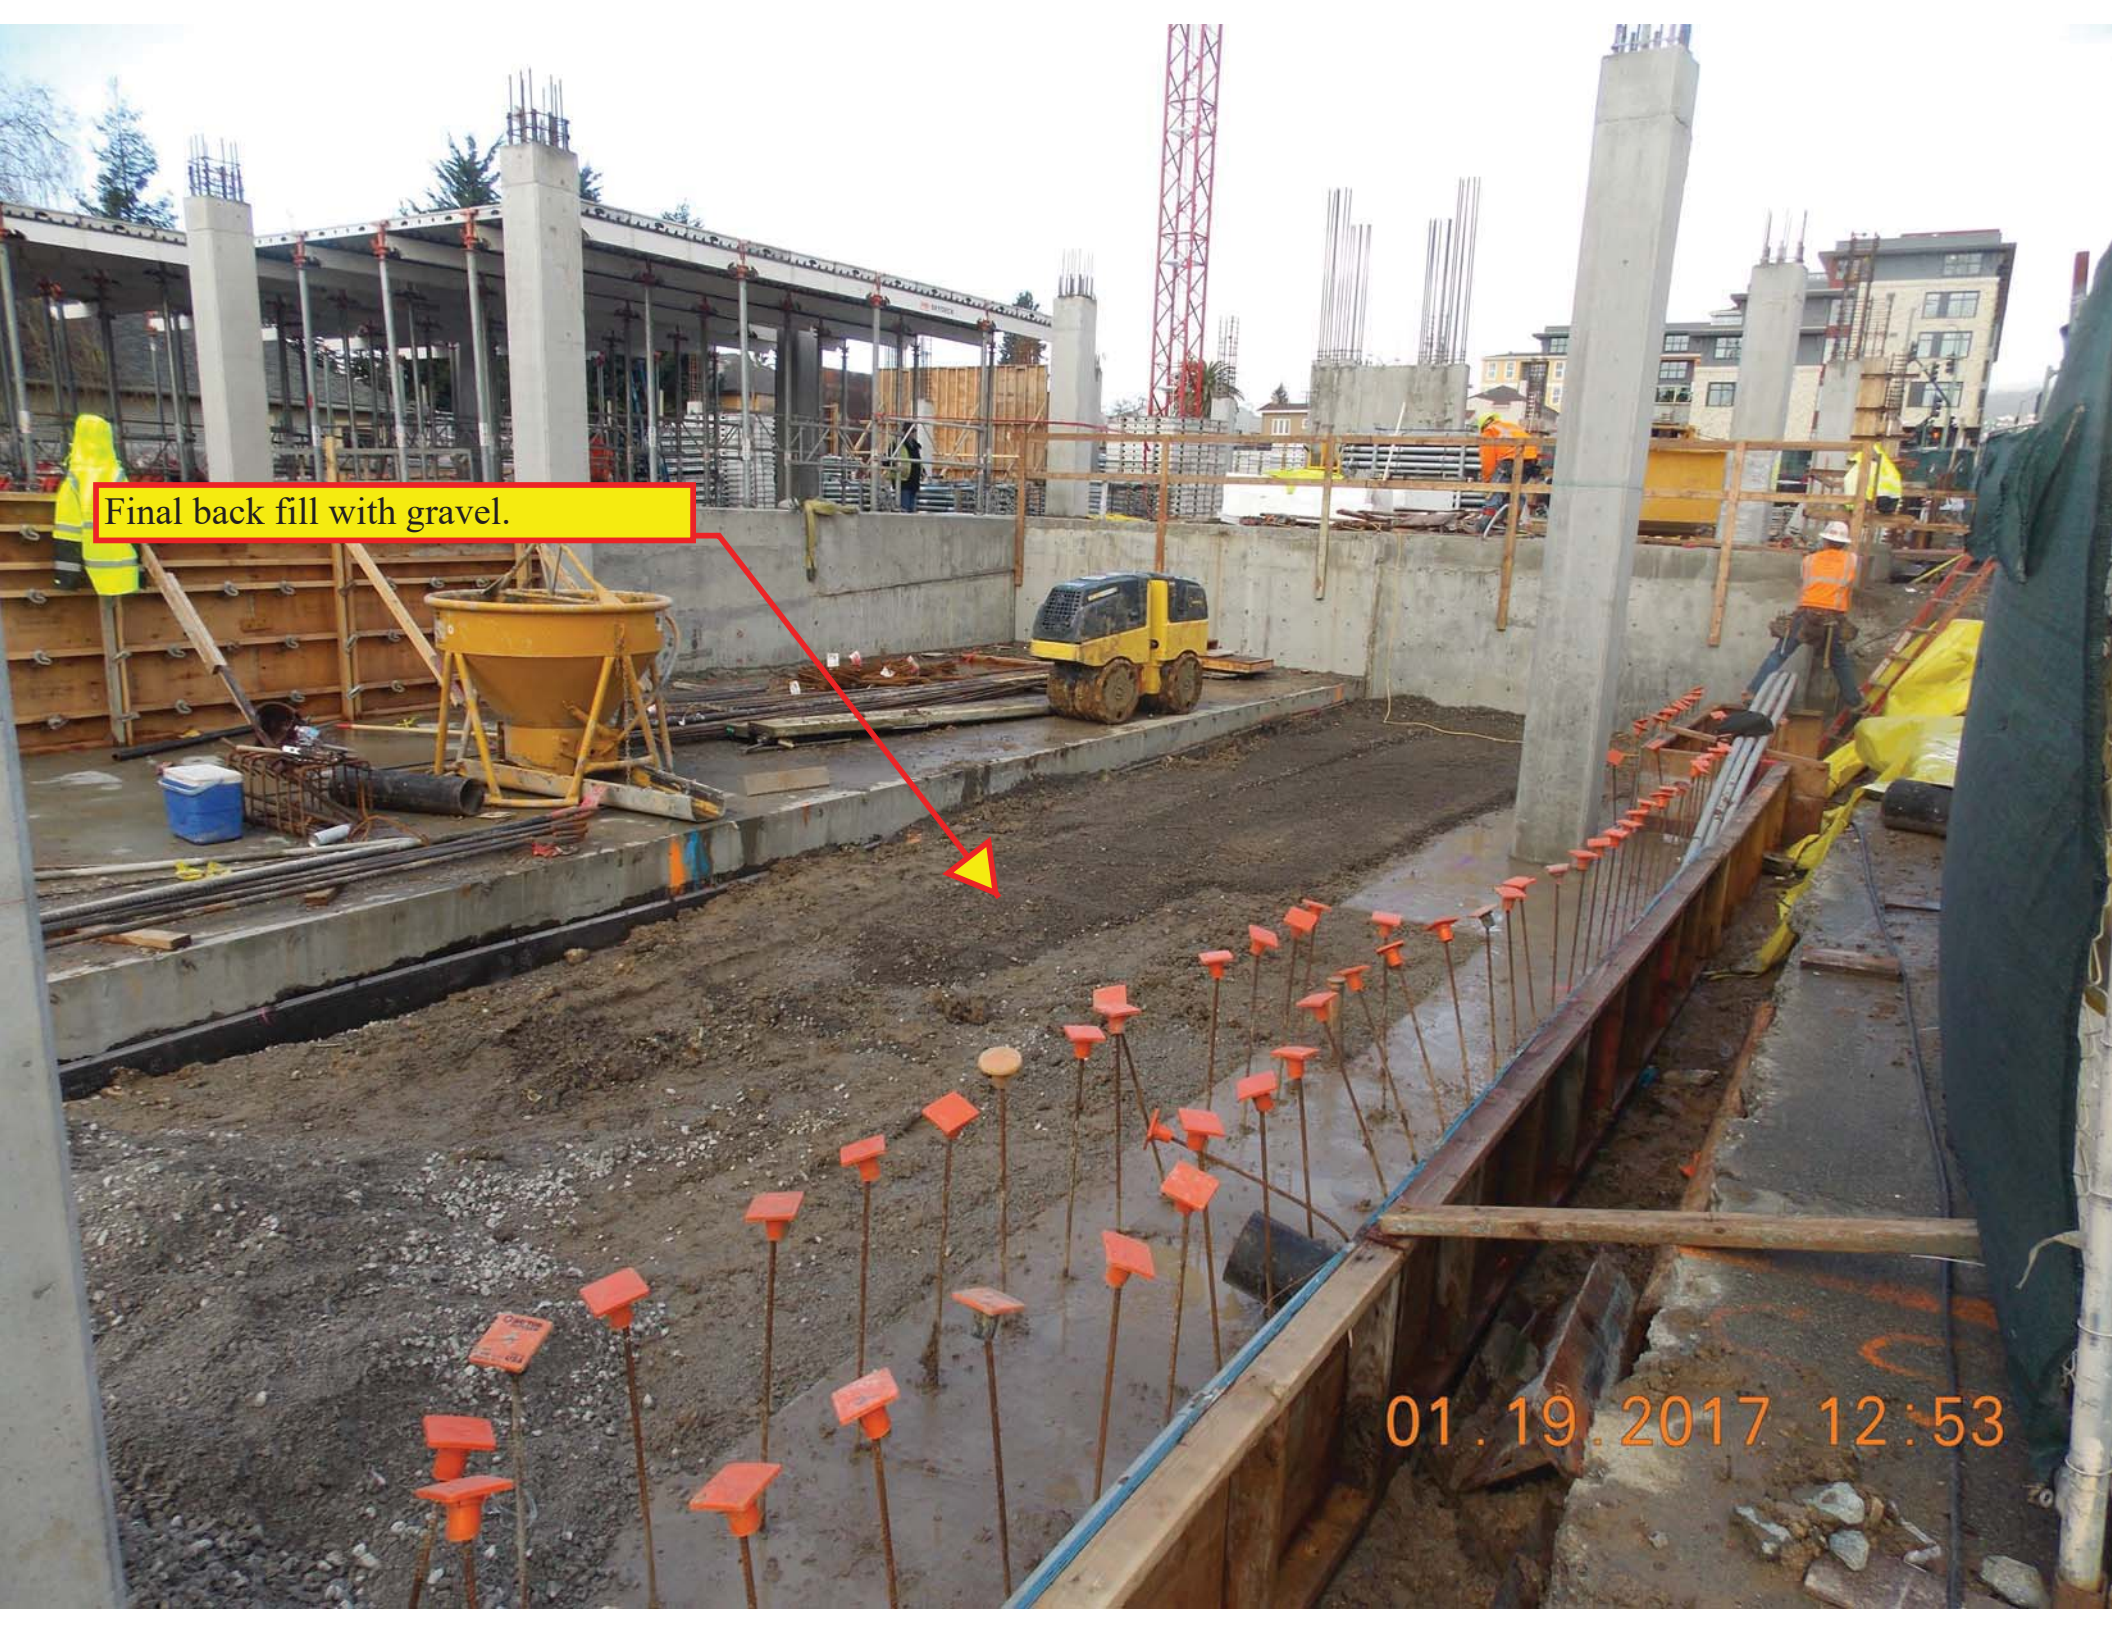
12.06.2016 13:08

Final back fill with gravel.

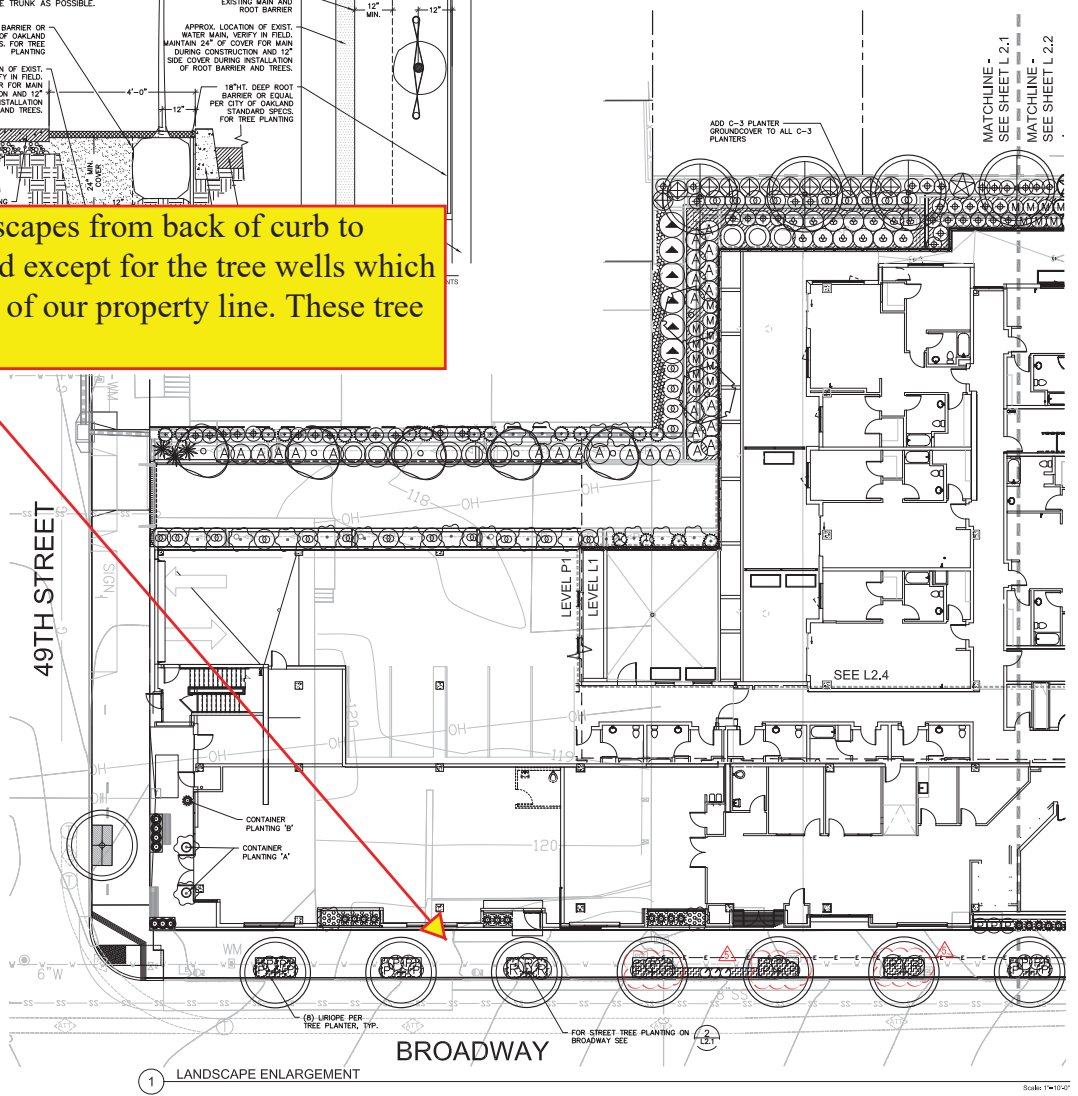
PERMIT RESUBMITTAL
 LANDSCAPE PLAN
 - AT GRADE

The completed project will have hardscapes from back of curb to building wall. No soils will be exposed except for the tree wells which are located in the right of way outside of our property line. These tree wells will have 12" of new topsoil.

As shown on annotated photographs in Appendix A, there will be no exposed soil along Broadway which encompasses the area of concern. The small planters are lined and above grade, and will be filled with landscape soil/topsoil. The public right of way will have new concrete sidewalks poured.
