BATARSE  
PHASE 1  
REPORT

**BATARSE PROJECT SITE**  
**East 14<sup>th</sup> Street and 105<sup>th</sup> Avenue**  
**Oakland, California**

**Phase I Environmental**  
**Site Assessment Report**

**October 2000**

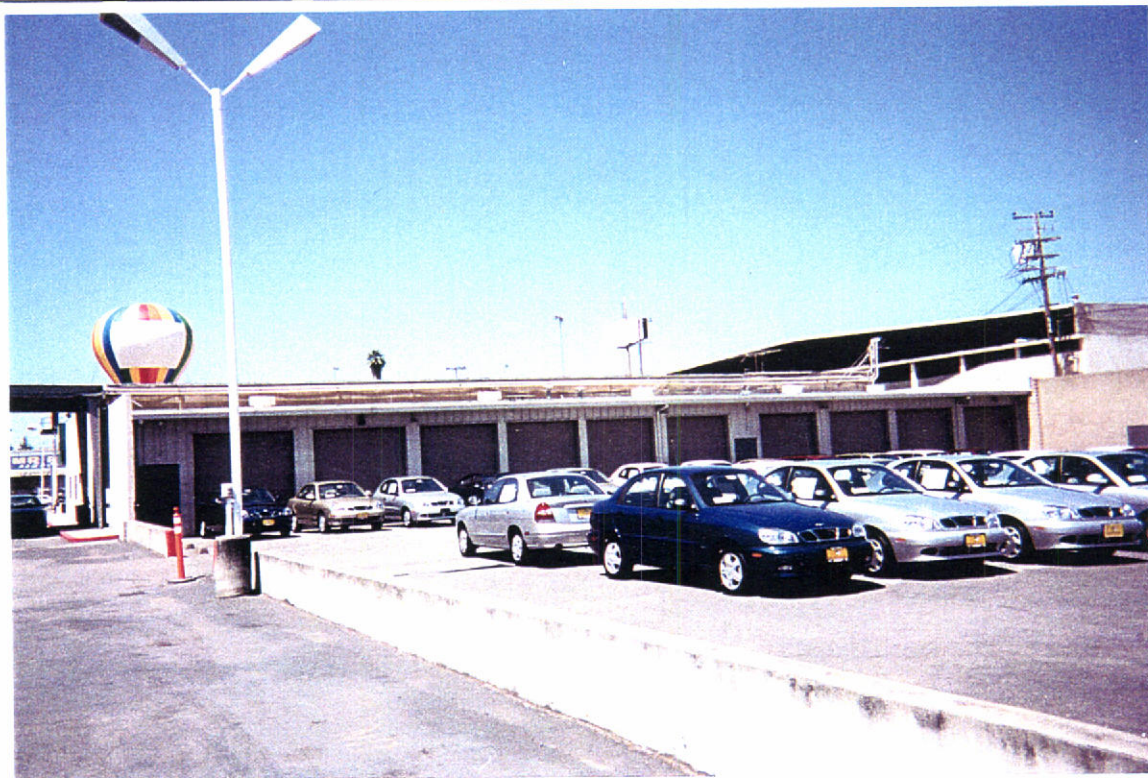
According to Mr. Rich, the property owner's representative, vehicle repairs have not been performed on these parcels for approximately one year. However, waste oils and solvents were used on these parcels in the past. These substances were stored in tanks and drums located within or near the service buildings.

Several aboveground storage tanks (ASTs) were observed inside the buildings on these parcels. At the time of ENSR's visit, these ASTs were empty. Staining was noted on the concrete floor around some of the ASTs.

A number of hydraulic lifts were present on these parcels in the past; however, one lift was present at the time of ENSR's visit. A subsurface oil/water separator was also present on the site at the time of our visit. The contents of the oil/water separator were not observed

2. Maintenance shop for Lloyd Wise at 1424 105<sup>th</sup> Avenue.

- Due to the past history (dating back to the 1960s) of auto repair/vehicle maintenance at 1424 105<sup>th</sup> Avenue and in the service building at 10550 East 14<sup>th</sup> Street, consideration should be given to collection and analysis of soil and groundwater samples from the areas around these buildings.

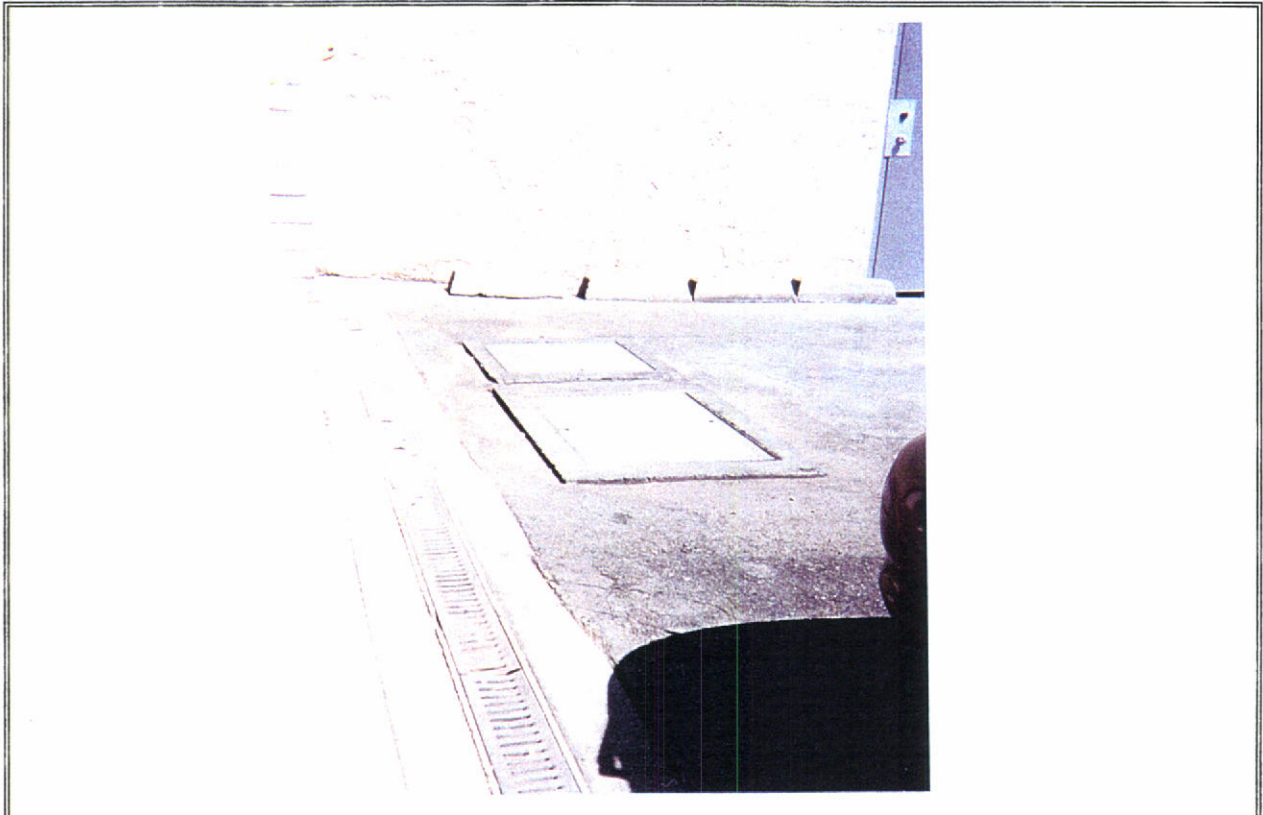
3. Oil/water separator at Lloyd Wise maintenance shop (1424 105<sup>th</sup> Avenue).

- A subsurface oil/water separator and sump are present at 1424 105th Avenue. ENSR recommends that soil and groundwater samples be collected from the areas of the oil/water separator and sump to evaluate if leakage has occurred in the past.

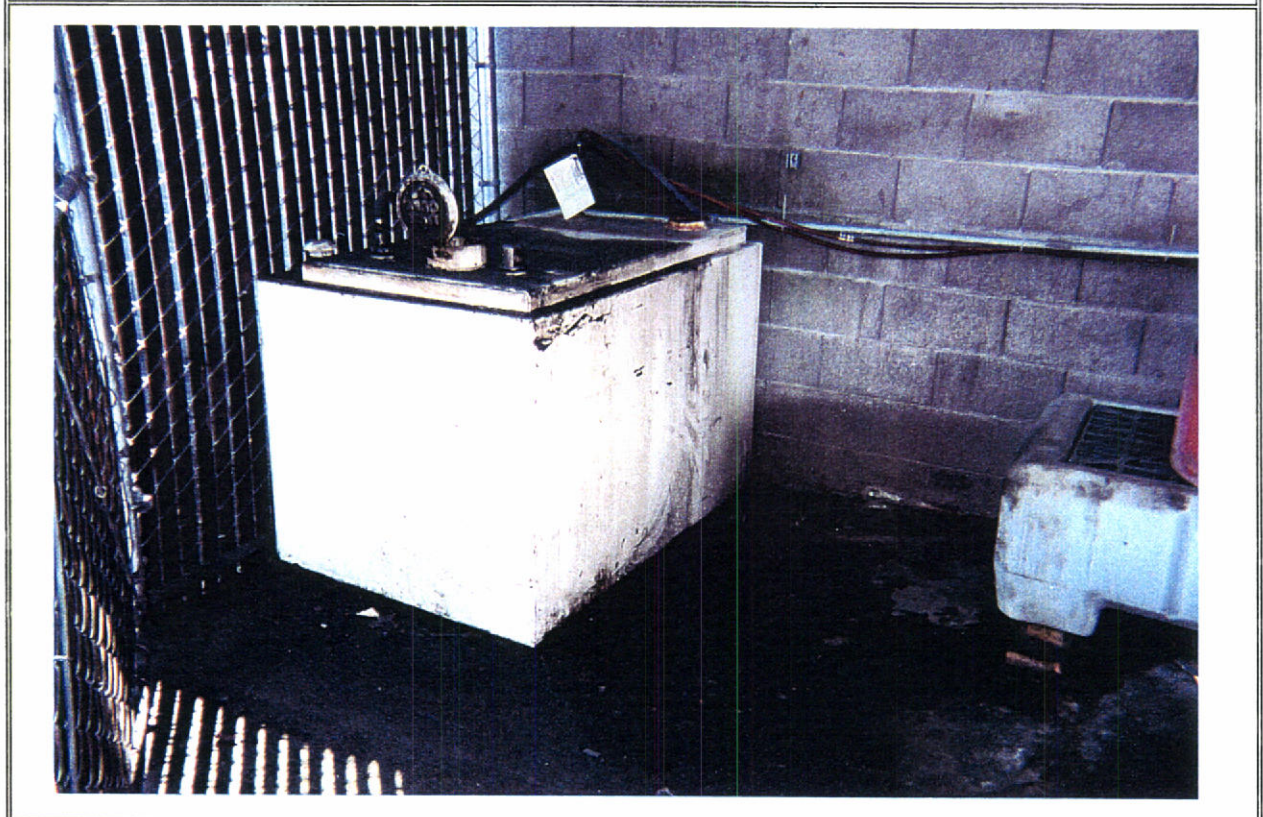
4. Empty AST outside Lloyd Wise service building (10550 East 14<sup>th</sup> Street).

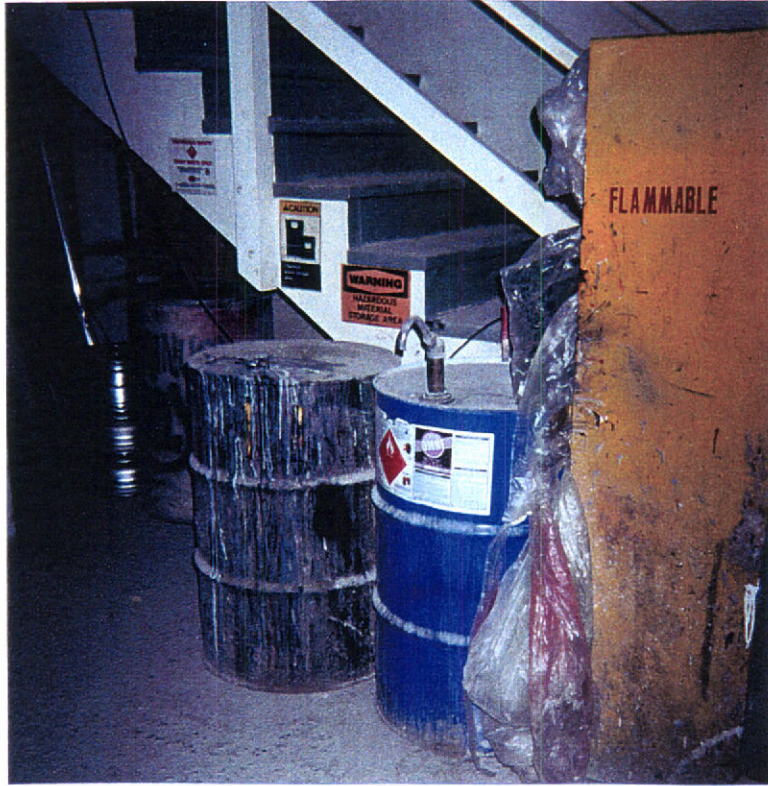
5. Drums of new thinner and waste paints/thinners at Bill & Bill's (1500 105<sup>th</sup> Avenue).

- ENSR recommends collection and analysis of soil and groundwater samples from the area around 1500 105<sup>th</sup> Avenue to evaluate if past activities at the candy factory and photo development laboratory have impacted the subsurface.

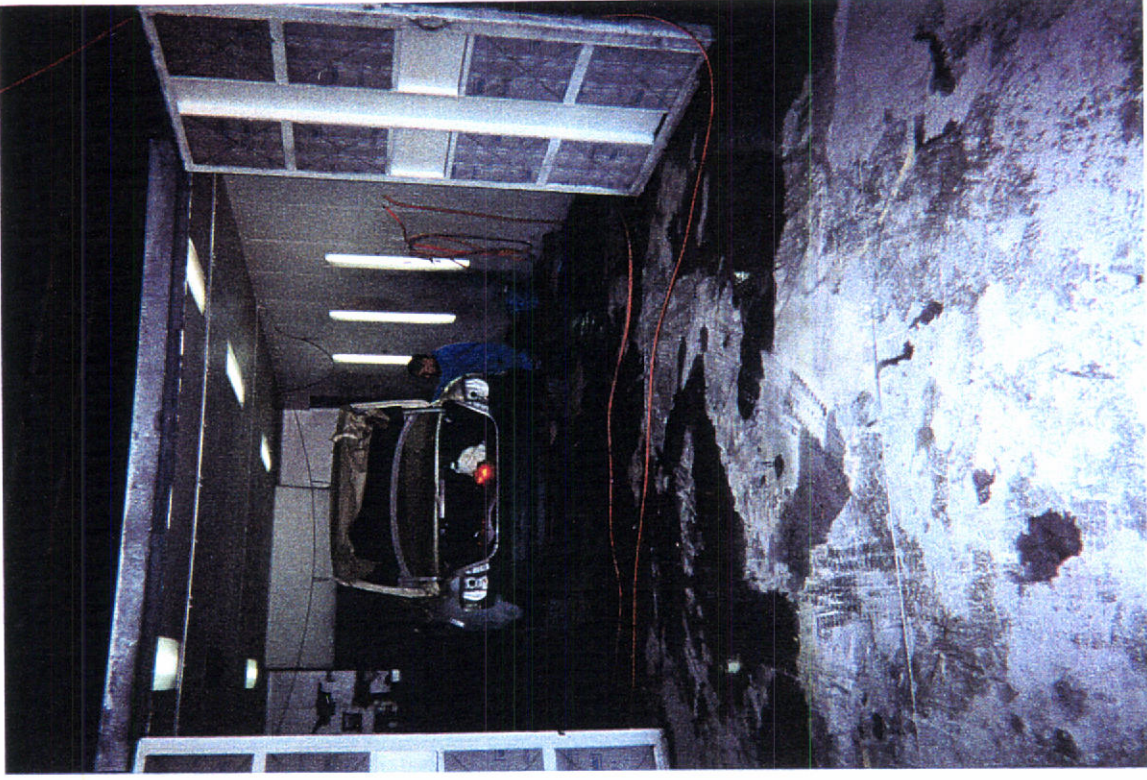
8. Spray paint booth at Ward's Custom Paints.

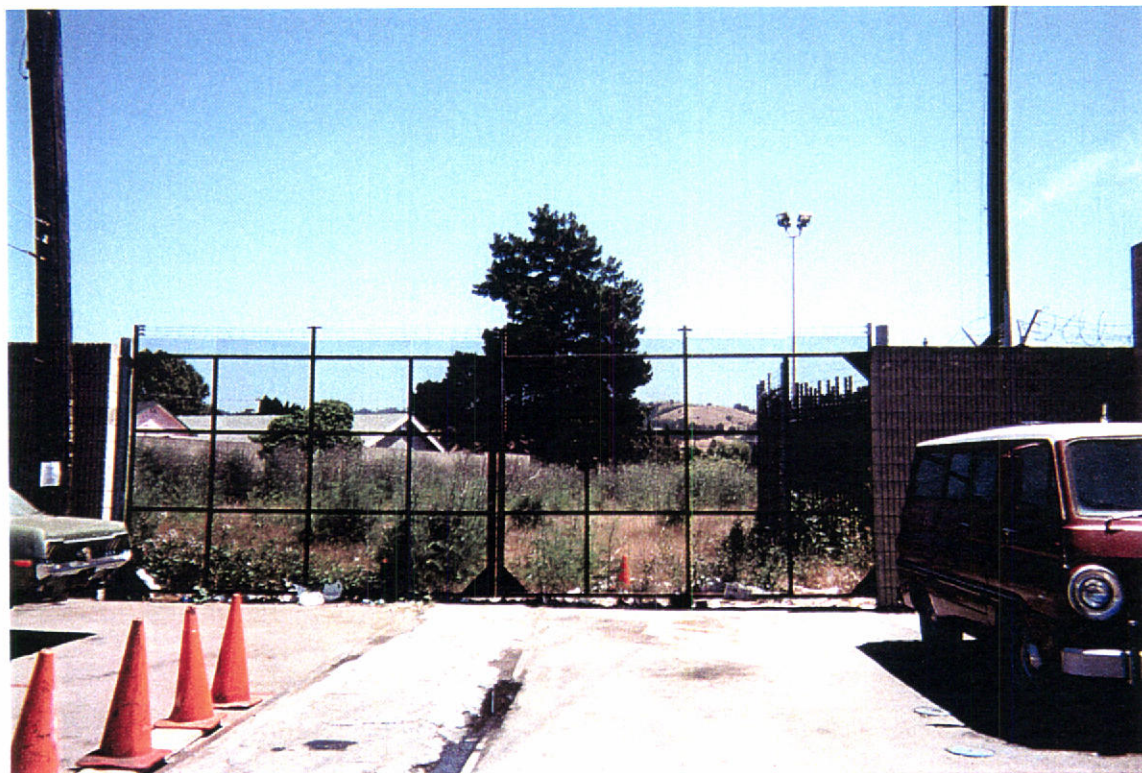
10. A/C Transit Parcel (northeast end of 105<sup>th</sup> Avenue).

- ENSR recommends collection and analysis of soil and groundwater samples from borings placed on the A/C Transit parcel to evaluate impacts to the project site from the A/C Transit vehicle wash building (i.e., leakage from chemical storage areas or subsurface oil/water separators).

- Soil samples should be collected from along the railroad tracks located on the A/C Transit and UPRR parcels to evaluate the subsurface conditions in these areas.
